Project 678  
appendix A

1/18/2001  
report

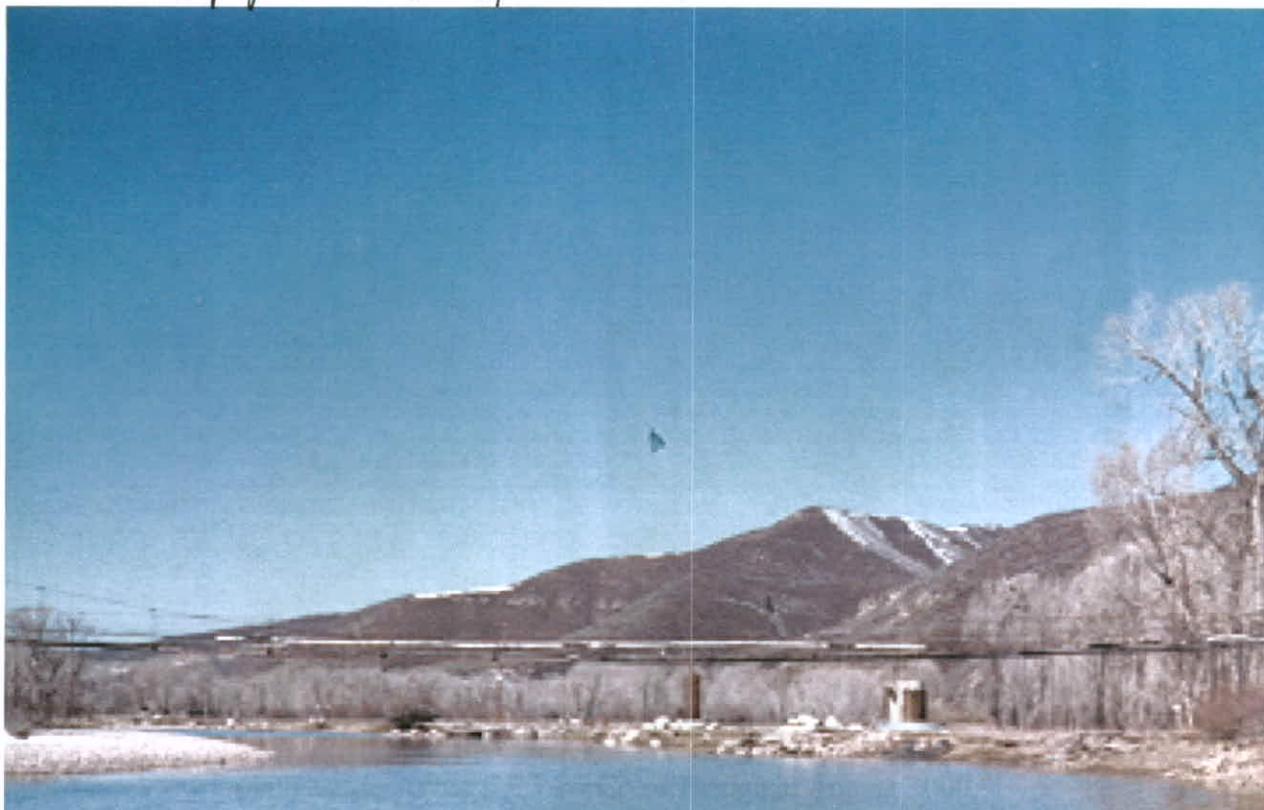
Photo 1 – View of Tow Creek Bridge looking west.

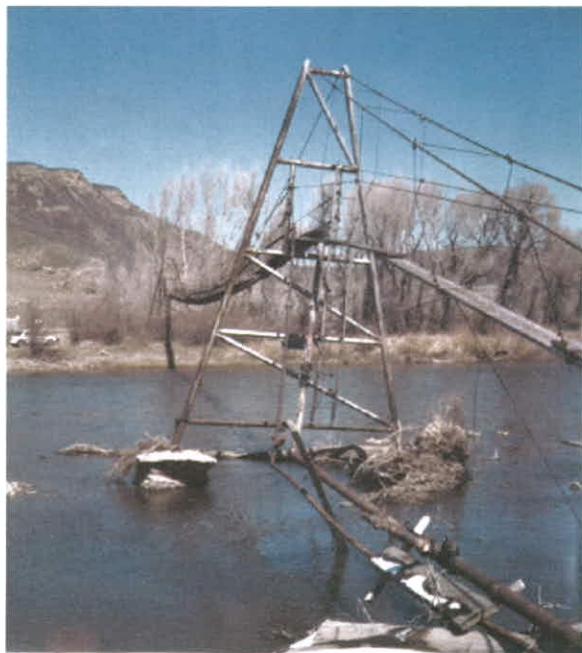
Photo 2 – View looking north at south bridge abutment.

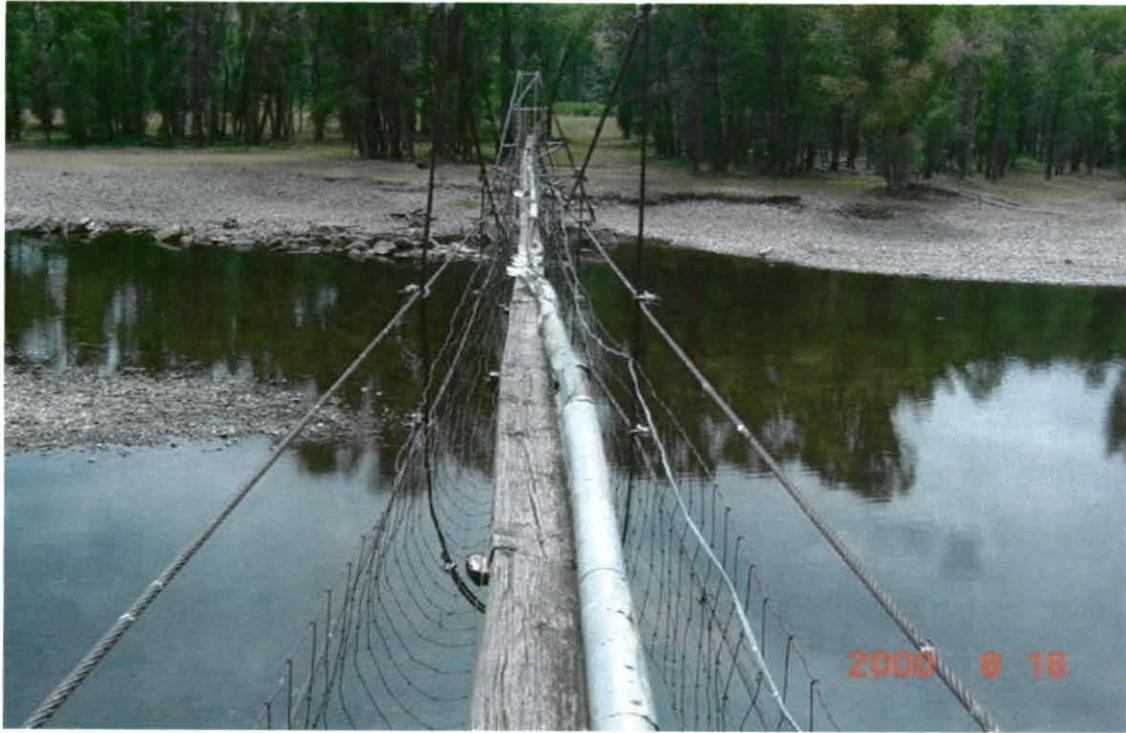
Photo 3 – View looking south across the Tow Creek Bridge in August 2000.

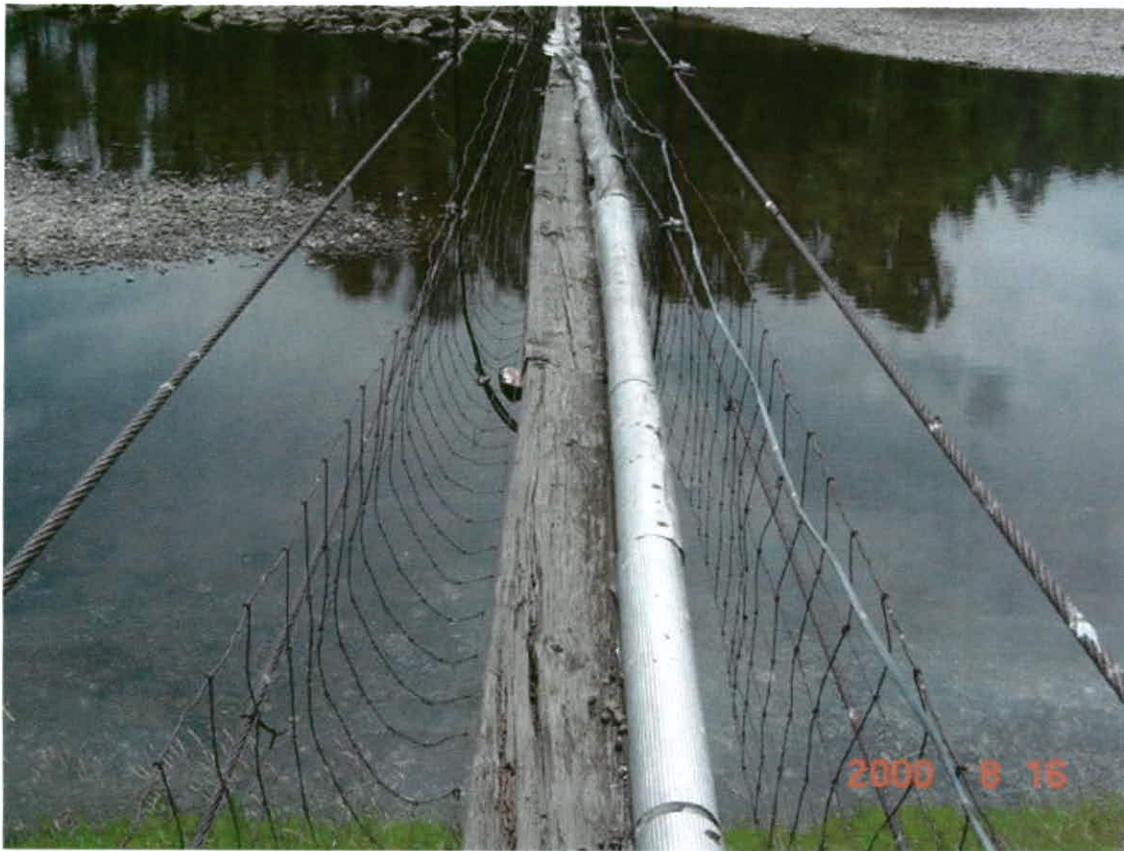
Photo 4 – View looking south across the Tow Creek Bridge in August 2000.

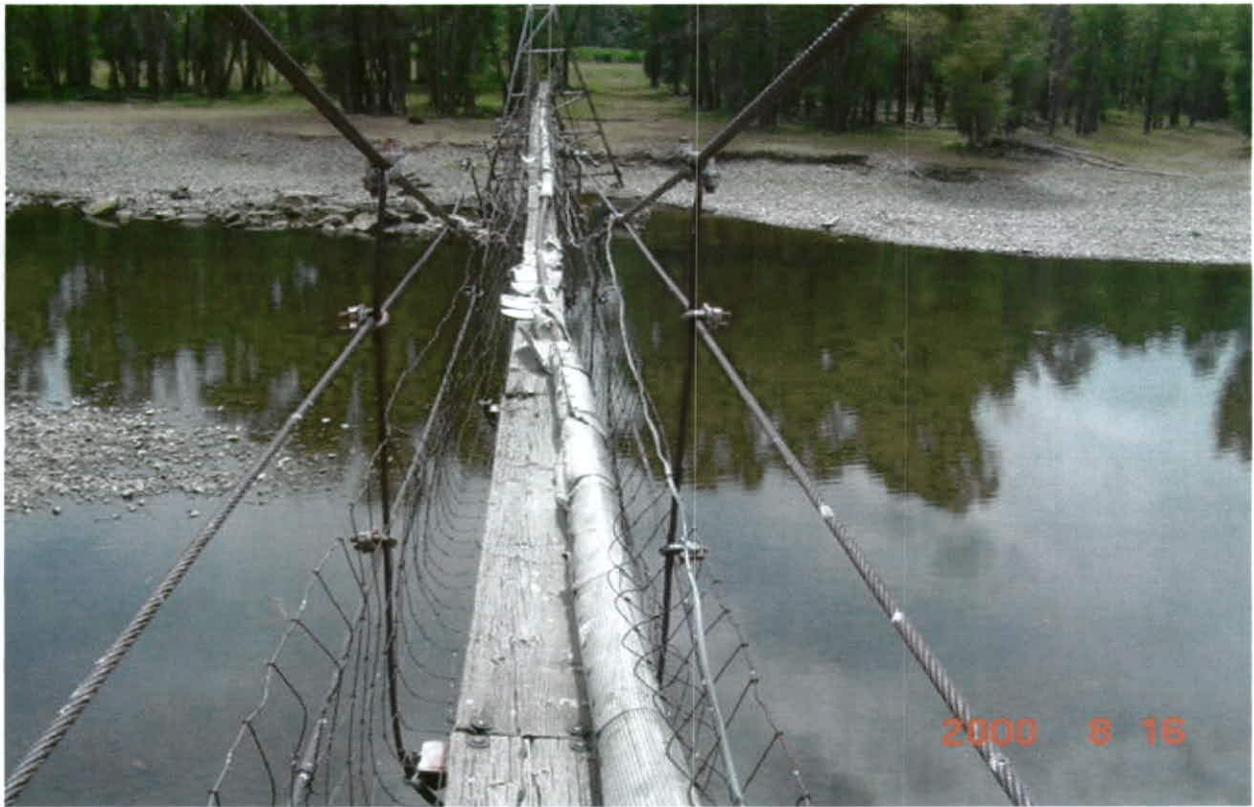
Photo 5 – View looking south in August 2000 (low water) at pipeline with damaged insulation.

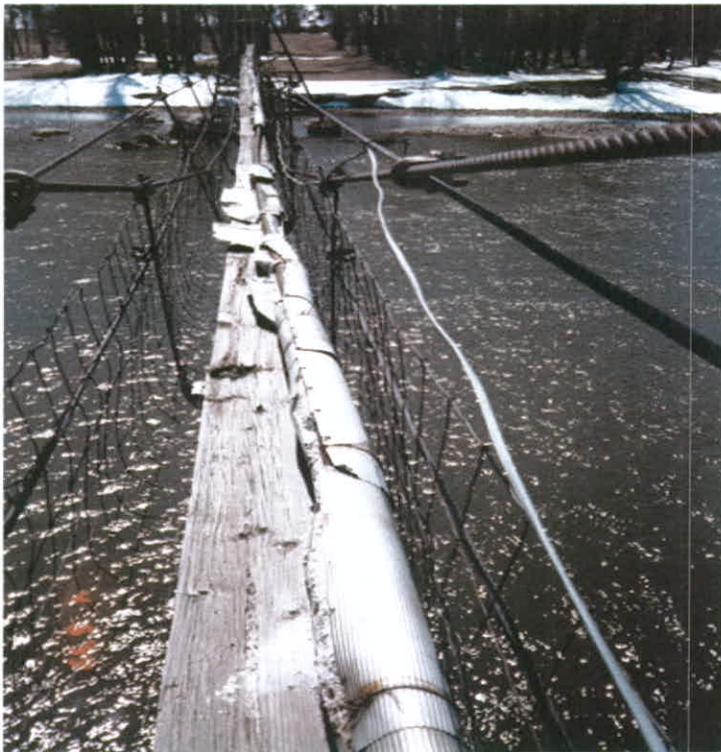
Photo 6 – View looking south in April 1999 (high water) at pipeline and damaged insulation.

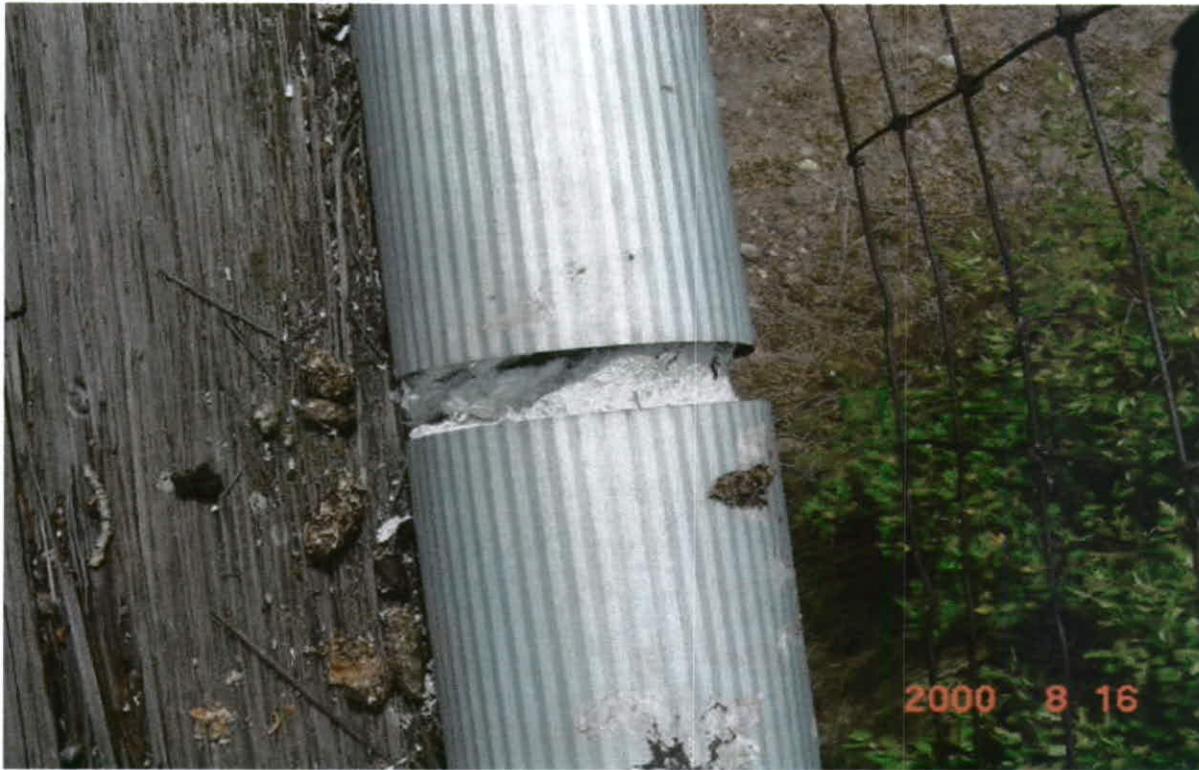
Photo 7 – Close up view of opened seam in metal jacket around asbestos insulation

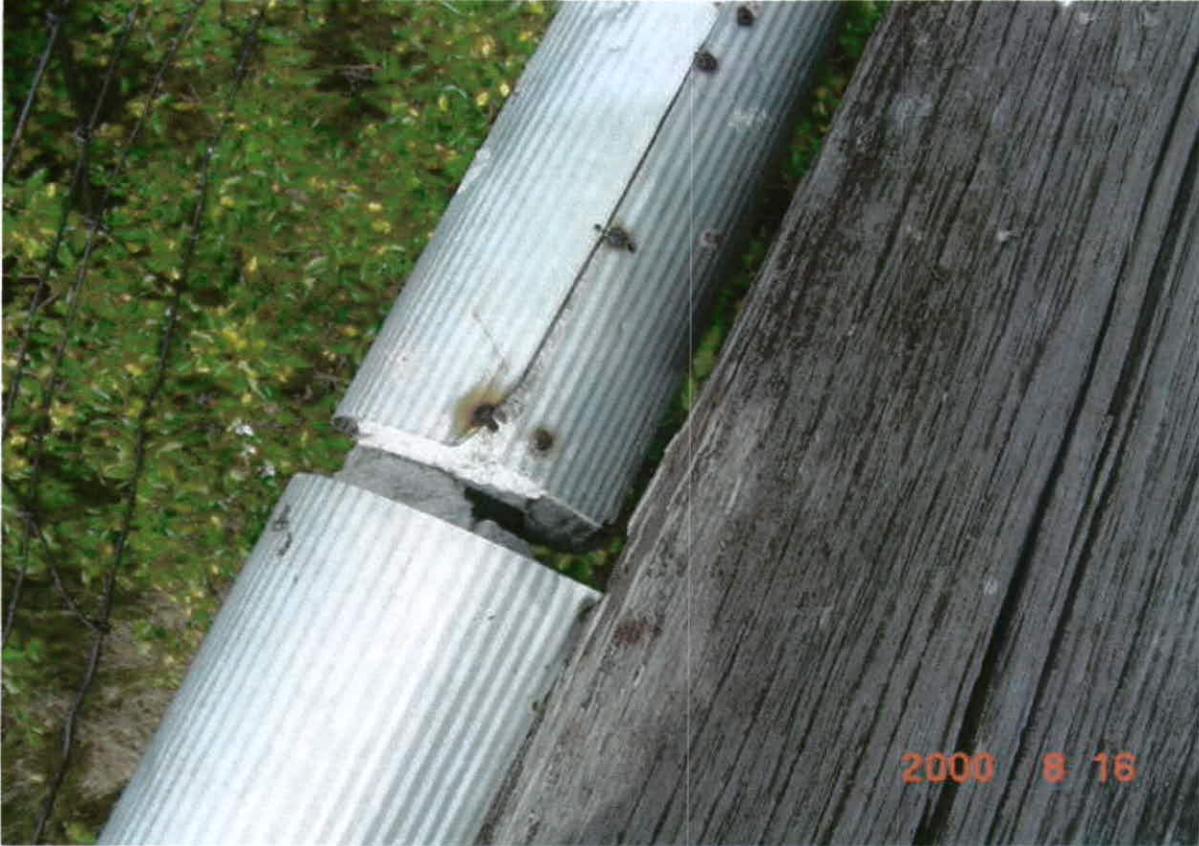
Photo 8 – Close up view of seam in jacket around asbestos insulation.
