PIT STATUS EVALUATION FORM

S.S. PAPADOPOULOS & ASSOCIATES, INC.

County: Elbert, CO
County Code: 039

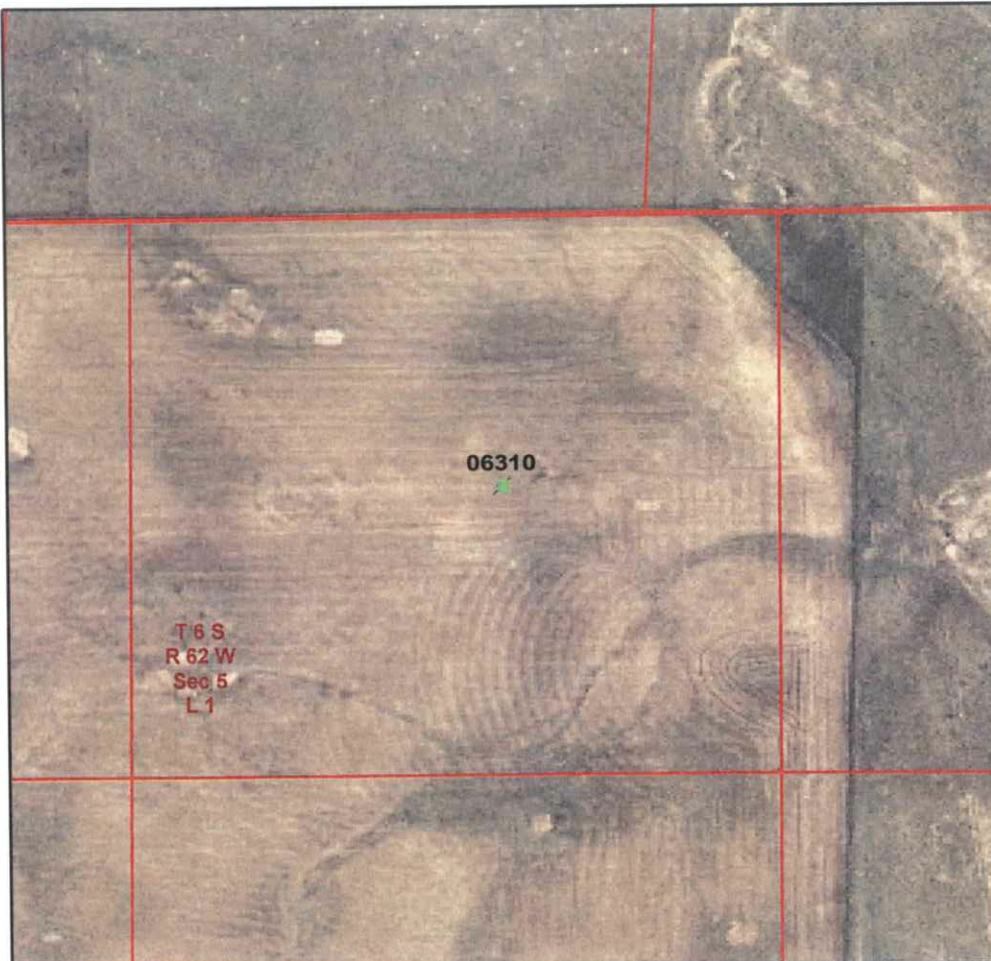
Pit Name: MILLER 41-5 1

Notes: LIF (1982) 10'x14' pit, no produced water; recommend covered
skim pit. Aerials indicate site recontoured.

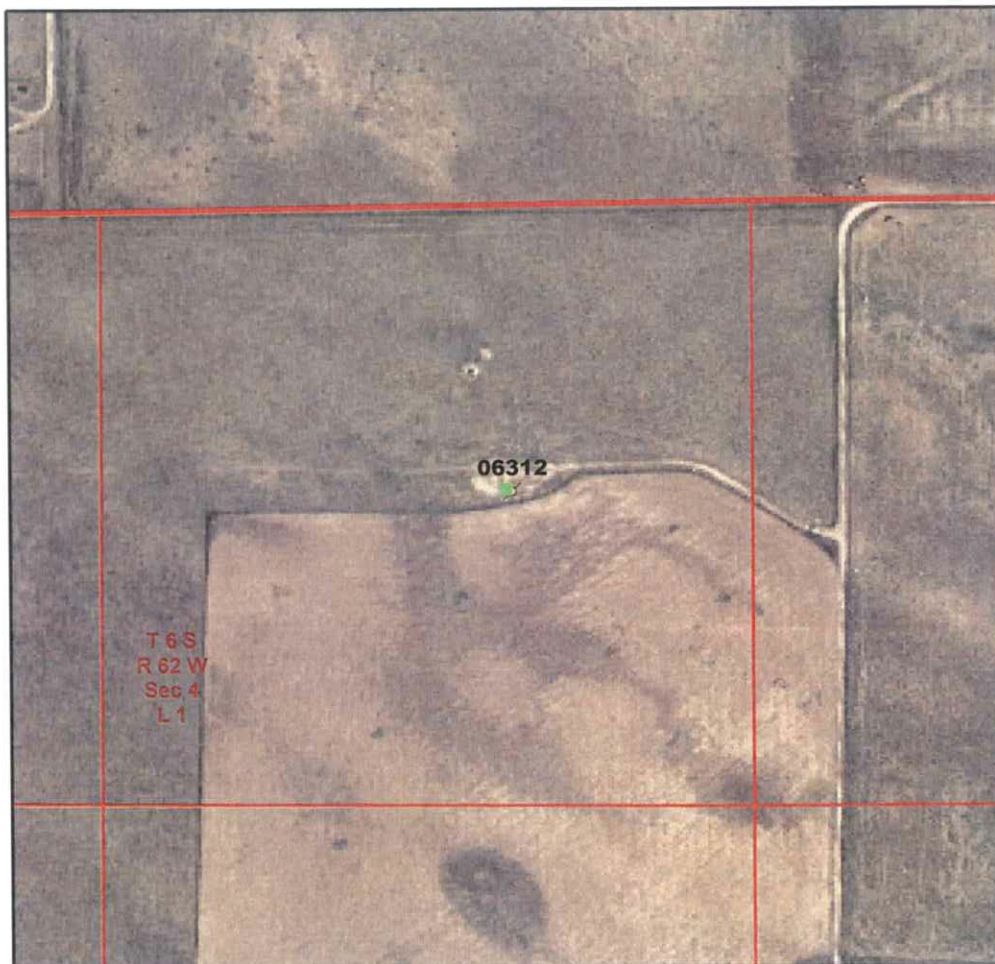
Pit Name: HAY 4-1, 4-9, 4-15

Notes: LIF (1985) "No pits" and "level"

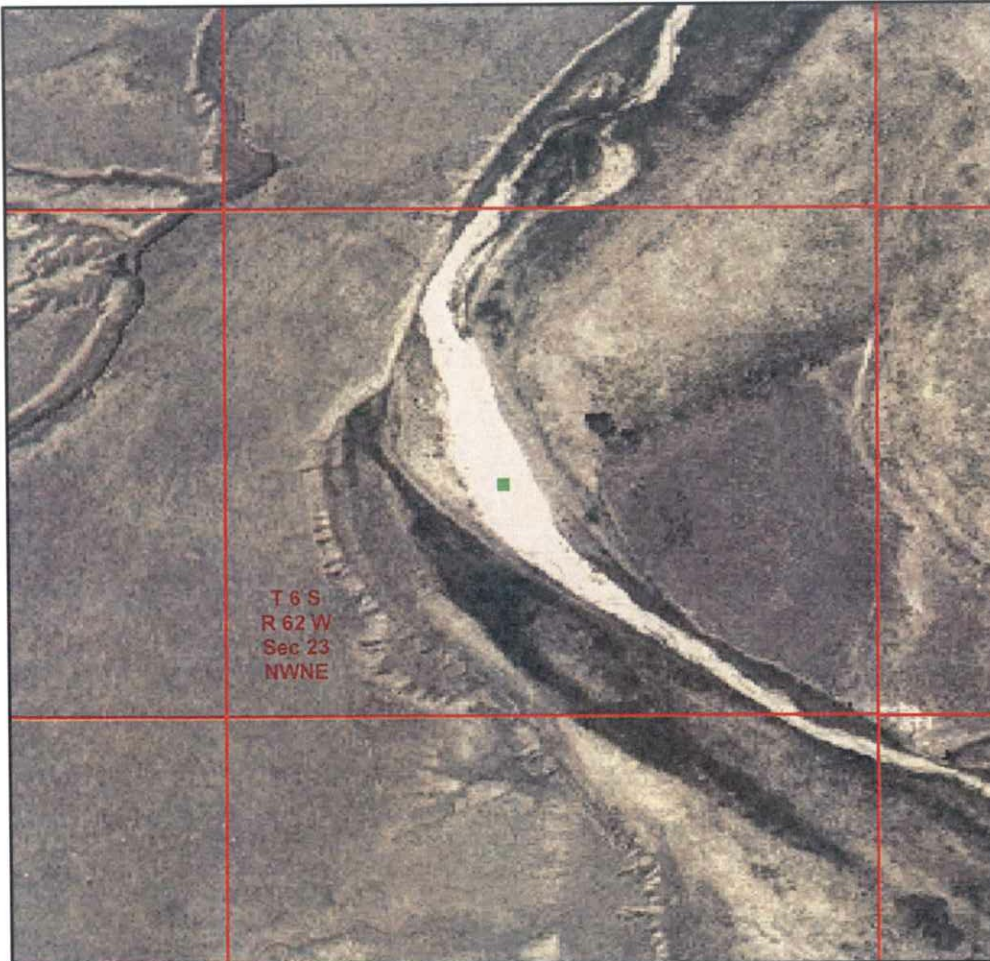
Pit Name: NEIRAN

*Possible wrong
coordinate location*

Notes: All wells in surrounding section are PA.

Possible that pit is associated with Facility ID # 115144 NEIRA

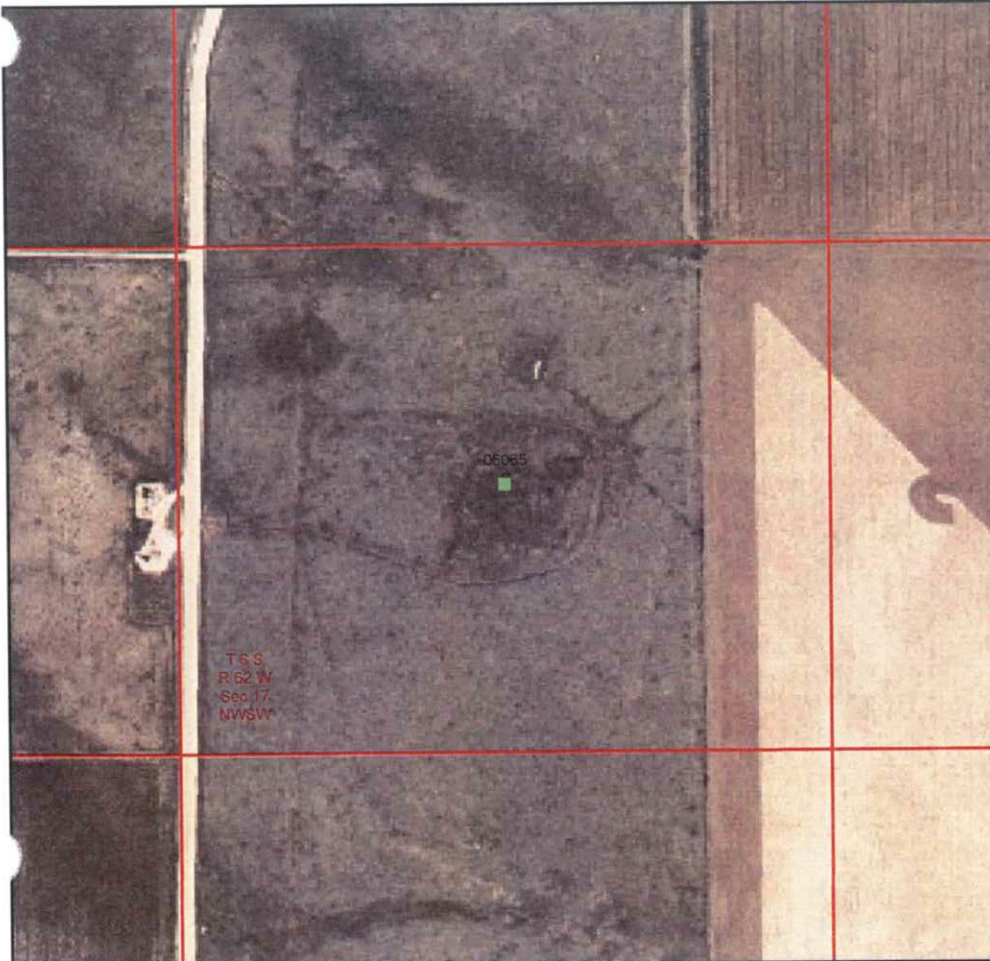
Pit Name: WHITEHEAD 13-17

Notes: Map# 690657. 100' x 100' emergency use pit. LIF (8-8-1986) "Pit 1"
Rehab - did find 20' length steel cable (minor) "8" Pit 2: no sign of
T-B site"

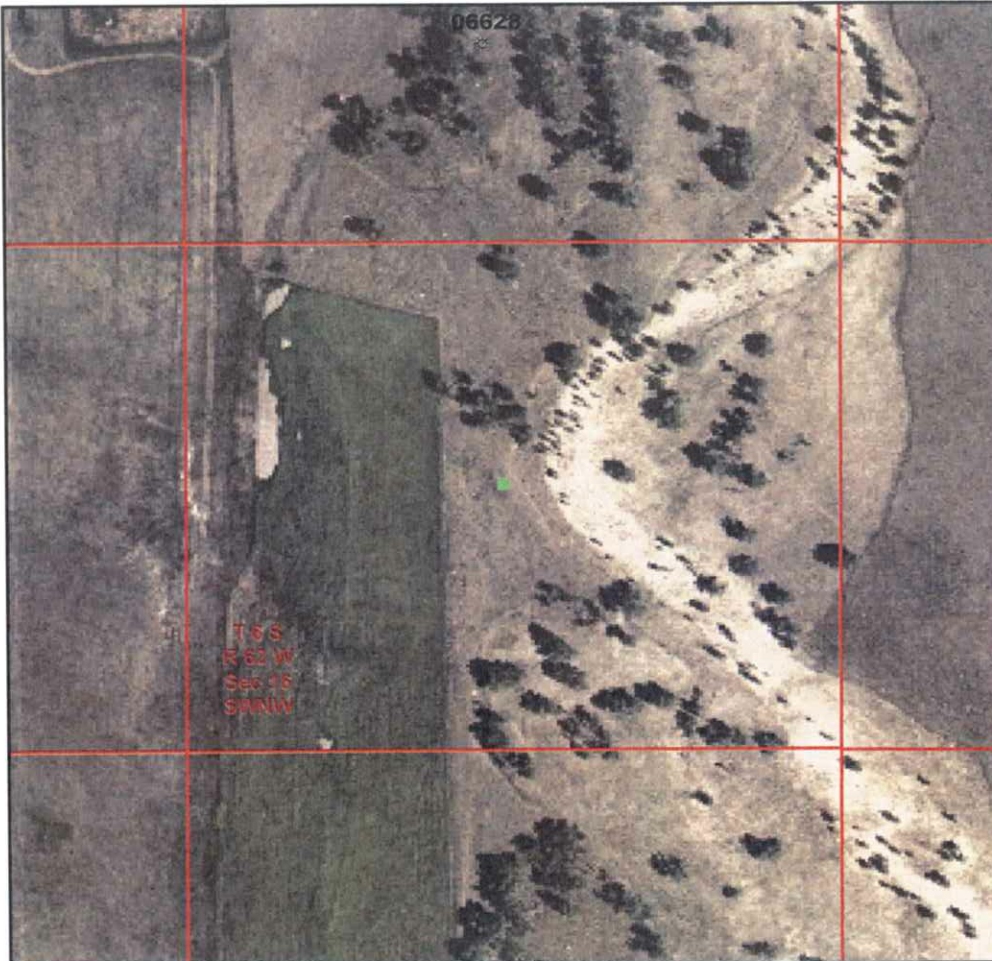
Pit Name: LOIS WHITEHEAD 13-16 1

Notes: Map doc# 690644. LIF 20'x30' skim.
WSIF (1993) Pits backfilled & site clean.

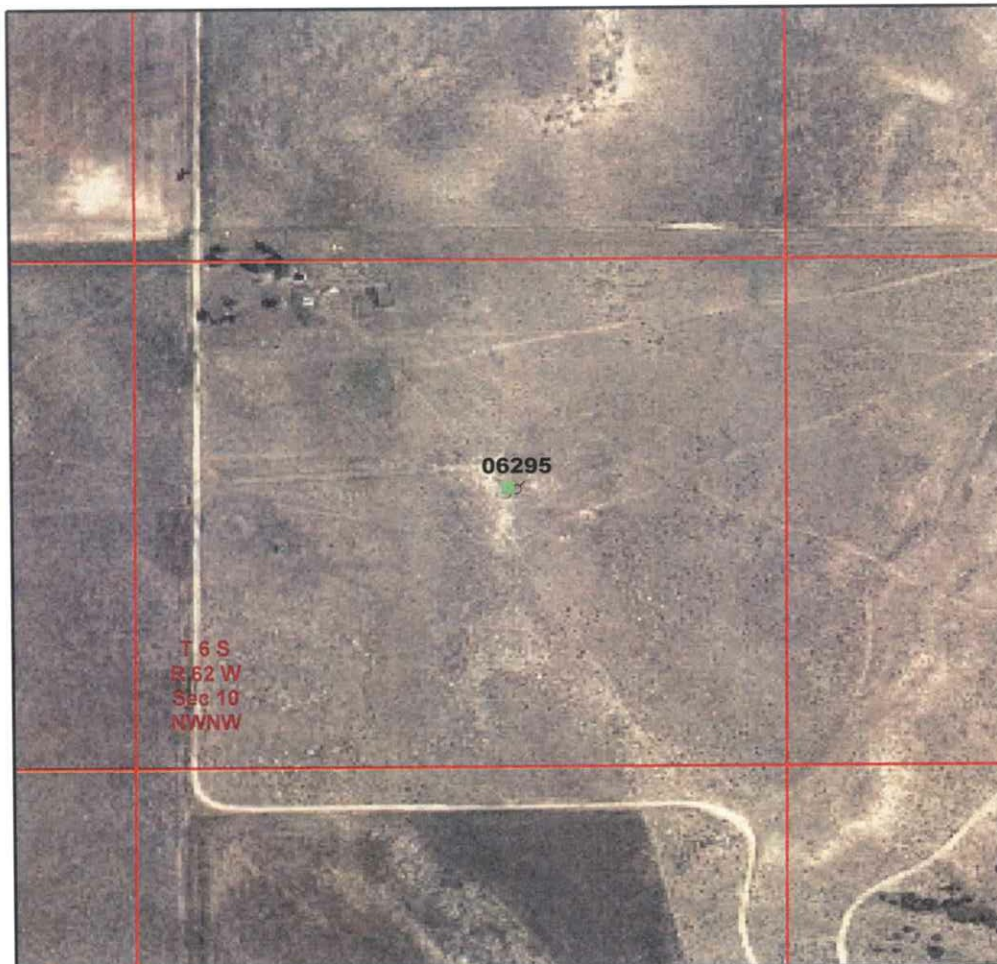
Pit Name: MARRS 10-4

Notes: LIF (8-27-1985) 20' x 20' crd, fenced, 1/2 full
WSIF (1988) pits backfilled

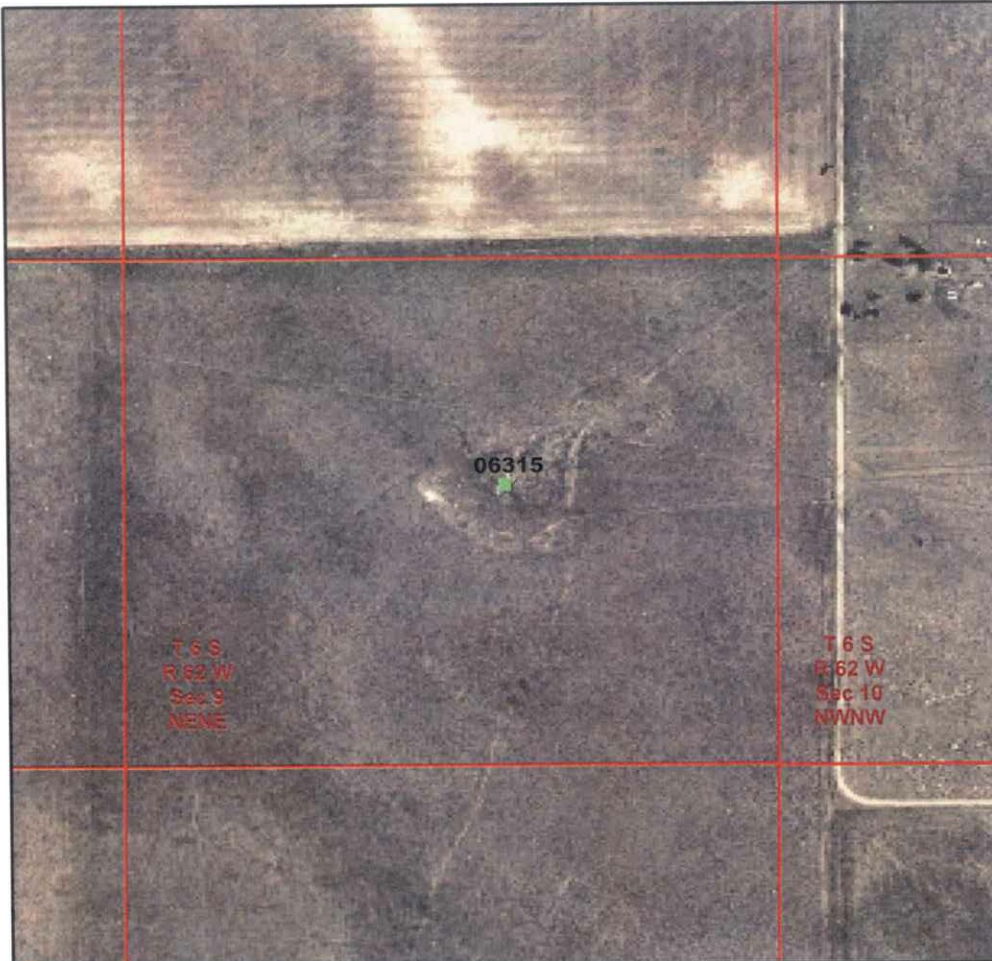
Pit Name: WHITEHEAD 41-9 1

Notes: LIF (1988) 20'x30' screened pit, unlined, unfenced
WSIF (11-1988) pits backfilled & site clean

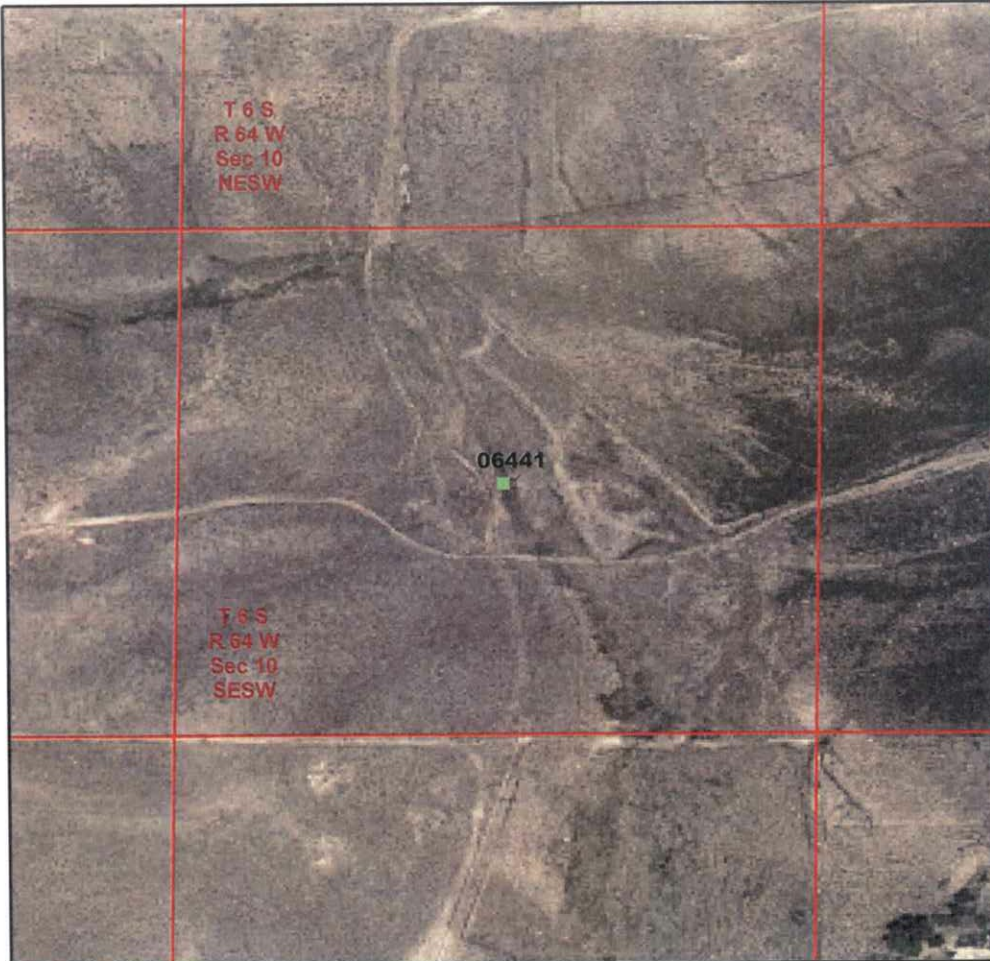
Pit Name: COGGINS 10-14

Notes: doc # 581288 is associated with this pit but is not describing correct pit.
FIR for ID# 115138 (12-28-1995) indicates site needs to be leveled
aerials indicate pit & site remediated

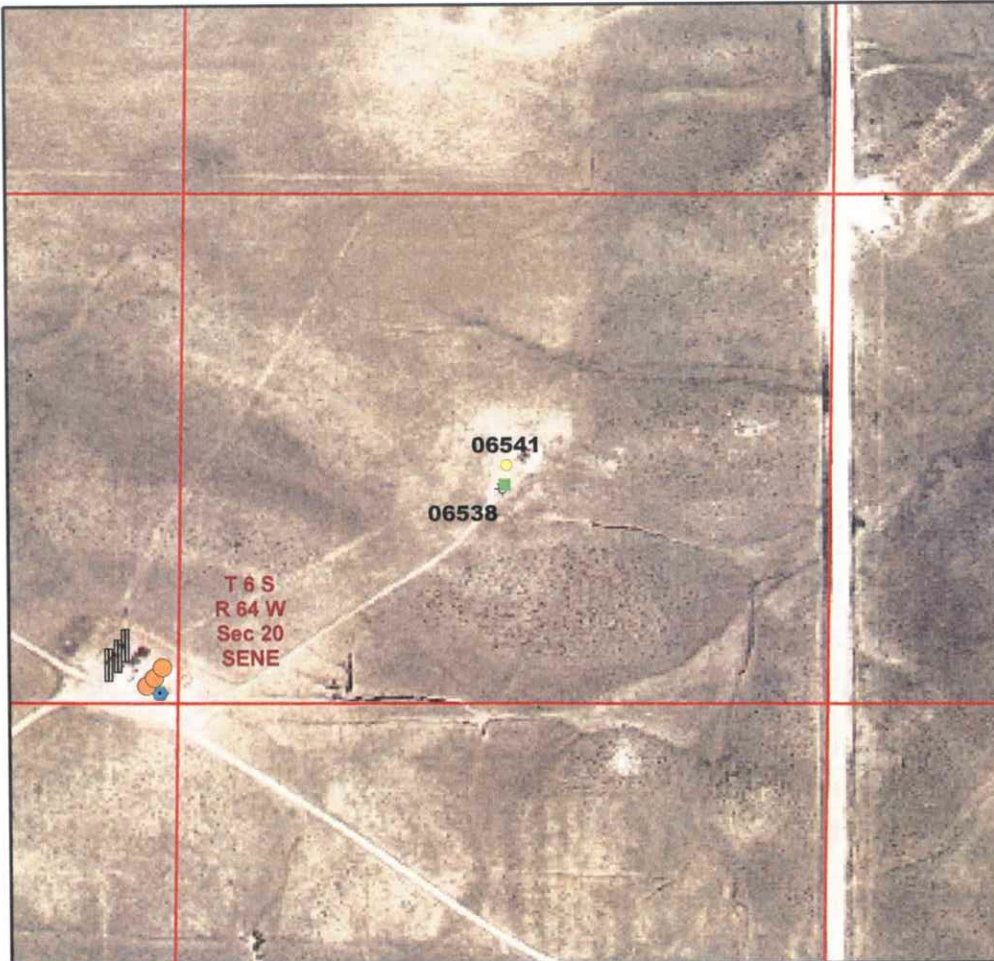
Pit Name: NORDMAN TRUST 42-20X

Notes: Pit Status & documentation under #115151
Common Use battery tank site for 32-20, 42-20, 42-20X and 33-20
fi

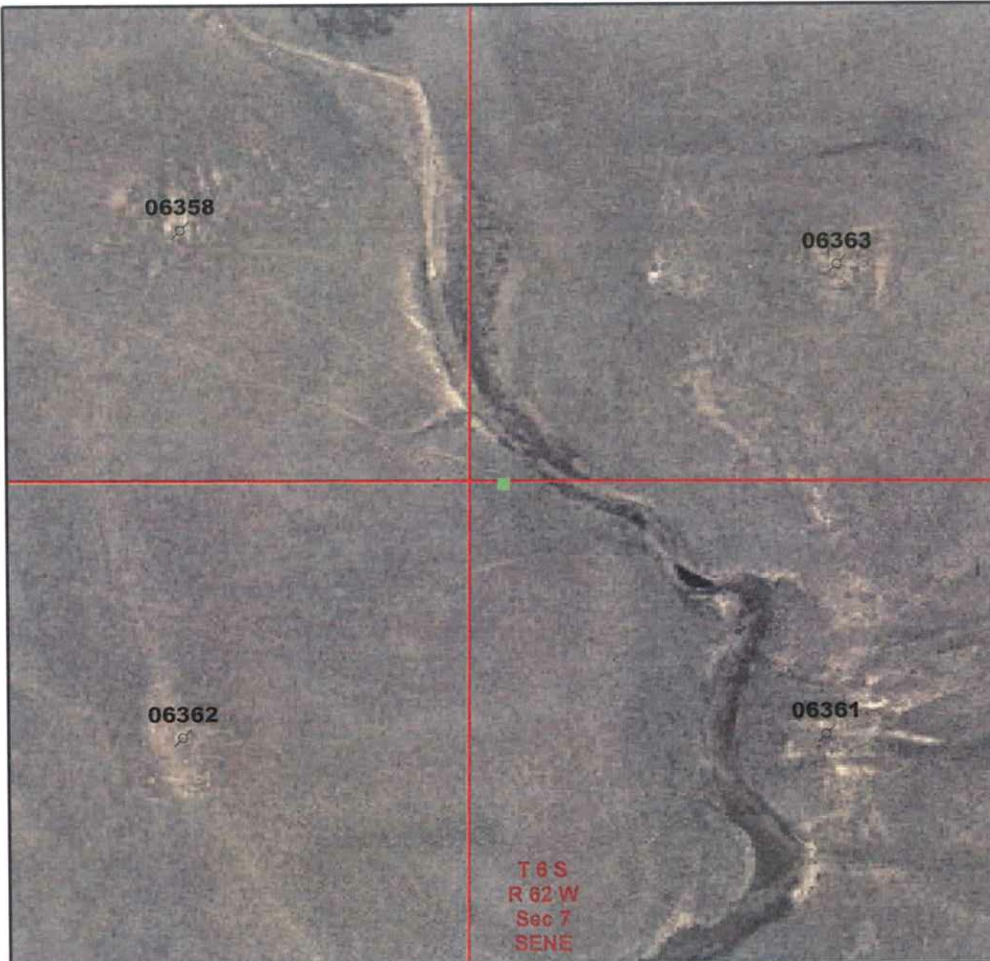
Pit Name: WHITEHEAD 41-7 4

Notes: WSIF# 436628, # 436804, # 436785 (1987) Pit backfilled.

FIR# 447394 (11-8-85) No visible sign of API seq No 06352

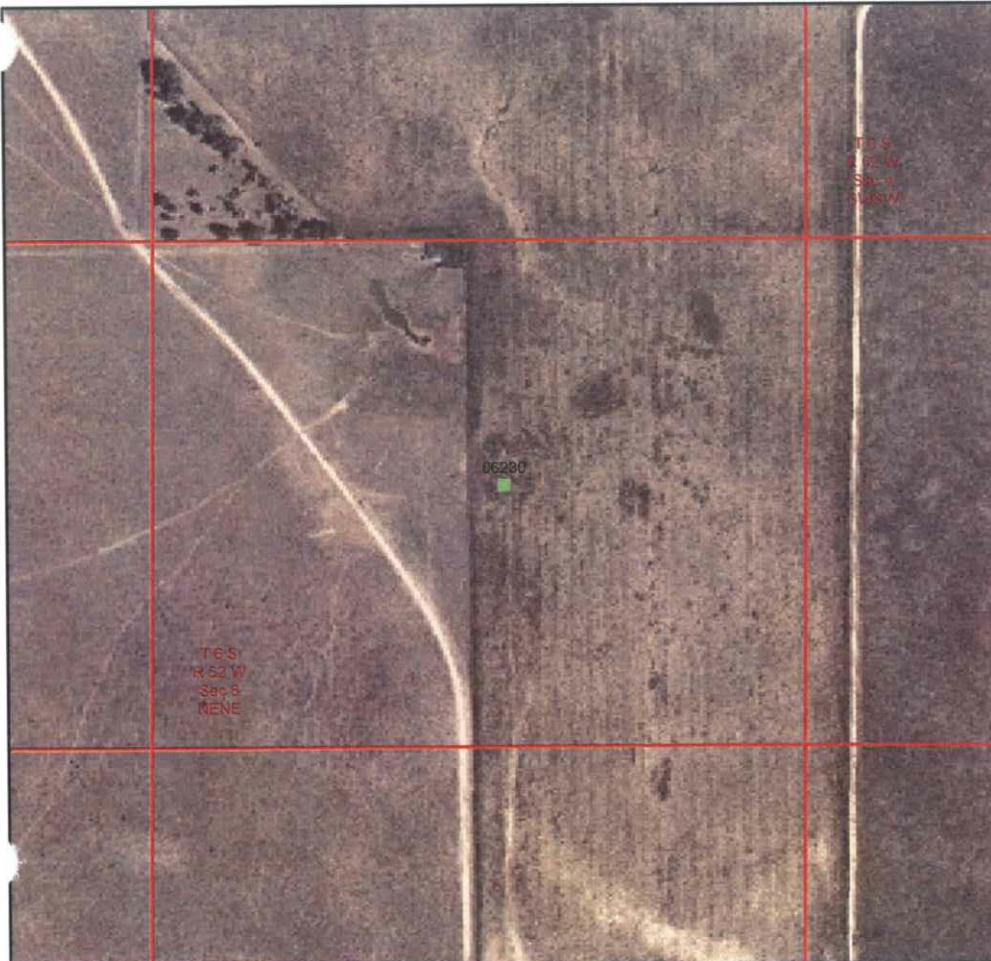
Pit Name: NEIRA

Notes: WSIF (1987) pits backfilled & site clean

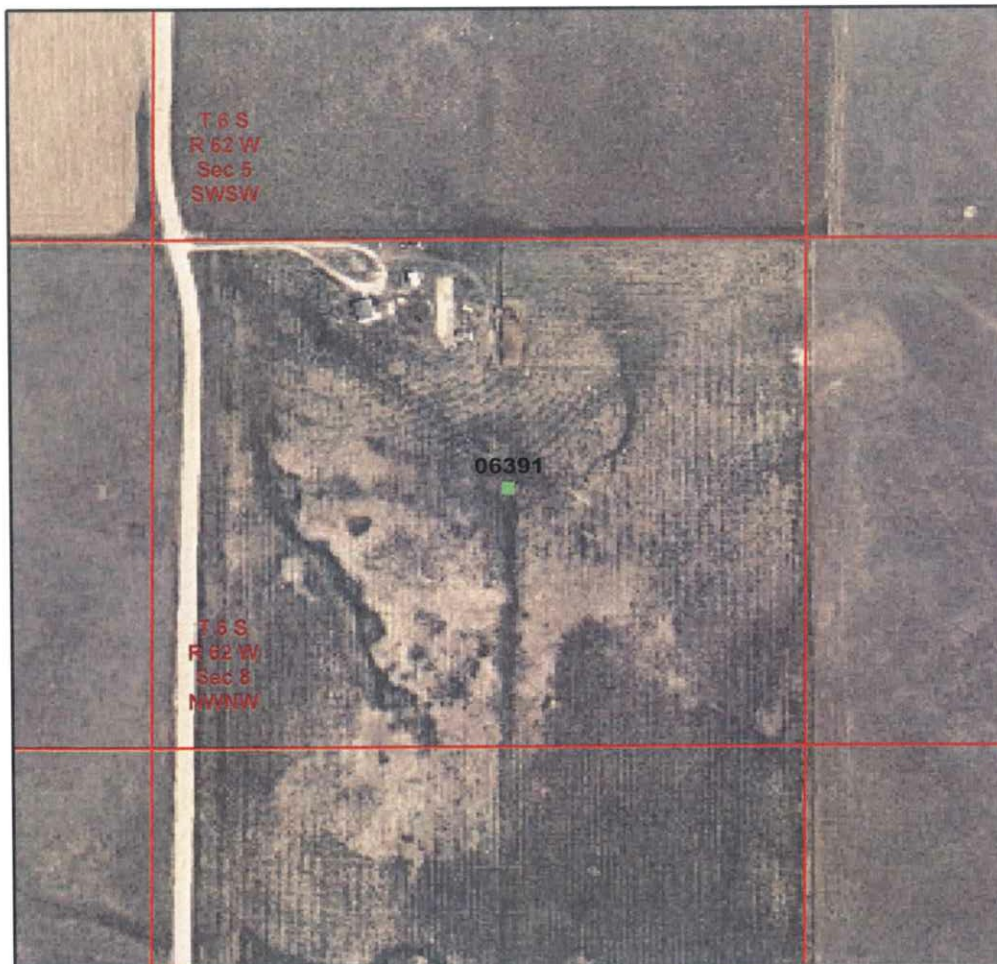
Pit Name: MORRIS 8-4

Notes: WSIF (1987) pits backfilled & site clean

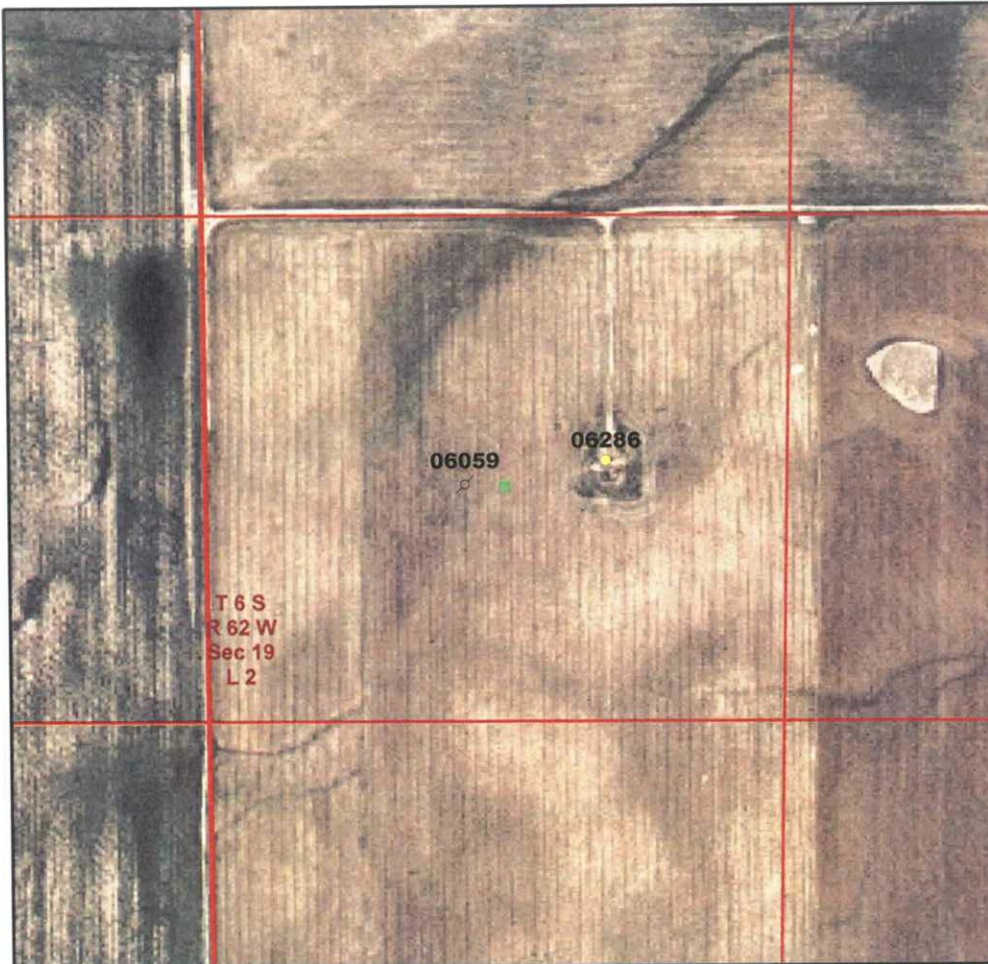
Pit Name: GORDON 1-A

Notes: LIF (1987) 30'x40' skim pit, wire crd, unlined

Well change of operator (1998) indicates 2 injection wells but no pits

doc # 429470 (6-24-1998) FIR (9-12-07) three 400 BBL Uprights

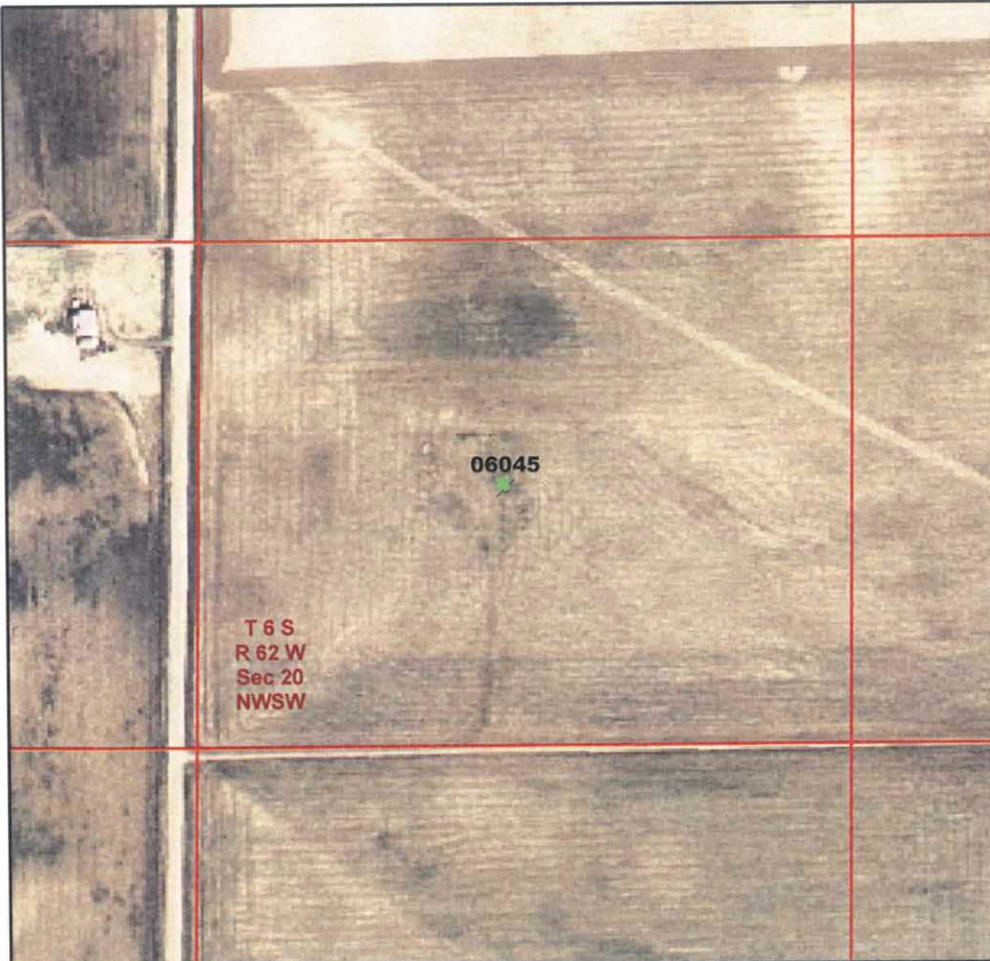
Pit Name: SABO 13-20

Notes: LIF (8-19-1987) skim pit 20' x 30'
FIR (2001) indicates location restored.

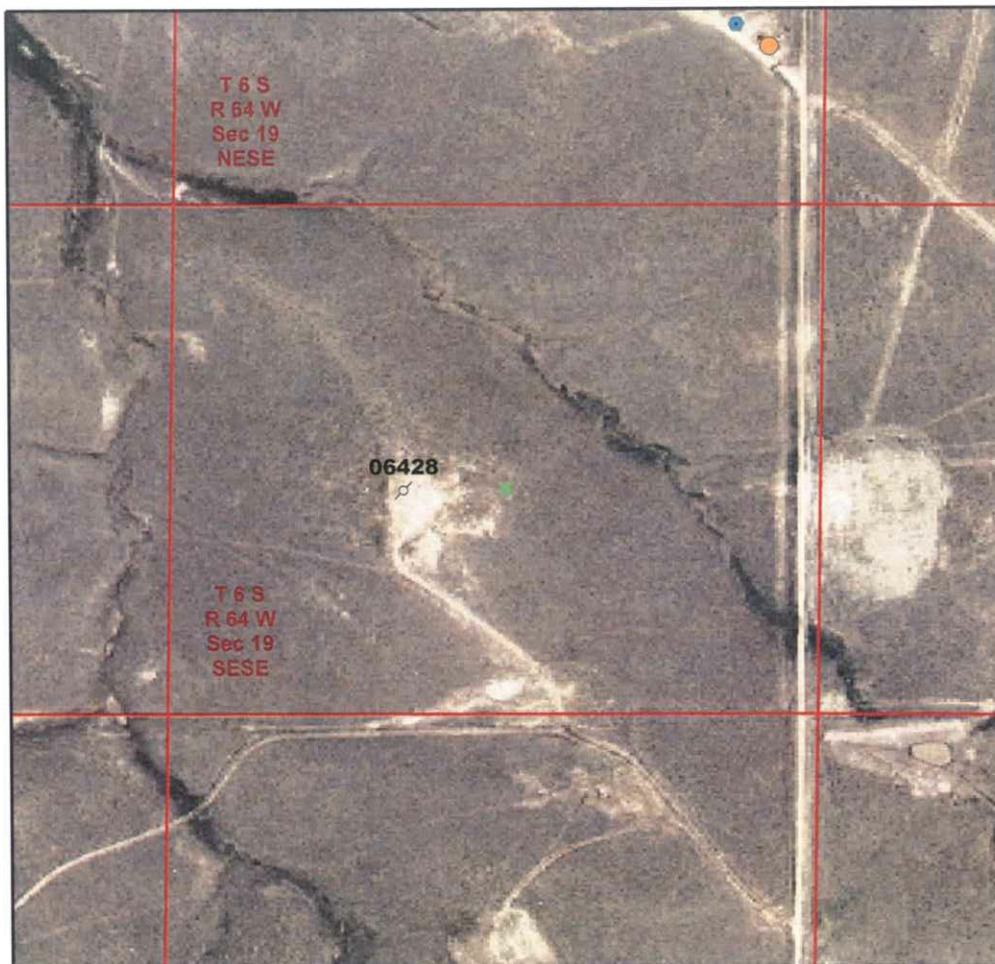
Pit Name: EVERITT 1

Notes: FIR(2005) indicates approved for interim approval until reregulated.
No Remediation docs online.

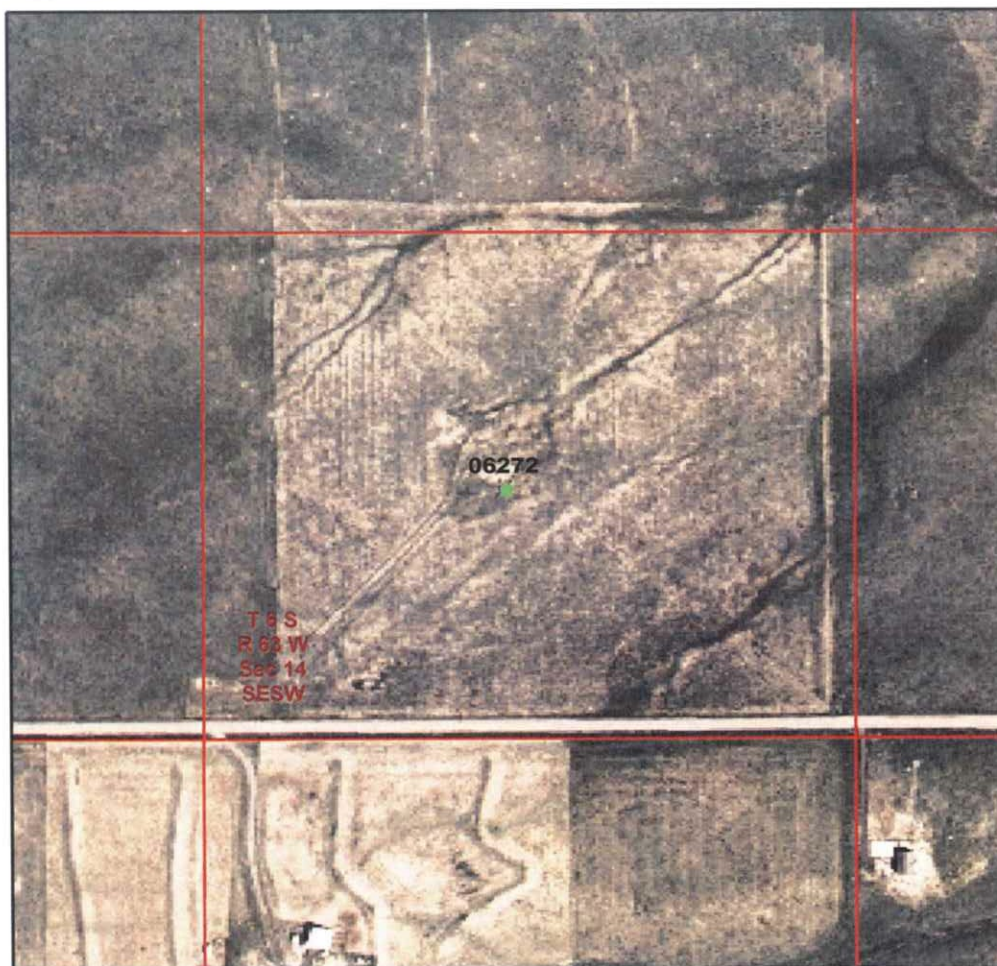
Pit Name: STEWART 14-14

Notes: WSIF (1988) pits backfilled & site clean. Note * No pits inventoried in historical LIFs; possible pit did not exist.

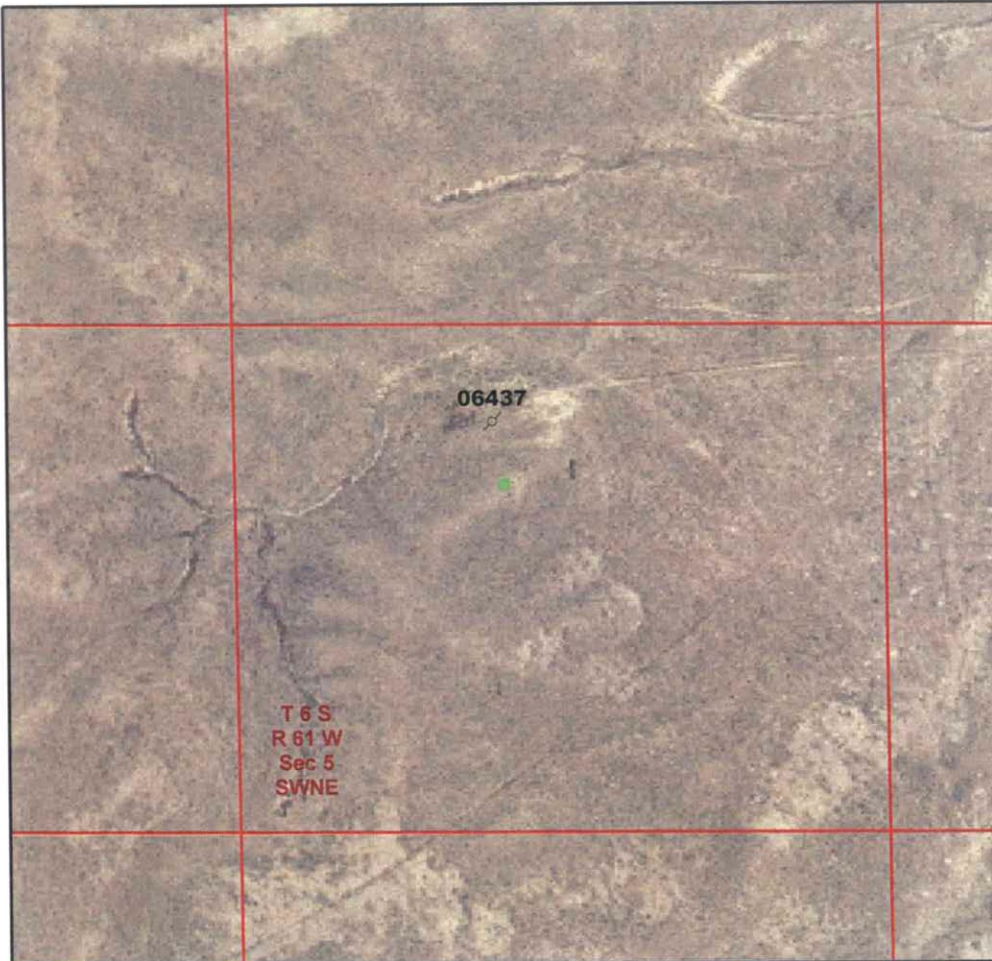
Pit Name: MCCOY 32-5 1

Notes: LIF (1987) 15'x15' skimpit.

WSIF (1988) pit backfilled & site clean.

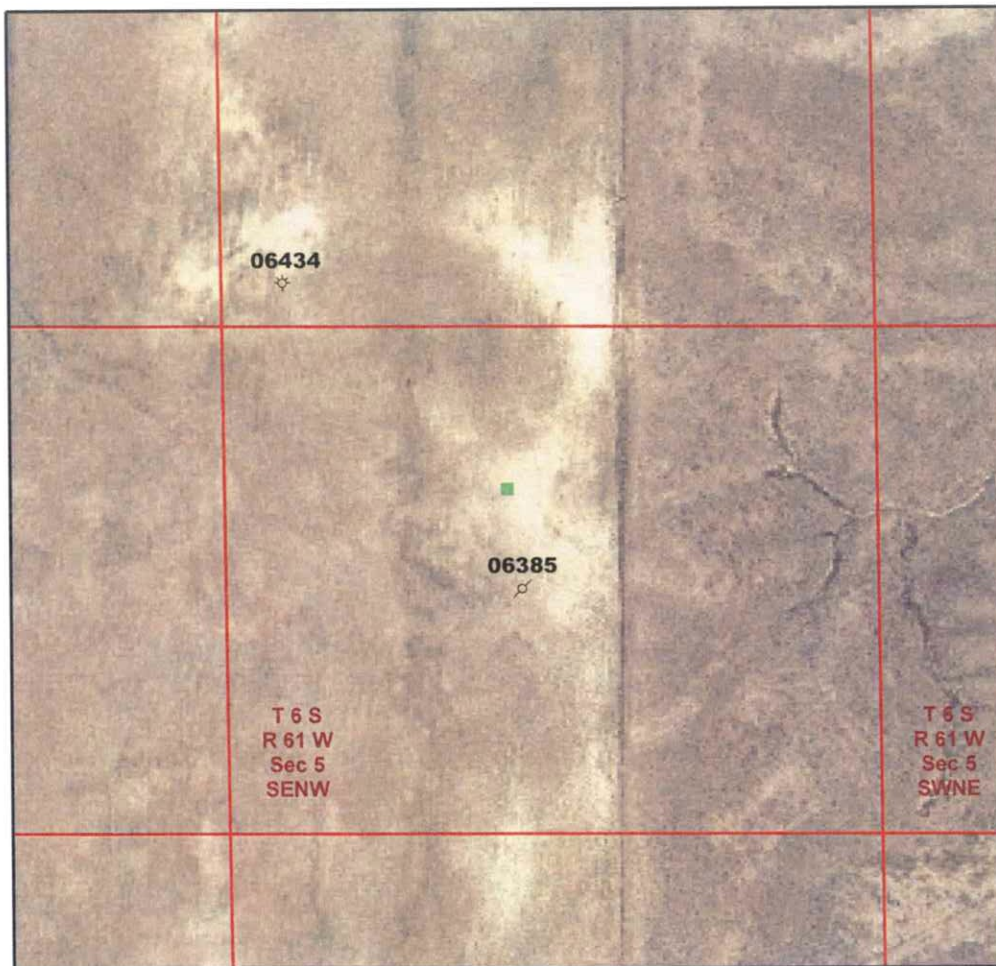
Pit Name: MCCOY 22-5

Pit Status & documentation under Pit ID # 115047.
WSIF (1992) pits backfilled & site clean
DUPLICATE RECORD

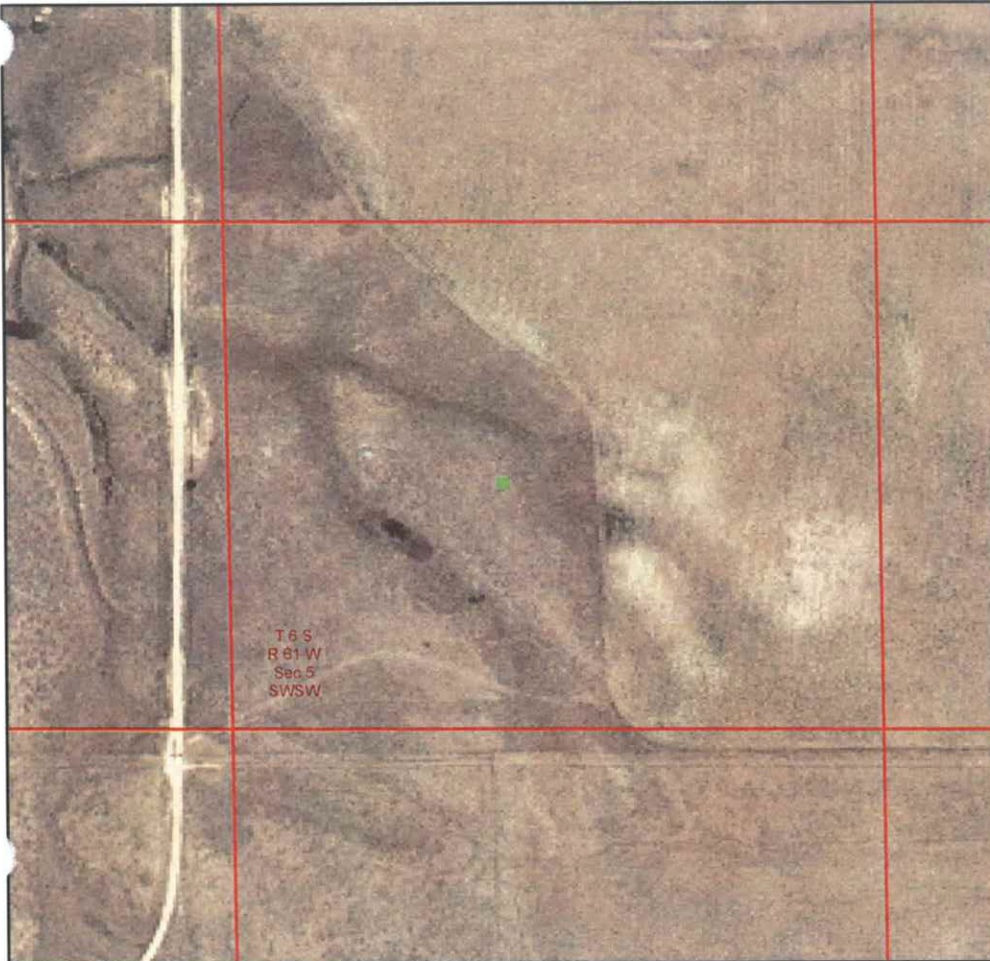
Pit Name: MCCOY 12-5X

WRONG

LOCATION

Notes: No Form 15. Location of Well/pit is in SWNW of Sec 5. Multi-well use
MCCOY-AMOCO 12-5, 12-5X and 22-5. LF (1987).
WSIF (2) Pits backfilled & site clean

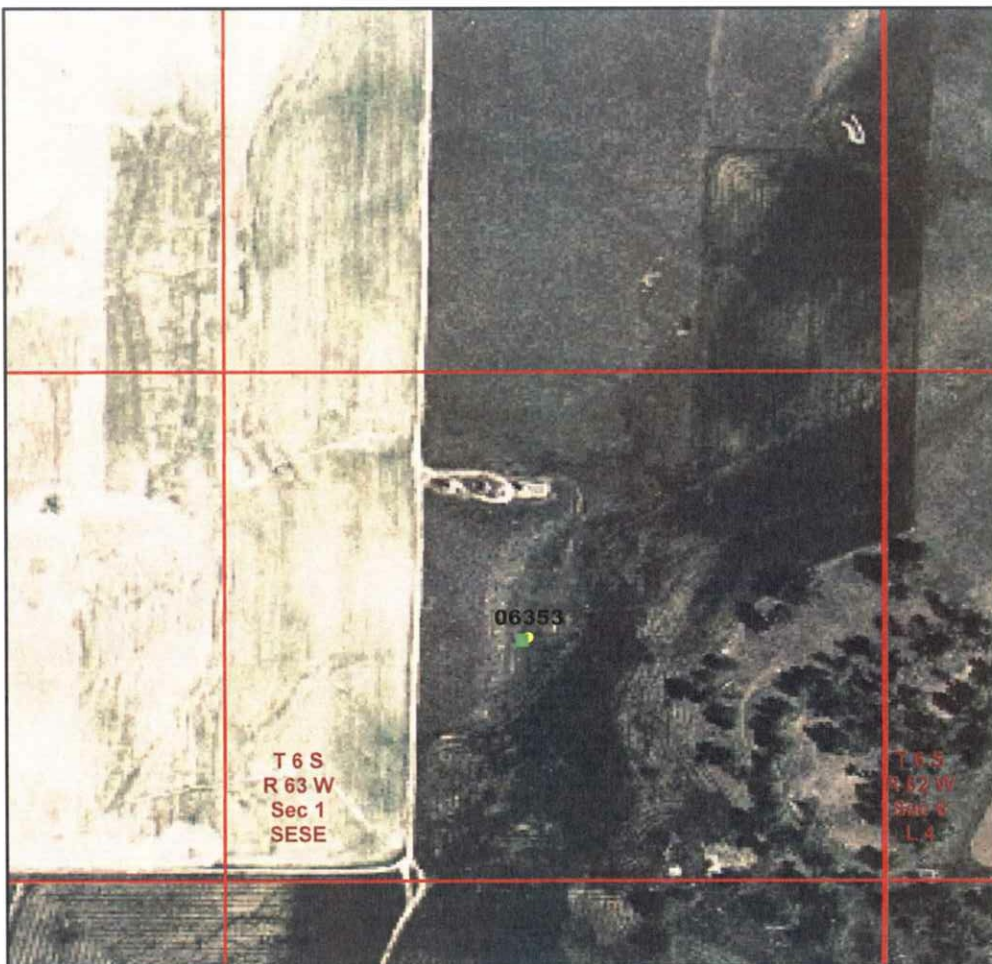
Pit Name: CHAMPLIN 548 1&2

Notes: Common use for Champlin 548 1&2
DUPLICATE RECORD -
