**PIT STATUS EVALUATION FORM**

Facility ID: 115089

Pit Name: WHITEHEAD 4-11

S.S. PAPADOPULOS & ASSOCIATES, INC.

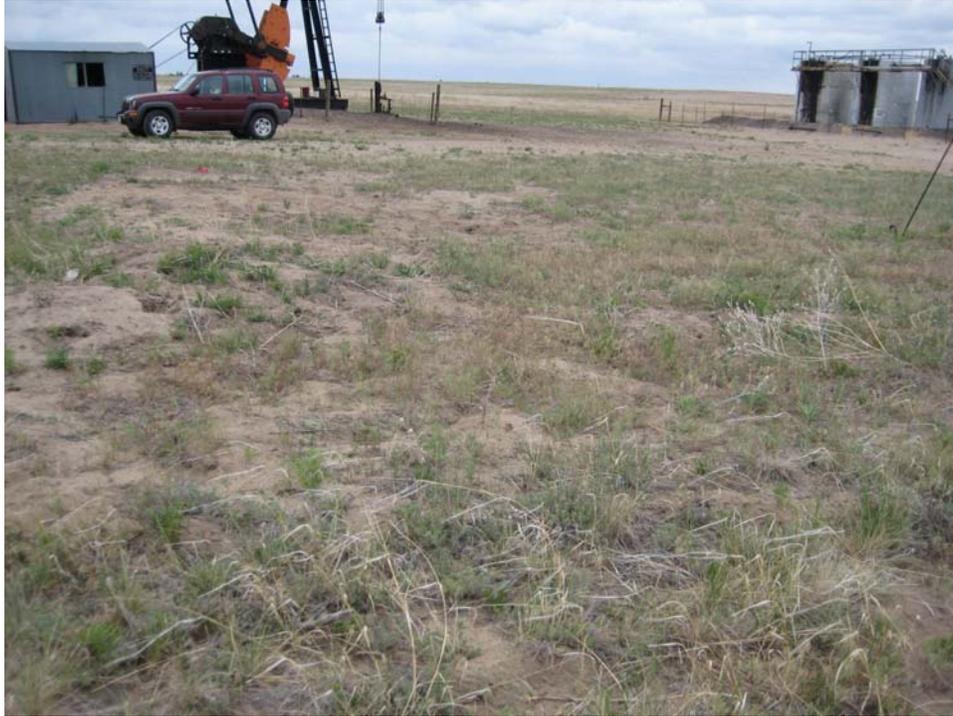
Notes: FIR (5-1996) indicates earthen overflow pit & buried metal skim tank  
FIR (6-15-2007) indicates 3,200 BBL upngnts #200124015  
FIELD VISIT 6-4-2008 : PIT BACKFILLED. SITE CLEAN

**Photo 3. Looking north at former location of pit in foreground of wellhead**

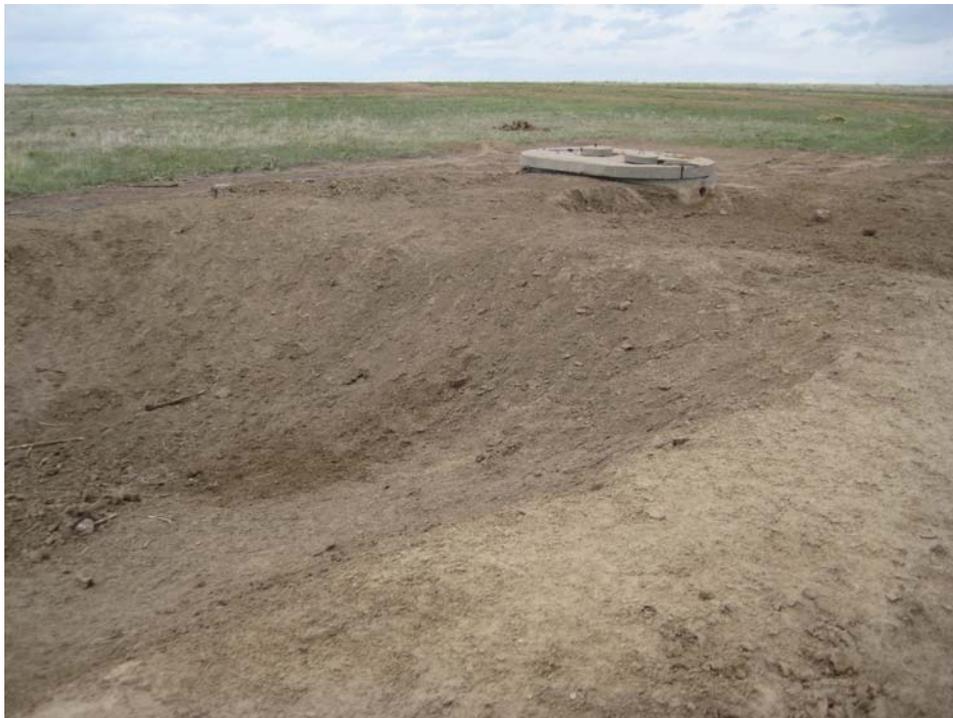
Notes: FIELD VISIT 6-4-2008: Found fiberglass tank, concrete vault & earthen pit. Recent earthwork on pit; not covered; no oil & sparse e; no fence. Recommend pit closure if not in use.

**Photo 4. Looking southwest at earthen pit and concrete vault**

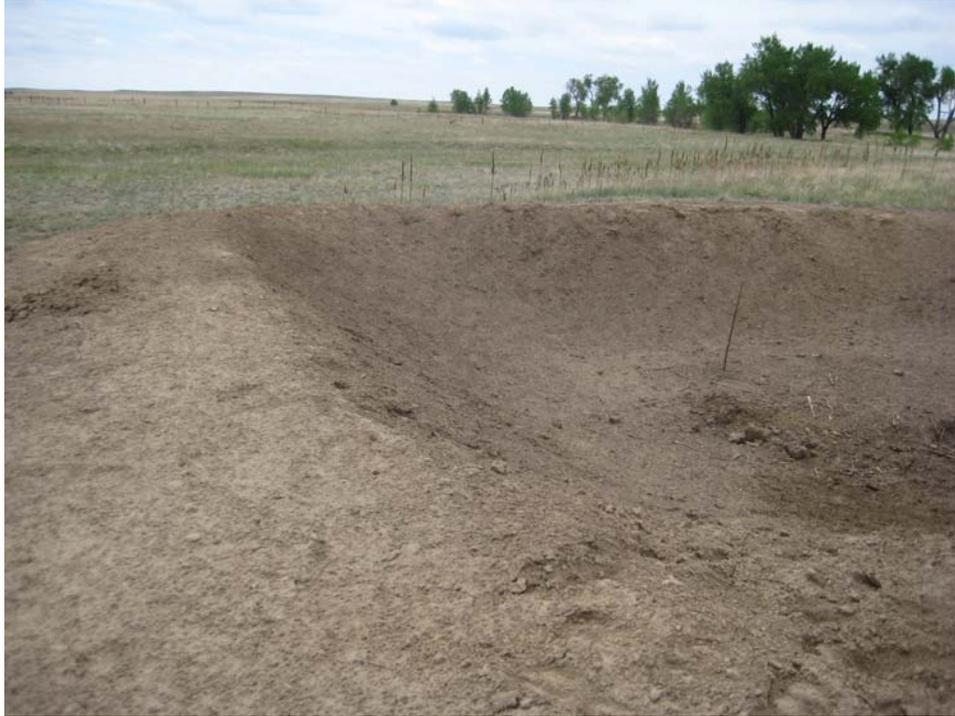
Photo 5. Looking east at earthen pit

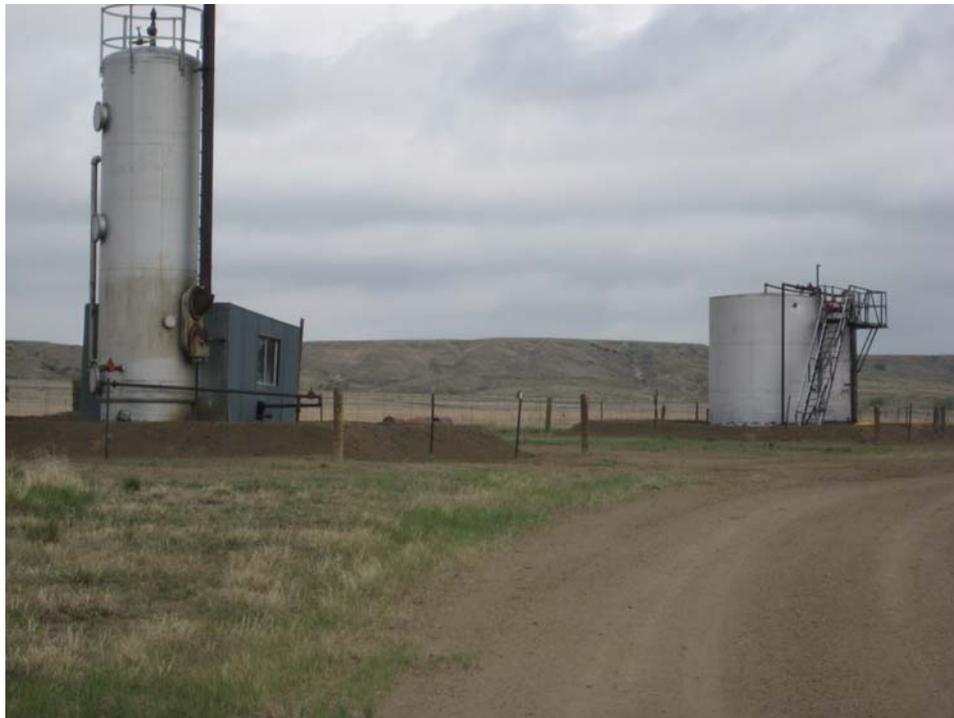
Photo 2. Looking north showing part of the former pit site to the west of the lease road

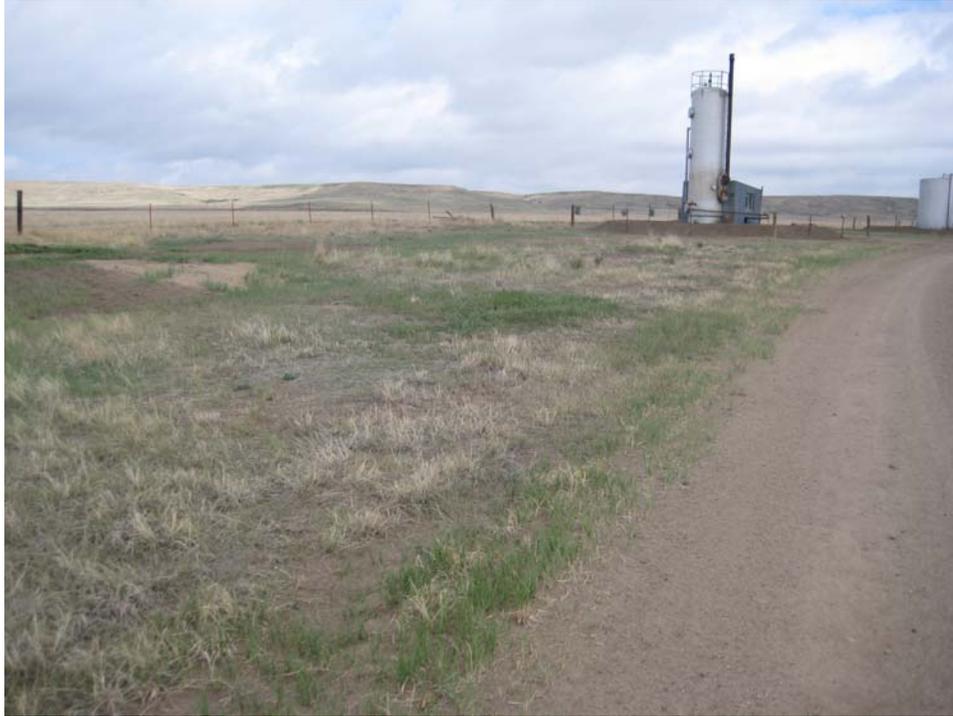
**Photo 3. Backfilled pit area, formerly two 40'x40' pits and one 75'x50' pit**

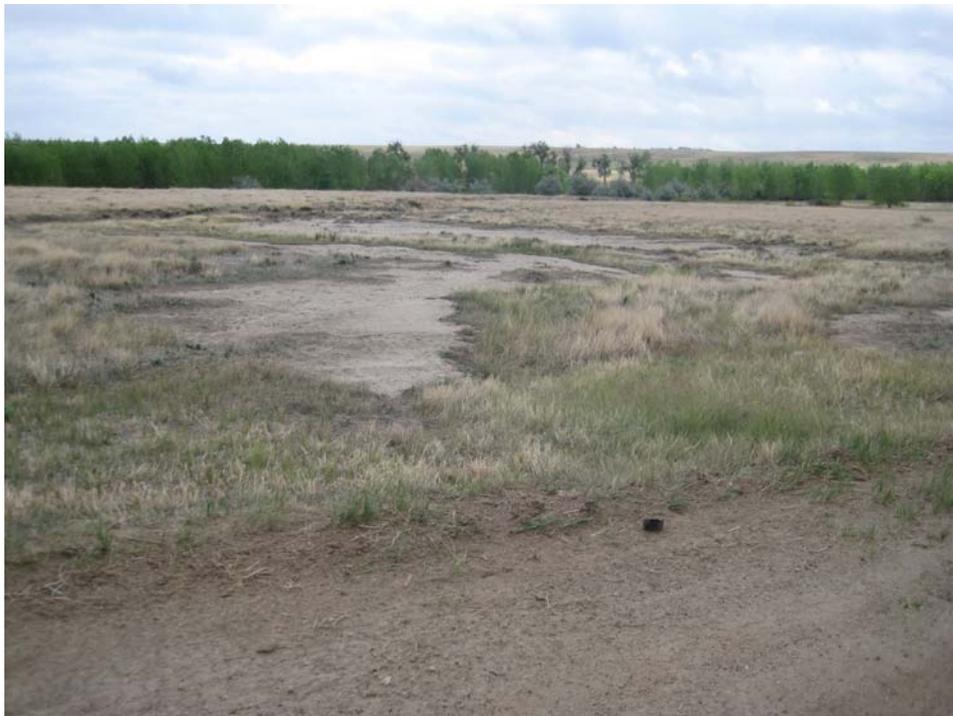
**Photo 4. Looking east across from former pits at possible impacts from water drainage under road culvert**

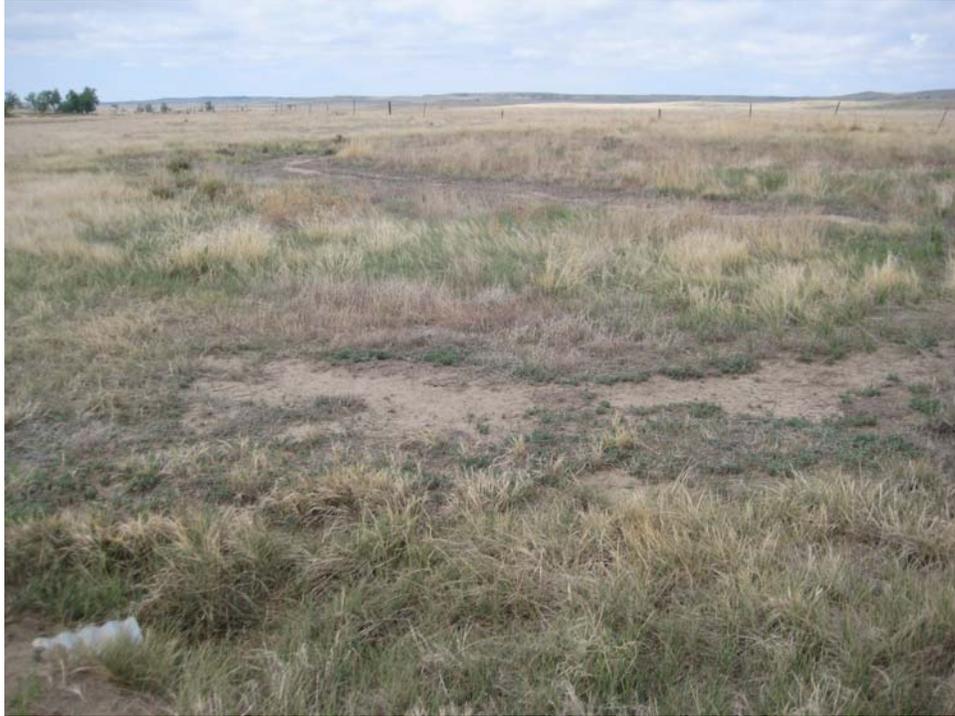
**Photo 5. Looking southwest towards former pits showing possible vegetation impacts**

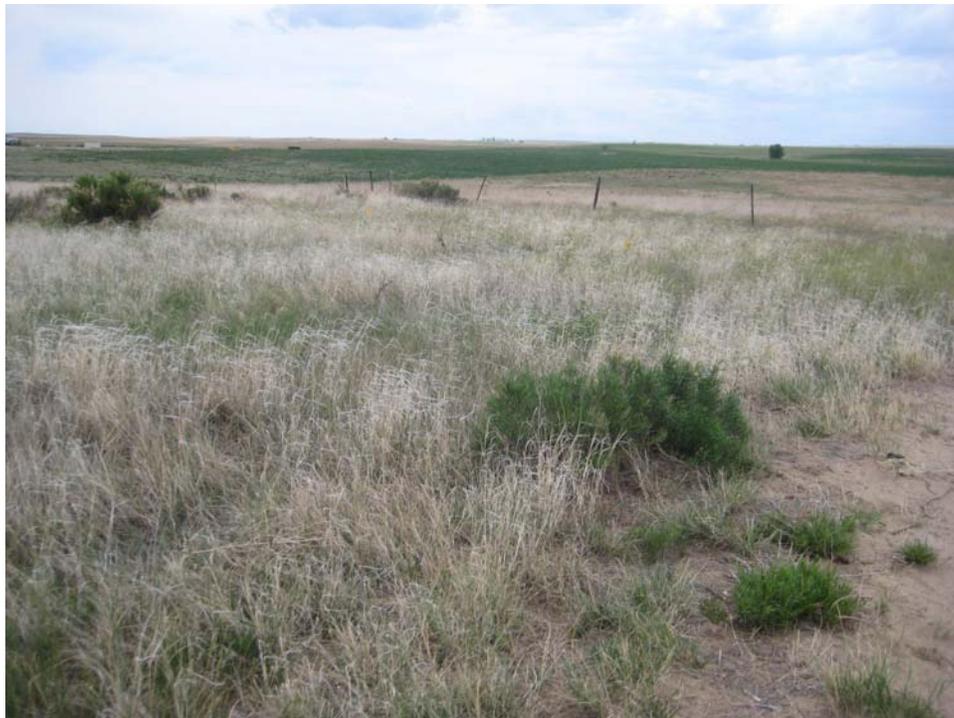
Photo 2. Looking south towards former pit site

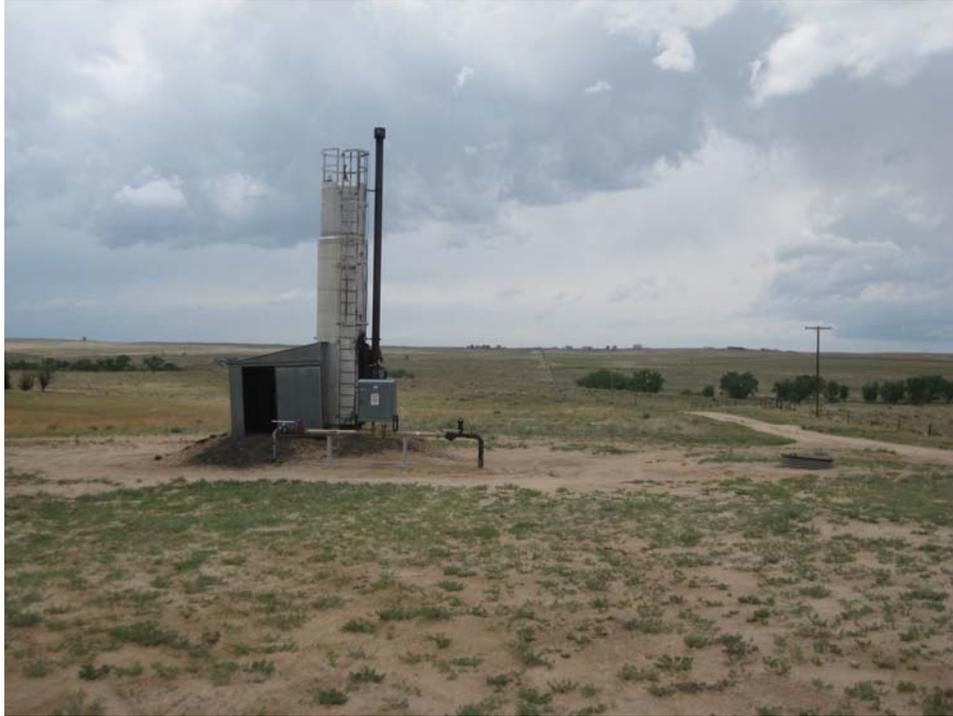
**Photo 3. Looking east at former pit site beyond vertical separator**

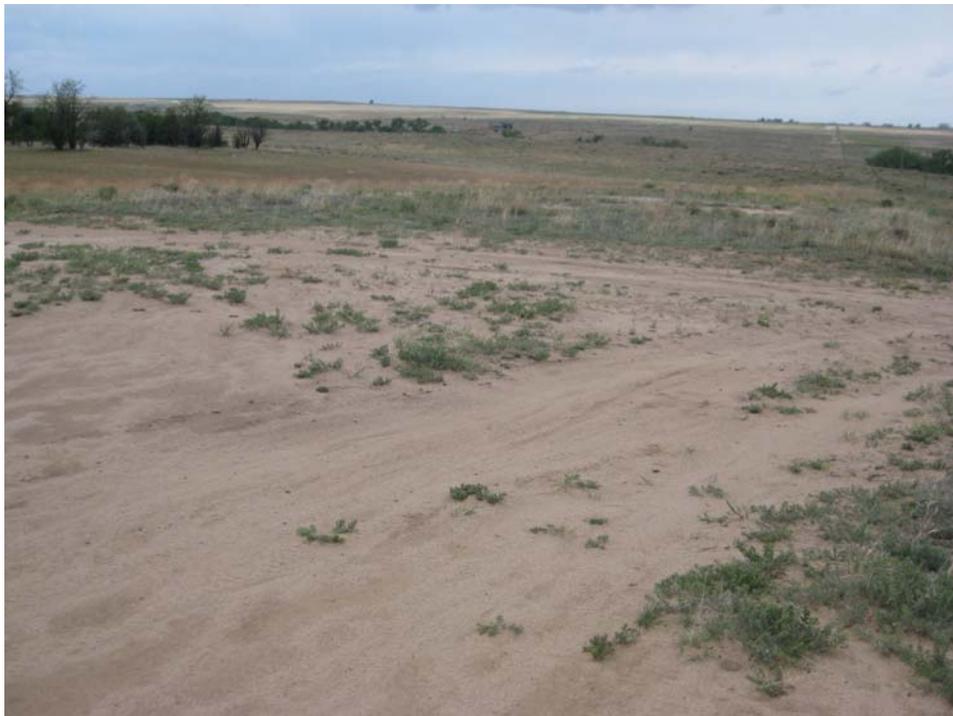
Notes: LIF #690673(8-87) 30'x30' wire covered, unlined pit, Pictures (1999)  
FIELD VISIT 6-4-2008: PIT BACKFILLED  
found covered steel tank for water storage

**Photo 4. Backfilled pit site**

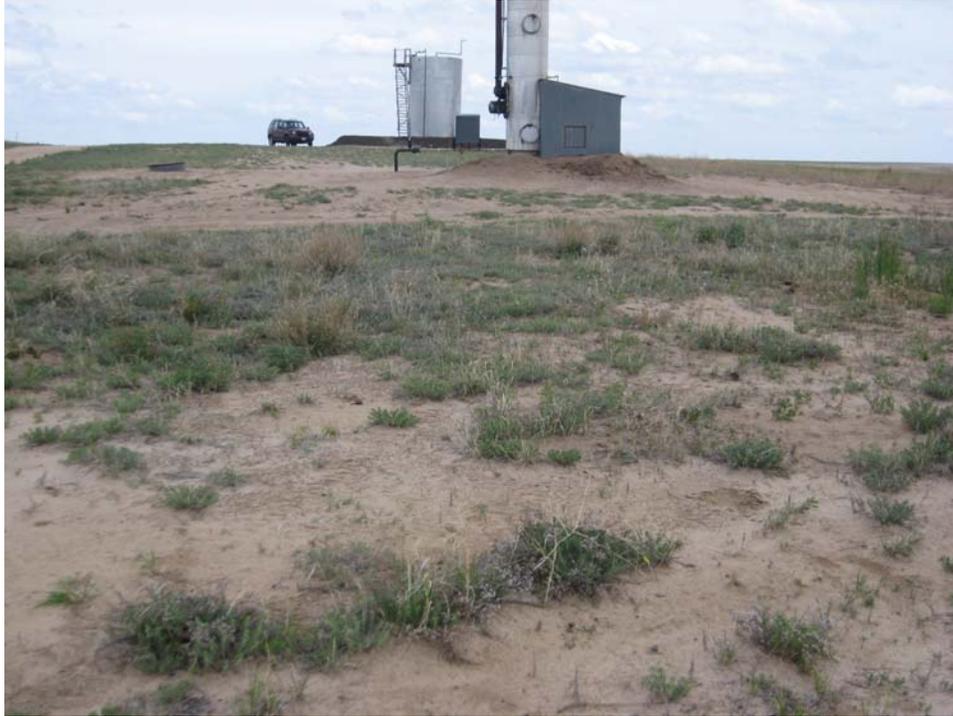
**Photo 5. Looking east at backfilled pit site in foreground**

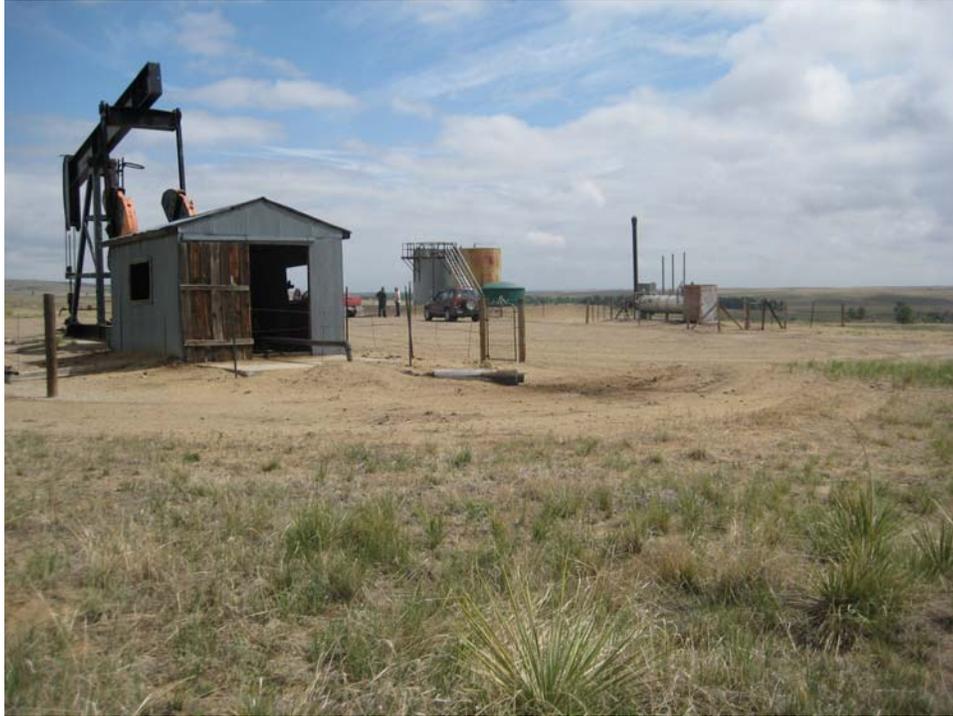
**Photo 5. Looking northeast from the southwest corner of well pad.  
The former pit site may have been at the southeast corner of the well pad (right in photo).**

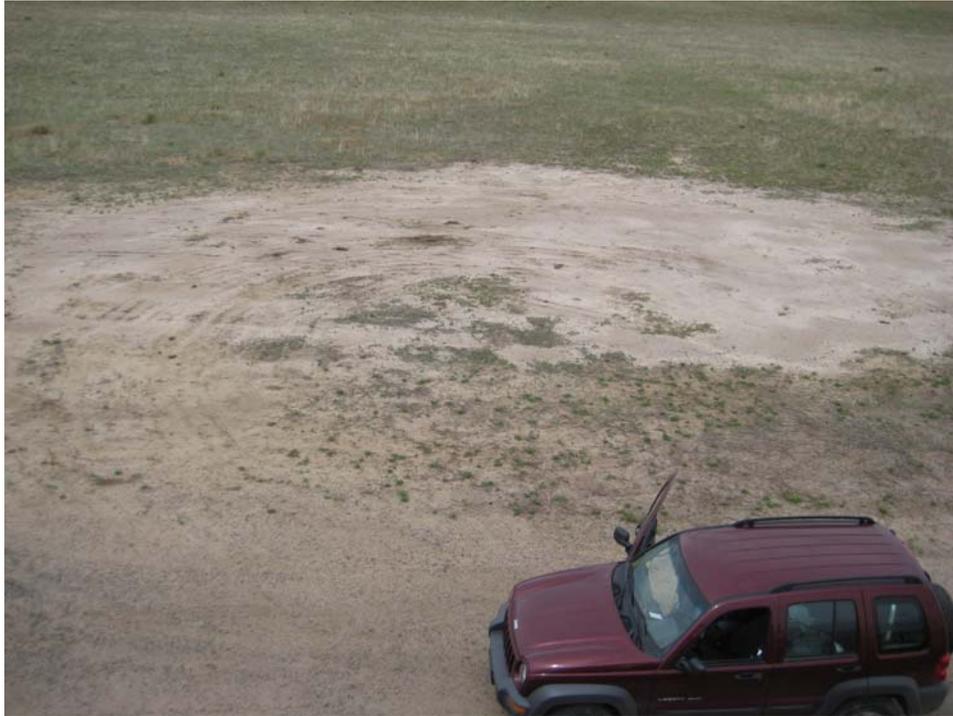
Notes: Common Use battery site (06284 & 06257) WSIF (1988) pits backfilled  
& site clean 06237 #8-10  
FIELD VISIT 6-4-2008: PIT BACKFILLED

**Photo 3. Former pit site to the west of steel tanks**

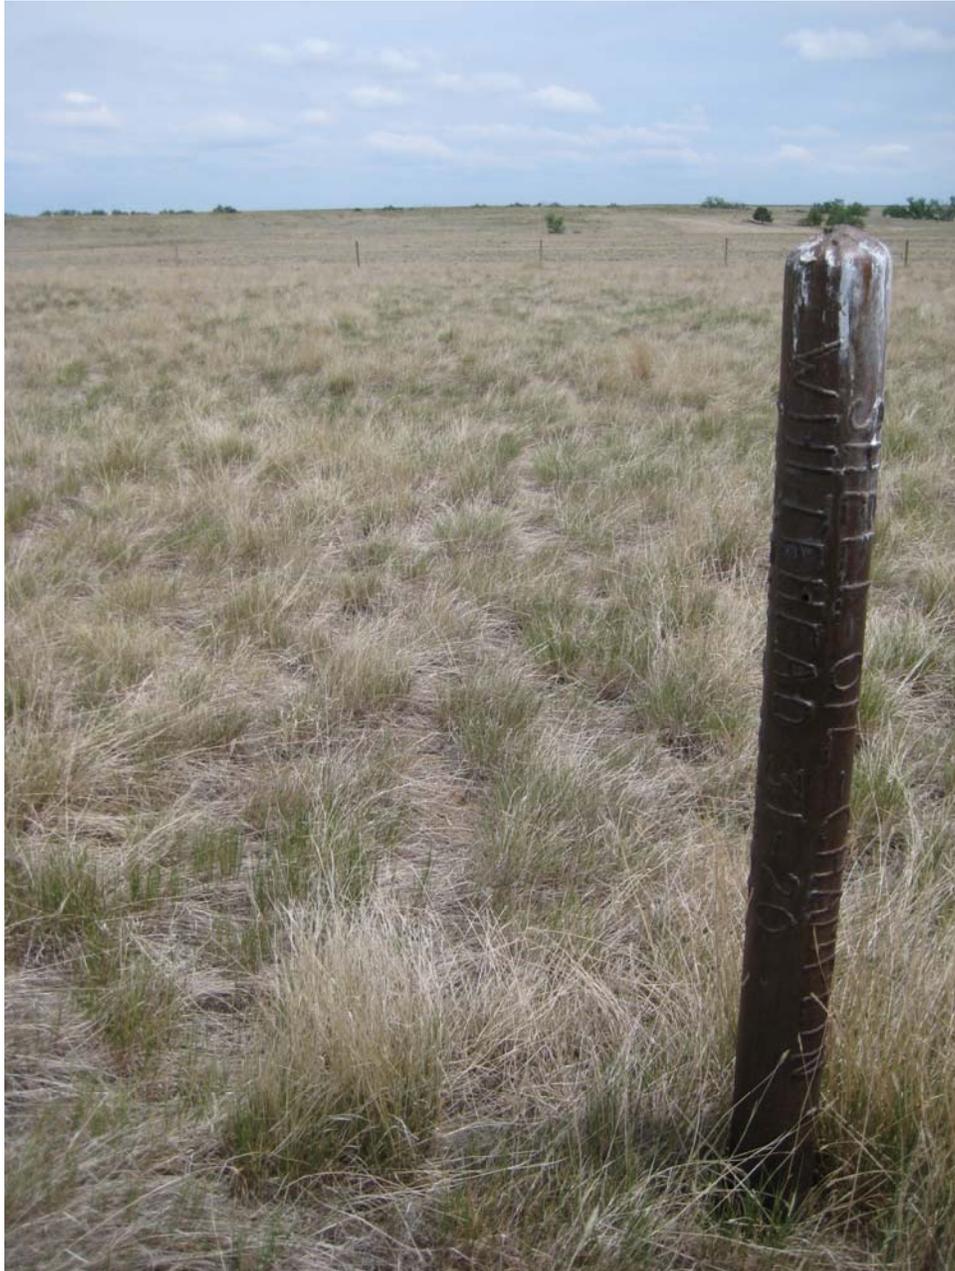
**Photo 1. Looking east at marker for Whitehead 31-20 plugged and abandoned well; former pit site is beyond marker.**

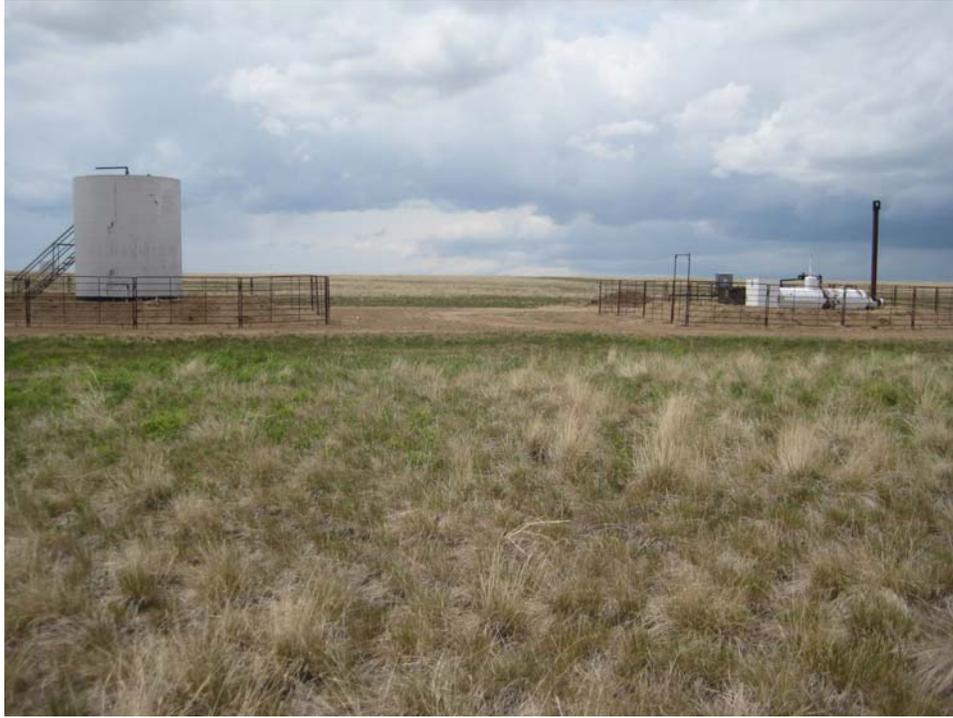
FIELD VISIT 6-4-2008: PIT BACKFILLED & SITE CLEAN.

**Photo 2. Looking west at former pit site in foreground and Whitehead 31-20A wellhead and equipment**

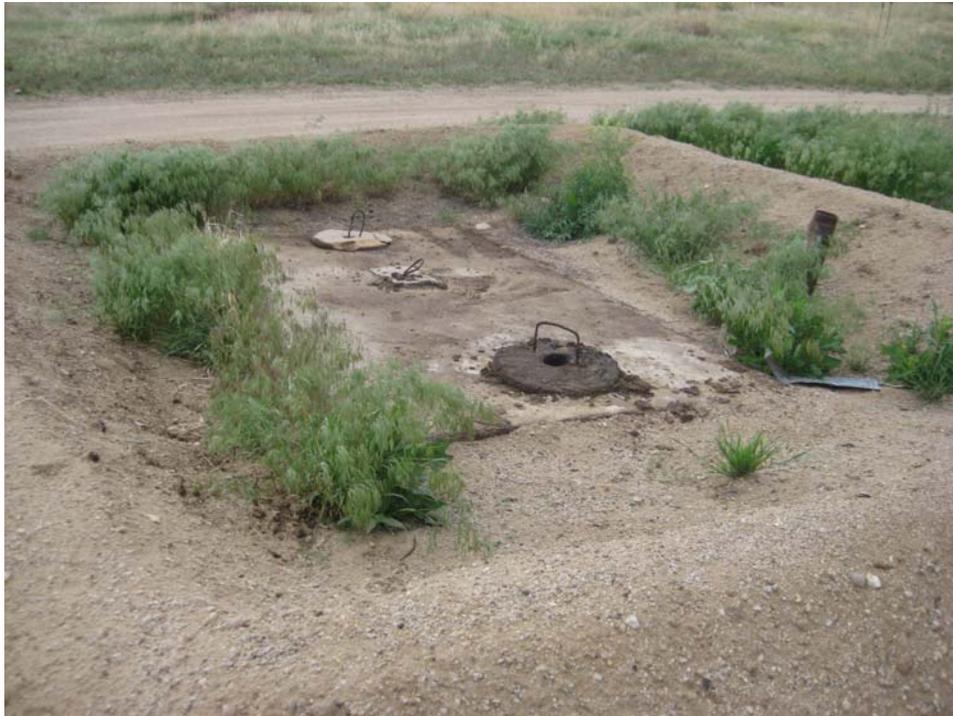
Notes: Common use for Champlin 548 #1 & #2  
FIR (2004) "Vault open"  
FIELD VISIT 6-4-2008: Concrete Vault. No pits at either well site.

Photo 2. Buried concrete vault

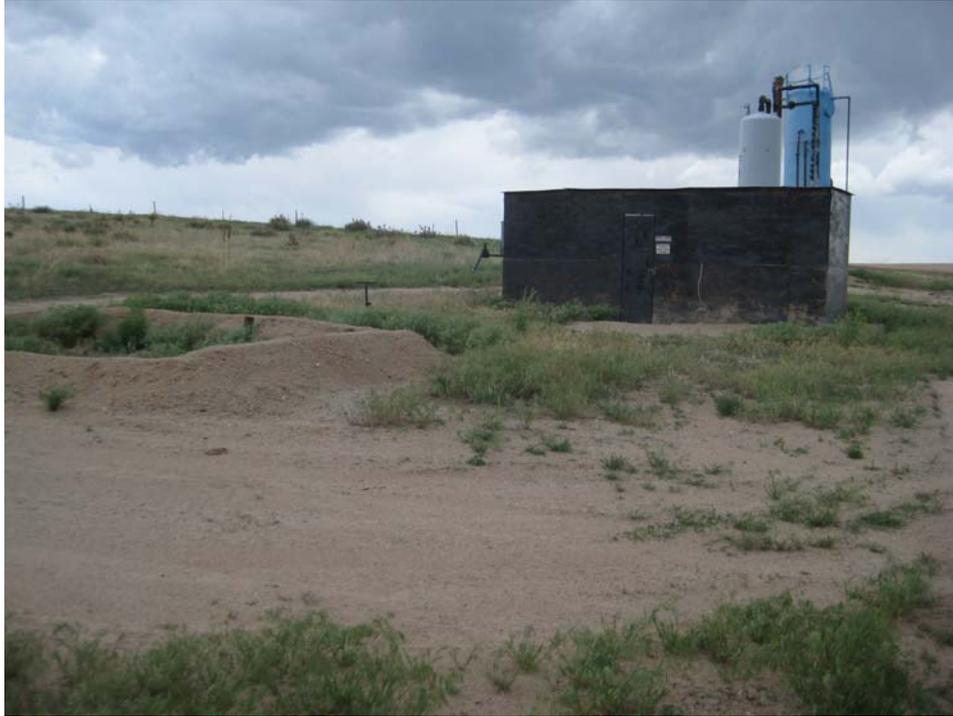
**Photo 3. Buried concrete vault and two separators to the west**
