SITE ASSESSMENT

DRAINAGE PLAN

SOUTHERN UTE 26-5

LA PLATA COUNTY, COLORADO

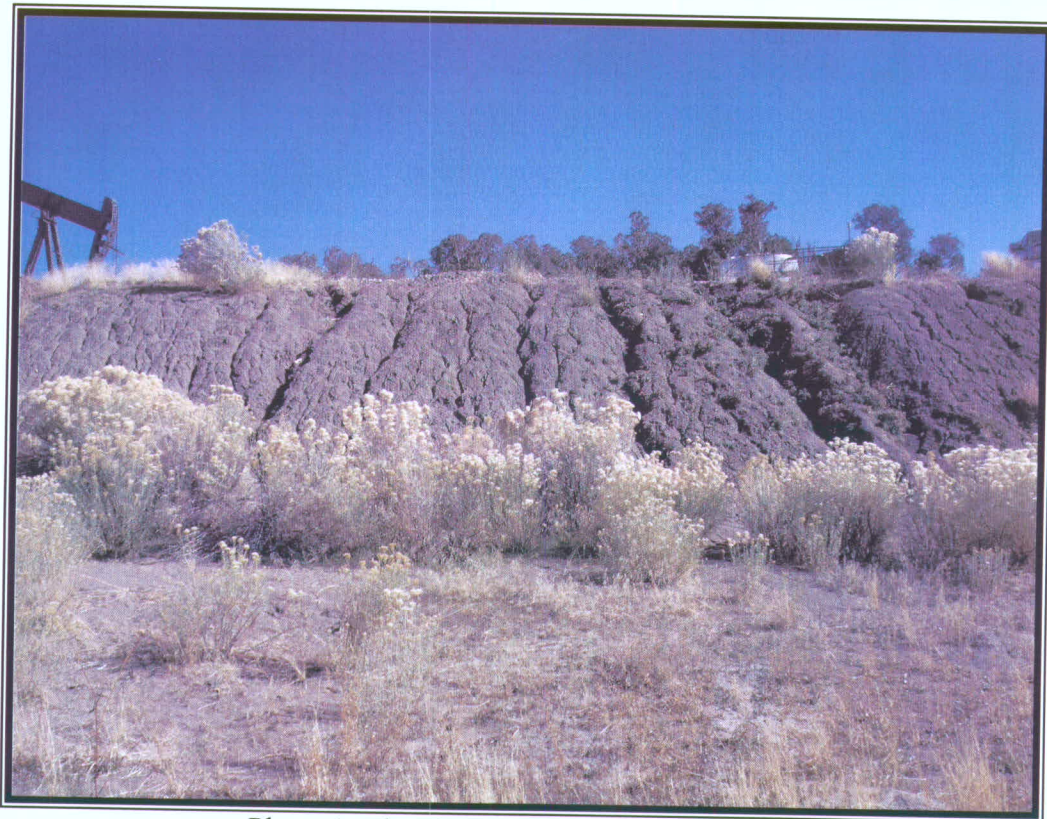
The steep slope to the north and west of the pad causes the runoff to gain velocity very quickly, leading to significant incising. The soil type is easily eroded, as demonstrated by gullies and tunneling apparent at the edge of the pad. An abandoned reserve pit is to the west of the well pad at the bottom of a steep slope approximately 20 feet high; see **Figure 2, Site Map**. This reserve pit is revegetating well and could serve as a kinetic energy sink for the runoff. The structure constructed for achieving this must be appropriate to the soil type. Because of the observed tunneling it is believed that installation of a berm to redirect the runoff would be undercut and fail due to water tunneling underneath it and creating a new channel. The remaining berm would continue to concentrate the flow into the new channel created by the berm failure and a new arroyo would be created. A cobble lined ditch along the north and west sides of the drill pad would be a more stable solution under these conditions; see **Figure 3, Structure Map**. The channel constructed from the well pad down to the reserve pit would also need to be cobble lined (a rock rundown); see **Figure 4, Structure Detail**. Due to slope angle this rock rundown should be reinforced with green juniper pickets and heavily seeded with a site appropriate mix of grasses and shrubs. The juniper pickets will keep the cobble in place until vegetation is established. The size of picket required does not necessitate the cutting down of entire live trees. If such action is approved the needed pickets could be harvested near the site by limbing surrounding juniper trees with a chain saw. A cobble splash pad at the bottom of the rock rundown will prevent the structure from failure caused by undercutting. A pipe or culvert installation here is not recommended as it is likely that water would tunnel around it in this soil type, causing failure and creation of a new arroyo in place of the pipe or culvert.

Photo 1: The slope as viewed from the reserve pit.

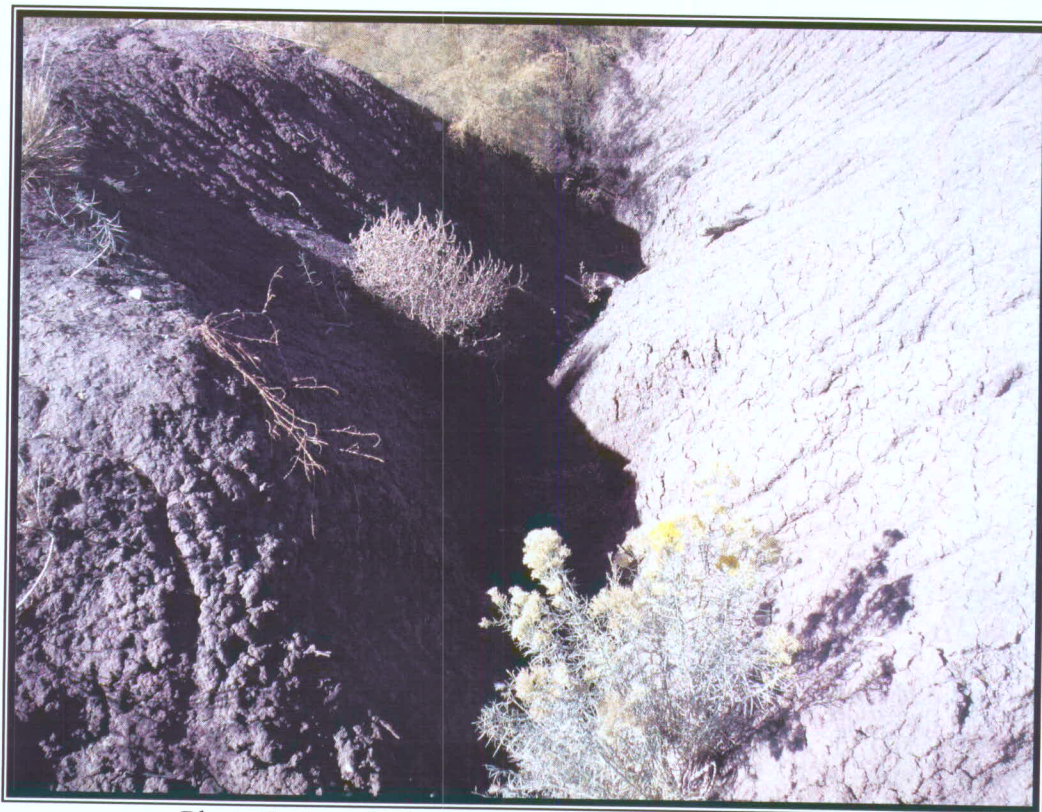
Photo 2: A typical arroyo on the northwest corner of the pad.

The existing gullies at the north and west edges of the pad are being prevented from revegetating by continuous erosion. Construction of the cobble lined ditch would essentially stop the erosion by redirecting the water away from them. The steepness of these arroyos will make it difficult for vegetation to reestablish itself here. This process could be facilitated by the construction of juniper wicker dams to increase retention of soil moisture and fine sediment.

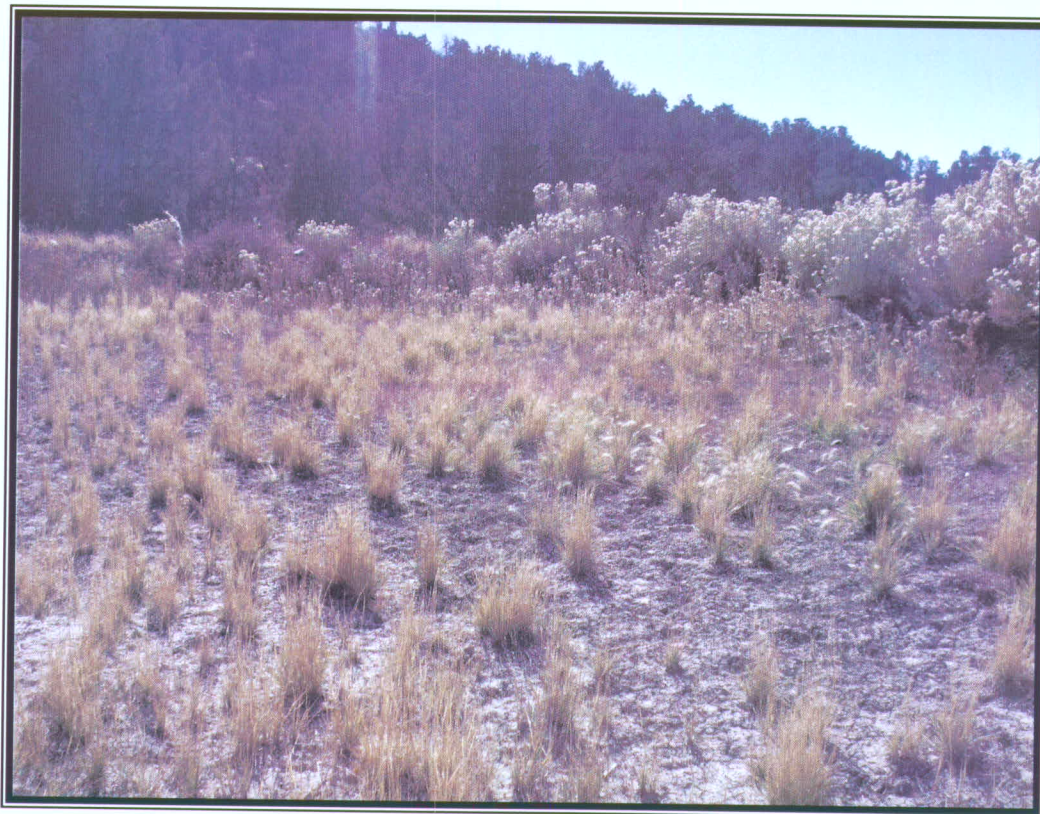
Photo 3: The reserve pit.

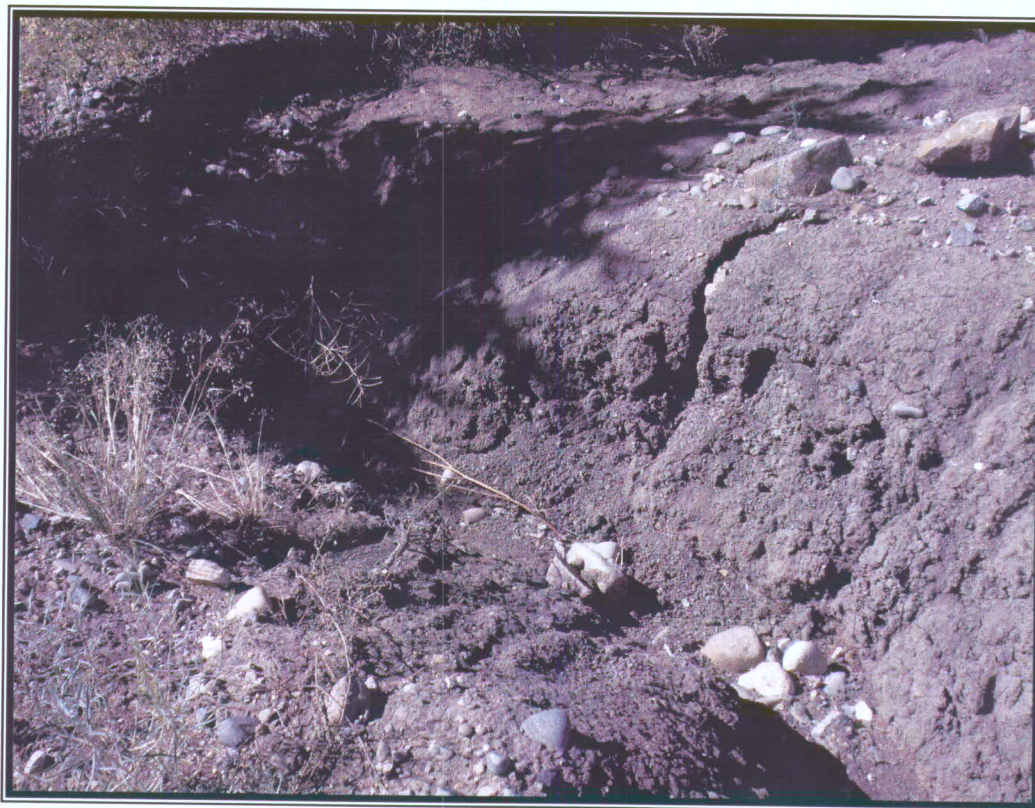
Photo 4: Downcutting bar ditch west of the access road.

The access road is drained by a bar ditch immediately west of the road. This bar ditch is causing a migrating headcut which could eventually reach the road and create an arroyo through it. Installation of a stone Zuni bowl would stabilize this headcut, preventing deepening of the existing arroyo and protecting the access road; see **Figure 4, Structure Detail**.
