DRAINAGE PLAN INSTALLATION

SOUTHERN UTE 26-5
LA PLATA COUNTY, COLORADO

PROJECT No. 92270-203
DECEMBER 2007

RE: DRAINAGE PLAN INSTALLATION AT THE SOUTHERN UTE 26-5, LA PLATA COUNTY, COLORADO.

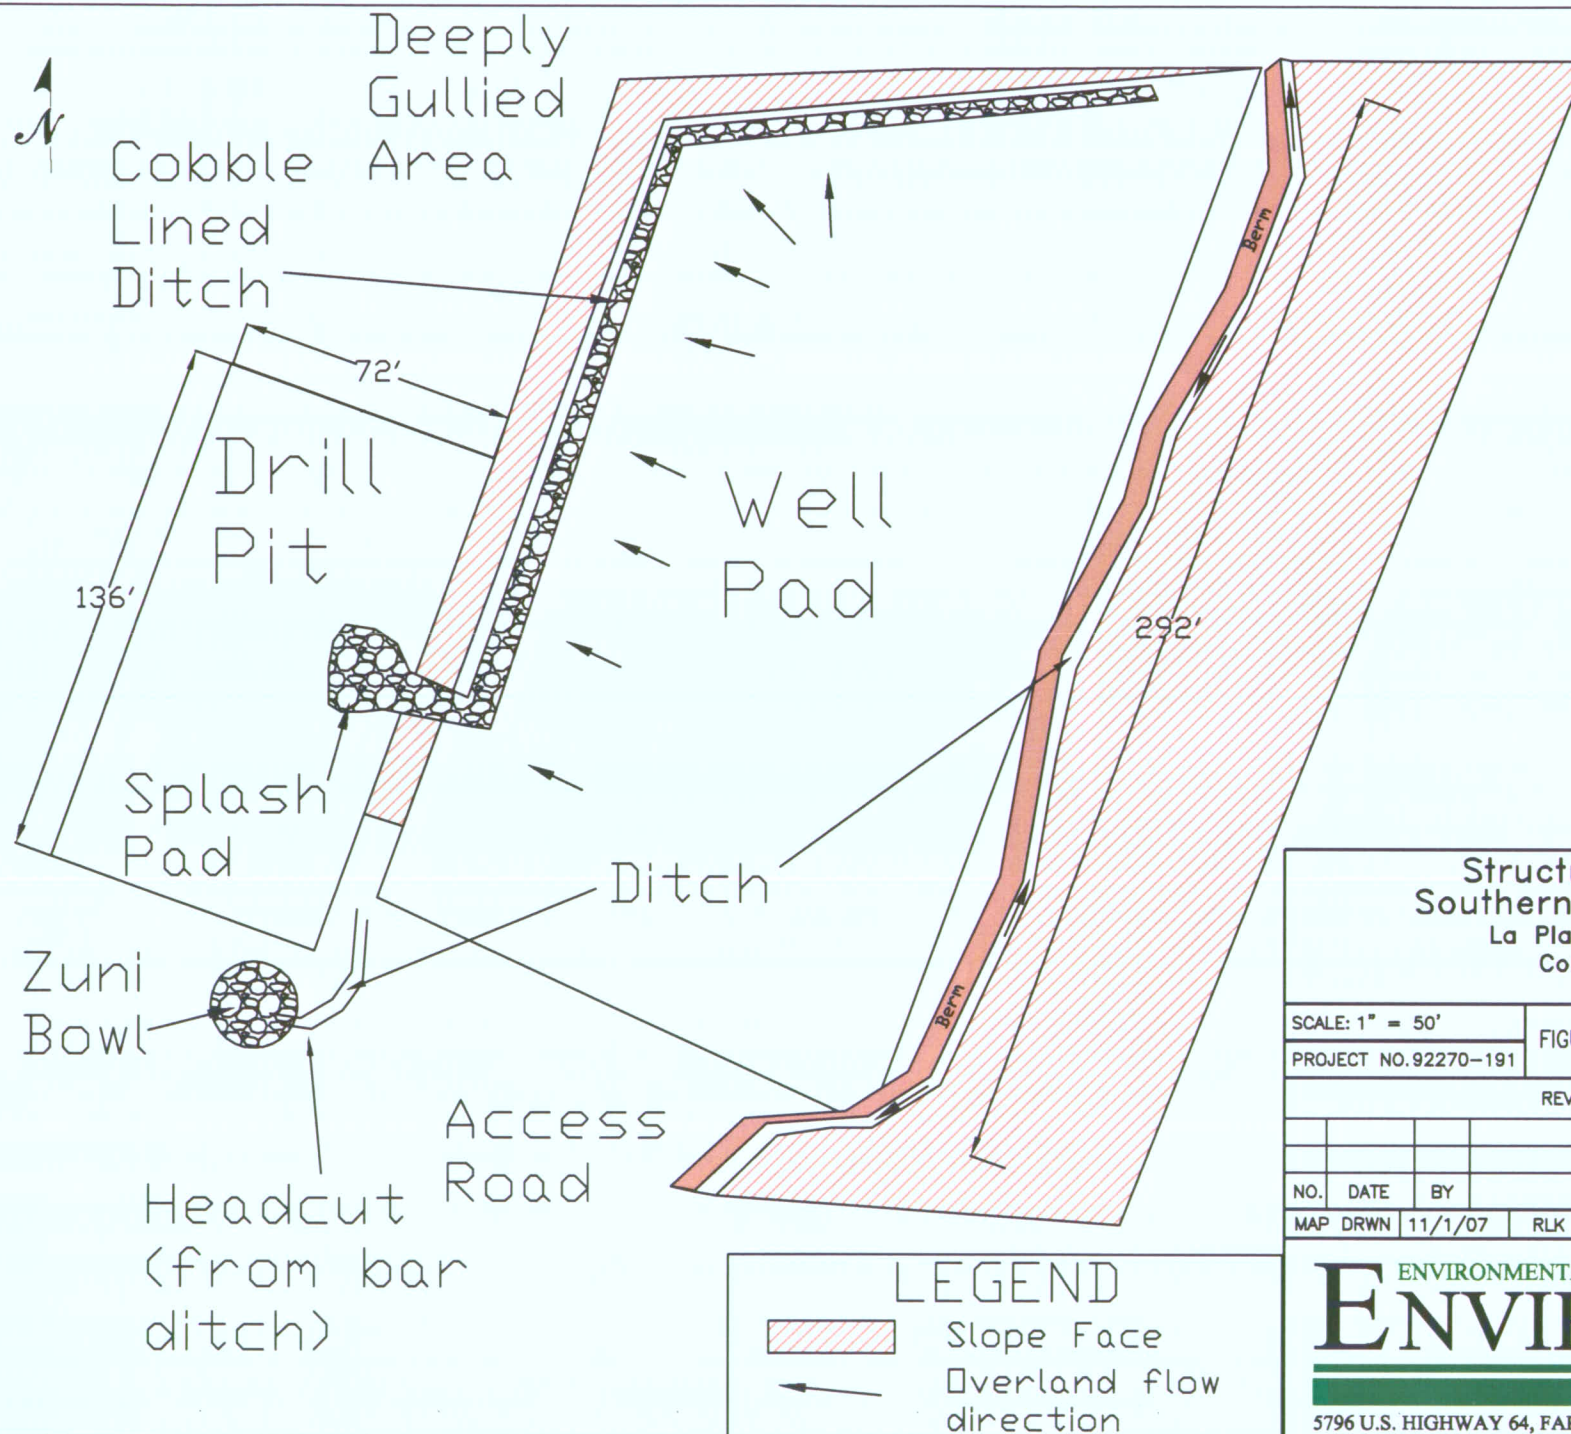
Structure Map
Southern Ute 26-5
La Plata County
Colorado

Envirotech, Inc. was contracted to install a drainage system to address significant erosion at Chevron North America's Southern Ute 26-5 well site; see **Figure 1, Vicinity Map**. Drainage off of the well pad caused gullies to be formed on the north and west side of the pad where construction of the pad caused steep slopes; see **Figure 2, Structure Map**. These gullies down cut rapidly due to the slopes' angle and soil characteristics. A cobble lined ditch was constructed to direct pad runoff to a juniper-reinforced rock rundown leading to the reserve pit; see **Appendix A, Site Photography**. This re-routing of runoff will prevent further erosion in the heavily gullied areas.

An environmental scientist, backhoe and operator, and a field technician arrived at the site along with a 12 yard dump truck loaded with cobble. Installation began with the construction of a cobble lined ditch along the north and west sides of the well pad; see **Figure 2, Structure Map**. A channel was shaped using the backhoe; see **Appendix A, Site Photography**. Cobble was then delivered by the backhoe and placed by hand to produce a channel liner with maximum coverage and minimum resistance to flow.

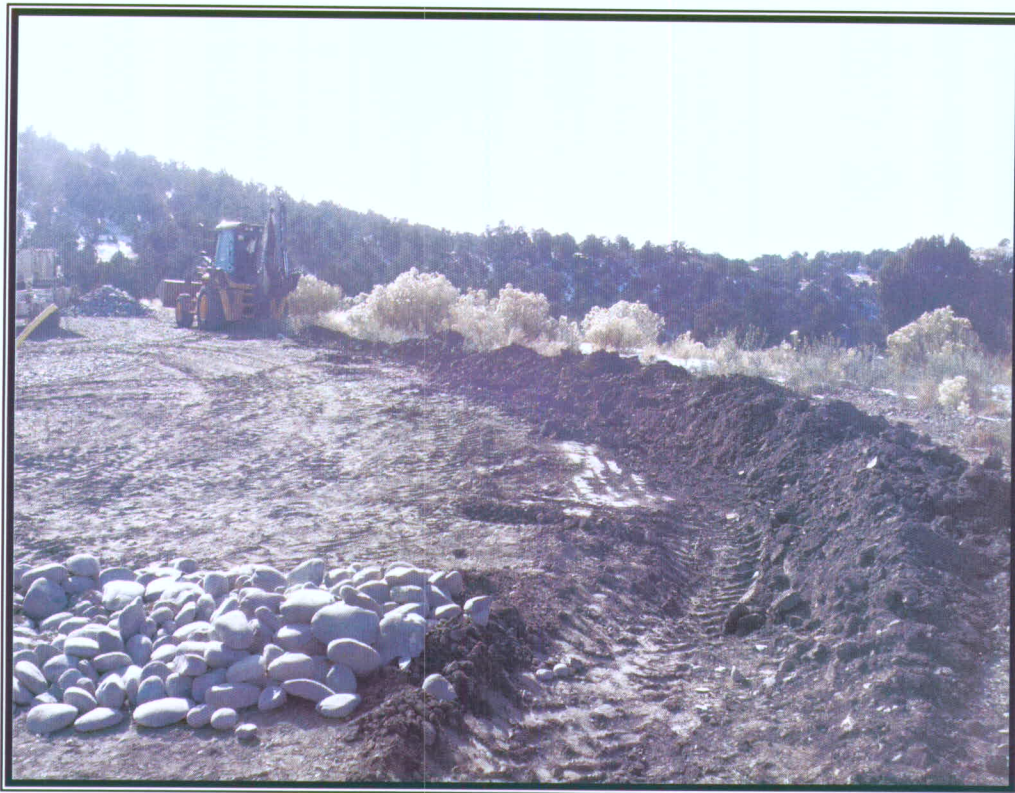
Photo 1: Construction of the ditch channel.

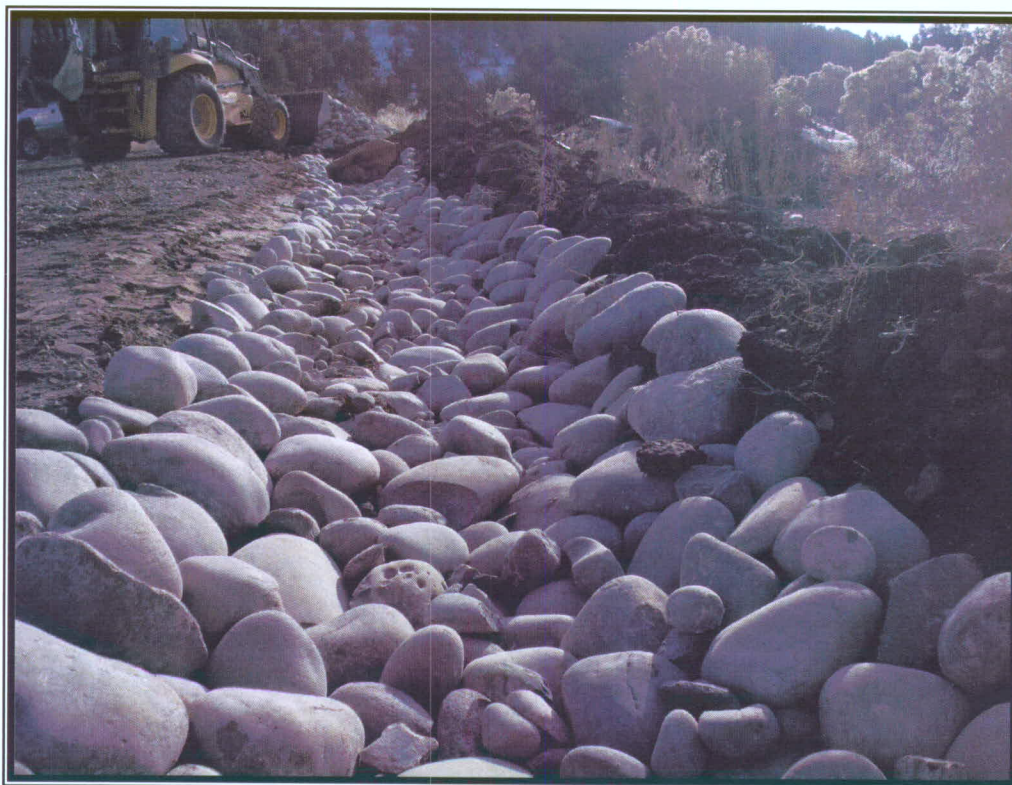
Photo 2: The cobble liner.

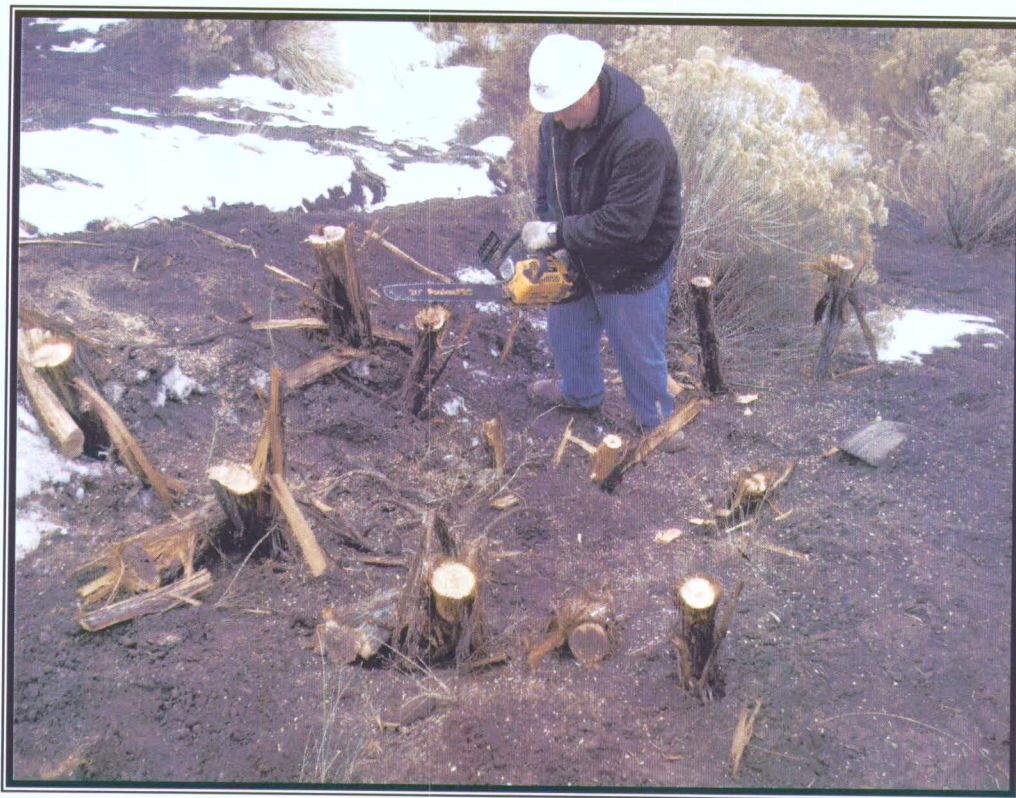
Photo 3: Trimming the pickets in the rundown.

A field technician and environmental scientist returned to begin the rock rundown. The rundown was constructed in an existing eroded channel of appropriate size and cross section. This was done to minimize disturbance to the fragile slope soils and vegetation. Green juniper stakes were harvested by selective limbing of surrounding trees. These limbs were turned into usable pickets by sharpening one end with a chain saw. The pickets were driven 2-4 feet into the channel with a sledge hammer and trimmed to approximately one foot above ground surface. The slash produced was then woven between the pickets to anchor the structure; see **Appendix A, Site Photography**. Cobble was delivered down the slope with the backhoe then placed by hand.

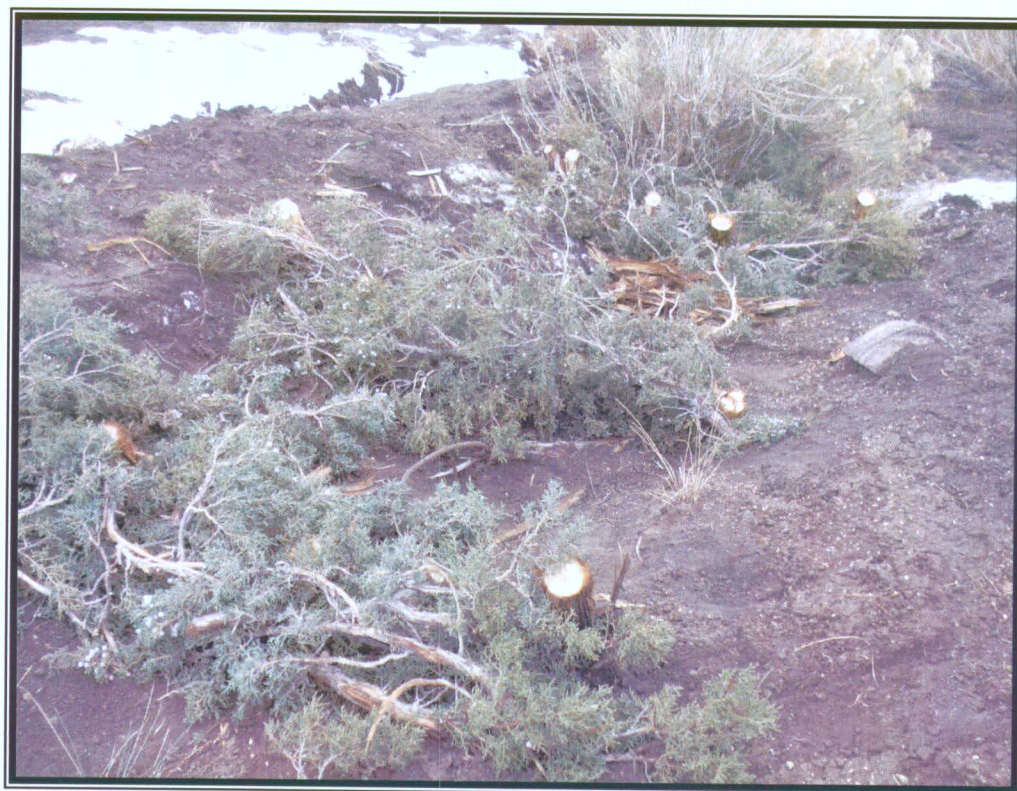
Photo 4: Pickets woven with juniper slash.

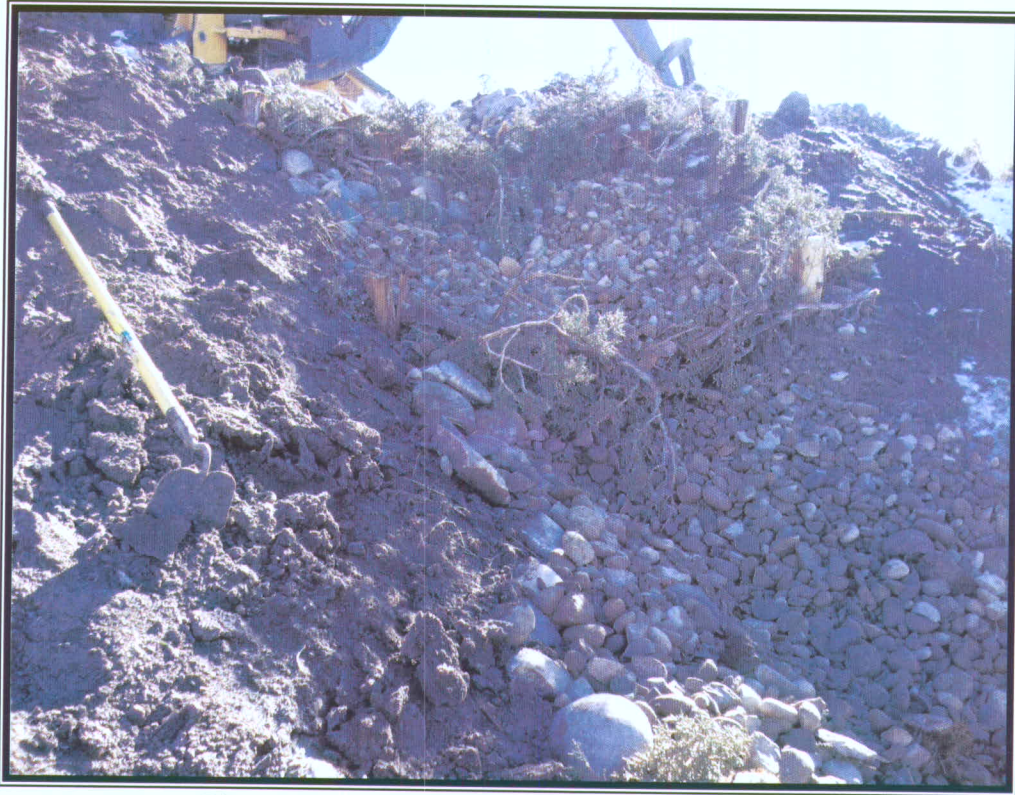
Photo 5: Gravel being placed on rock rundown.

An environmental scientist and field technician returned with a 12 yard truckload of gravel. Repairs to the rundown were completed by hand and placement of the gravel in the ditch and rundown began. Gravel was delivered with the backhoe then raked or hoed across the cobble to facilitate incorporation into the structure. A layer of gravel was placed on the surface of the rundown to provide material for the structure to be self-repairing if shifting of the cobble occurred due to settling or thawing of the soil.

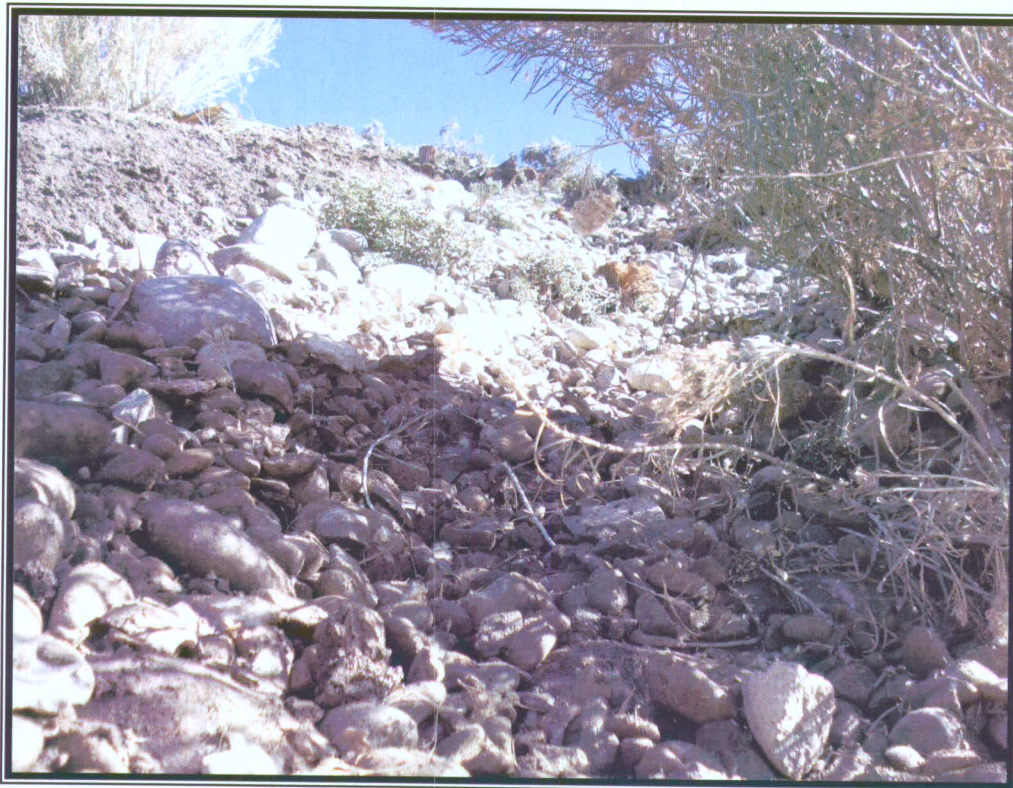
Photo 6: Looking up completed rock rundown.
