From: Caplis, Chris [Chris.Caplis@Williams.com]
Sent: Thursday, September 30, 2010 9:52 AM
To: Andrews, David
Cc: Matt Mandarich
Subject: Bradenhead Charts from SP 14 pad 9/27/10 and 9/25/10
Attachments: Braden Heads Pressure Monitoring - SP 14 - 9-27-10 and 9-28-10.doc

Subject: Multiple Braden Heads Pressure Monitoring on the SP 14 Pad (15,000 psi Pressure Transducers)
 Jobs Pumped: SP 321-14 MV 2, SP 13-14 MV 3, SP 321-14 MV 3, SP 321-14 MV 4, and SP 321-14 MV 5
 Submitted By: Lucas Mahar
 Dates: 9/27/10 and 9/28/10

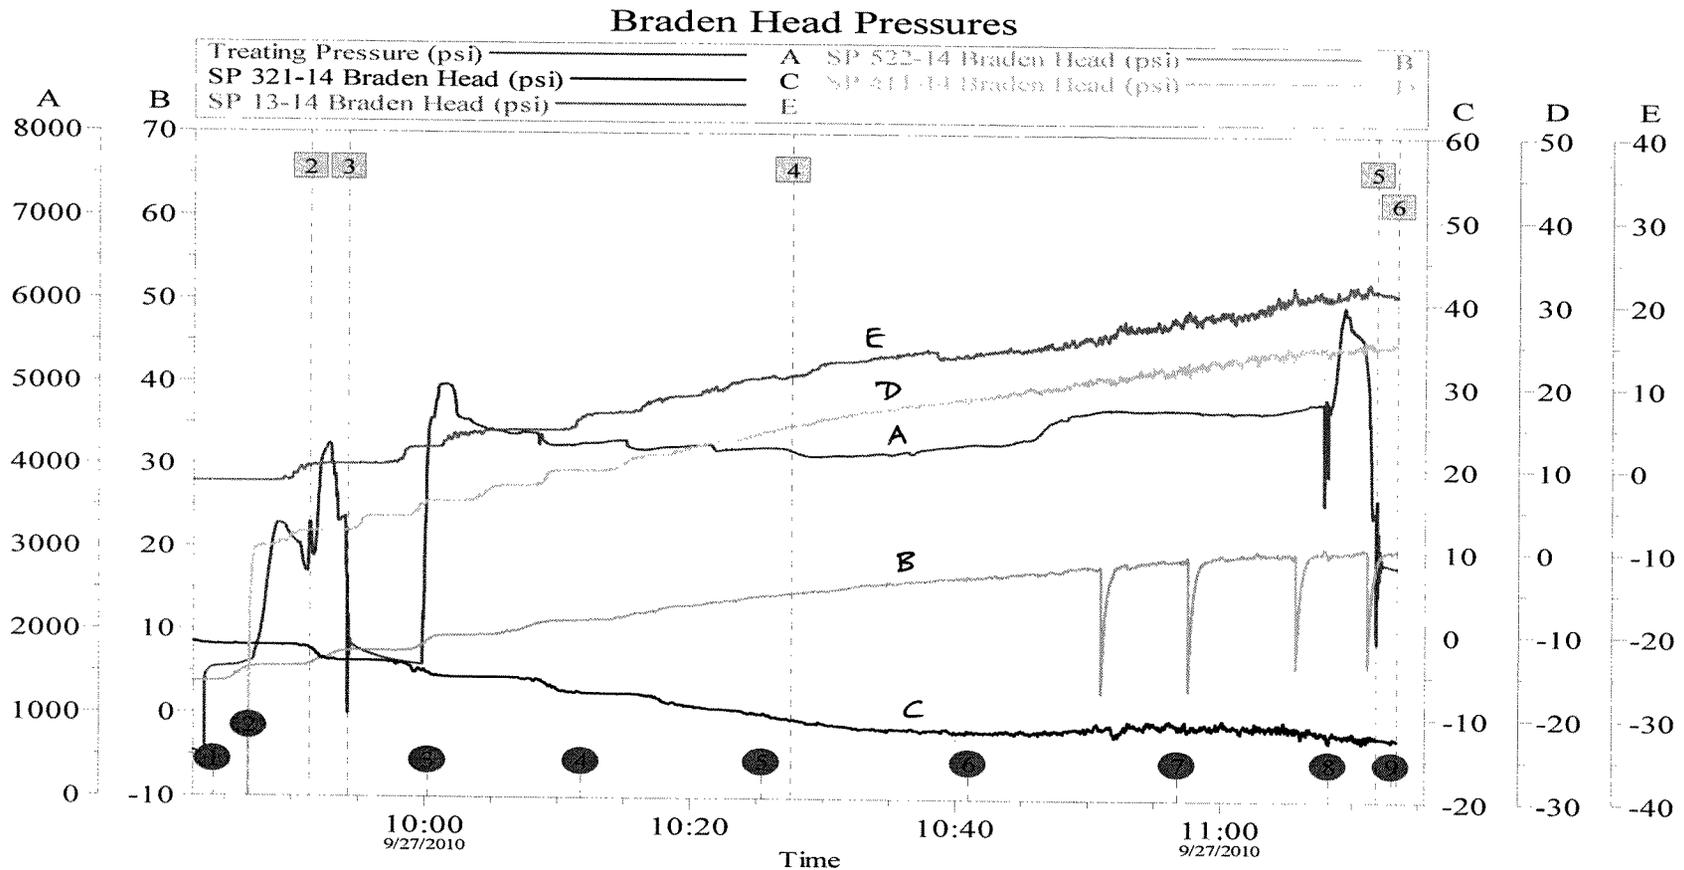
Customer: WILLIAMS PRODUCTION RMT INC	Job Date: 27-Sep-2010	Sales Order #: 7650294
Well Description: SP 321-14	UWI: 05-045-18827

*Zeroed all Braden Head pressure transducers before the start of the job, except for the SP 411-14 which was zeroed at the Stage 2 flag.

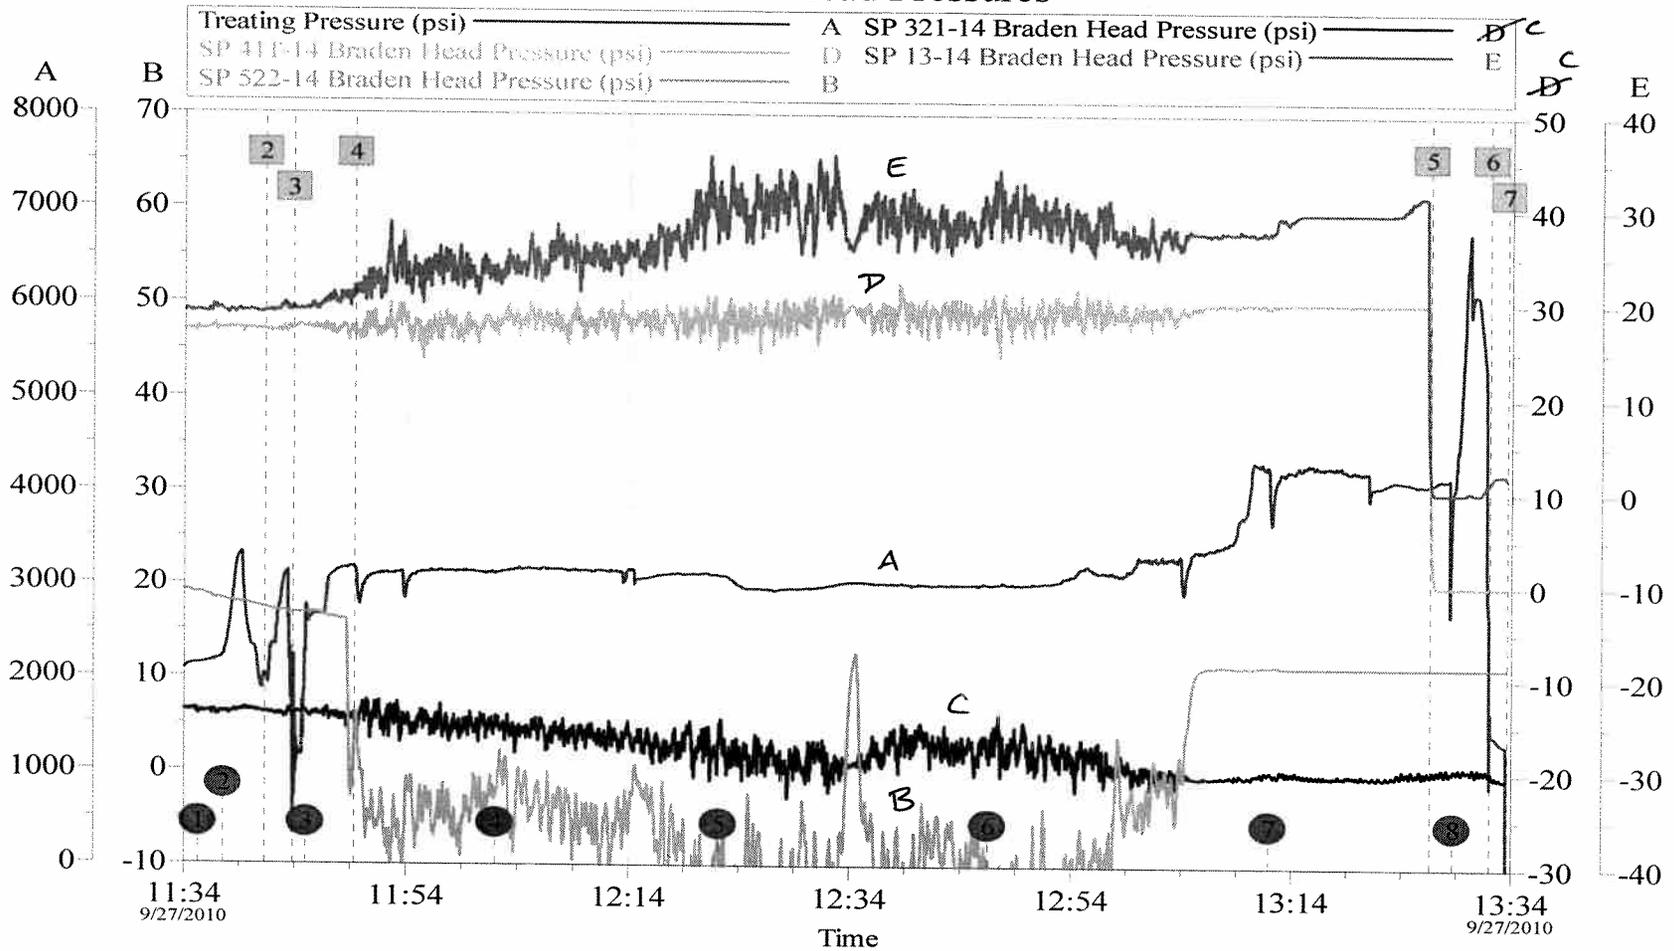
Customer: WILLIAMS PRODUCTION RMT INC
 Well Description: SP 13-14

*Braden Heads and pressure transducers were left alone between the first job and this one. All Braden Head pressures read the same at the beginning of this job as they did at the end of the first. At Event flag 5 we got a new zero on the pressure transducers for the SP 13-14 and SP 411-14 Braden Heads. They didn't have any pressure on them.

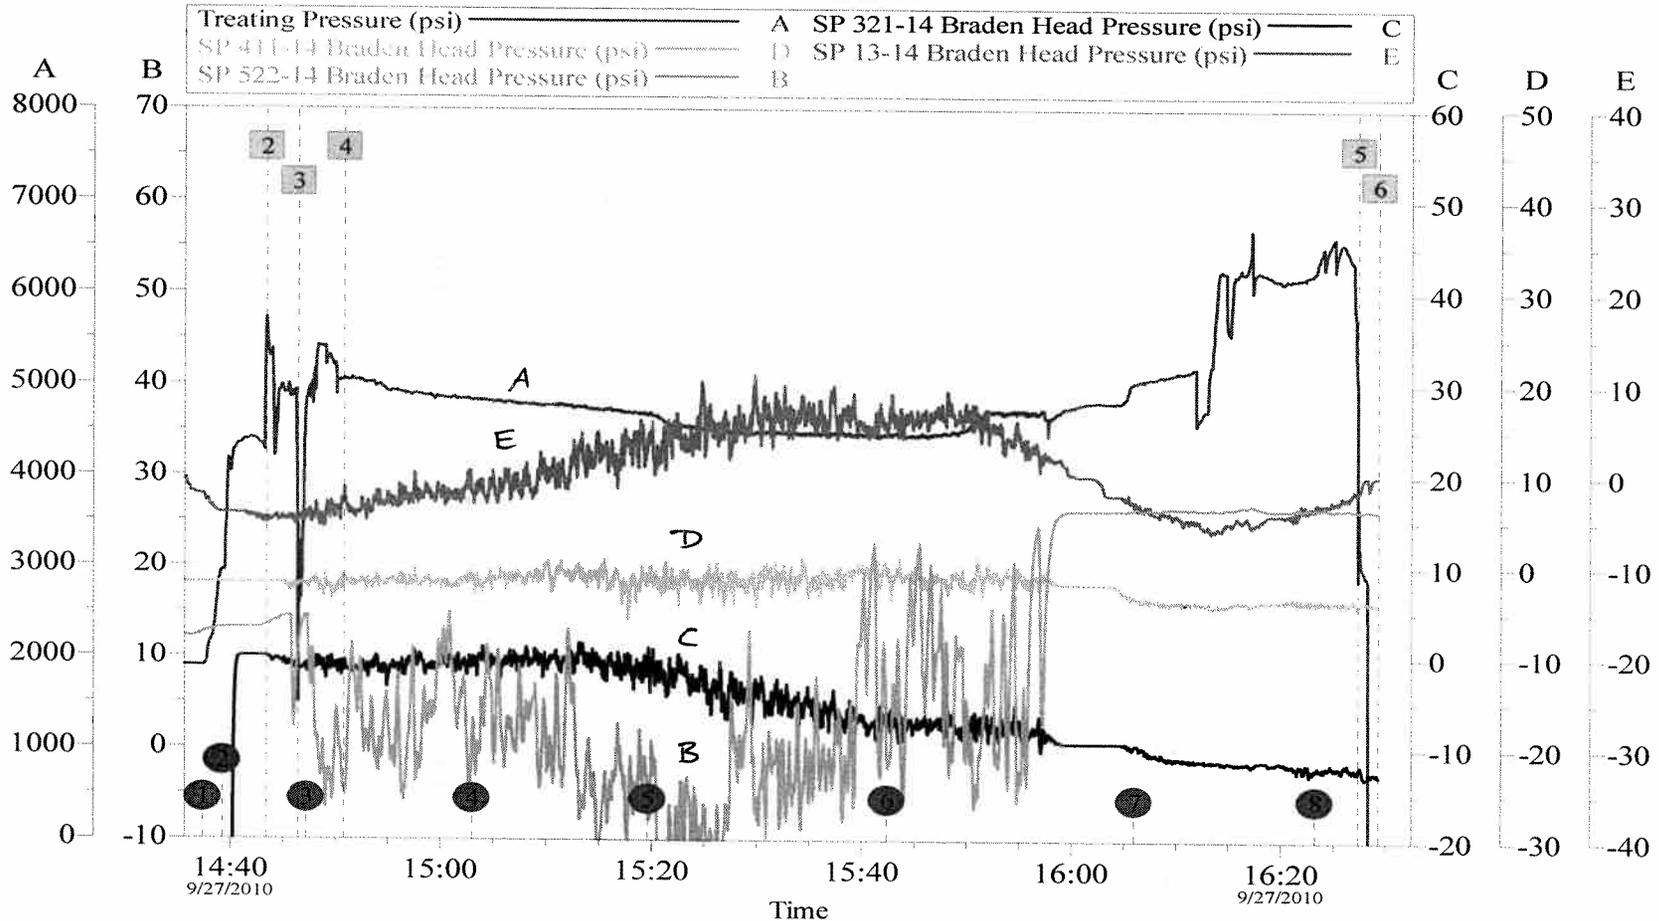
Customer: WILLIAMS PRODUCTION RMT INC	Job Date: 27-Sep-2010	Sales Order #: 7660555
Well Description: SP 321-14	UWI: 05-045-18827

*All Braden Heads and pressure transducers were left alone between the last job and this one. Just after the Stage 2 flag the pressure transducer for the SP 321-14 Braden Head was re-zeroed. No pressure was on it.

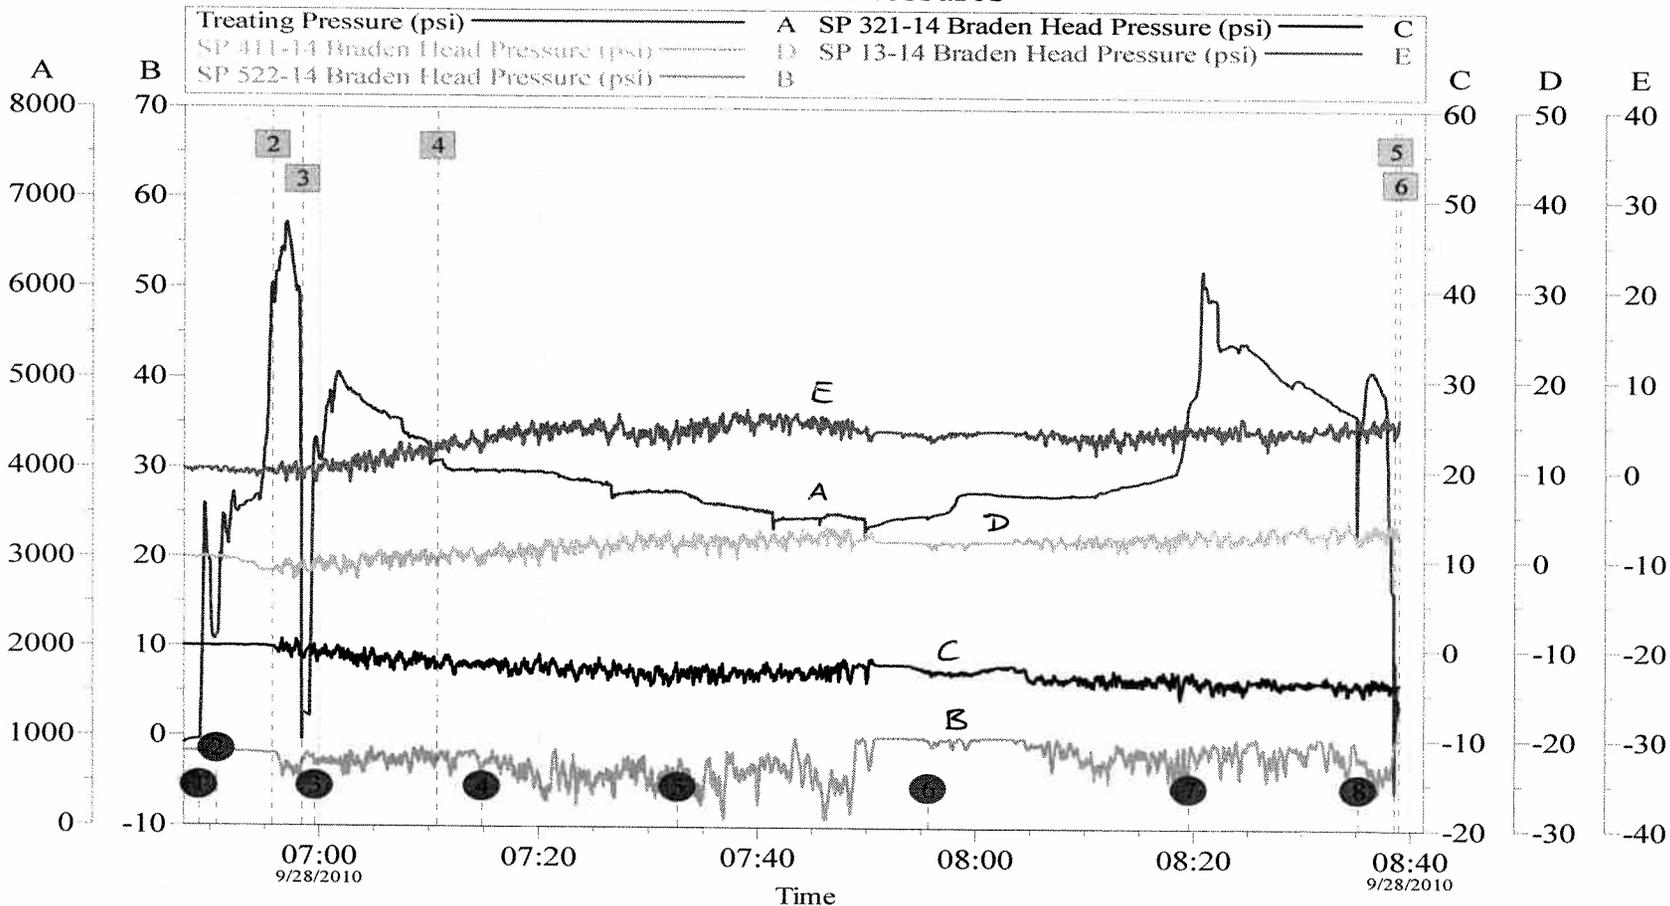
Customer: WILLIAMS PRODUCTION RMT INC	Job Date: 28-Sep-2010	Sales Order #: 7659875
Well Description: SP 321-14	UWI: 05-045-18827

*All pressure transducers were re-zeroed before this job. No pressure was on any of them. They were also opened at the end of this job and there still wasn't any pressure on them.

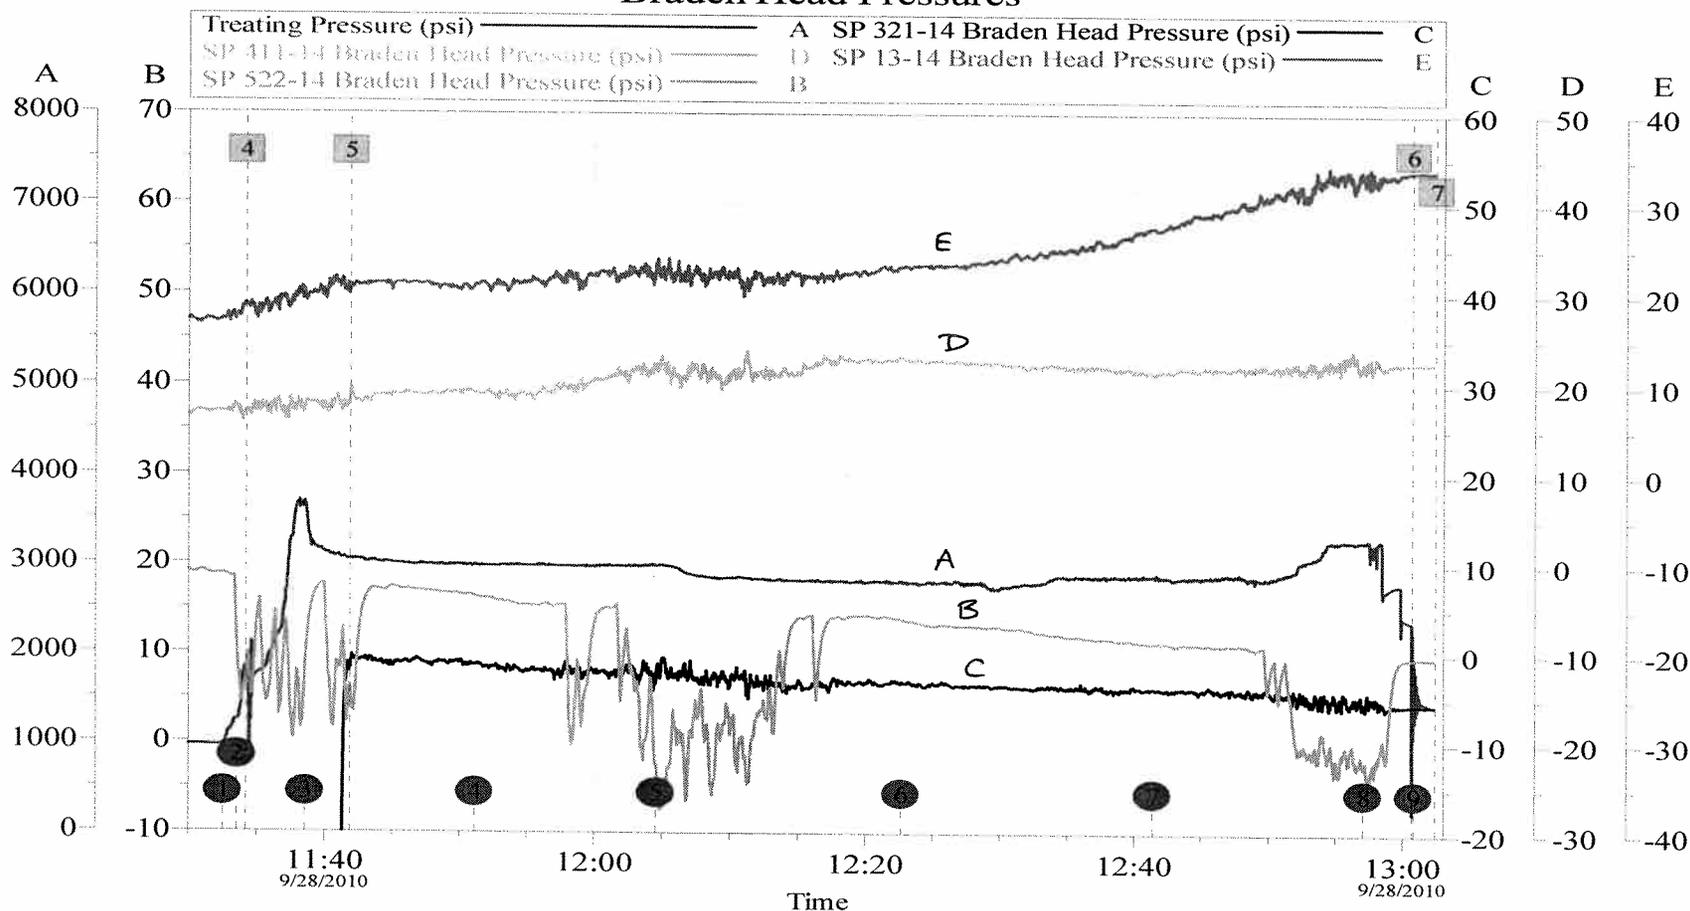
Customer: WILLIAMS PRODUCTION RMT INC	Job Date: 28-Sep-2010	Sales Order #: 7660157
Well Description: SP 321-14	UWI: 05-045-18827

*At Event flag 5 we got a new zero on the SP 321-14 Braden Head pressure transducer, which had no pressure on it.
