From: Fernandez, Frank [Frank.Fernandez@encana.com]
Sent: Sunday, August 15, 2010 1:35 PM
To: Fernandez, Frank; Andrews, David
Cc: Asuchak, Edward A.; Candelaria, Larry R.
Subject: RE: WF04B-22 surface depth request

Regarding Patterson rig 303 drilling ops on Encana's K22 pad.

At roughly 11:00 Wed 8/11 rig Patterson 303 was drilling on WF14D-22 @ 202' when flow-back was reported on the previously drilled surface string WF04B-22 between the 16" conductor and 9-5/8" surface casing. Pumps were stopped and operations halted until plans were organized to stop the cross-flow.

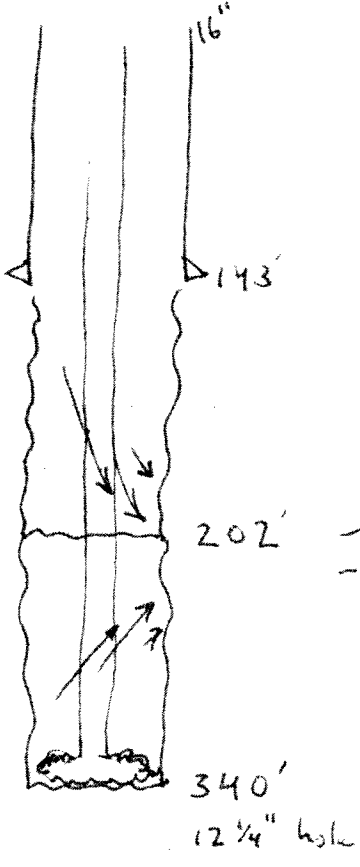
140-22

At 339' MD the drilling fluid breached surface through the WF04^B~~D~~-22 conductor/surf csg annulus once again. Plans were ordered to heal the fracture system via cement.

It is believed the cmt plugged the fracture zone and isolated the 2 wells. It does not appear that cmt made it to the WF04B-22 annulus.

The cement plug has been drilled out. As of 18:30 we are drilling @ 585'. Cross flow between wells is no longer occurring.

2. RIH with 4-1/2" drill pipe open ended as close to drill depth and still be able to swedge up cement equipment. (319')
3. Pump full cement volume to fill WF14D-22, fracture system and WF04B-22 exposed annulus. Add 100% excess.

4. Pull drill pipe and flush (displace cmt) with water as we pull out of the hole.
5. obtain a dredge pump to suck out cellars
6. Circulate excess cement to catch tank.

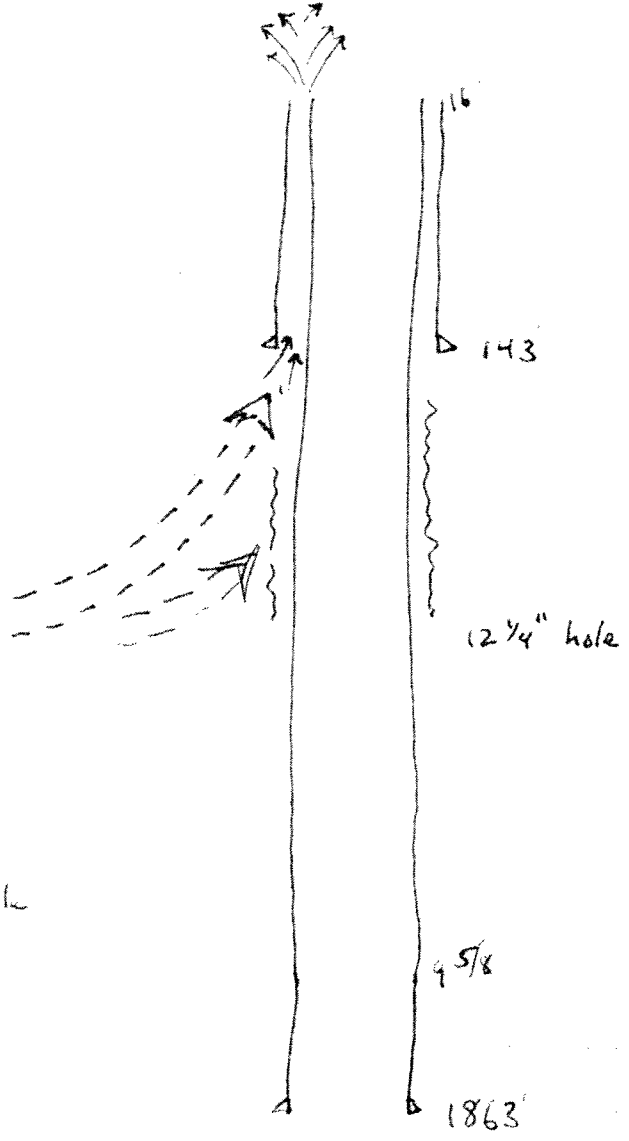
04B-22

Lost cement returns 14 bbls into displacement. Calculated cement top estimated right around conductor shoe.

Footnote: On the WF04B-22 we lost cement returns on the surface cement job at 14 bbls before bumping the plug. Theoretically, that would have put us close over the conductor. This cement plan may possibly heal the lost circ fracture zone and fill missing cement on the WF04B-22.
