From: Fernandez, Frank [Frank.Fernandez@encana.com]
Sent: Sunday, August 15, 2010 1:35 PM
To: Fernandez, Frank; Andrews, David
Cc: Asuchak, Edward A.; Candelaria, Larry R.
Subject: RE: WF04B-22 surface depth request

Regarding Patterson rig 303 drilling ops on Encana's K22 pad.

Regarding WF04B-22 (K22), API# 05-04-18861-00

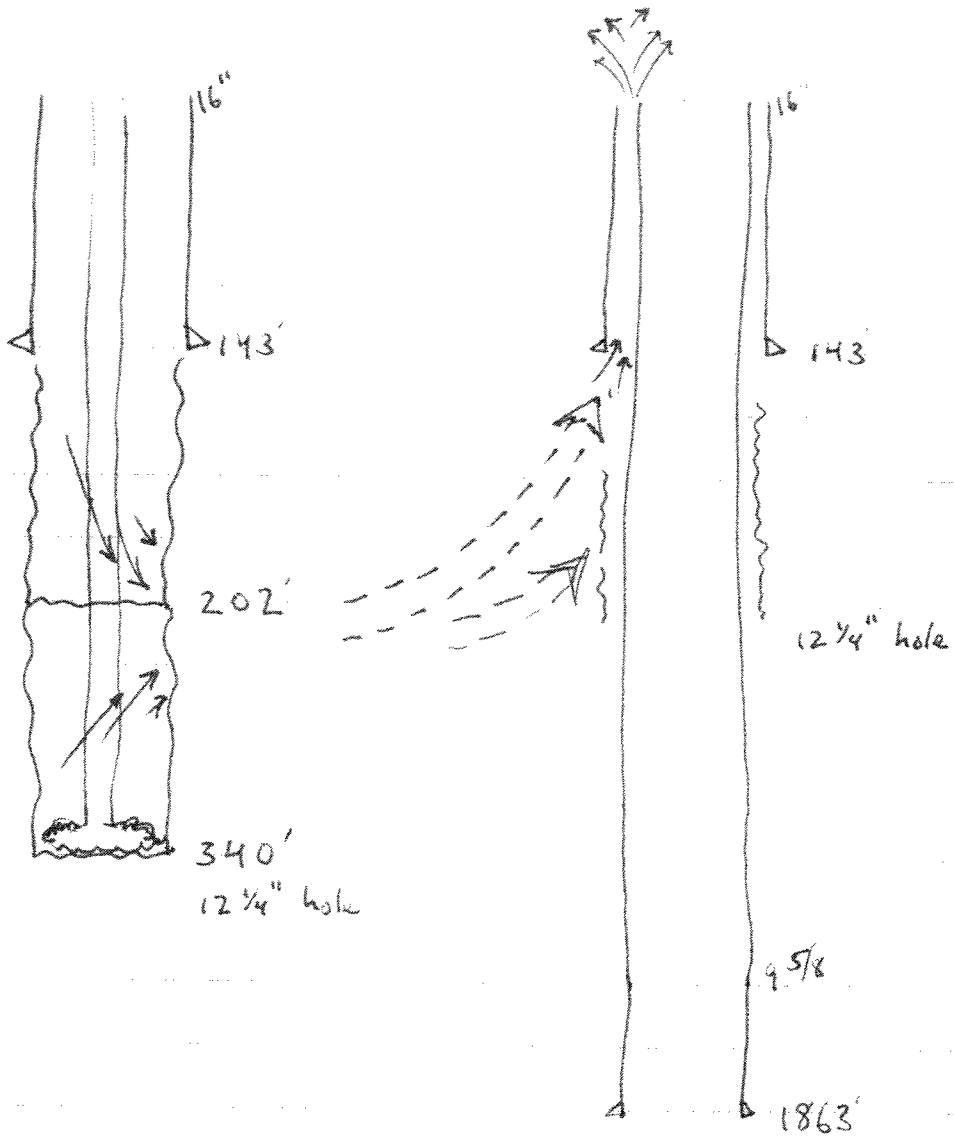
140-22

04B-22

WF140-22

$$\frac{15.75^2 - 4.5^2}{1029.4} (143) = 31.7$$

$$\frac{12.25^2 - 4.5^2}{1029.4} (59) = 7.4$$

$$\frac{12.25 - 4.5^2}{1029.4} (138) = 17.4$$

WF04B-22

$$\frac{15.75^2 - 9.625^2}{1029.4} (143) = 21.6$$

$$\frac{12.25^2 - 9.125^2}{1029.4} (59) = 3.3$$

① → 81.4 bbls plus fracture system

② → 100 bbls

③ → 100% excess

④ → 200 bbls cement ordered

$$\textcircled{5} \rightarrow 200 \text{ bbl cement} \left| \frac{5.6 \text{ cu ft}}{1 \text{ bbl}} \right| \left| \frac{1 \text{ sx}}{1.17 \text{ cu ft}} \right| = 757 \text{ sx cement}$$
