**SITE INVESTIGATION AND REMEDIATION WORKPLAN**

Tracking No: **2608926**

**REMEDIAL WORKPLAN (Cont.)**Facility Name & No: Merit Rory #1 Tank battery

MERIT ENERGY  
RORY #1 TANK BATTERY  
NESW SEC 24 T4N R67W  
MILLIKEN, WELD COUNTY, CO

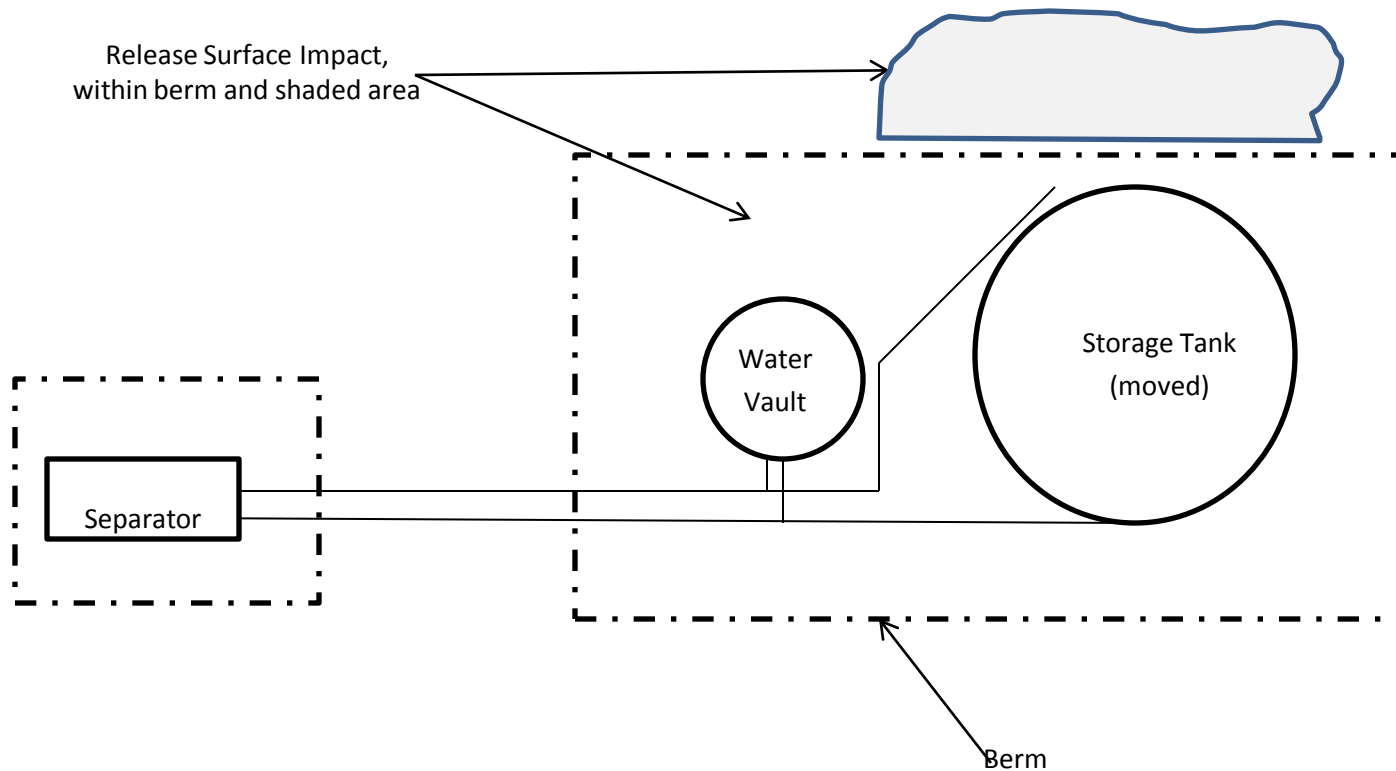
### RORY #1 TANK BATTERY SITE PLAN

**Description of Impact:** Majority of release was contained within berm, Some of the release overspray extended outside of berm to the west. Fluids soaked into the subsurface.

Release Surface Impact,  
within berm and shaded area

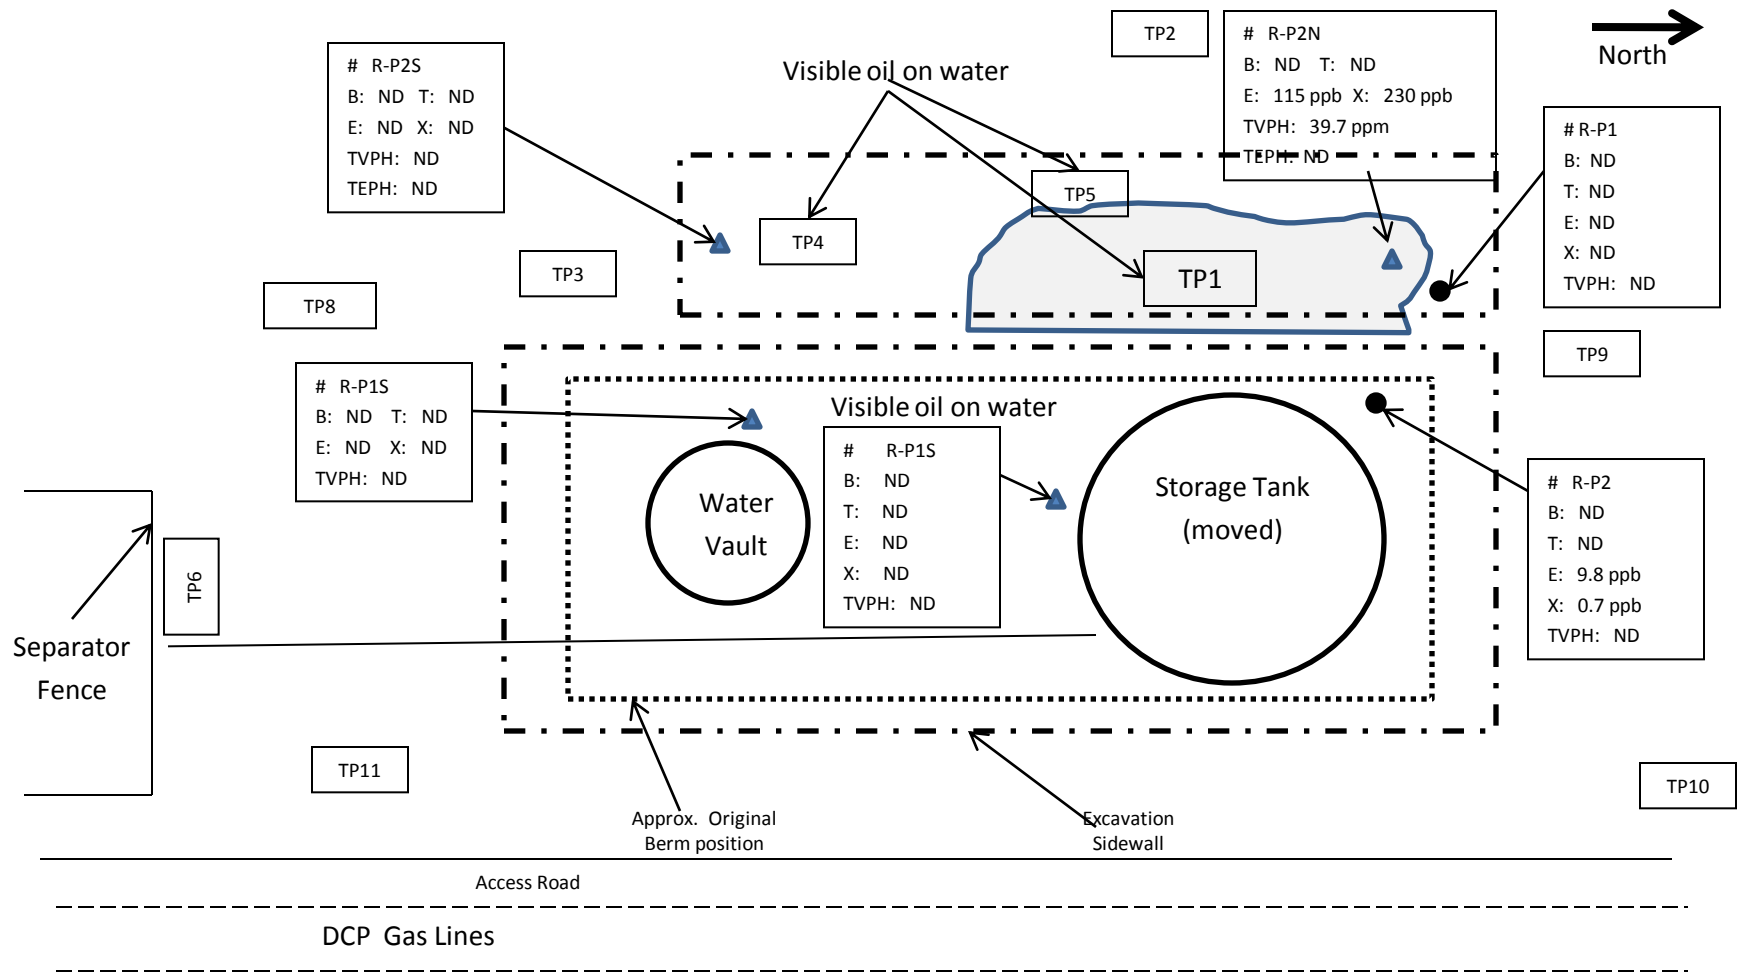
## RORY #1 TANK BATTERY Initial Excavation PLAN

**Describe how source is to be removed:** Storage tank and water tank were moved. On August 24, commenced excavation within the berm area. The excavation was extended outside the original berm area. Majority of the soils from surface to water table were impacted within the berm and approximately 15 feet west of the tank battery berm. The primary excavation area included below the tank battery was approximately 75 feet by 30 feet. A second pit separated from the primary pit by a 1' high berm (3' wide) to the west was approx 65 by 30 feet.

Attach samples and analytical results taken to verify remediation of impacts. Show locations of samples on an onsite schematic or drawing. At this time the only samples that have been completed are from the initial water samples from the pit and samples from the excavation base. These results are below regulatory action levels. Copies of this analytical are attached.

Field screening of the initial excavation indicates that residual impacts are present within the water table zone. To reduce or limit the potential for long term impact the excavation will be extended to remove a reasonable amount of impacted materials. The overburden materials will be set aside and reused as fill materials.

Overexcavation is necessary outside of the initial pit excavation. Subsequent samples of the lateral excavation will be collected. It is assumed that the lateral extension of the excavation to the east is limited by the presence of three gas lines buried in and east of the service road.
