Casing Inspection Evaluation Report

Client: Kinder Morgan
Well: Sand Canyon 8
Field: McElmo Dome
County: Montezuma
State: Colorado

Analyst: Chris McIlroy
Date: 10/05/2010
Location: Denver RES
Phone: (303) 899-4694

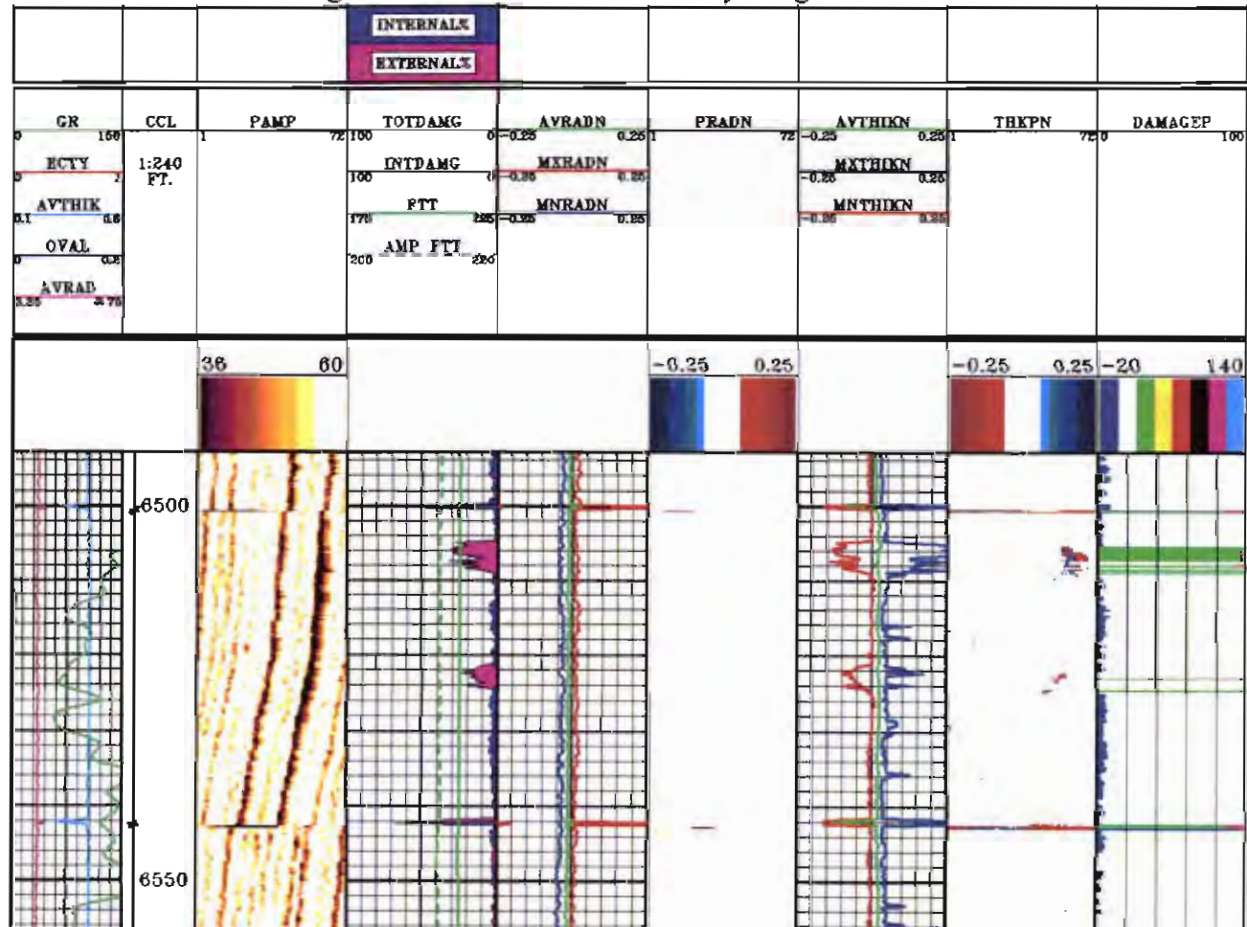
6500-6542

Looking at pipe amplitude in track 2 we notice some scarring on the inside of casing.

In track 3 we see both internal and external damage. This is corroborated by the thickness curves in track 6. Track 8, the total damage track, tells us that at its worst this damage is less than 20% as shown by the green color.

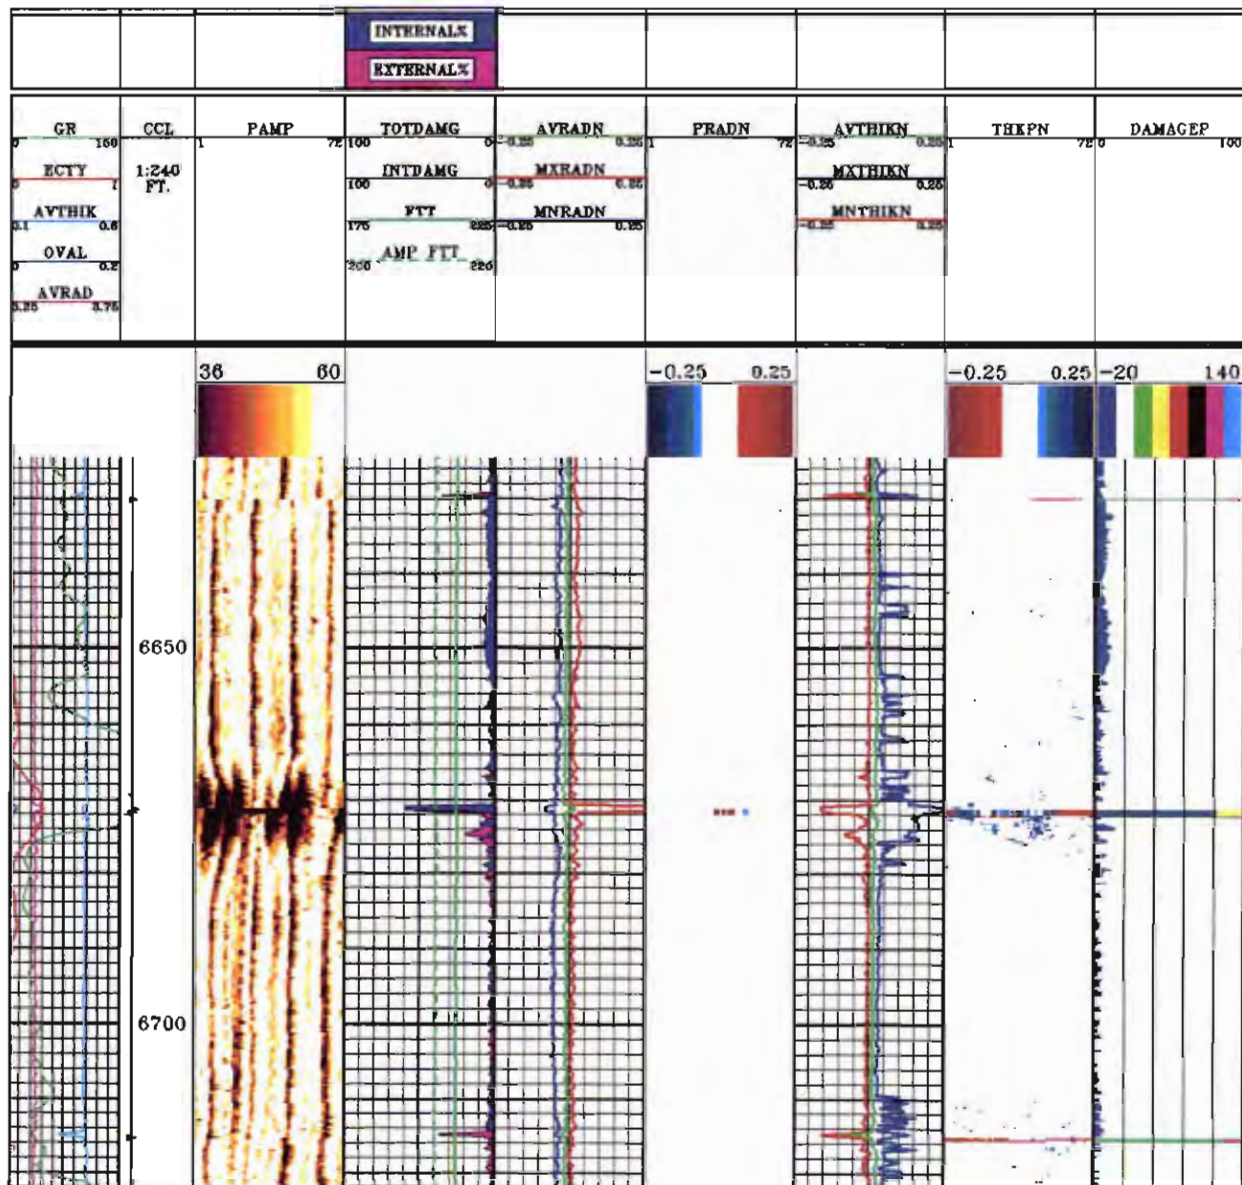
6664-6678 Looking at track 2 the amplitude curve points to the area around 6570' that we need to look at. The eccentricity in track 1 could be due to pipe damage at the joint or hole problems highlighting the overall poor condition of this collar.

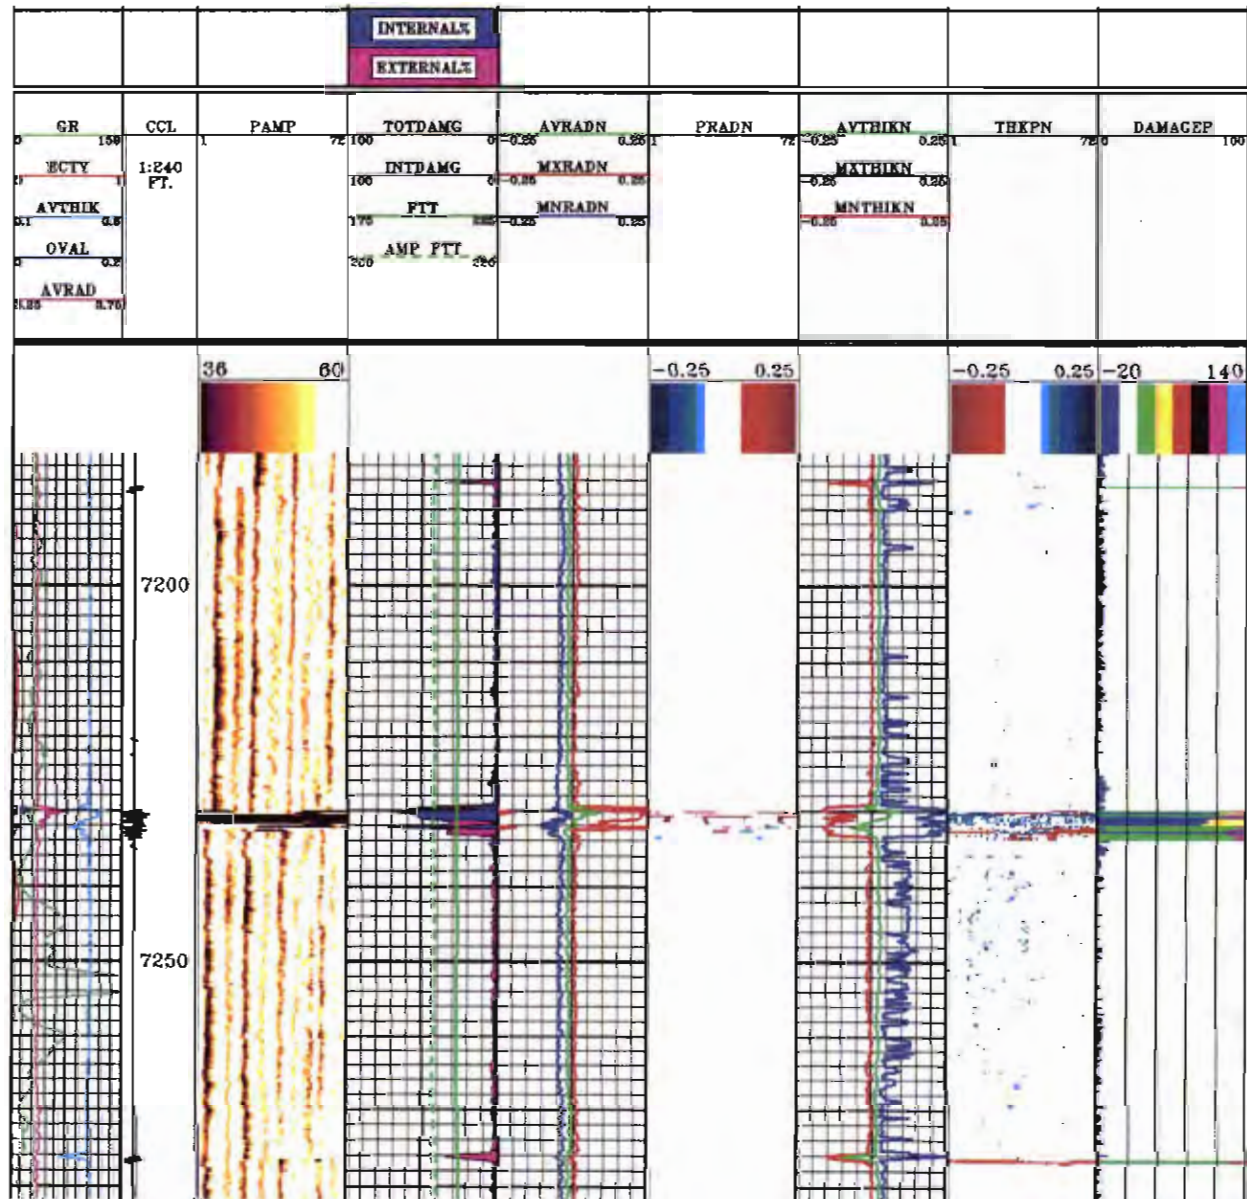
7228-7235 Starting in the depth track, the CCL shows a 5' color. Track 2 shows the collar at 7230' appears over a 5 foot interval. Tracks 4 and 5 show enlarged radius, tracks 6 and 7 show small thickness. Track 8 shows damage greater than 20% and is a cause for concern.
