**From:** Baroumand, Soraya  
**Sent:** Monday, May 02, 2011 1:35 PM  
**To:** Baroumand, Soraya  
**Subject:** FW: inspection report for wells 05-045-13388 and 13387  
**Attachments:** IMG00188-20110303-1118.jpg; IMG00189-20110303-1119.jpg; IMG00190-20110303-1120.jpg; IMG00191-20110303-1121.jpg; B33NETreatmentHistory.snp; IMG00185-20110303-1017.jpg; IMG00186-20110303-1018.jpg

Report				COGIS - Field Inspection	
API Number:	05-045-13388	Name:	COX #33-1 (B33NE)		
Location:	NWNE 33 6S 92W	Lat: 39.49031	Long: -107.66752		
Operator #:		Operator Name:	ENCANA OIL & GAS (USA) INC		
Inspection Date:	2/17/2011	Inspector:	SORAYA BAROUMAND

ENCANA API #S 05-045-13387 & 87 COX #33-1 & 33-3A

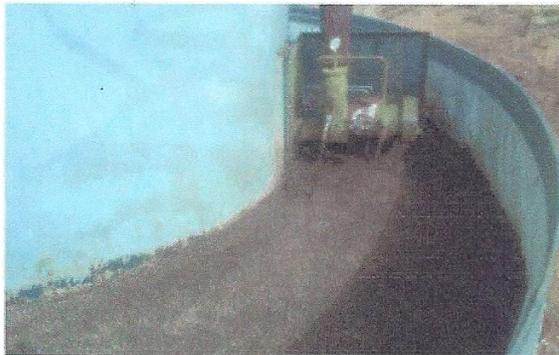
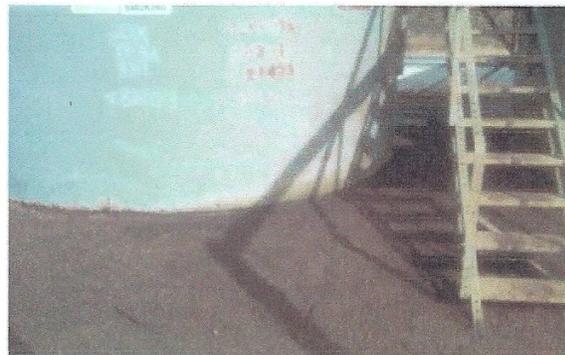
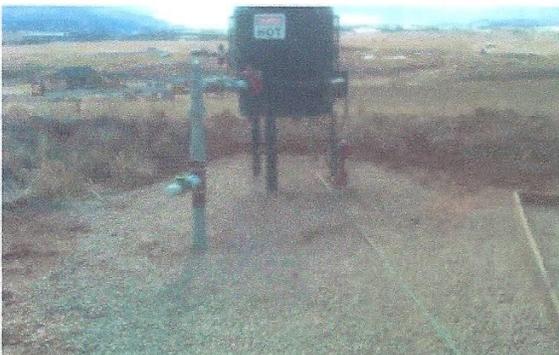
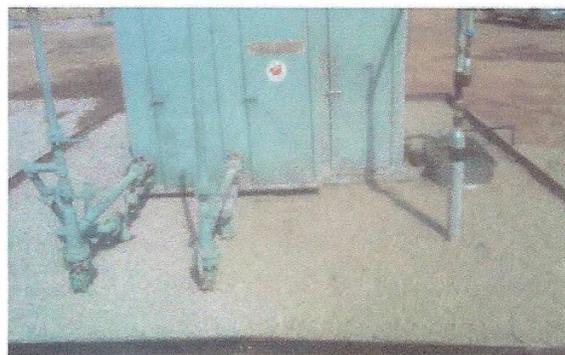
- photos of the location after clean up
- Pesticide application history

Also, with regards to equipment modifications, a screened trough and plumed scrubber were installed off the separator to limit the possibility of paraffin being ejected from the equipment in the future.

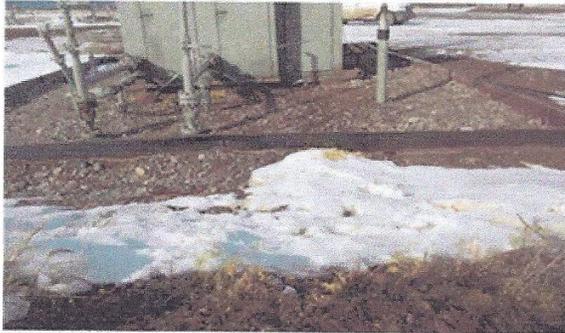
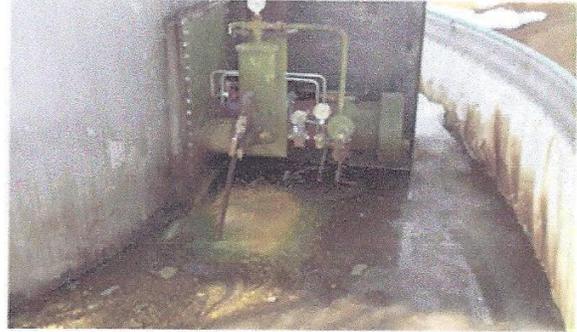
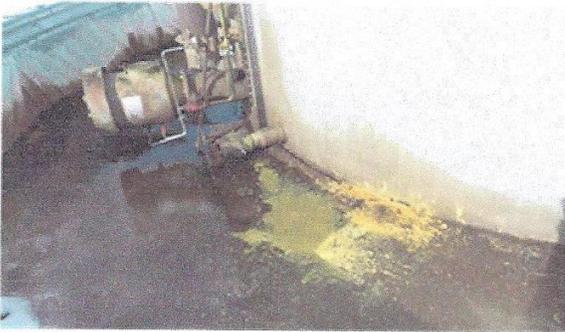
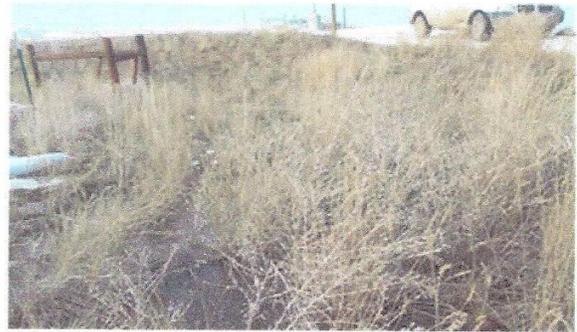
Insp. Comment	Inspection/Violation Comments
ACTION	MAINTAIN/REPAIR SEPARATOR AND EMISSION BURNER, AND REPAIR ASSOCIATED LEAKS. REMOVE CONDENSATE FROM THE TANK BATTERY'S SECONDARY CONTAINMENT AND IMPACTED SURFICIAL GRAVELS. INITIATE CONTINUAL WEED MITIGATION EFFORTS SELECTIVE FOR RUSSIAN KNAPWEED.
FIREWALL	3' METAL SECONDARY CONTAINMENT AROUND TANKS AND 6" METAL DIKE AROUND SEPARATORS.
GENHOUSE	POOR
SPILCOM	CONGEALED CONDENSATE HAS ACCUMULATED WITHIN THE TANK BATTERY'S SECONDARY CONTAINMENT, AND AROUND THE VERTICAL SEPARATORS AND EMISSIONS BURNER, WHICH REQUIRE REMOVAL AND PROPER DISPOSAL. NOTE: VISUAL ESTIMATION OF VOLUME IS WELL BELOW THE SPILL REPORTING REQUIREMENTS.
SURFRH	A PATCH OF RUSSIAN KNAPWEED WAS IDENTIFIED NEAR THE SOUTHERN REGION OF THE WELL PAD.
TANKBAT	2-300 BBL PRODUCED WATER/CONDENSATE TANKS, ELEVATED METHANOL TANK, COMBUSTOR, DIFFUSER, VERTICAL SEPARATORS, 2 WELLHEADS, PLACARDS AND SCREENS IN PLACE.
