RE: Complaint 200278900  
Stormwater and Erosion Control Best Management Practices

# COGIS - Field Inspection Report

API Number: <b>05-071-08459</b>	Name: <b>BLAZER #24-1</b>
Location: <b>SESW 1 32S 67W</b>	Lat: <b>37.28106</b> Long: <b>-104.84185</b>
Operator #:	Operator Name: <b>PIONEER NATURAL RESOURCES USA INC</b>
Inspection Date: <b>5/10/2011</b>	Inspector: <b>PETER GINTAUTAS</b>

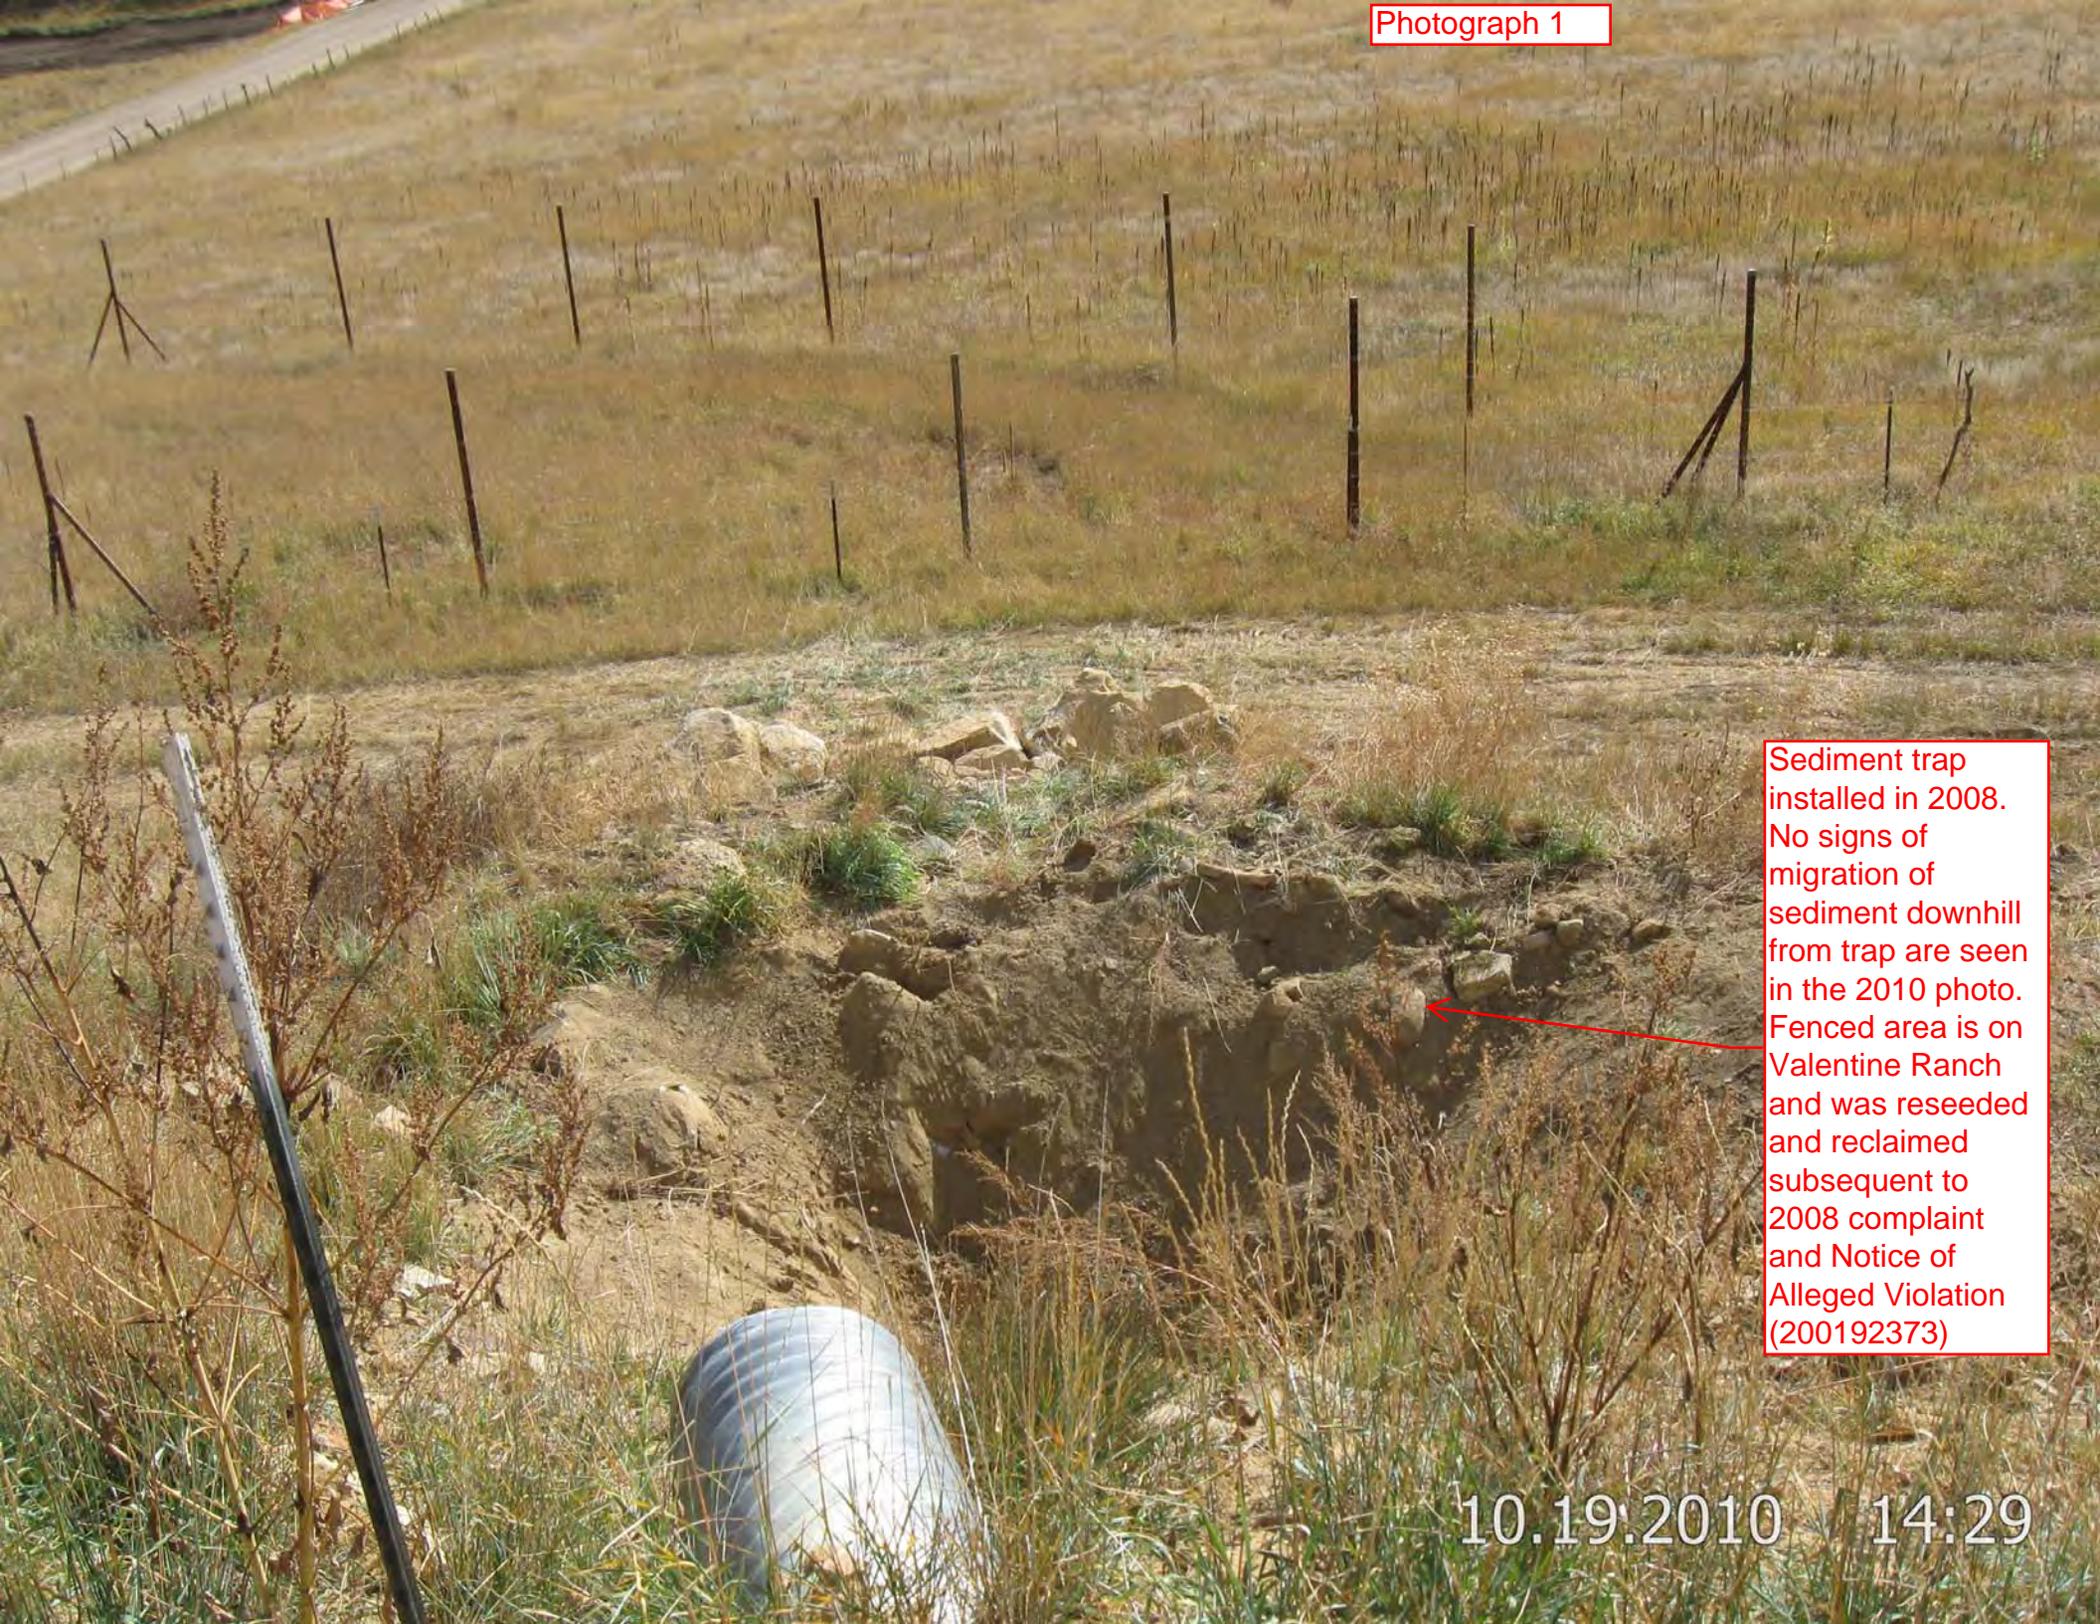
Sediment trap installed in 2008. No signs of migration of sediment downhill from trap are seen in the 2010 photo. Fenced area is on Valentine Ranch and was reseeded and reclaimed subsequent to 2008 complaint and Notice of Alleged Violation (200192373)

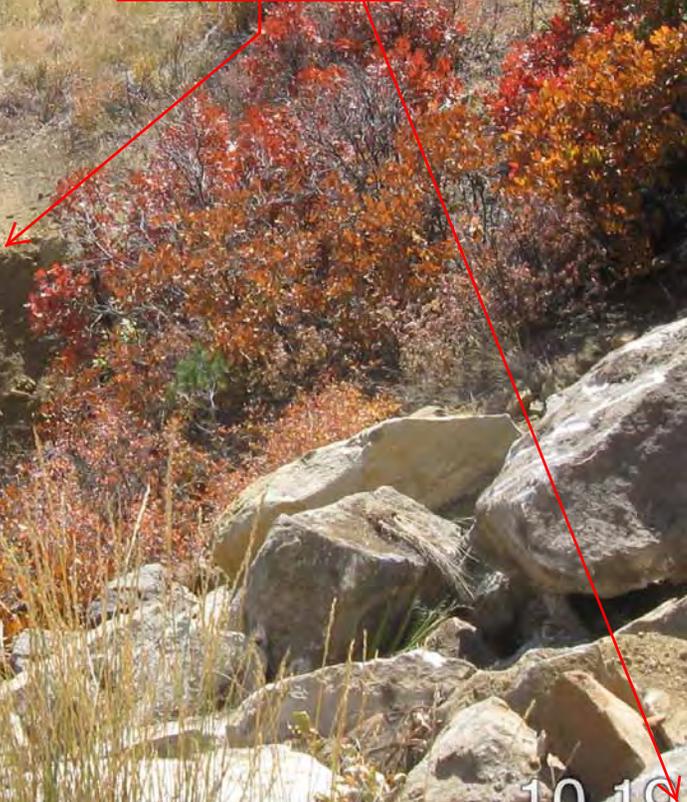
Photograph 2

Sediment trap and rip rap installed subsequent to 2008 complaint. Recent maintenance of sediment trap is evident. No signs of migration of sediment past trap in 2010.

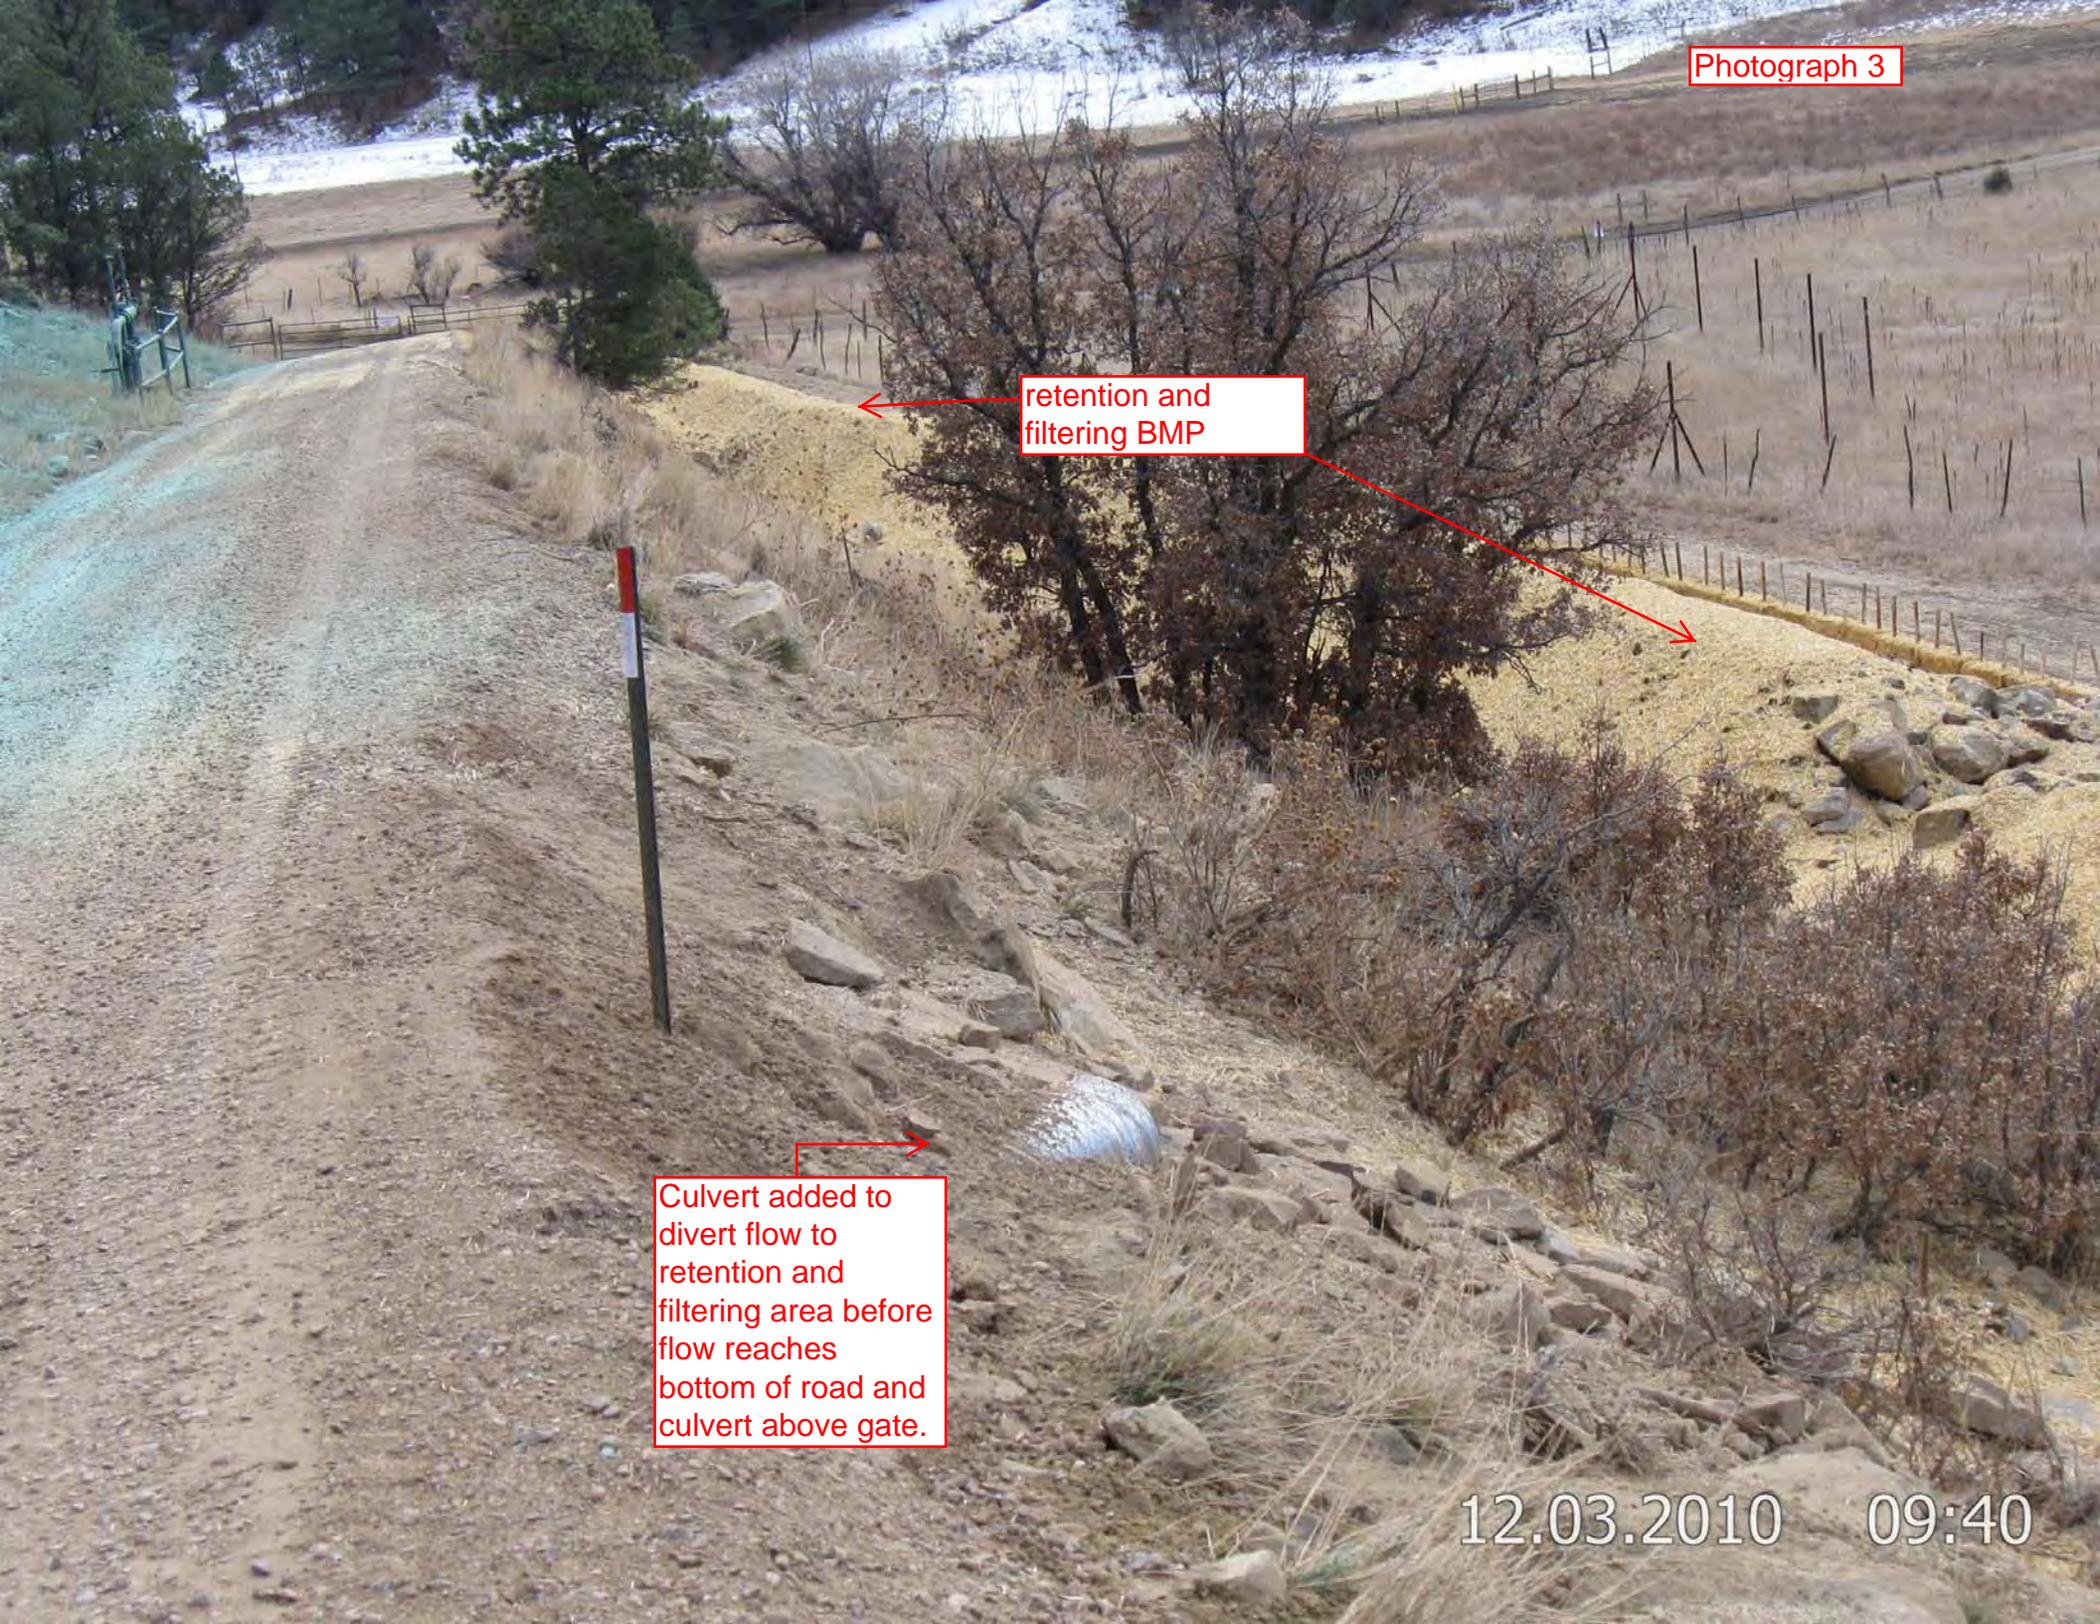
I again visited the area on December 3, 2010 and a photo of alterations to the stormwater and erosion controls had been nearly completed by the operator. Photograph 3 (Attachment 1) shows that new culverts had been installed to lessen the flow through each culvert. In addition, the operator had constructed a filtering and retention area so that sediment would have an opportunity to settle out of stormwater before the water leaves the immediate area of the lease road.

retention and filtering BMP

Culvert added to divert flow to retention and filtering area before flow reaches bottom of road and culvert above gate.

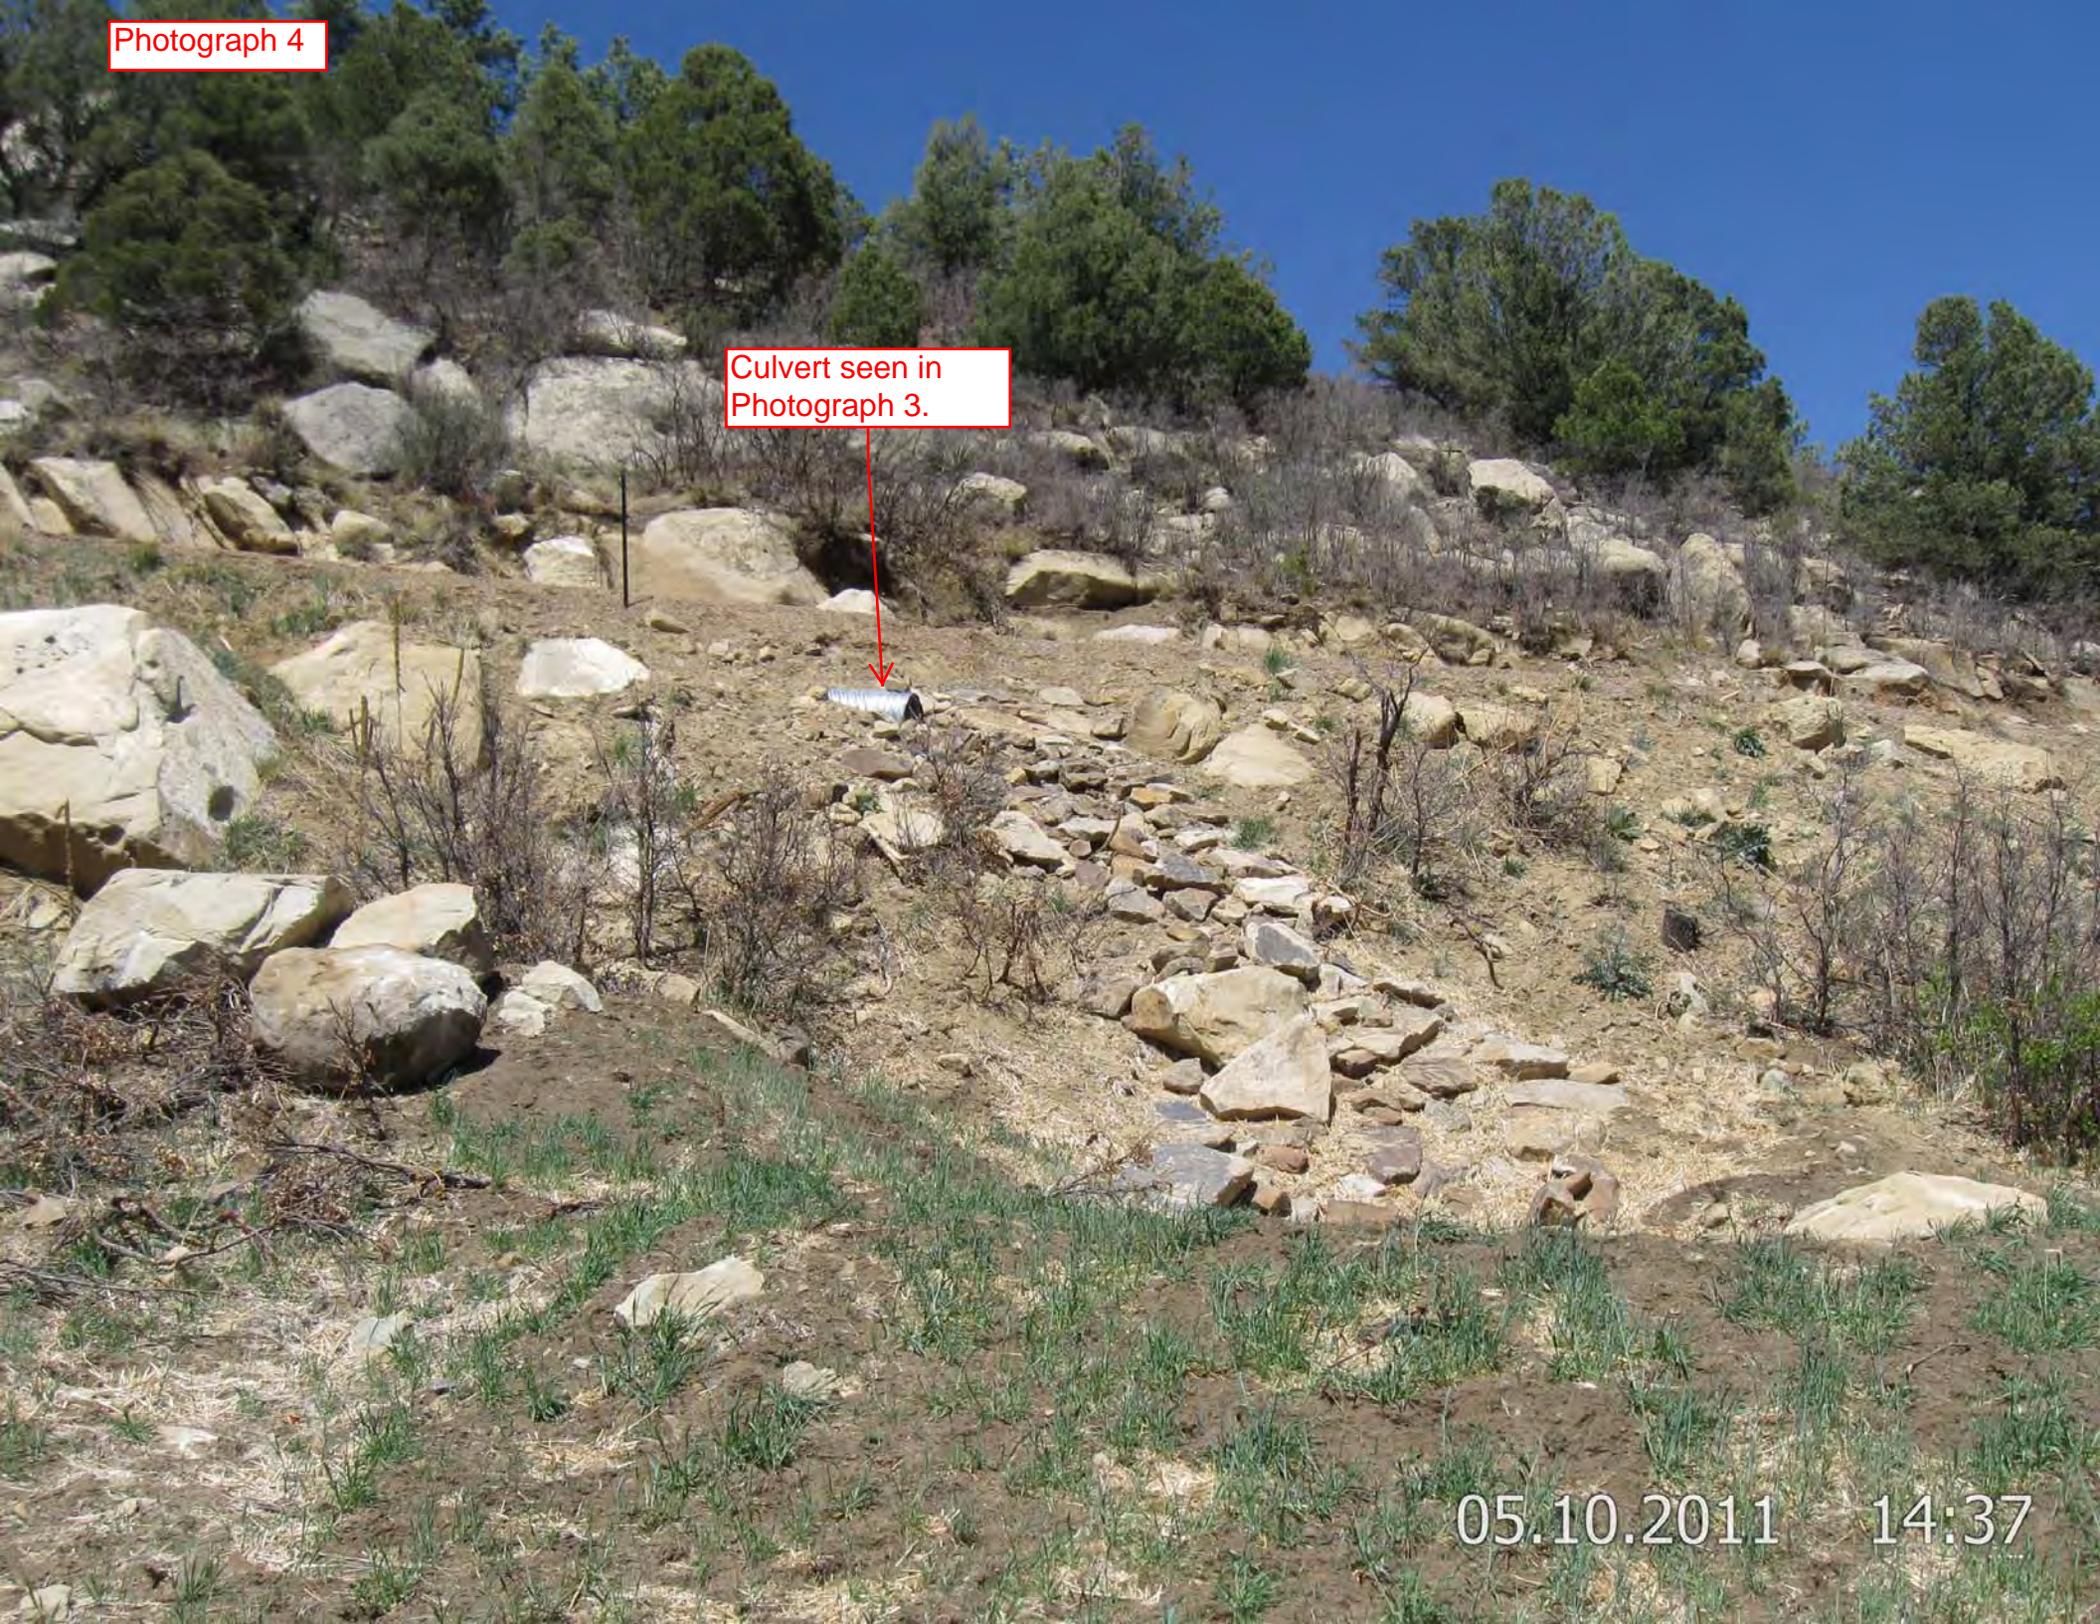
Photograph 4

Culvert seen in  
Photograph 3.

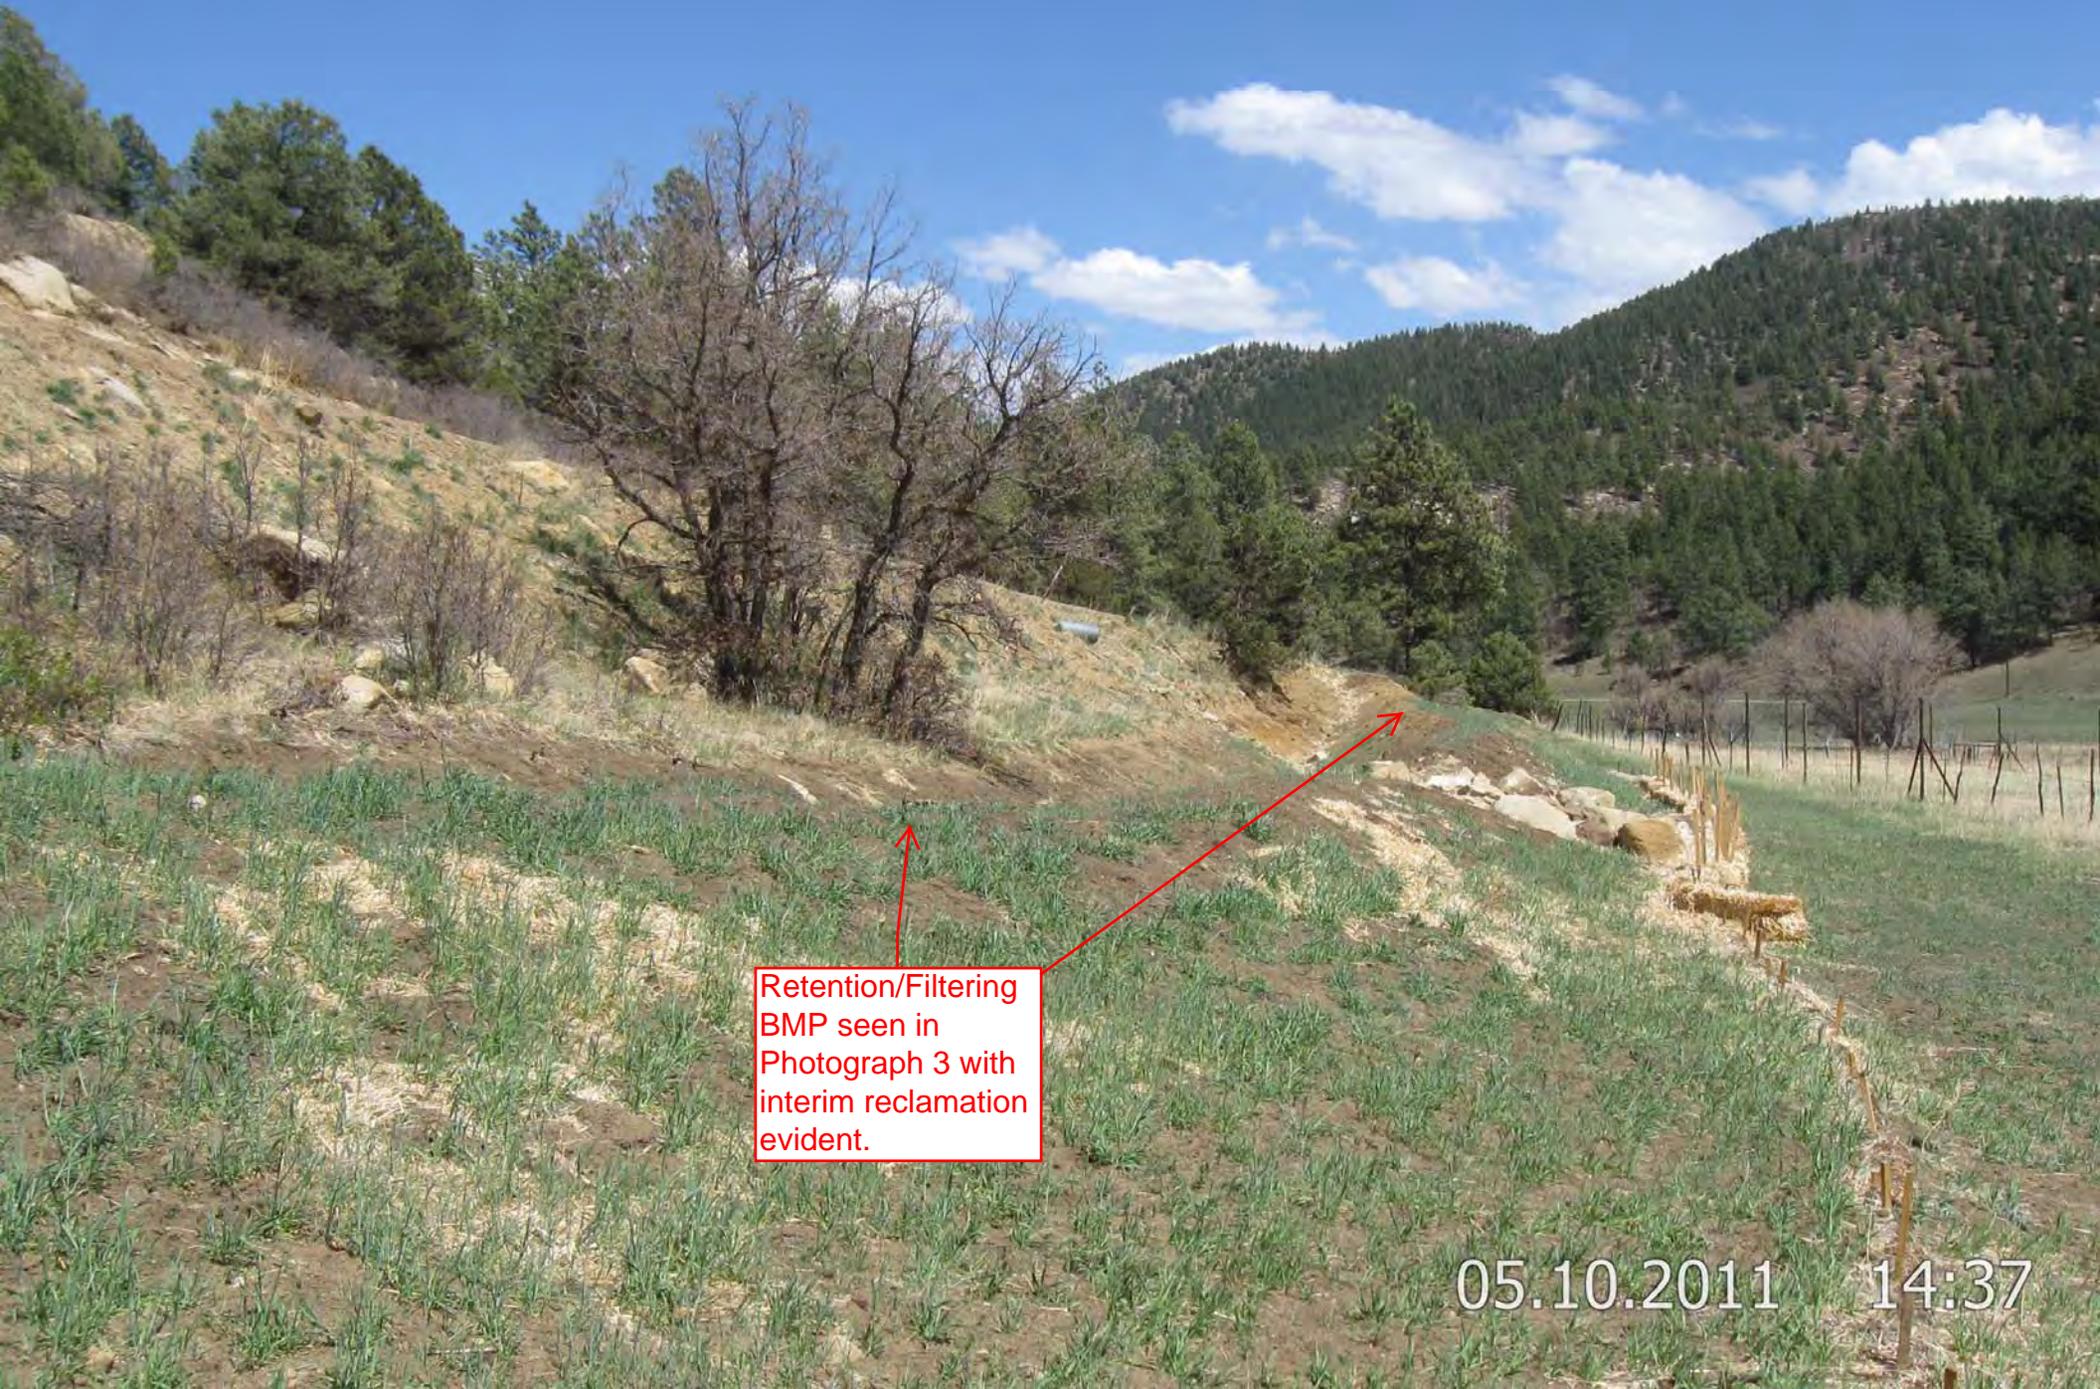
Photograph 5

Retention/Filtering  
BMP seen in  
Photograph 3 with  
interim reclamation  
evident.

Slope needing further seeding and plant growth to minimize erosion and downhill transport of sediment
