**Colorado Oil and Gas Conservation Commission
EnCana Oil and Gas (USA), Inc.
Investigation of Deason 11-36 Well Site Notice of Alleged Violation**

**Prepared by AgriTech Consulting
May 2011**

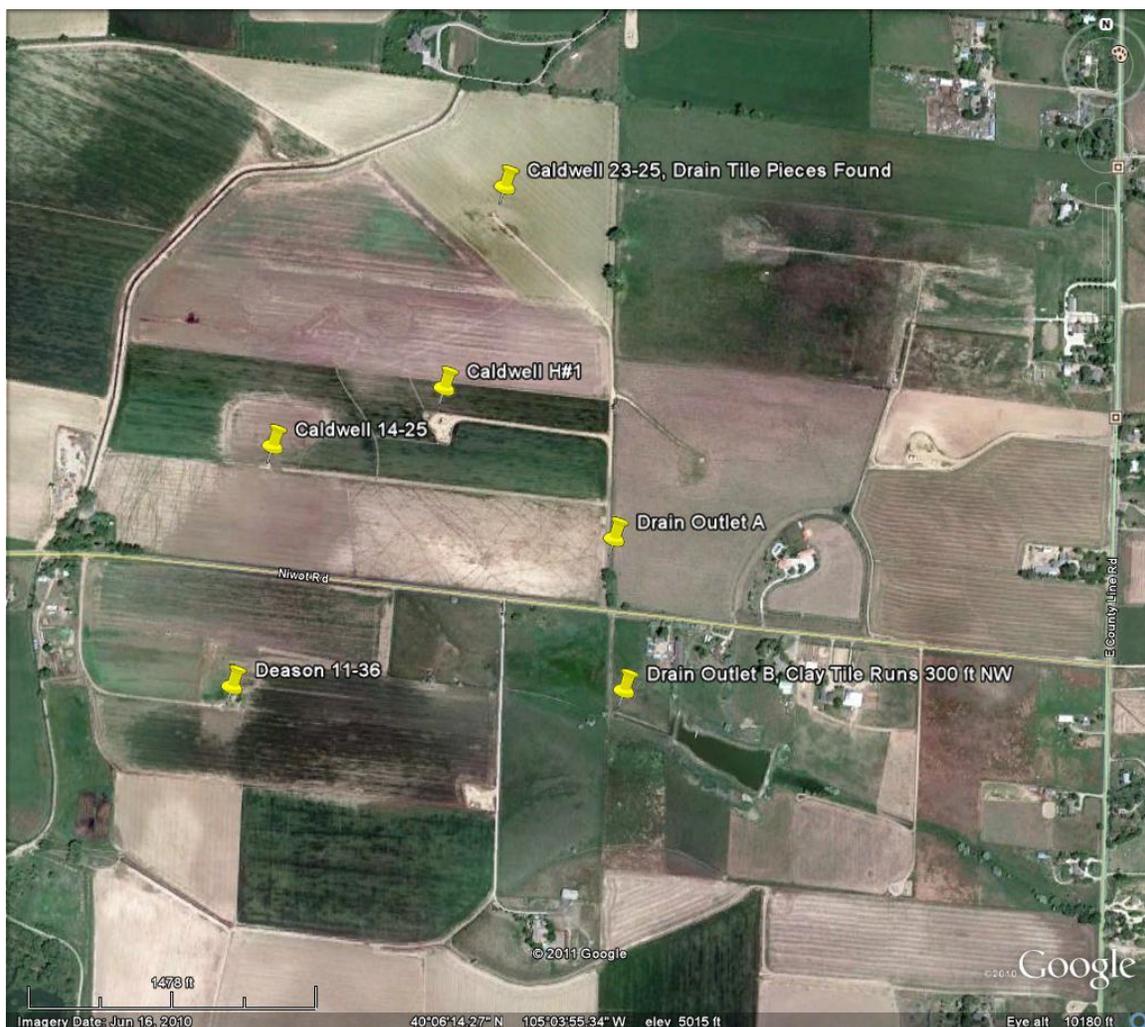
A drain line was believed to have been dug up or disrupted during the drilling of Caldwell 23-25 and the digging of the pit because pieces of drain tile were seen in the material being excavated. See figure below. There is a drain outlet in the east side of SW 1/4 Sec 25 along the field access road, about 300 feet north of Niwot Road (Drain Outlet A). Another drain outlet is located in the west portion of the NE 1/4 of Sec 36 (Drain Outlet B). That drain is connected to a clay tile line approximately 300 feet long running northwest from the end. This line was verified by Hartford Electric when in process of locating drains on the Deason property. Hartford Electric was retained by BCP&O to locate drain lines using a backhoe excavator.
