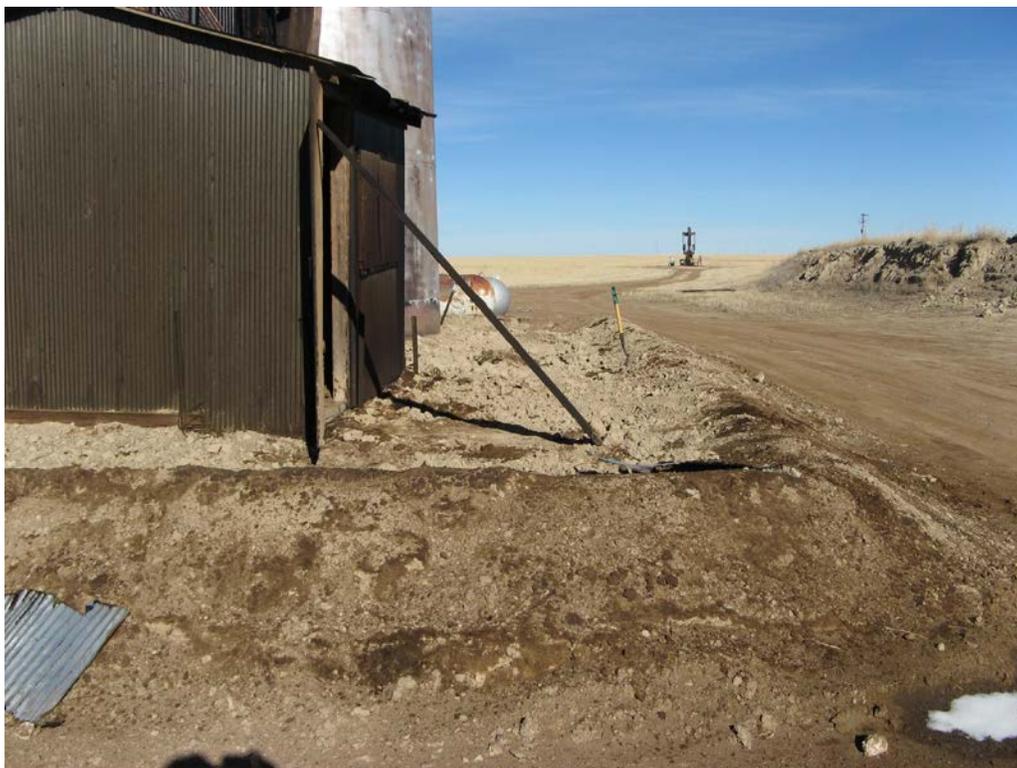
Looking North – east side of treater shed/battery.

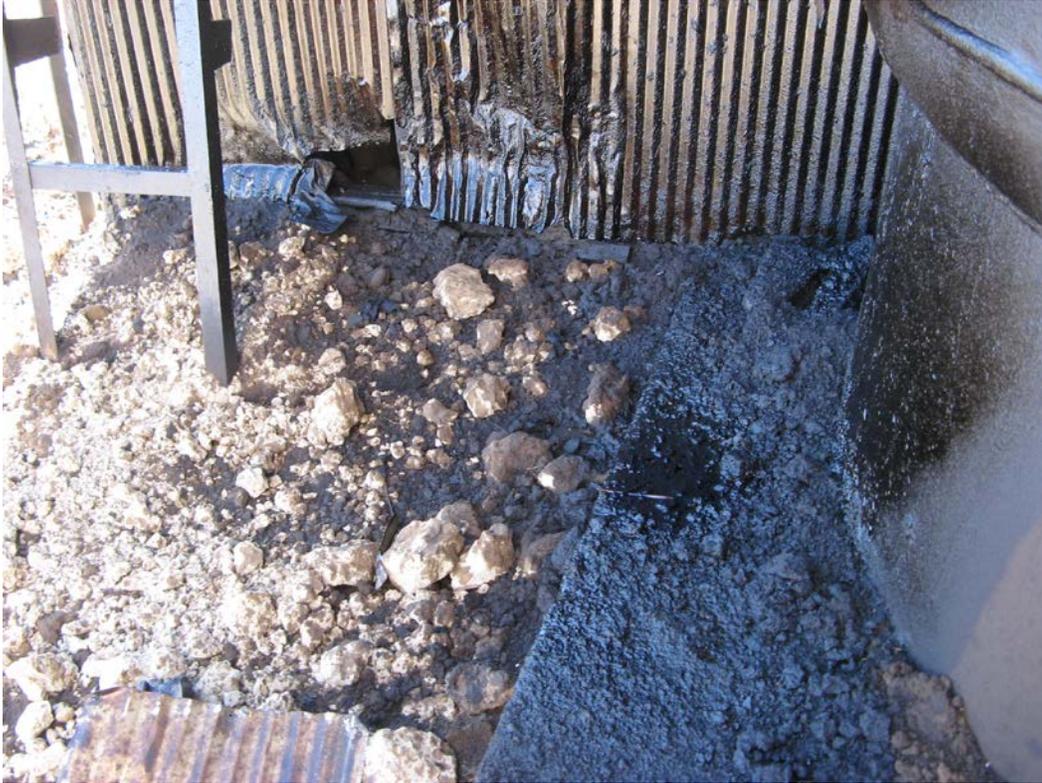
Free phase hydrocarbons at base of treater and fresh dirt covering oil saturated material.

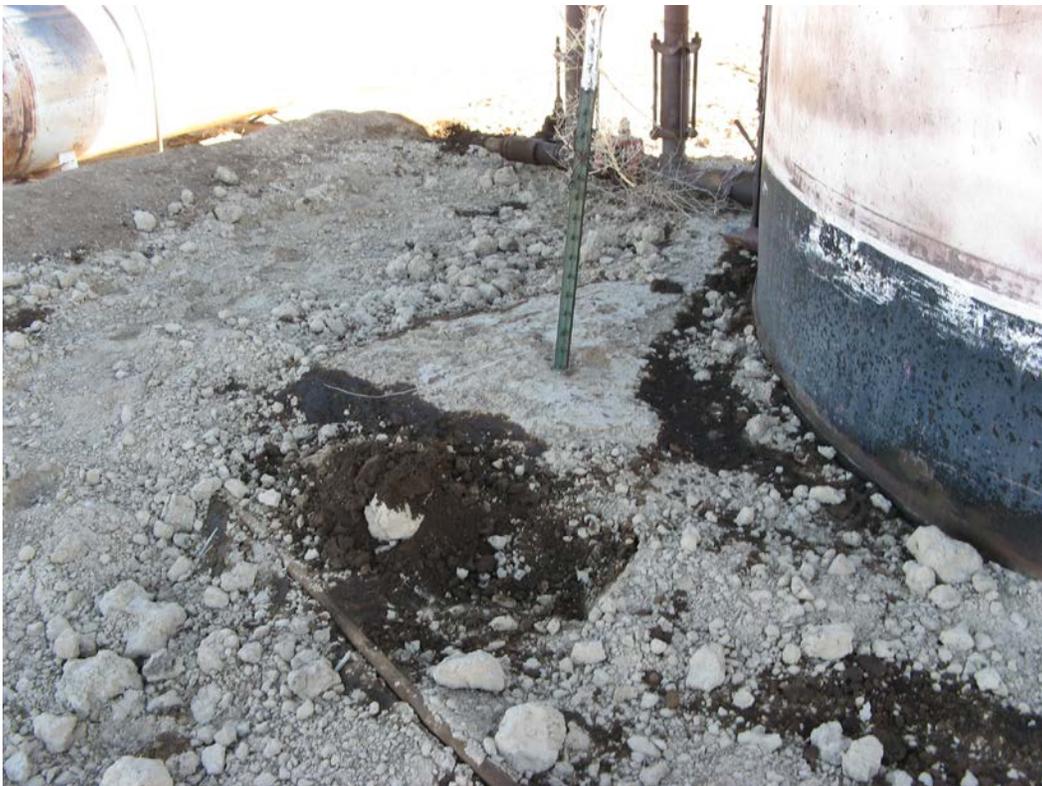
Fresh dirt covering oil saturated material NW corner tank battery.

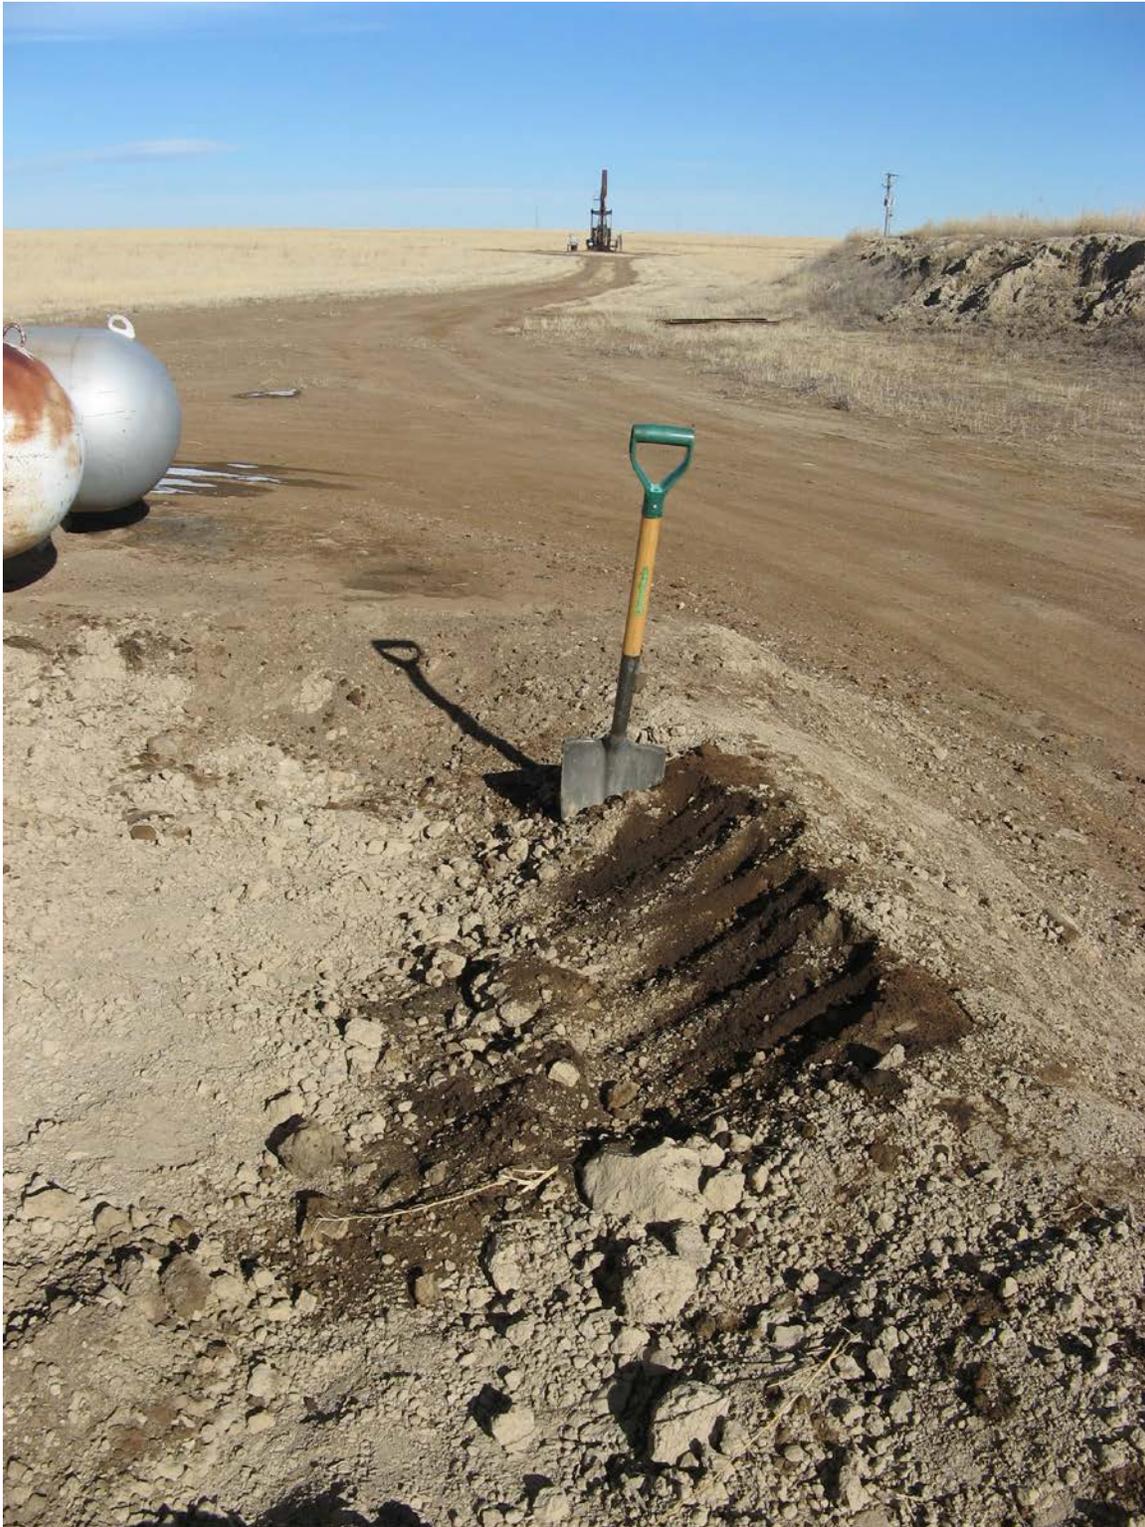
Fresh dirt removed from berm underlain by oil saturated material NE corner battery.

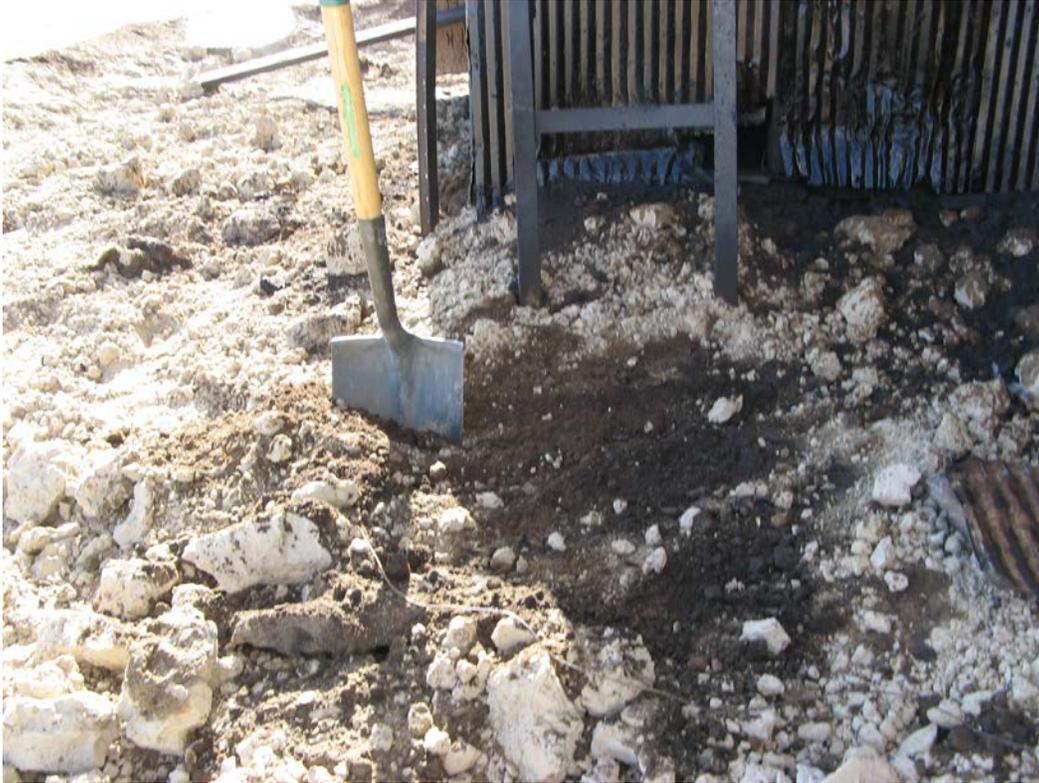
Fresh dirt scraped away adjacent treater shed underlain by oil saturated material.

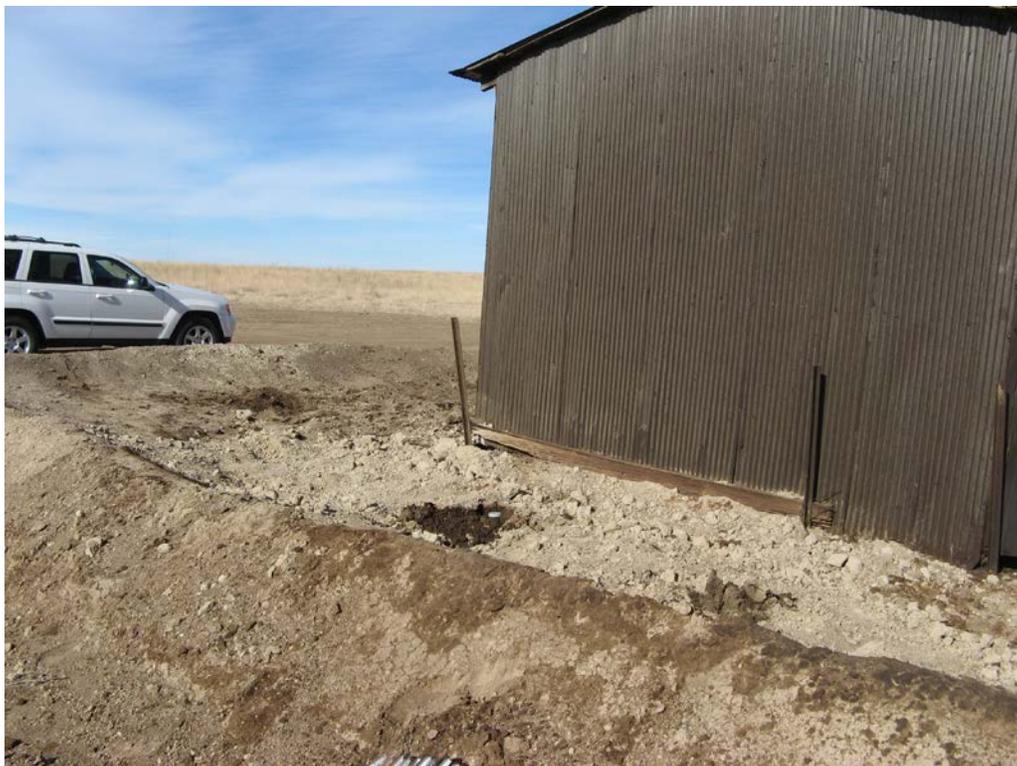
SS-1 Location south end of battery adjacent to treater shed from 1" to 6" bgs.

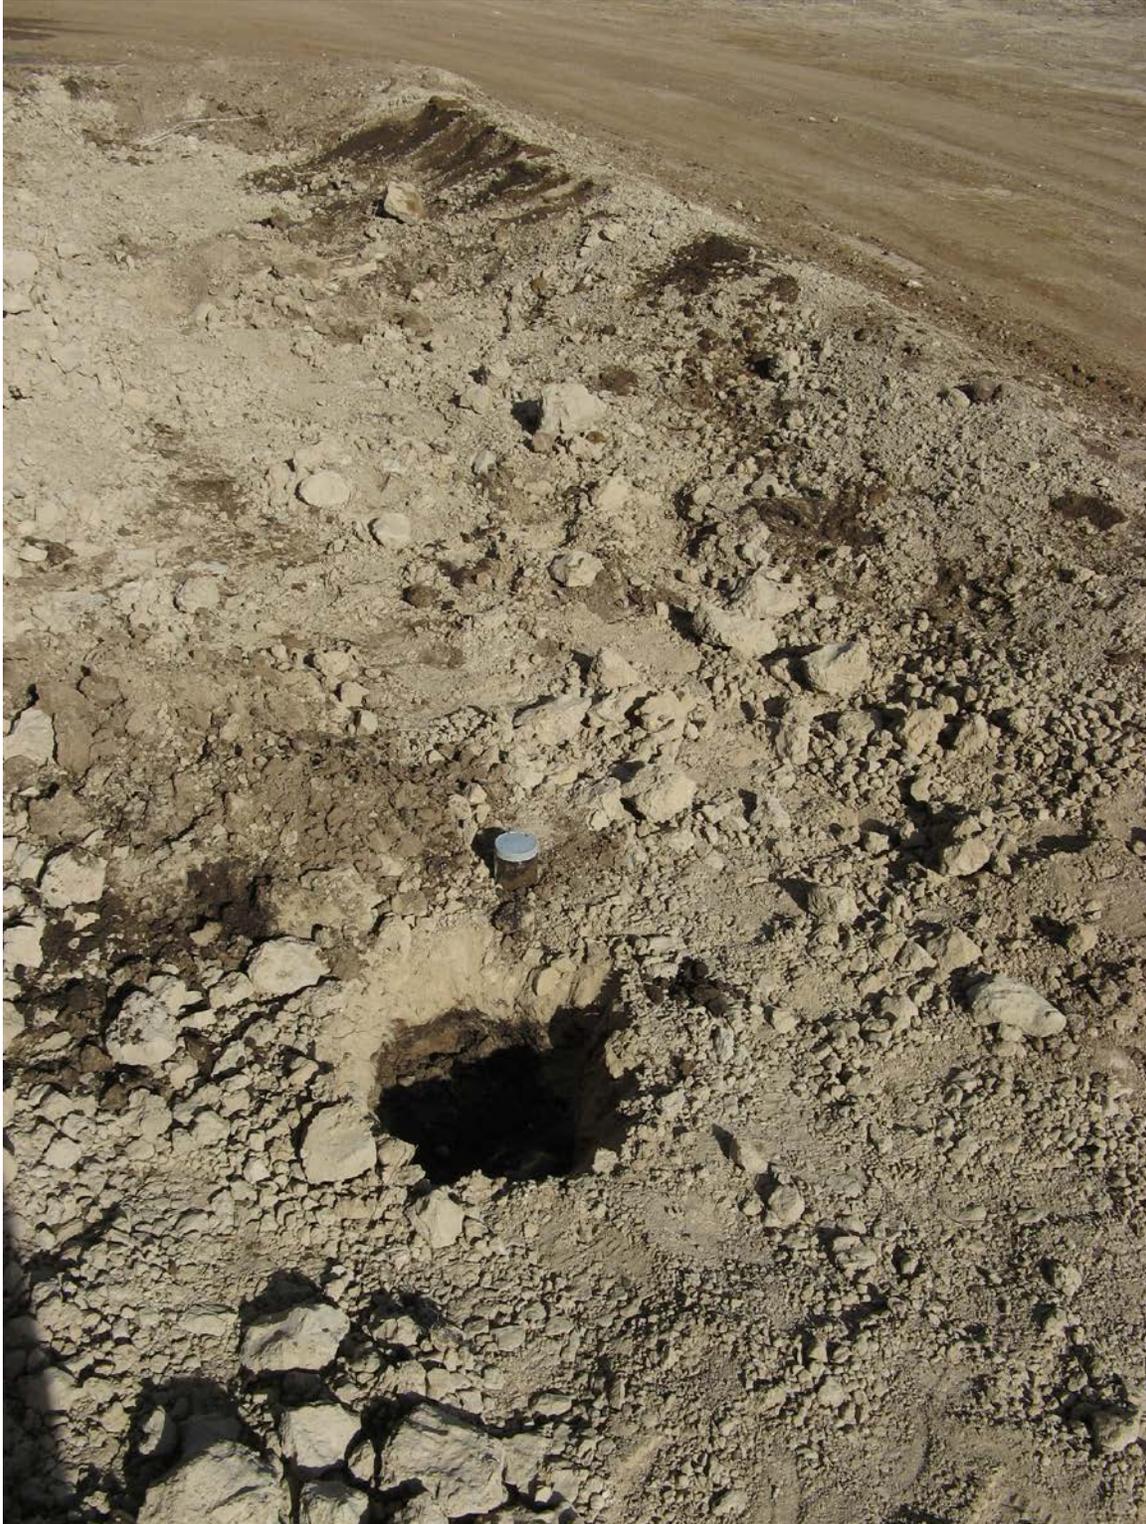
SS-2 Location center east side of battery - approximately 4" clean material.
Sample collected from 4" to 10" bgs.

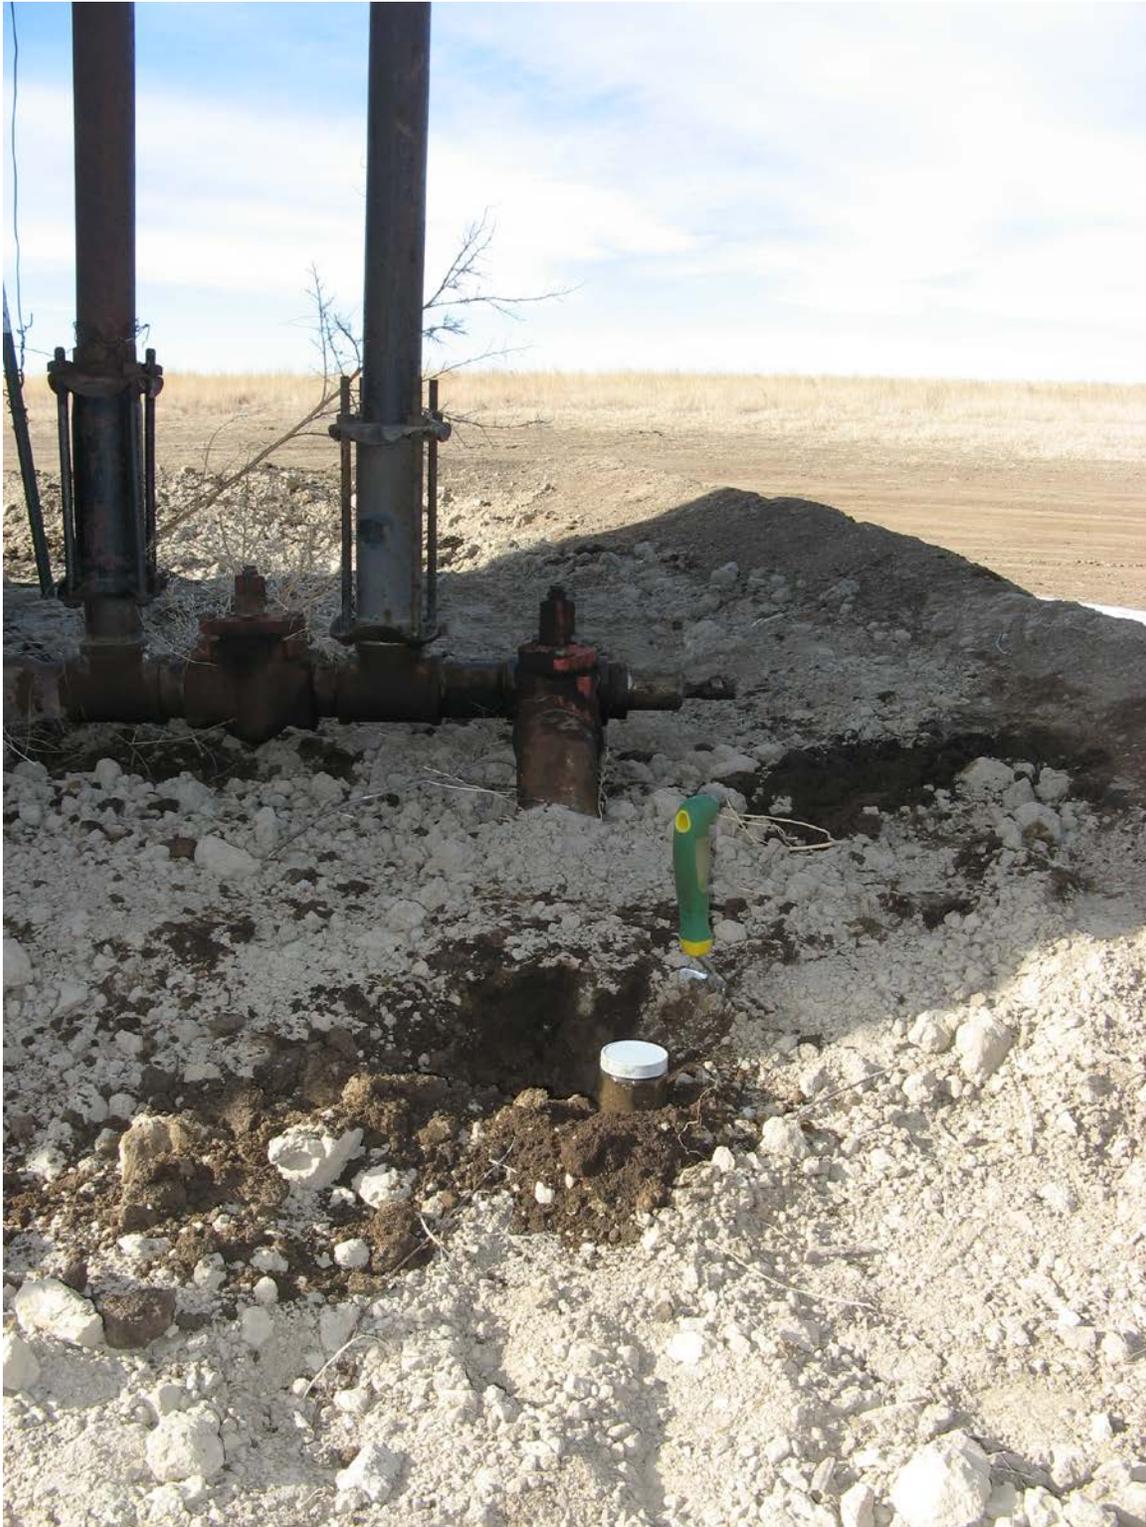
SS-3 Location north end of battery – sample collected from 0” to 6” bgs.

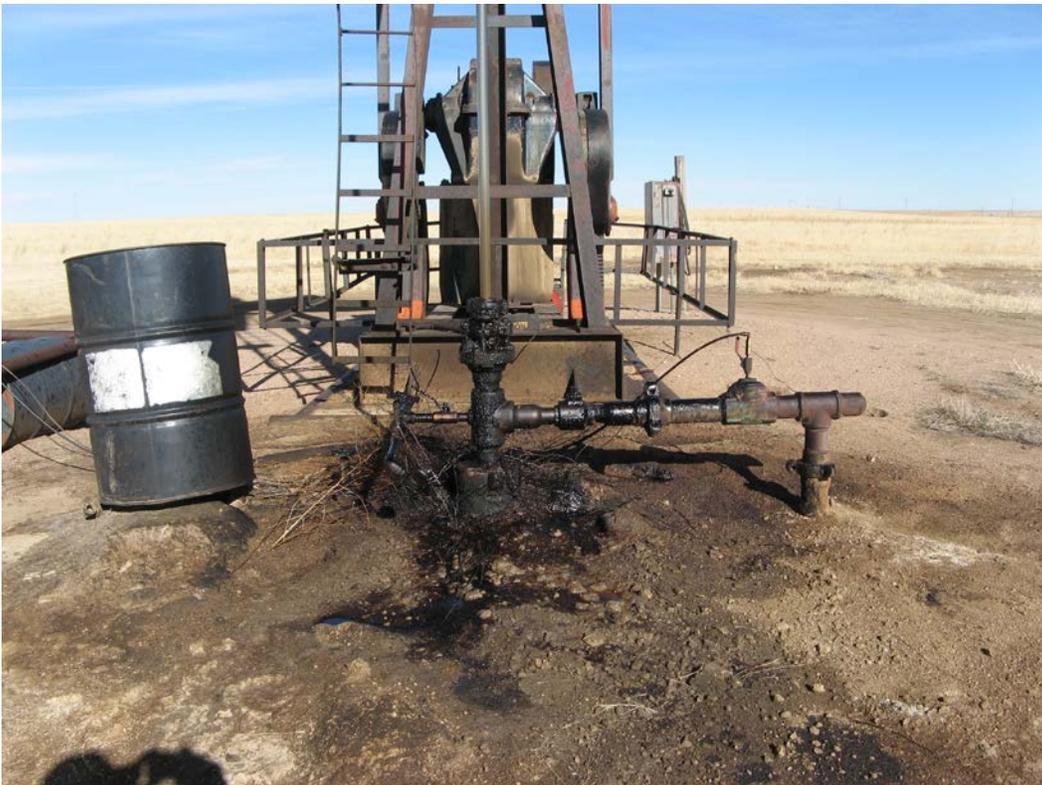
Ongoing leak at pumping unit.

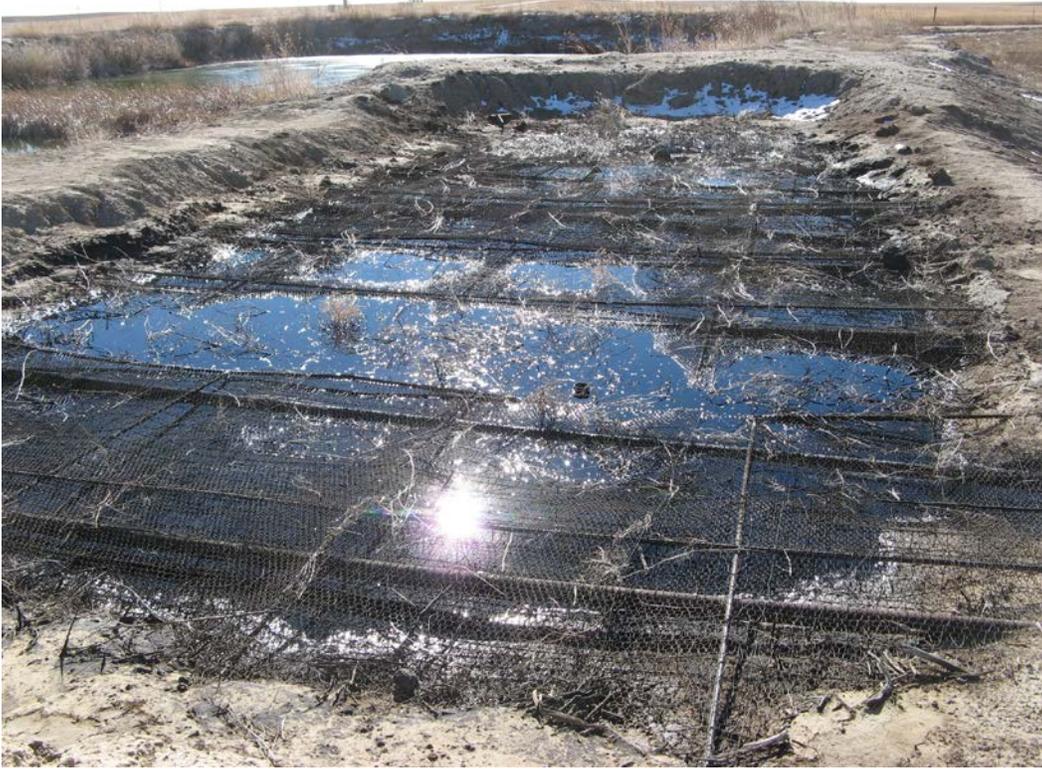
Skim pit cover submerged and inadequate freeboard.

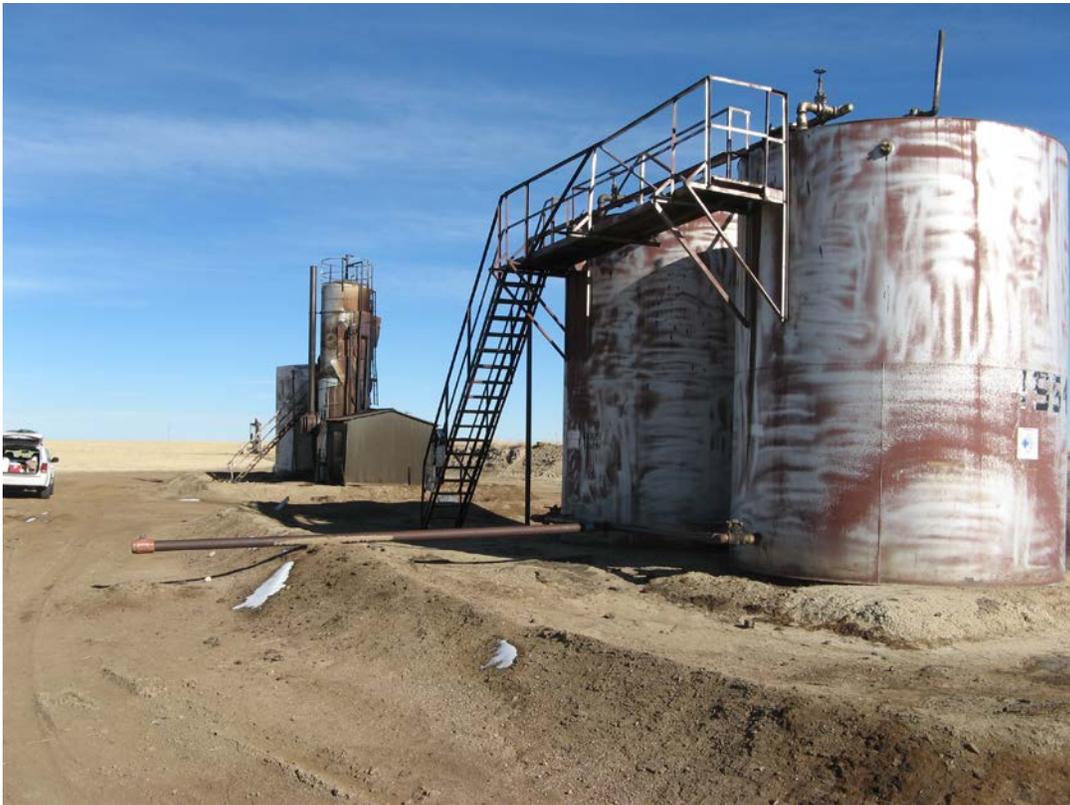
Oil stained dirt at production tank battery. Signs & labels inadequate.

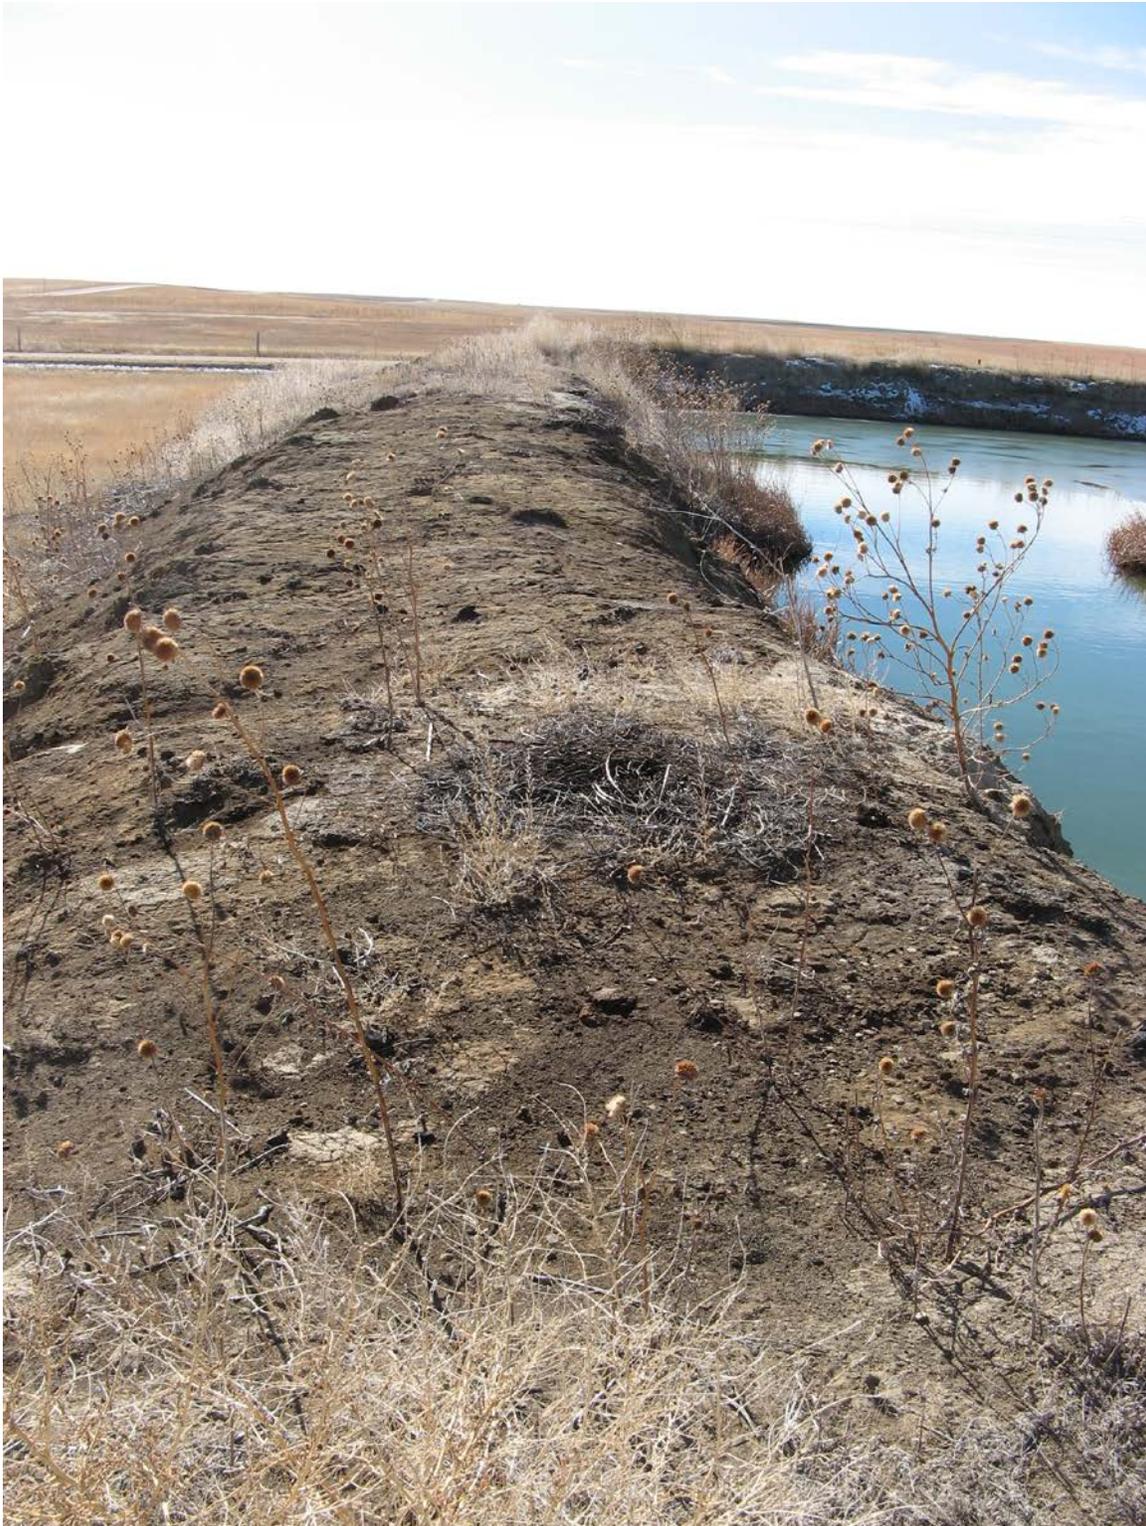
Looking south - oily waste in east berm of water pit.
