Rangely Weber Sand Unit

LARSON M.B. C11X25 Current Wellbore

01/26/12

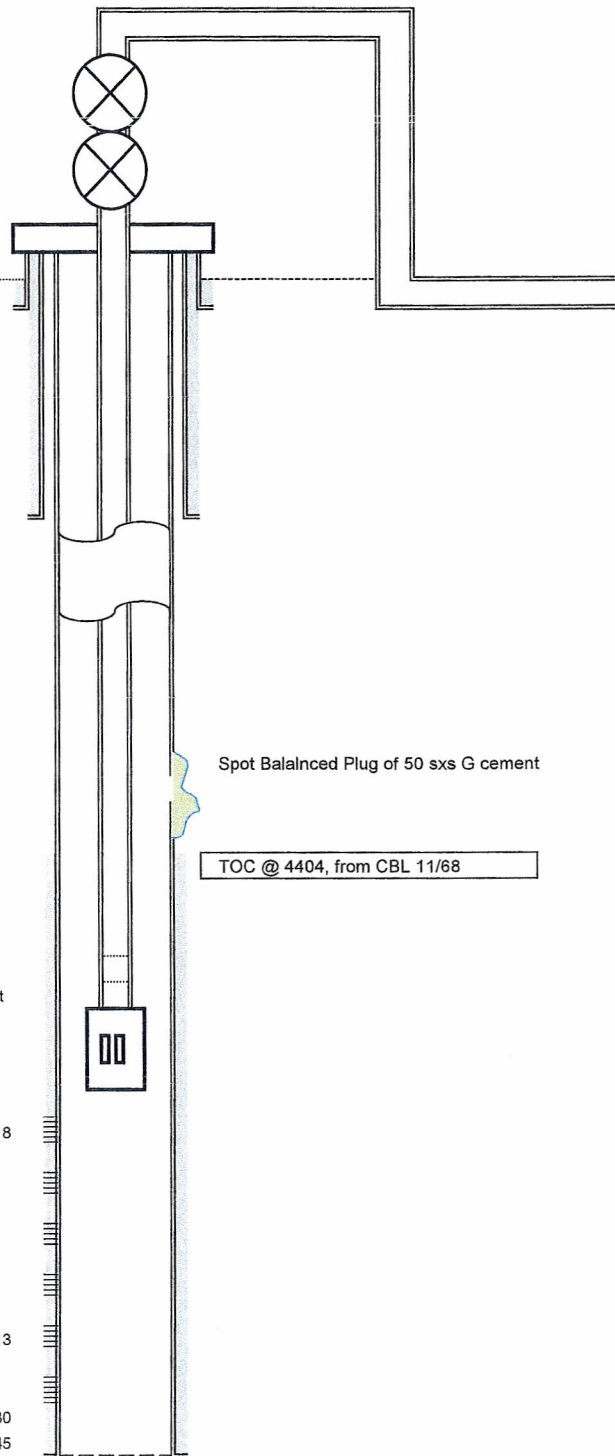
- 07/29/11: Could not pull ESP, set off at top pers and found obstruction at 4177, 10-3/4" surface csg broke / corroded at bottom of cellar. Patch & installed Brace.
- 07/27/11: While POOH w/ ESP, well was swabbed-in, suspect fluid exiting 7" into the 10-3/4" casing. celar.
-
