From: Andrews, David
Sent: Thursday, February 23, 2012 1:03 PM
To: 'Brandon Coutts'
Cc: Seth Hunter; Hector Gonzalez; bhartman@blm.gov; Longworth, Mike; Baroumand, Soraya; Kellerby, Shaun
Subject: RE: WF Clough Federal 14-12-6S-94W compliance

COGCC Well File, API No. 05-045-06484

VAQUERO ENERGY
WF Clough Federal 14-12

API# 05-045-06484

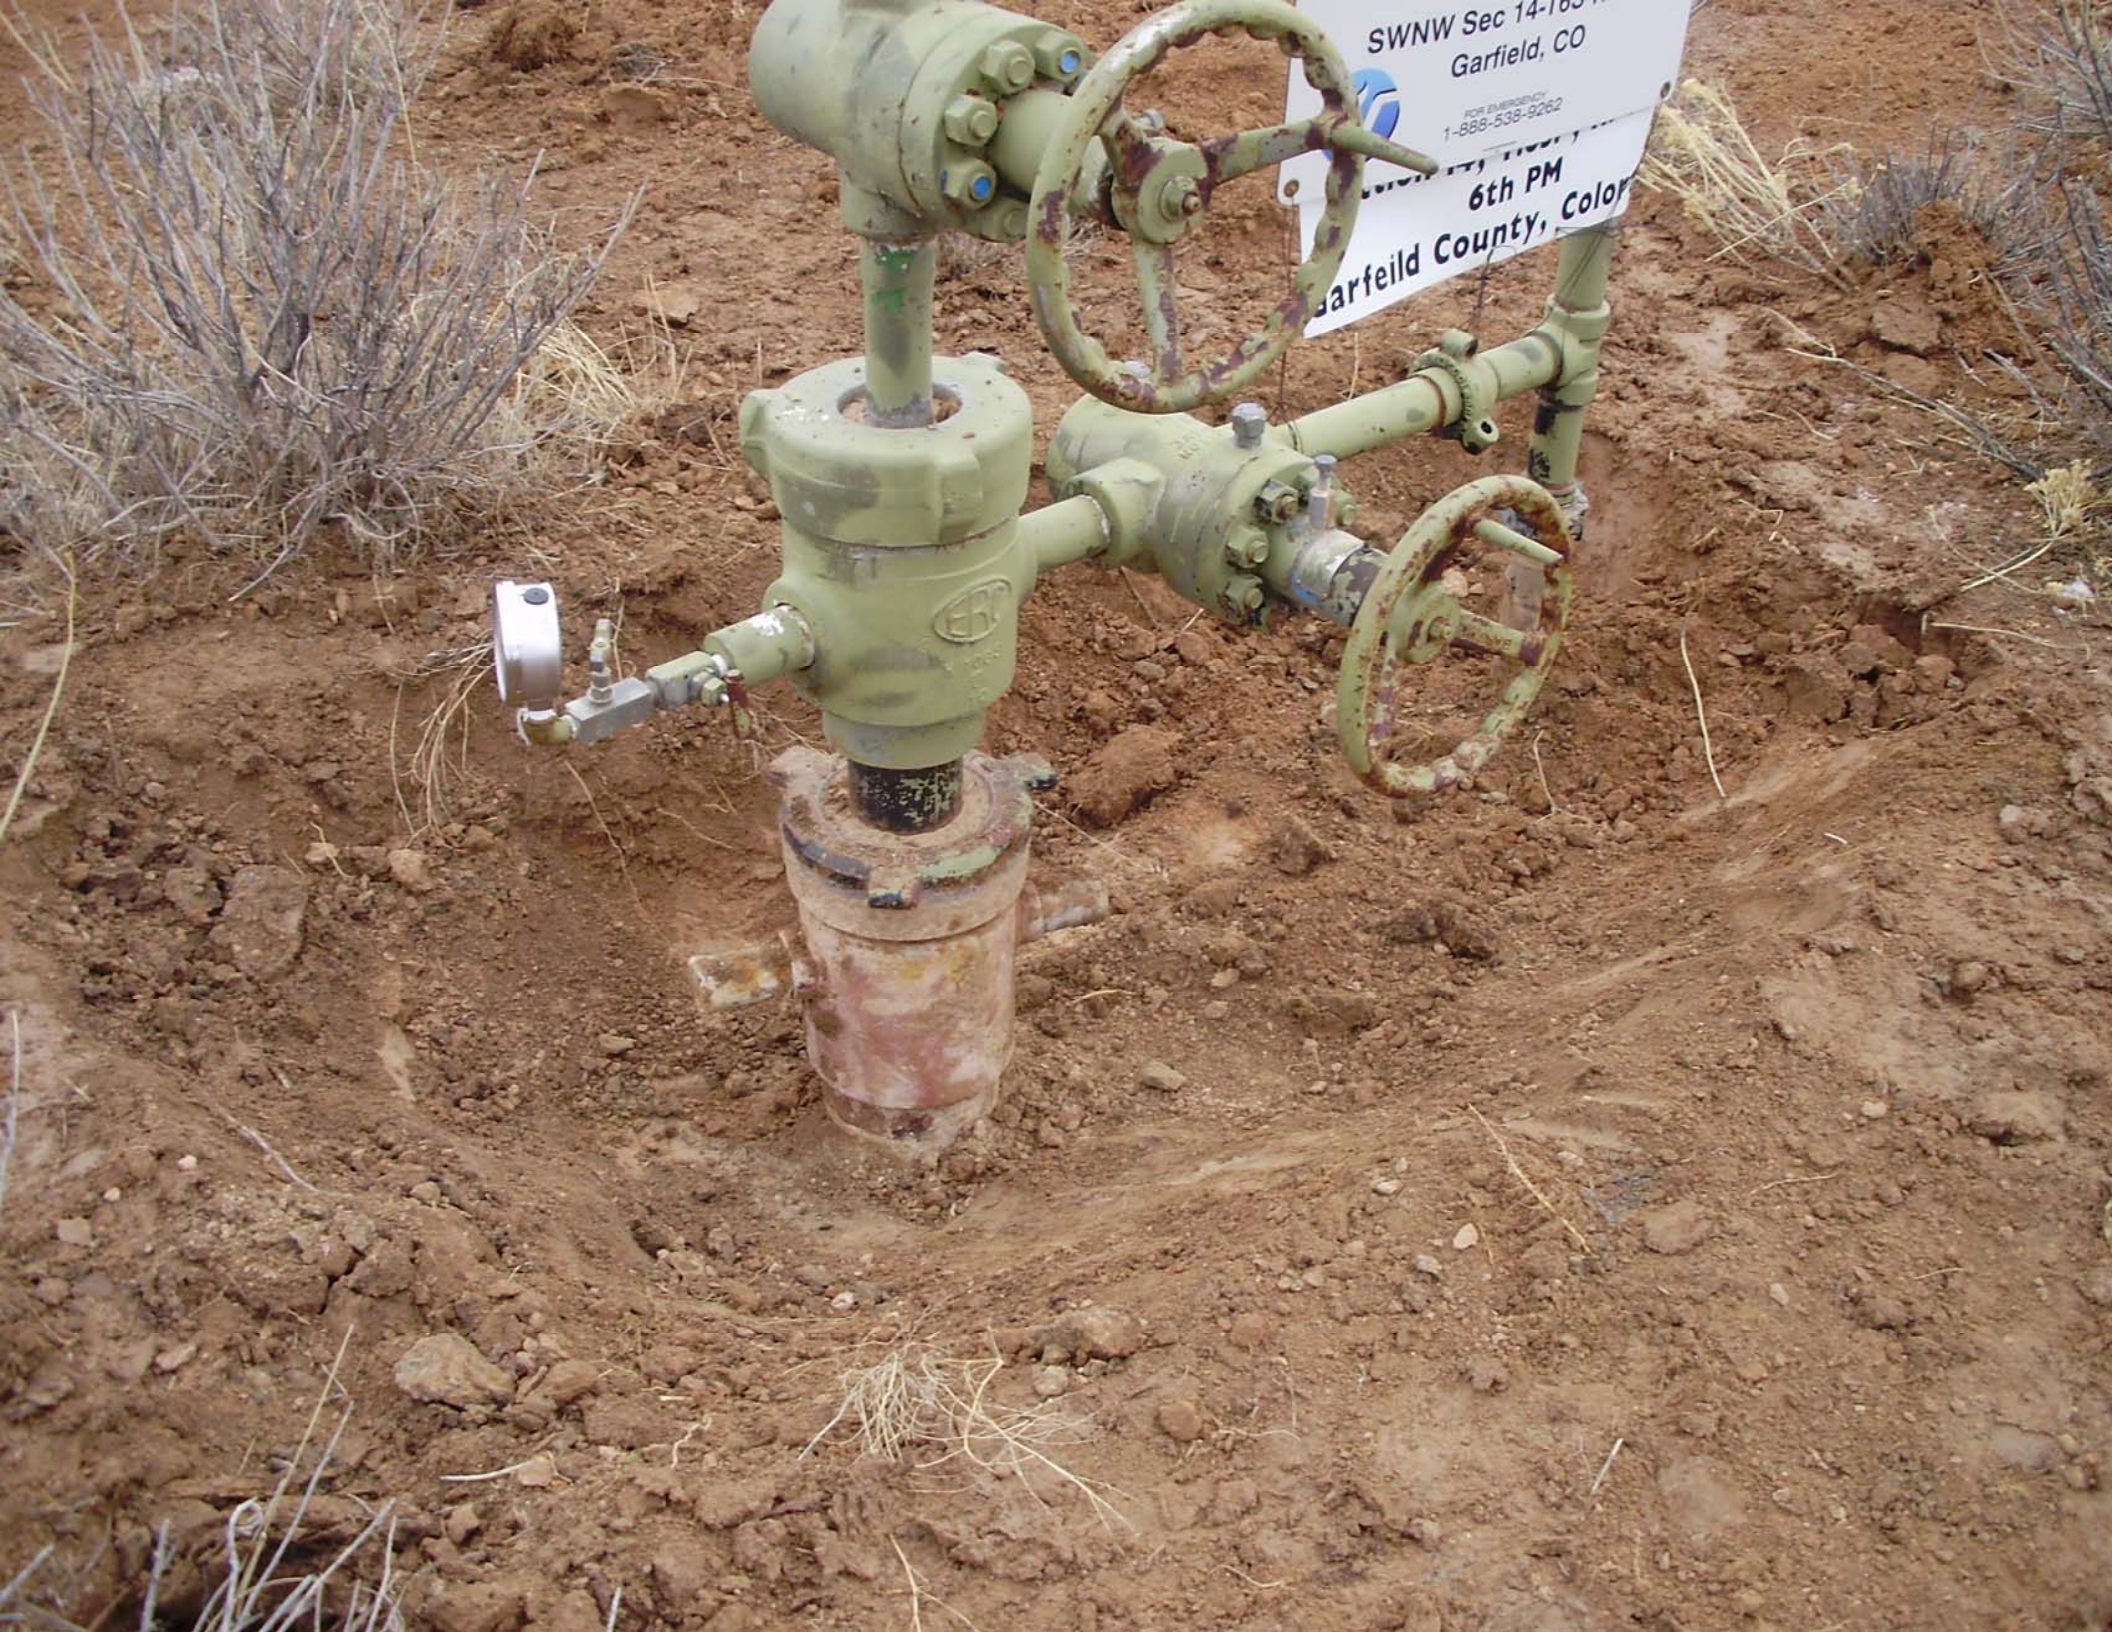
In the case of the bradenhead being manifolded to the production line or sales line, I would have to disagree with that statement as none of our wells had ever been hooked up in that fashion. I have included three photos of said well head in question that I hope will clarify this dilemma. If you are in agreement like me that the bradenhead is not connected to the production line are the bradenhead test and schematic flow diagram still needed?
