Location ID: 334955 Williams

“PA333-33 Pad”

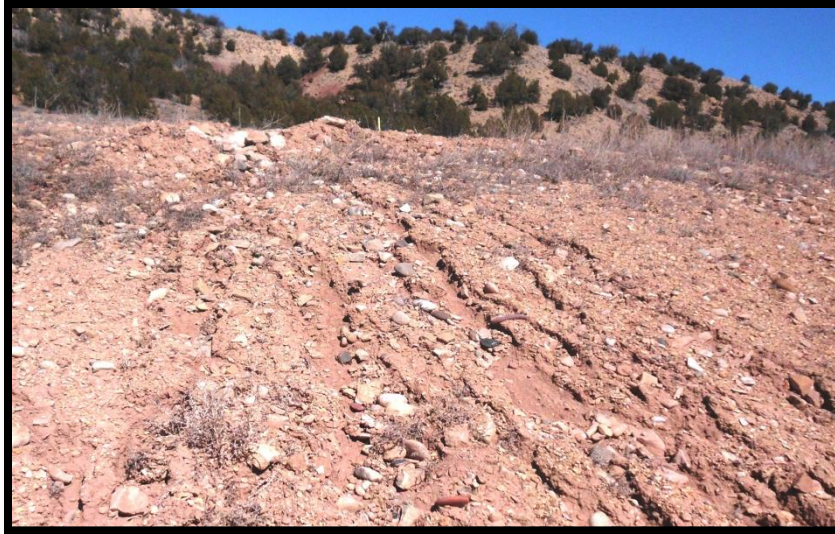
Viewing northerly: Rill erosion along fill slope

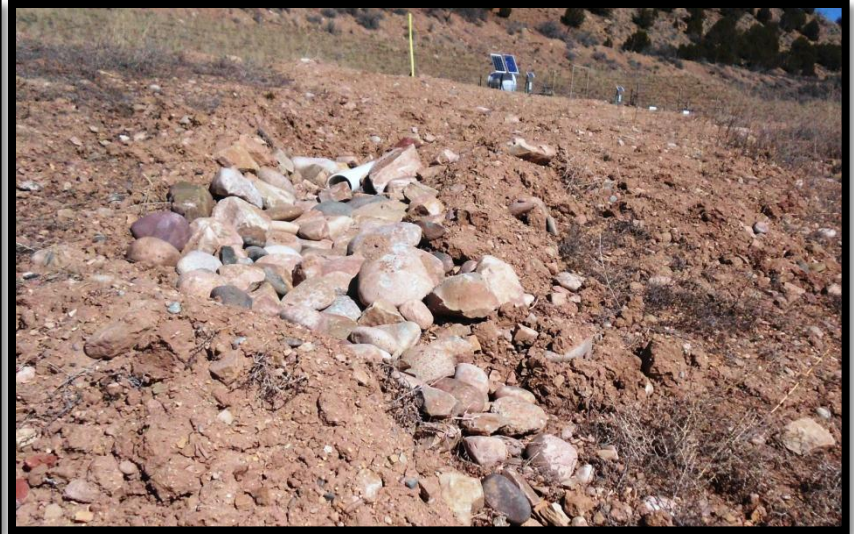
Viewing northerly: pipe outlet & riprap on fill slope

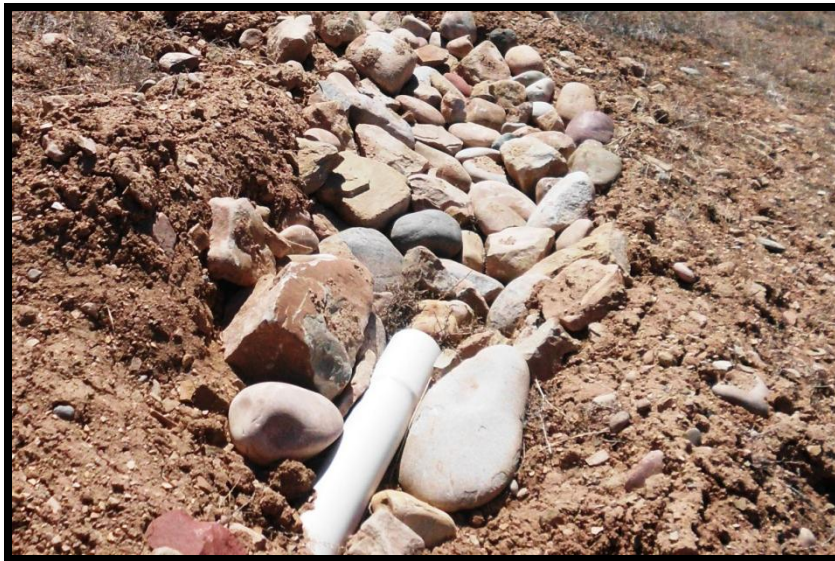
Viewing downslope (above). Stormwater collection drain to the right
