Geotechnical Engineering Report

**XENON WATER STORAGE PITS
PRELIMINARY SLOPE STABILITY ANALYSIS
North ½ Section 12, Township 7 North, Range 93 West,
6th Principal Meridian
West of Craig, Moffat County, Colorado**

June 28, 2012

Terracon Project No. AD125020

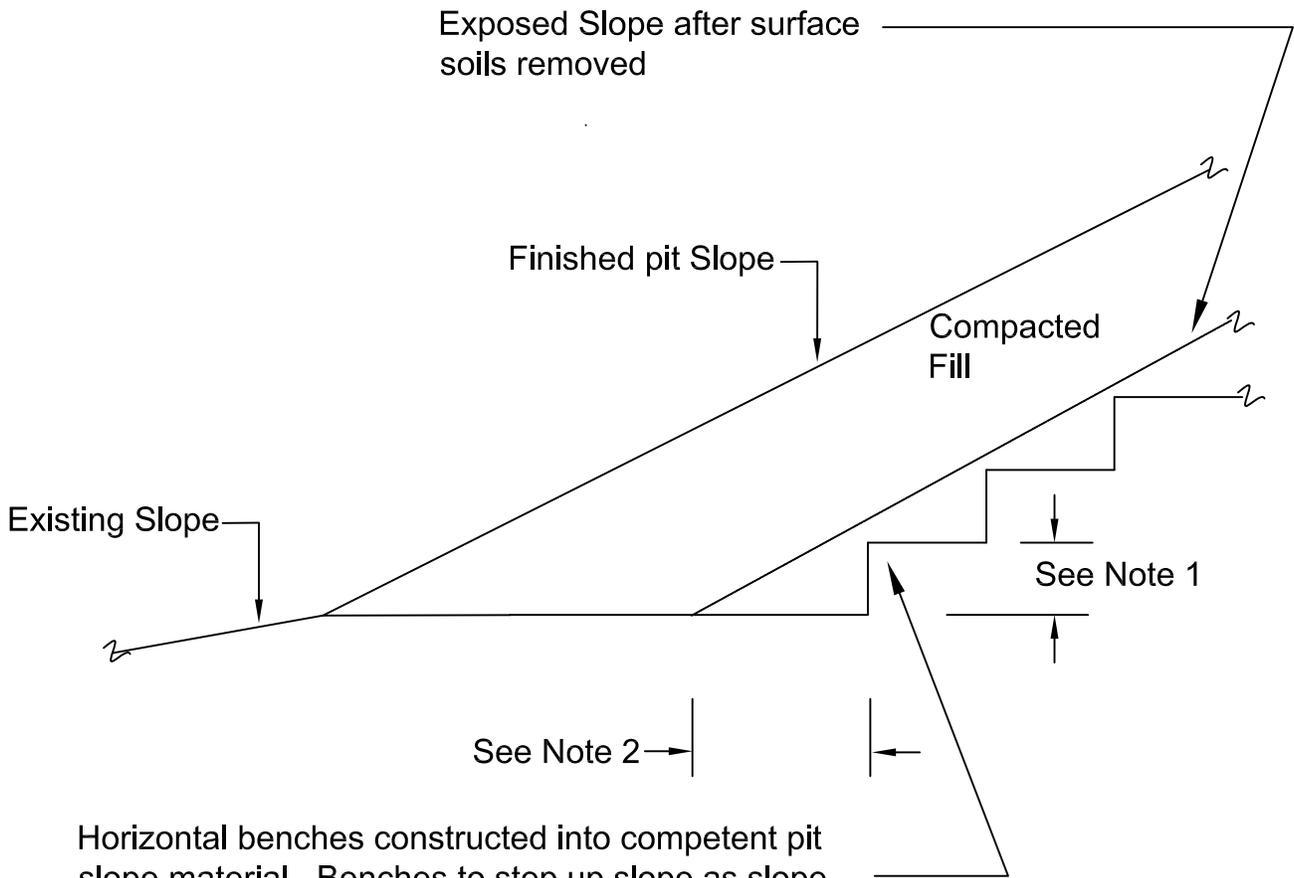
Horizontal benches constructed into competent pit slope material. Benches to step up slope as slope soil is removed to top of embankment. Bench heights determined during construction by Terracon. Benches may be constructed by removing the material, moisture conditioning, replacing on lower bench and compacting as discussed in the report.

Note 1: Excavated into competent pit slope material (estimated 3 to 5 feet). To be verified by Terracon during construction

Note 2: Bench width varies to accommodate equipment and bench depth.

- Pit maintenance should include re-compaction of the slope surface soils to a depth of at least 3 feet. A excavation and re-compaction bench concept is shown on Fig. A-2.

tension cracks and surface slumps observed were a result of combined shallow slope failure and settlement. The stability analysis indicates if the soils are well compacted the pit slopes are stable, however if the pit slopes are low density the stability of the pit slopes is marginally stable and likely have an accelerated slope creep to some degree of failure on an ongoing basis. In our opinion, design level geotechnical services are warranted to further investigate the four pits. Additional investigation would consist of a drilling and sampling program, laboratory strength testing and further stability analysis. Based on the results of this preliminary investigation, we believe remediation could consist of some degree of soils removal, moisture conditioning and replacement of a well compacted moisture conditioned fill. In one case, several feet of soils may be warranted. For discussion and preliminary consideration, we present the following: The exterior slope soils may be removed to a vertical depth of 3 feet, moisture conditioned and replaced in a well compacted manor. The exposed surface of the slope after slope soil removal should be benched horizontally at least 3 feet prior to replacing the slope soils. The bench concept is shown on Figure A-2. The slope soils should be moisture conditioned to within 2 percent of the optimum moisture content, placed in thin lifts (not exceeding 8 inches loos thickness) and compacted to at least 95 percent of the maximum standard Proctor (ASTM D-698) dry density.

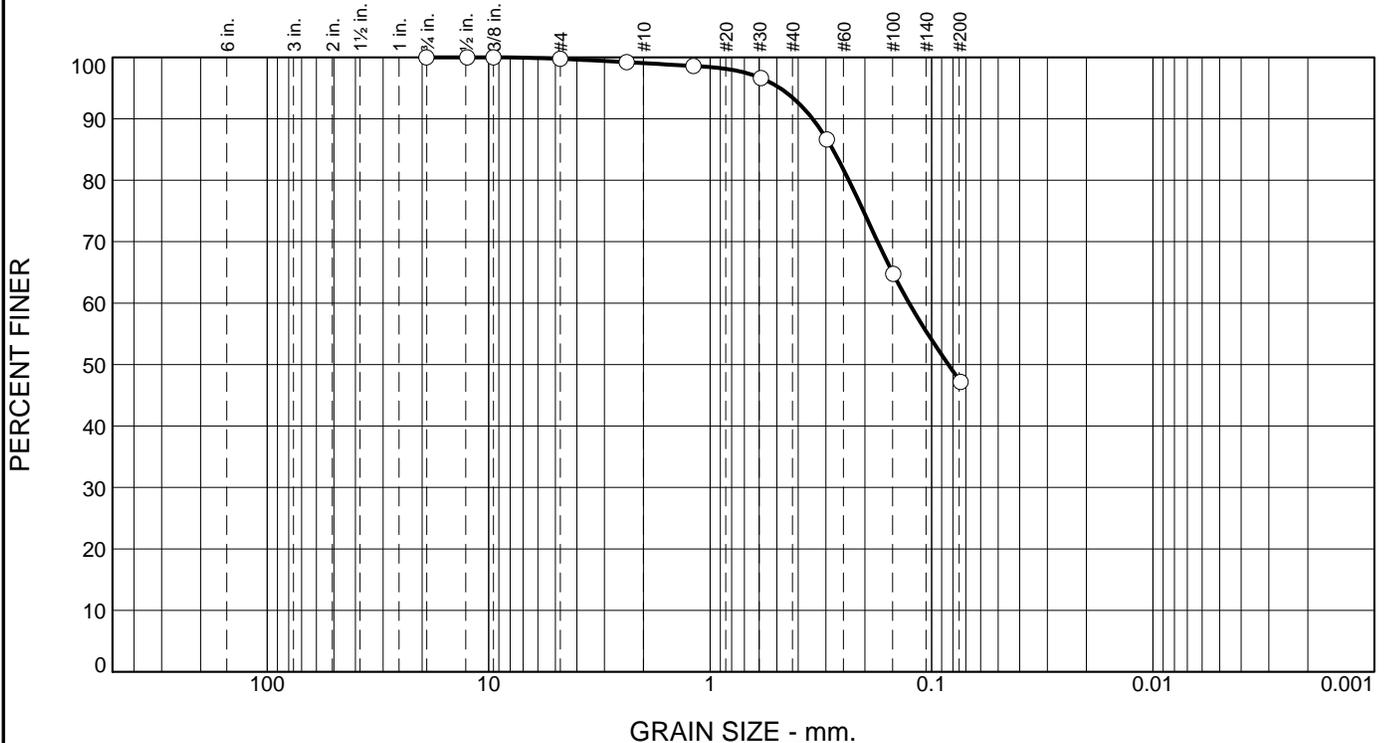
Project No: AD125020 Figure B-2

Sand, Very Clayey

PL= 18 LL= 24 PI= 6

USCS (D 2487)= SC-SM AASHTO (M 145)= A-4(0)

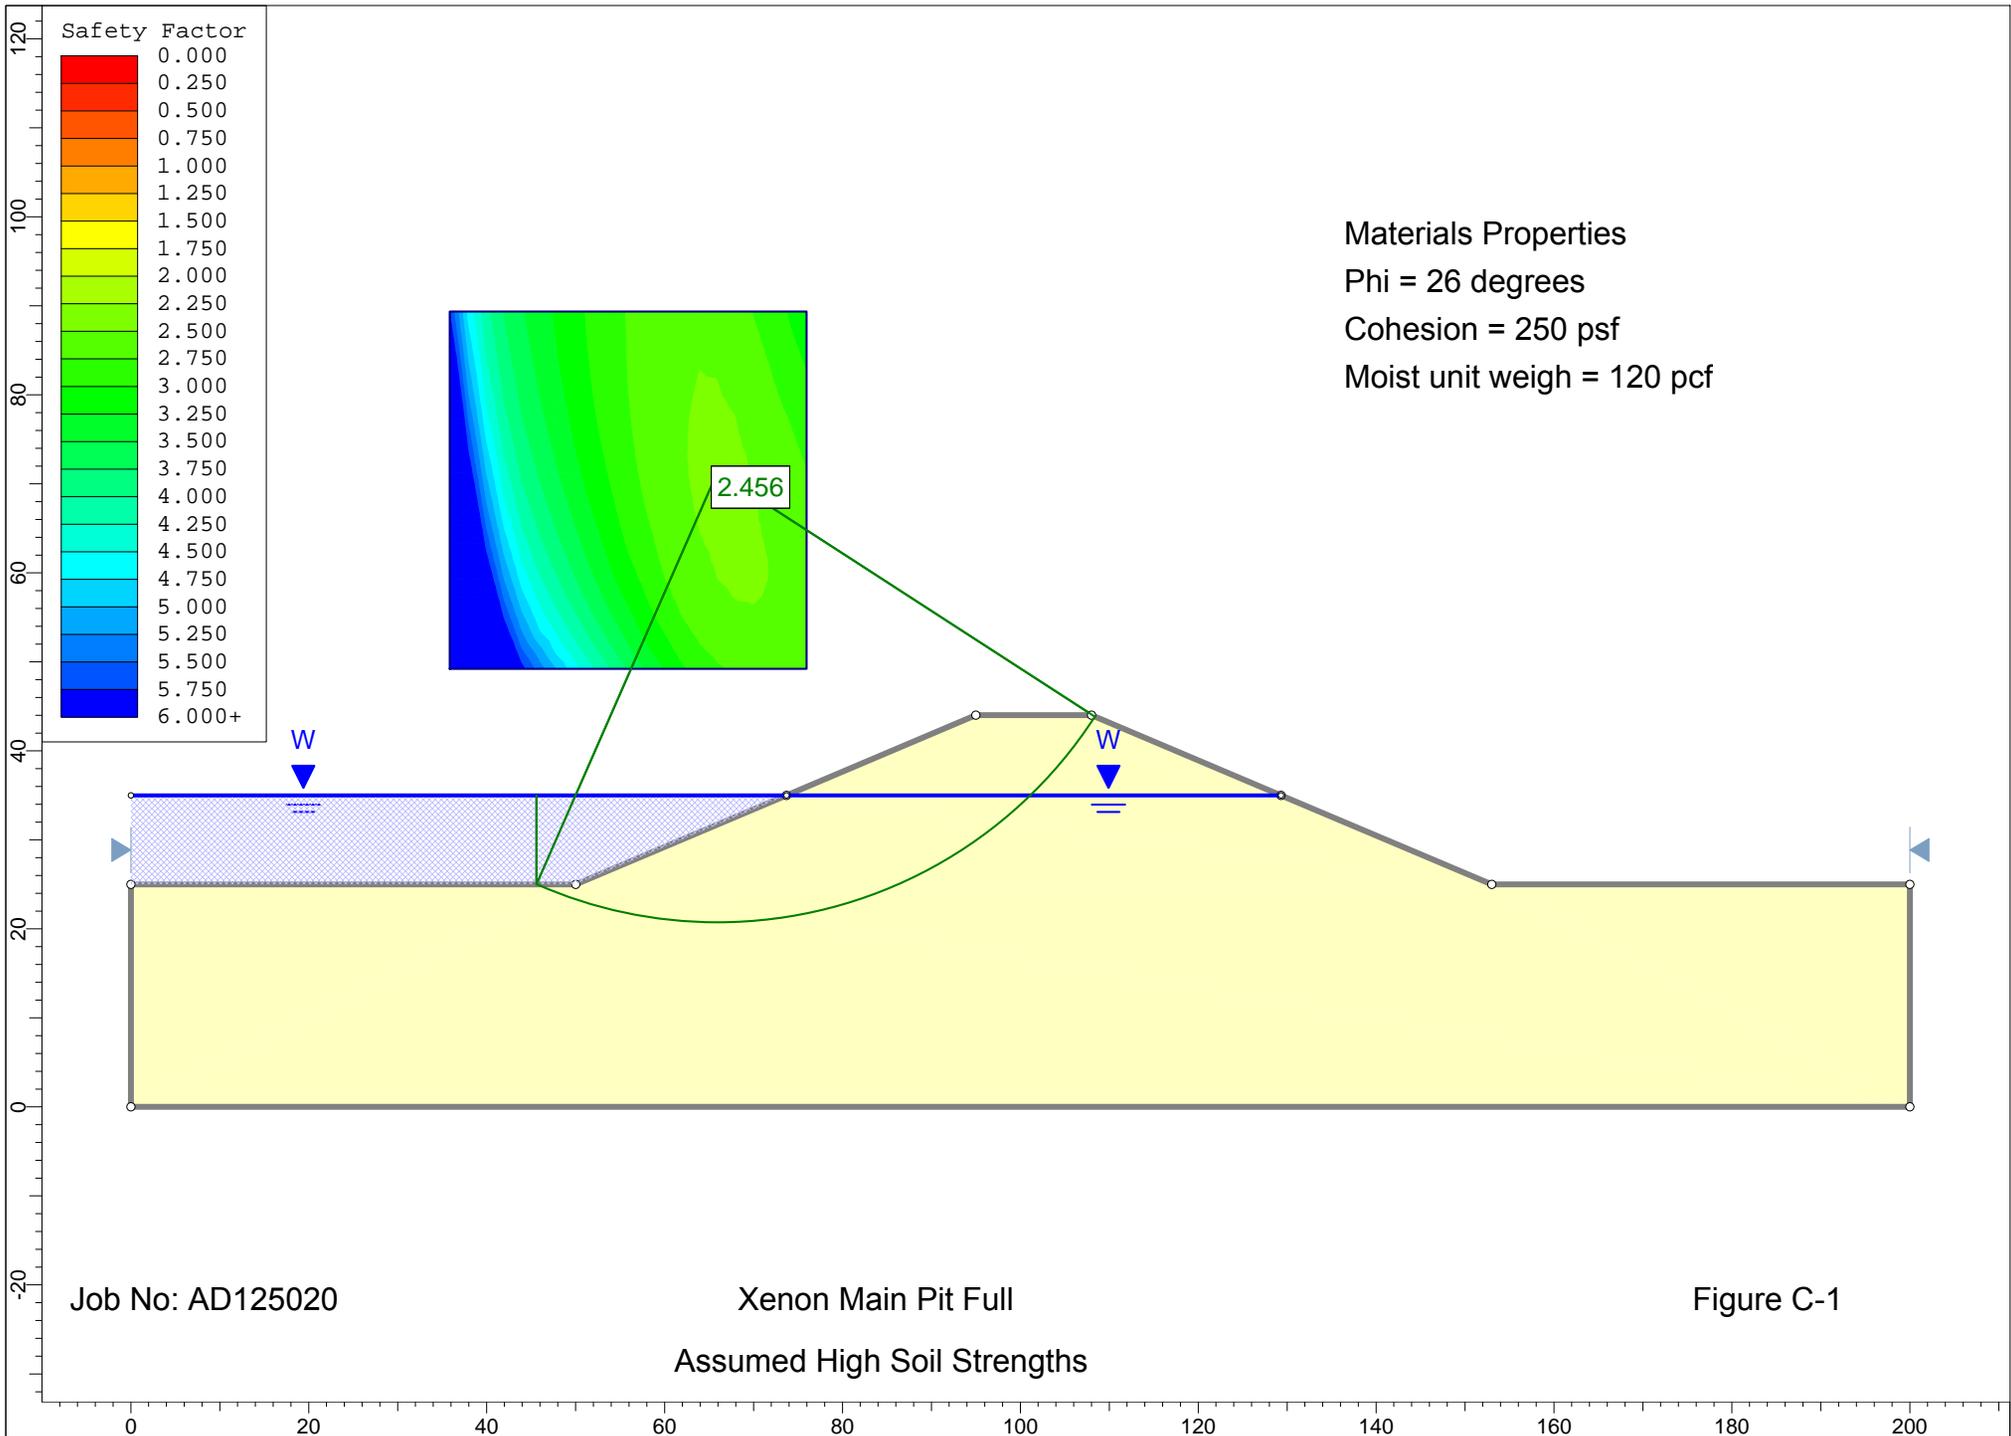
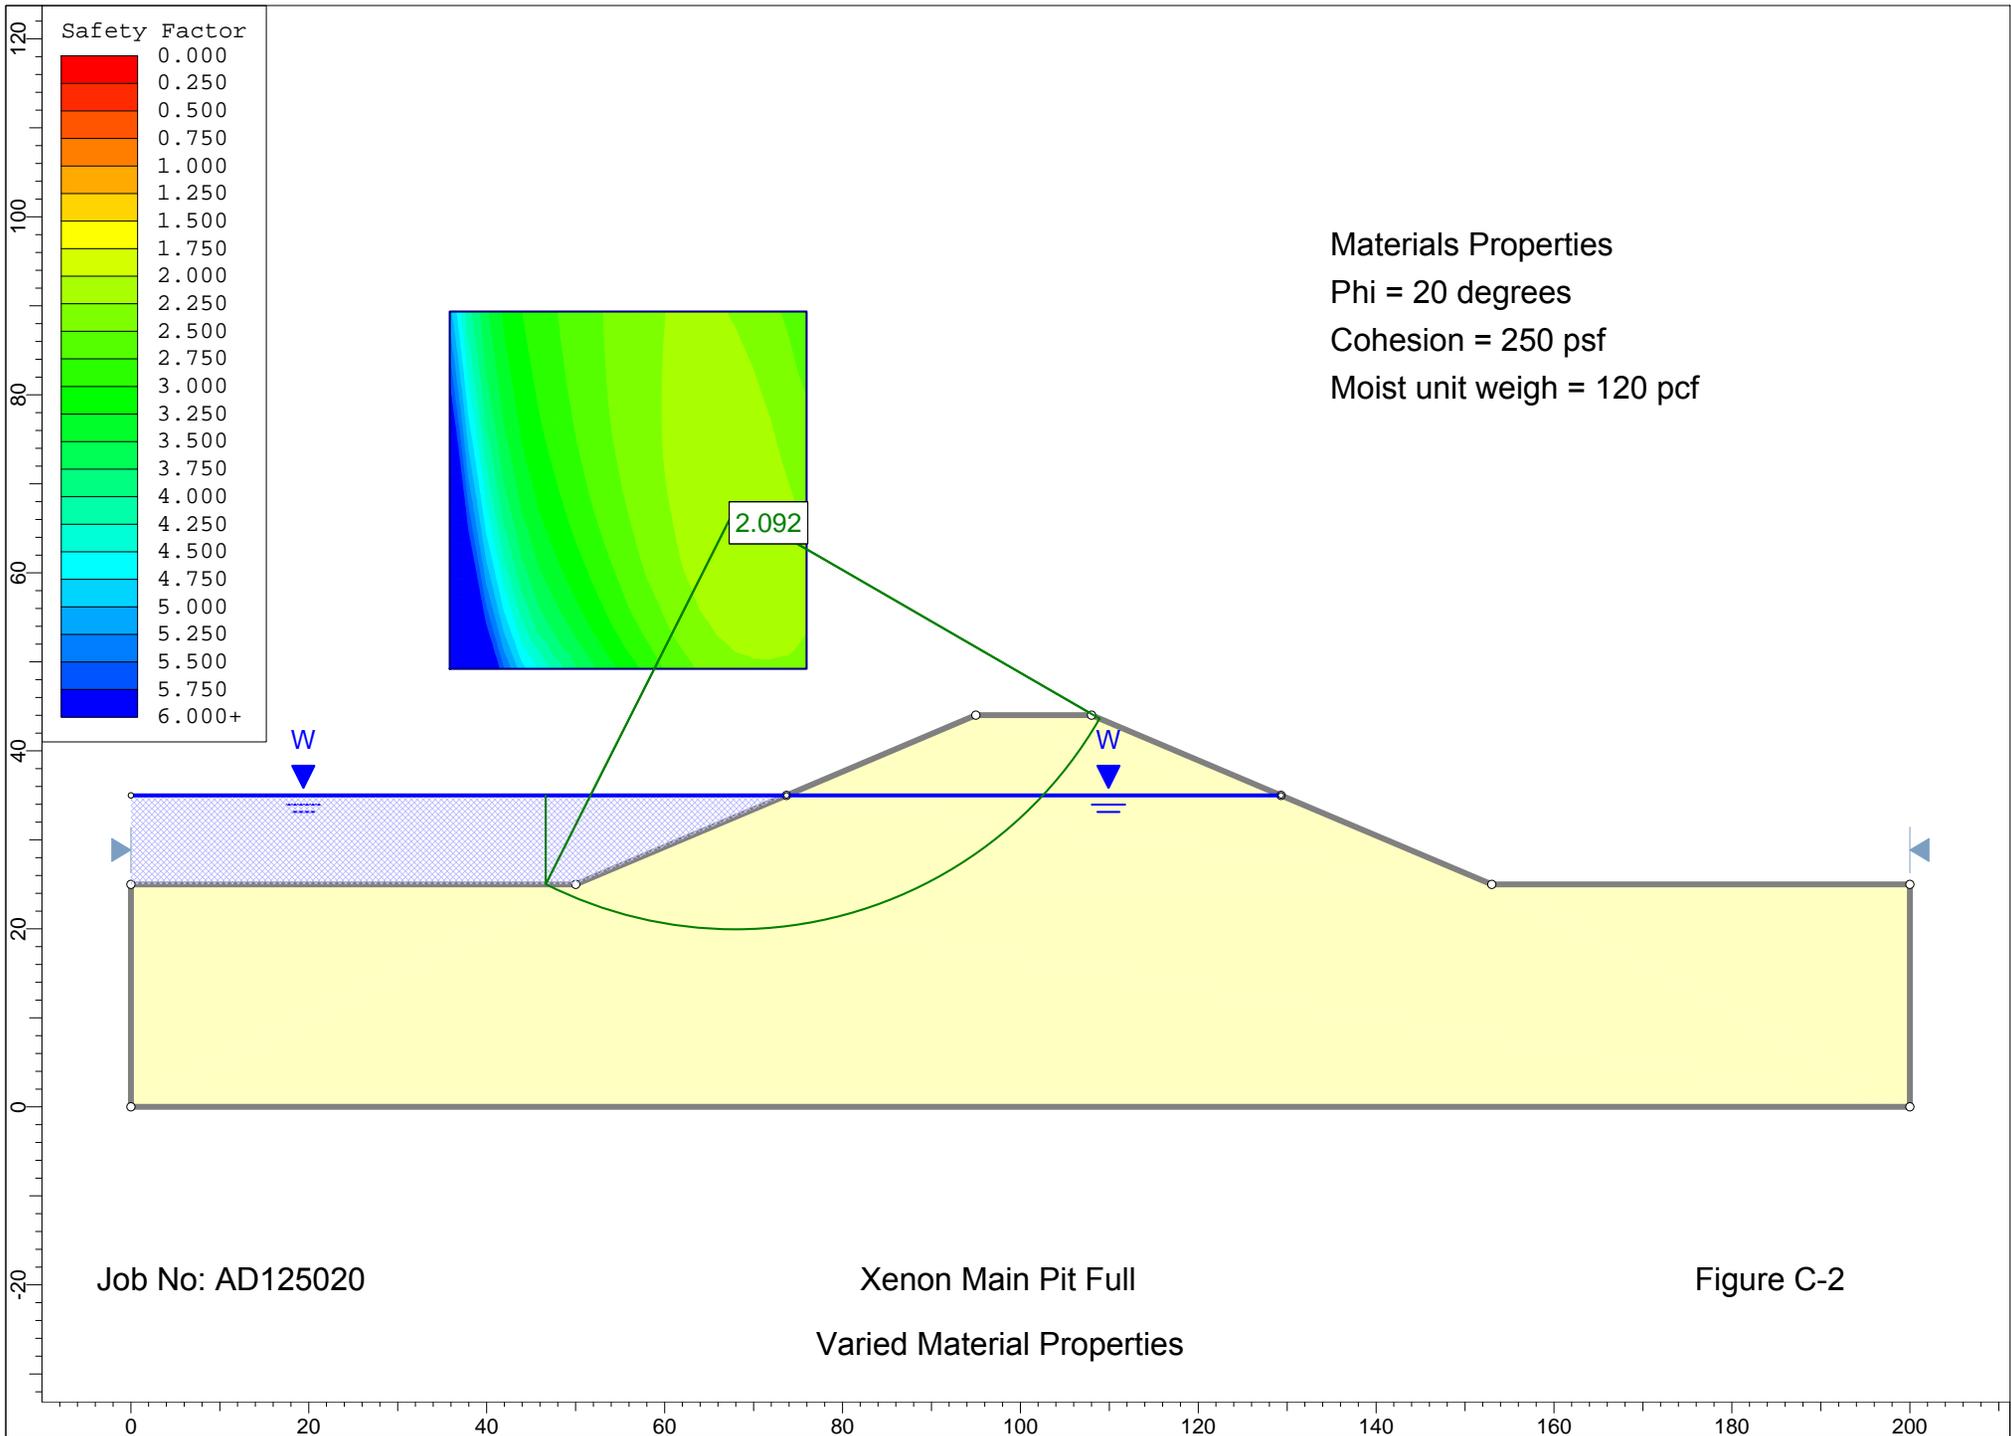
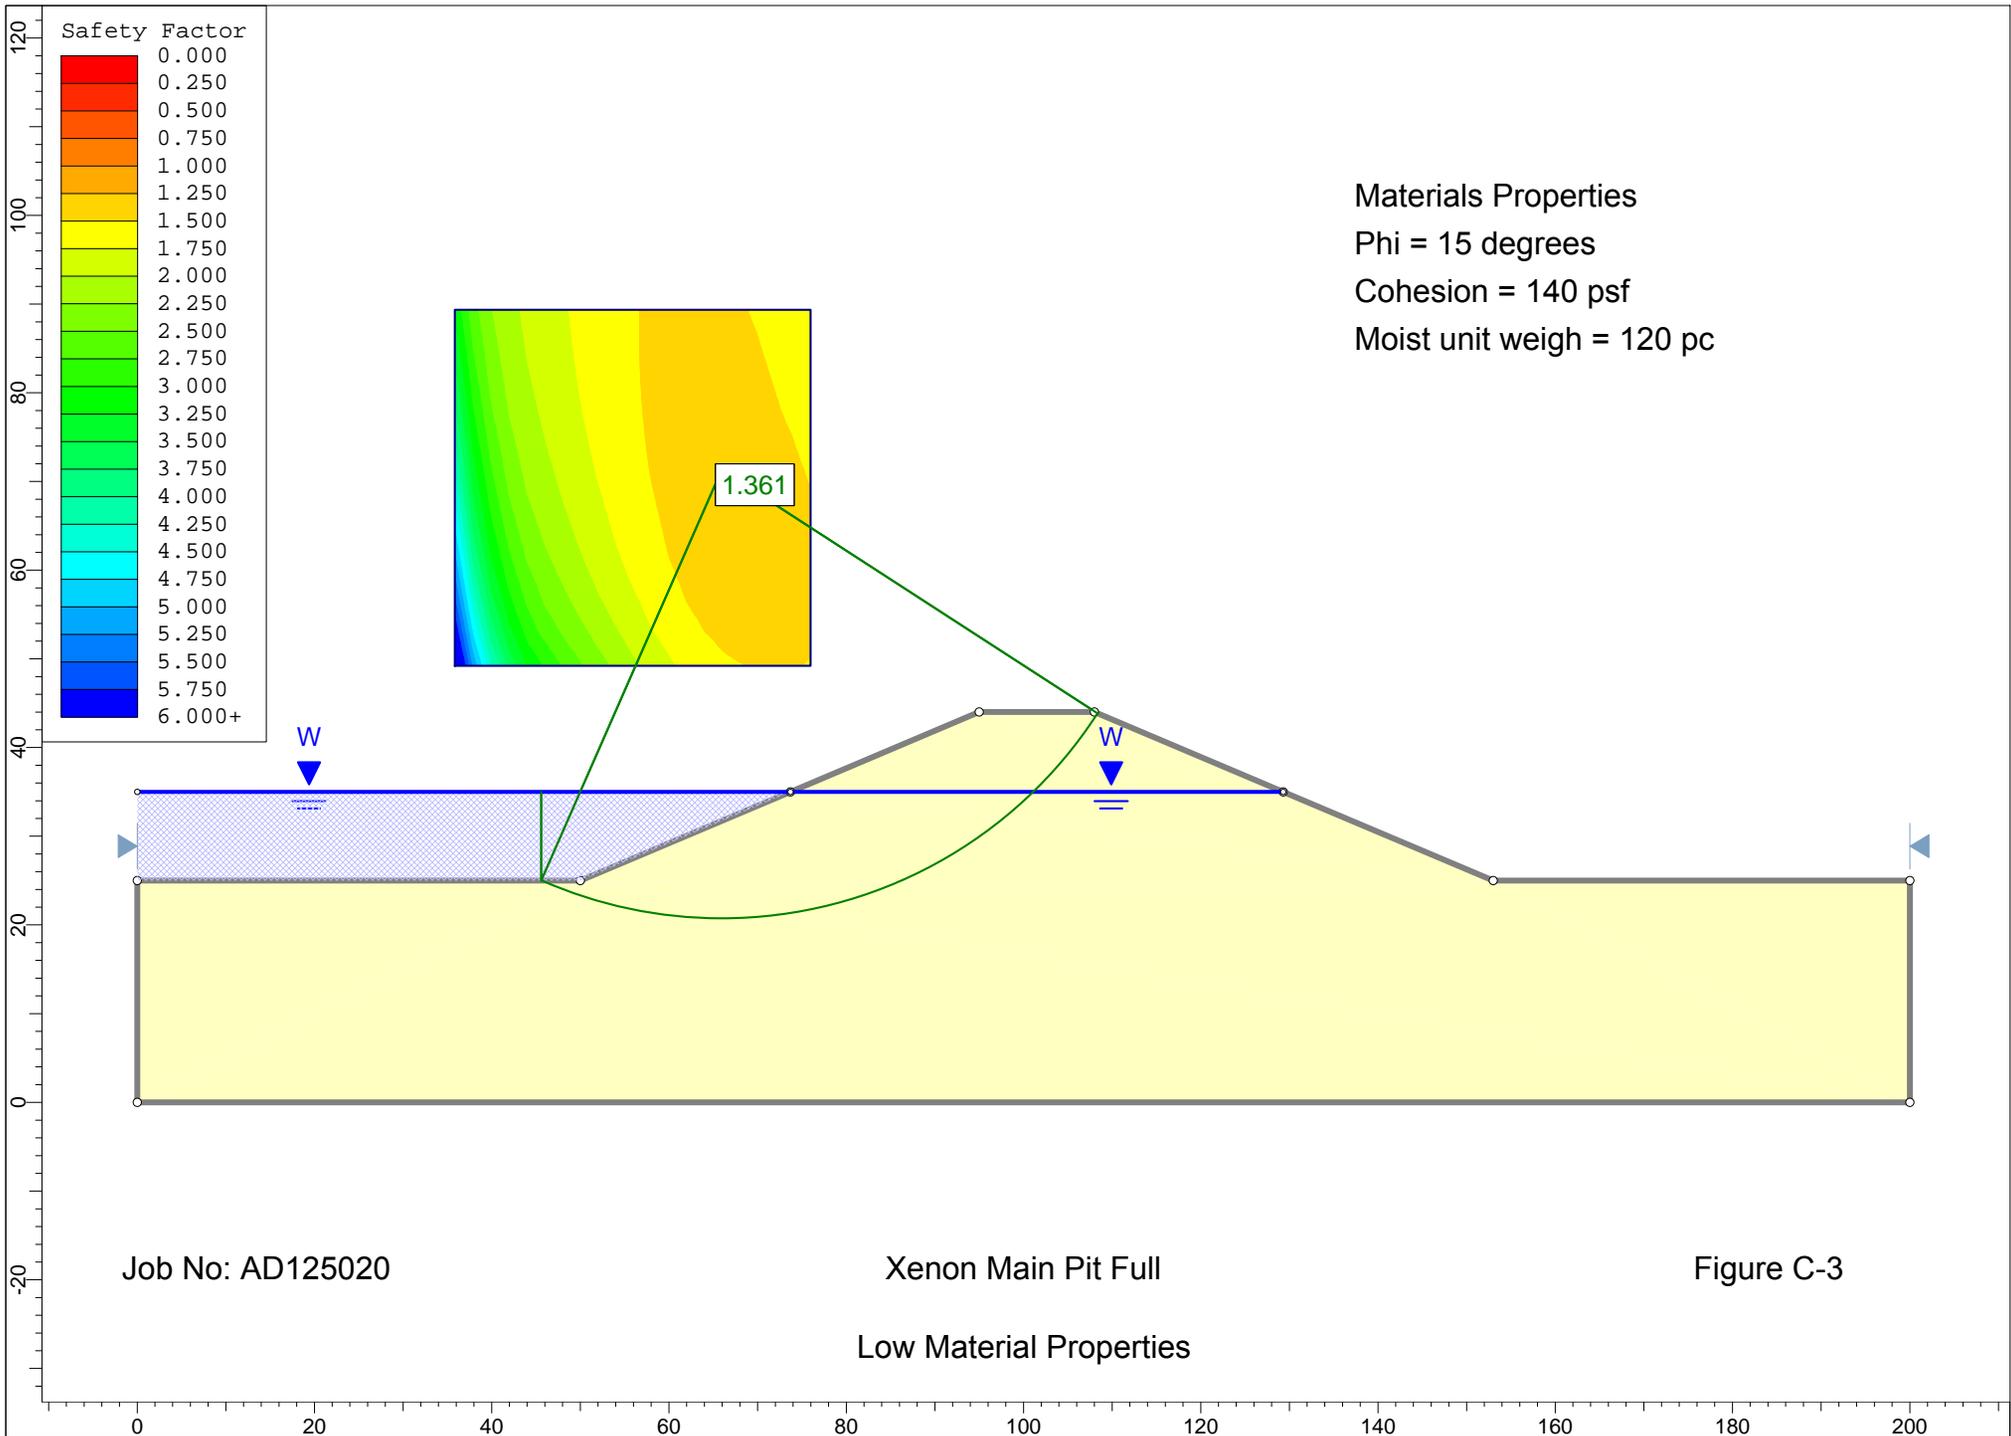
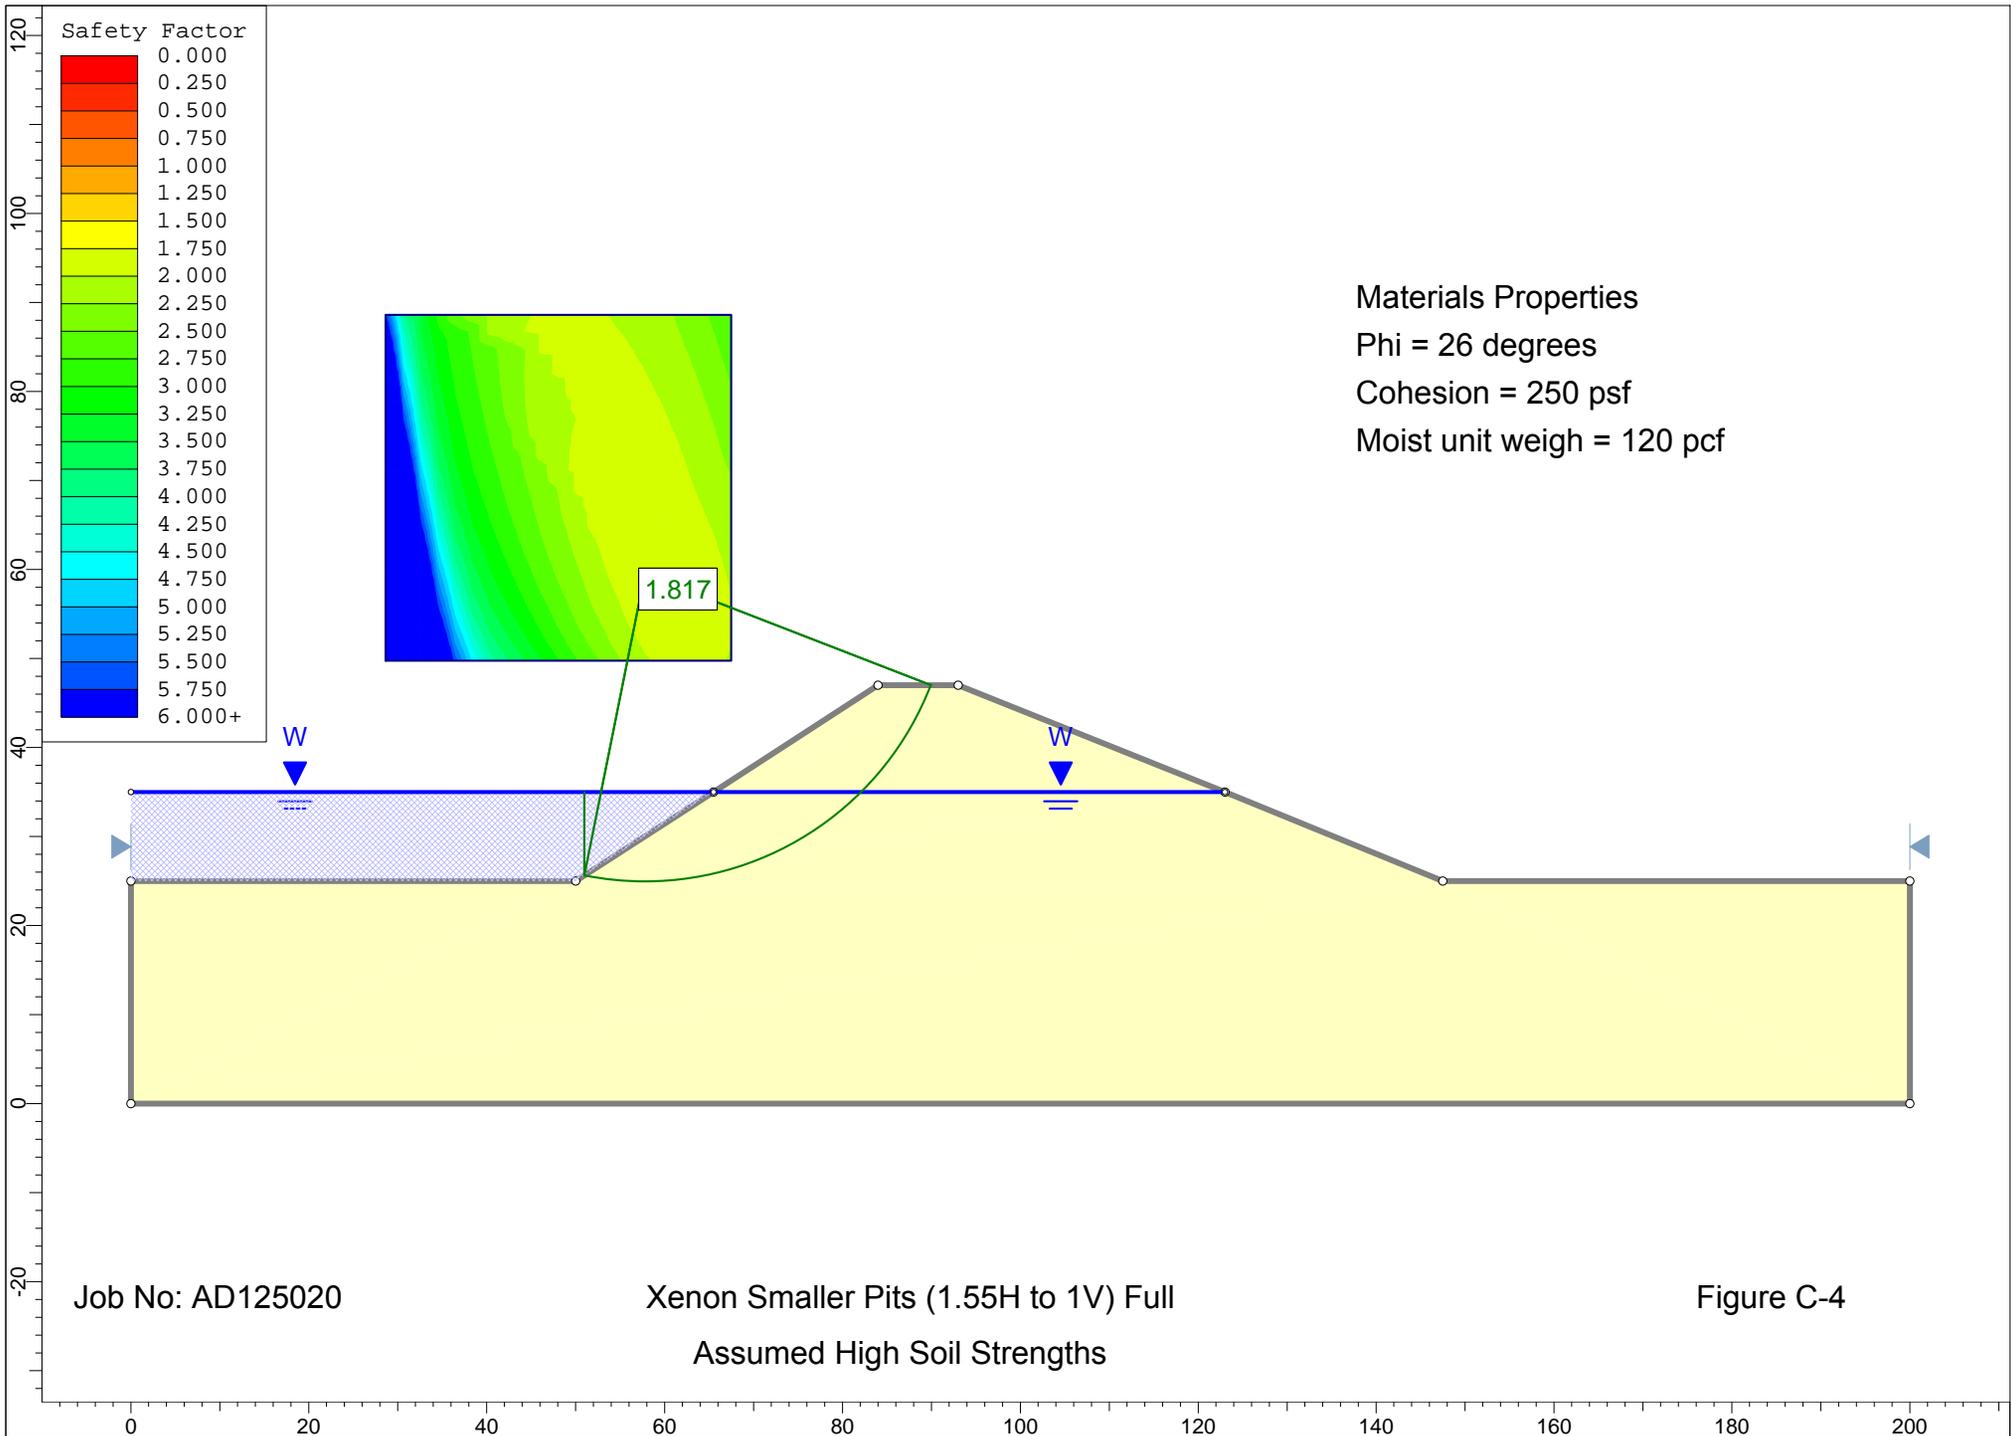
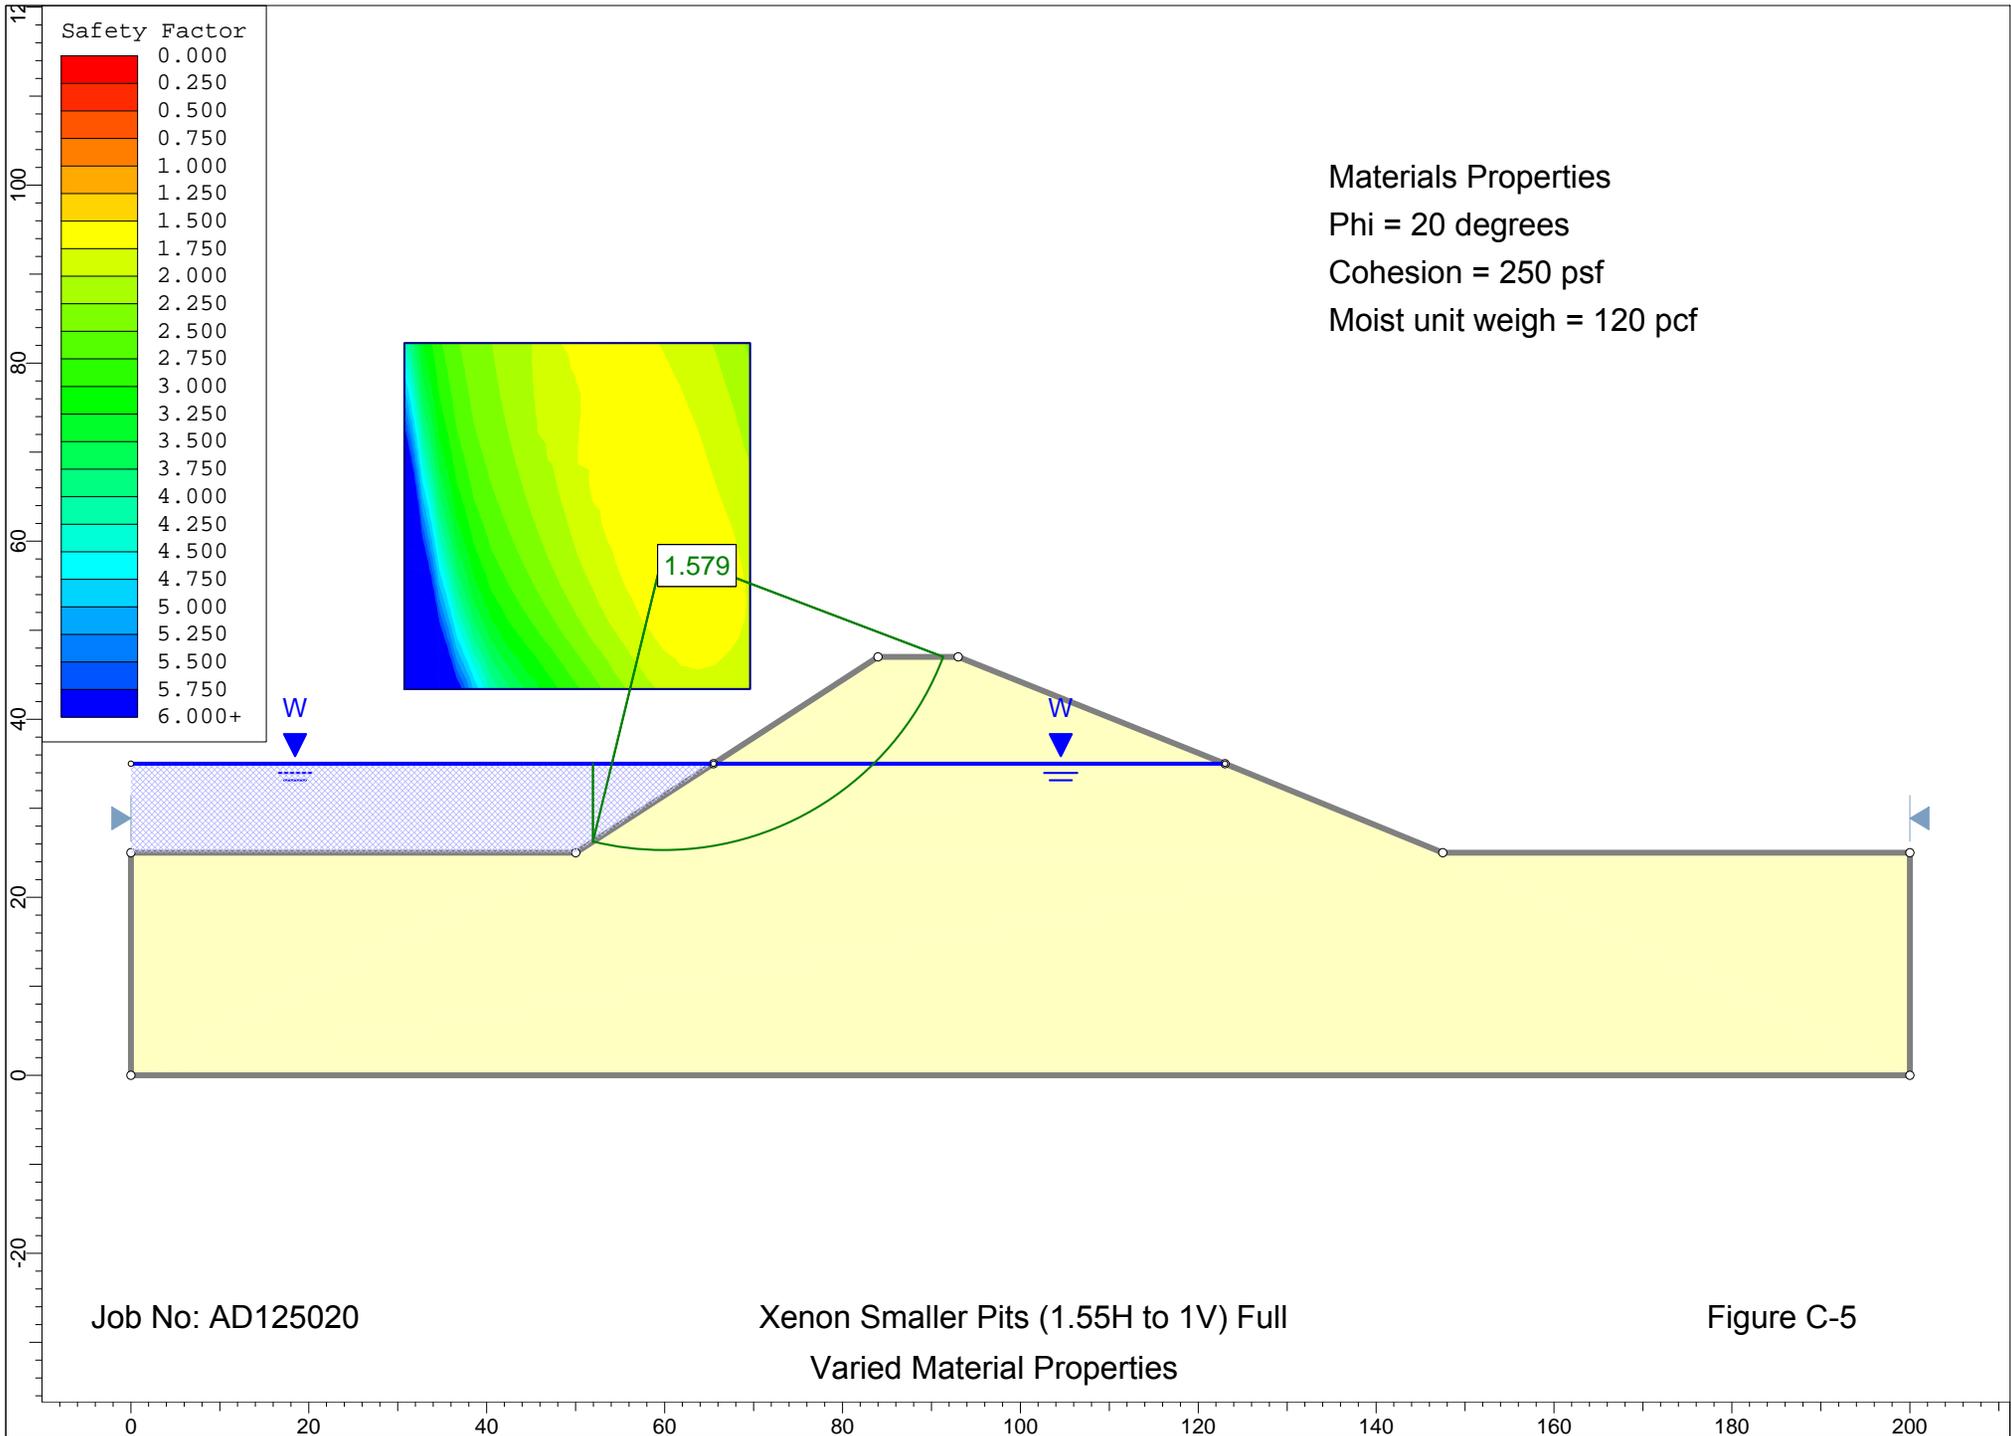
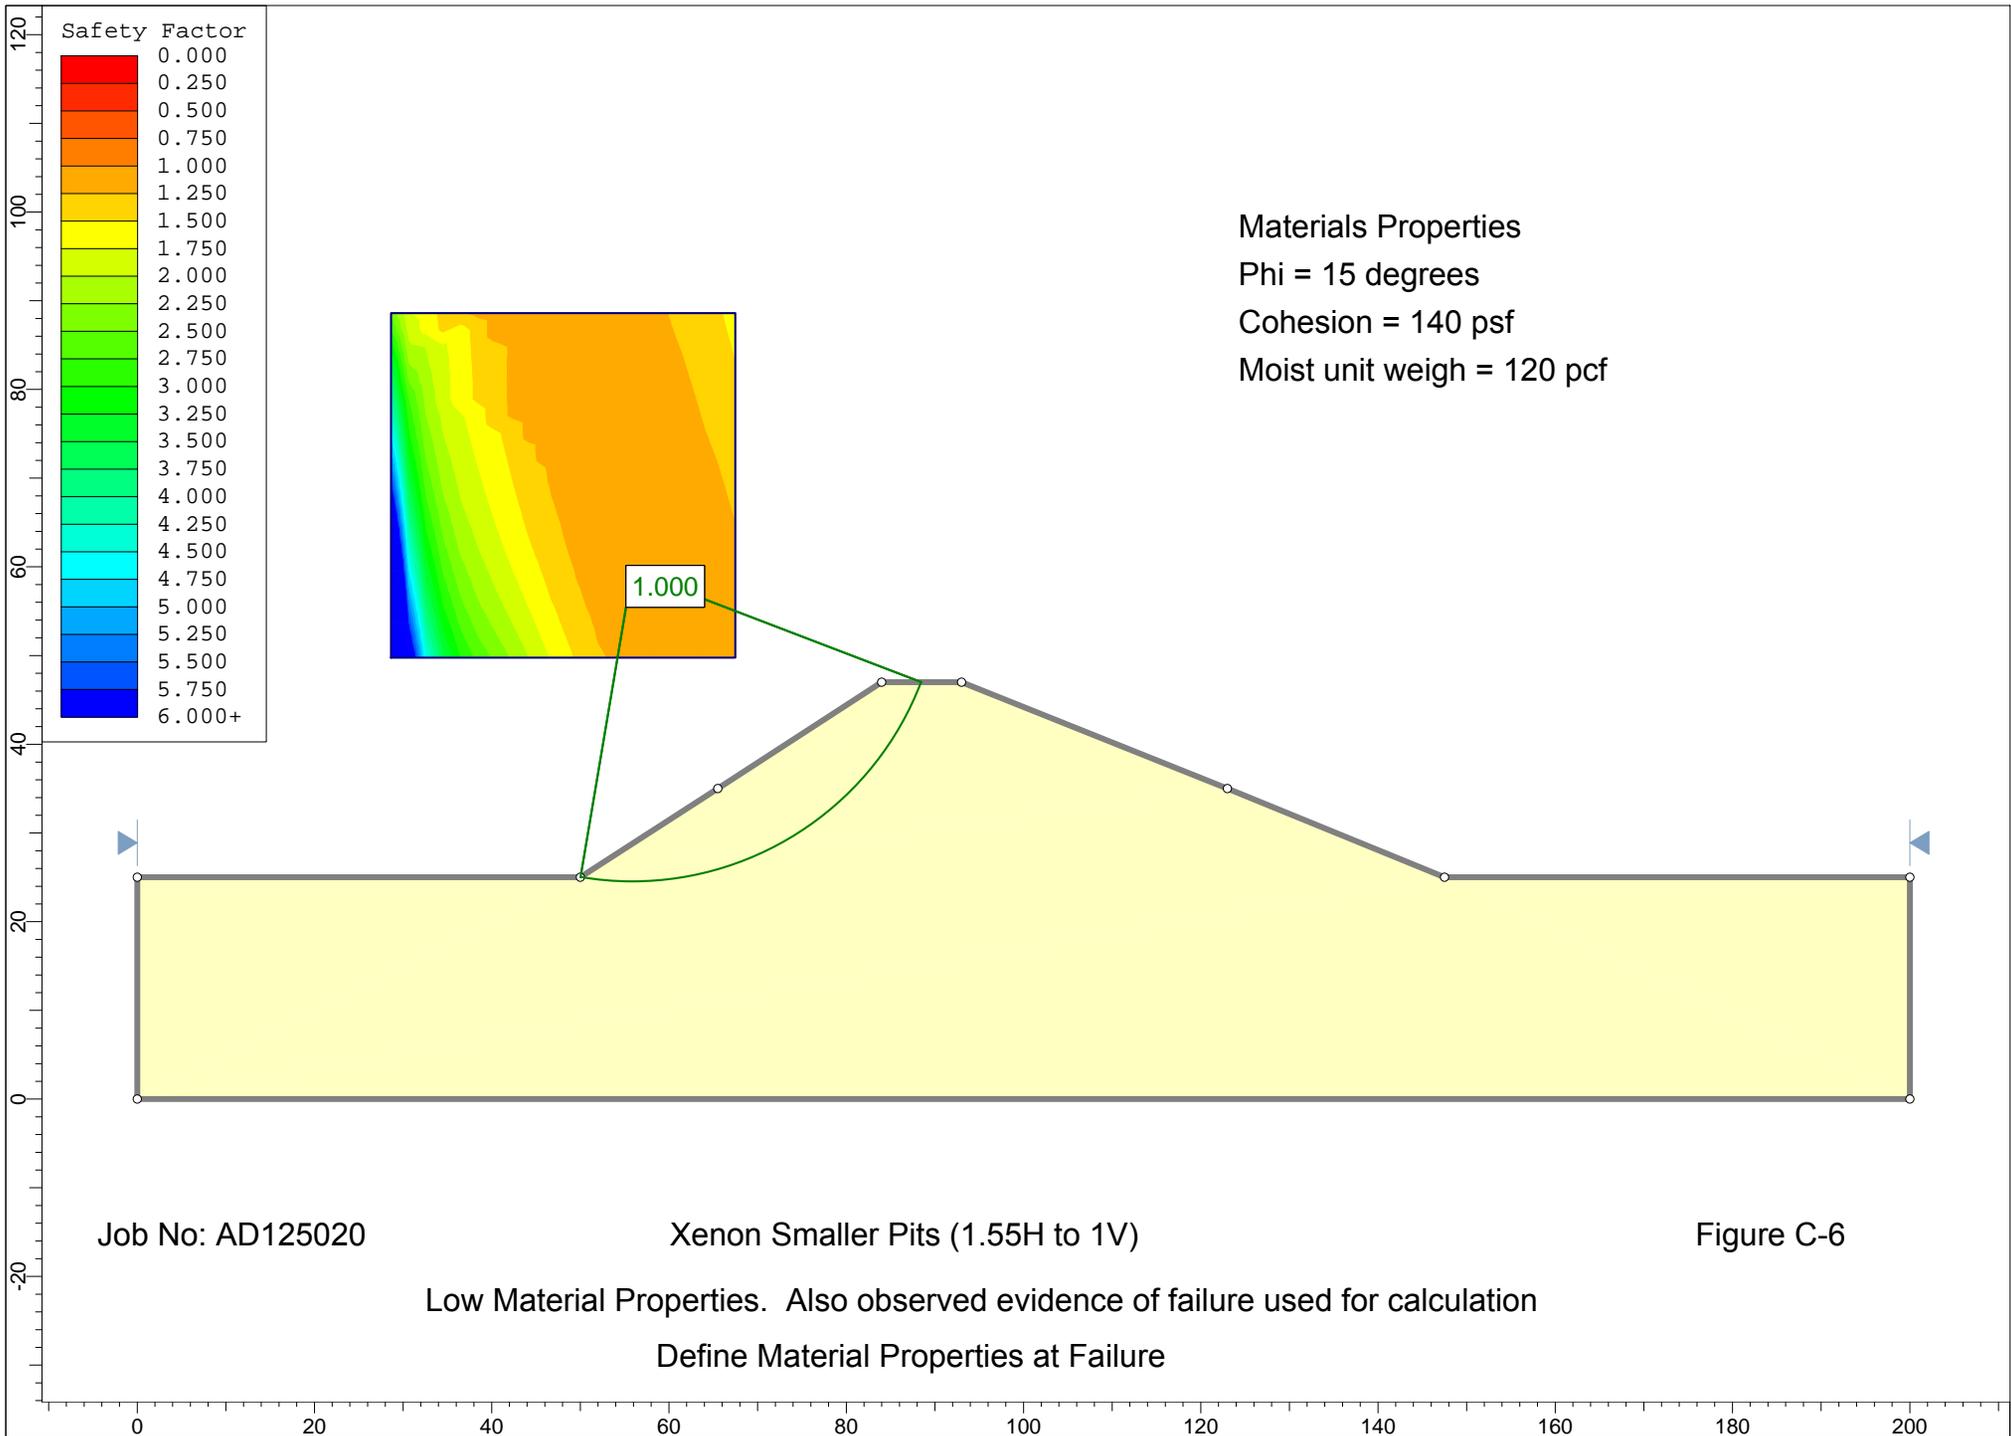
This stability analysis is based on the observed site conditions and existing slopes and depth of the pit. The main pit slope inclination is about 2.37 Horizontal to 1 Vertical for both interior and exterior slopes. The depth of the main pit is about 19 feet. The smaller pits slope inclinations are about 2.48H to 1 V interior and 1.55H to 1 V exterior. The depths of the smaller pits are about 22 feet. The maximum water depth in all pits is about 10 feet. We obtained shallow samples from the pit slopes for laboratory classification testing. We performed sieve analysis and Atterberg limits tests of one sample obtained from the pit slopes. Based on the laboratory soil classification test results we estimated soil strength properties of cohesion value of 250 psf and internal angle of friction of 26 degrees. We also performed a sensitivity analysis where soil strength parameters were back calculated for a slope stability factor of safety equal to 1, assumed slope failure condition. The low soil strength properties calculated included a cohesion of 140 psf and an internal angle of friction of 15 degrees. We used the graphical computer program Slide Version 6.0, manufactured by Rocscience Inc. and the Bishop simplified method of slices for our analysis. The stability analysis was performed for a cross section at the maximum depth of each pit slope and inclinations determined by site observation and as-built plan review. The stability analysis was performed using both the estimated soil strength properties based on laboratory classification tests and the low soil strength properties as back calculated from an assumed slope failure condition. strength properties for dry and wet conditions. We performed over 3500 separate theoretical failure plane analysis. This report presents the slope stability analysis with the lowest calculated factor of safety. The results of the slope stability analysis are presented on Figs. C-1 through C-8.

We consider a minimum factor of safety against slope movement of no less than 1.5 warranted for conditions such as those at the subject site (Reference "Soil Mechanics Design Manual 7.1", page 7.1-329, Department of the Navy, Naval Facilities Engineering Command dated May 1982). The slope stability analysis indicated a calculated factor of safety for the slopes ranging from 1.3 to 2.46 for the main pit for the estimated soil strength properties. The slope stability analysis indicated a calculated factor of safety for smaller pit slopes ranging from 1.0 to 1.87 using estimated soil strength properties.
