## Snyder-Barton-Porter 2-21 API# 045-06388

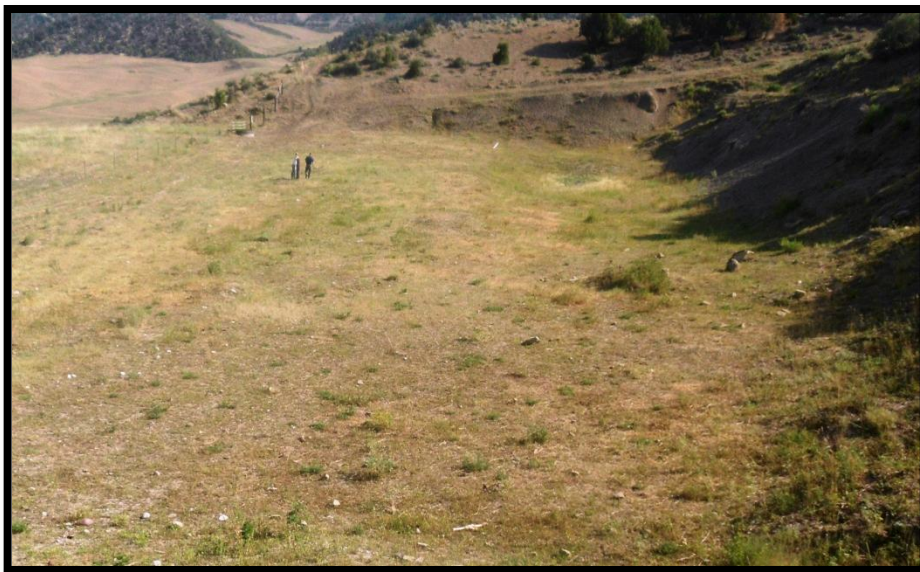
Viewing north. Well pad footprint, wellbore location, and cut and side slopes

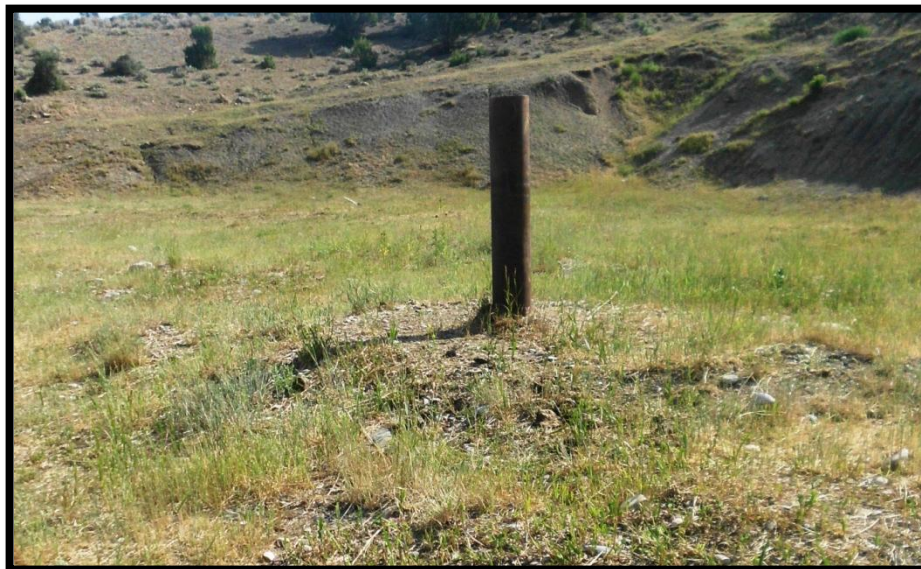
Viewing north: open cased wellbore on location.

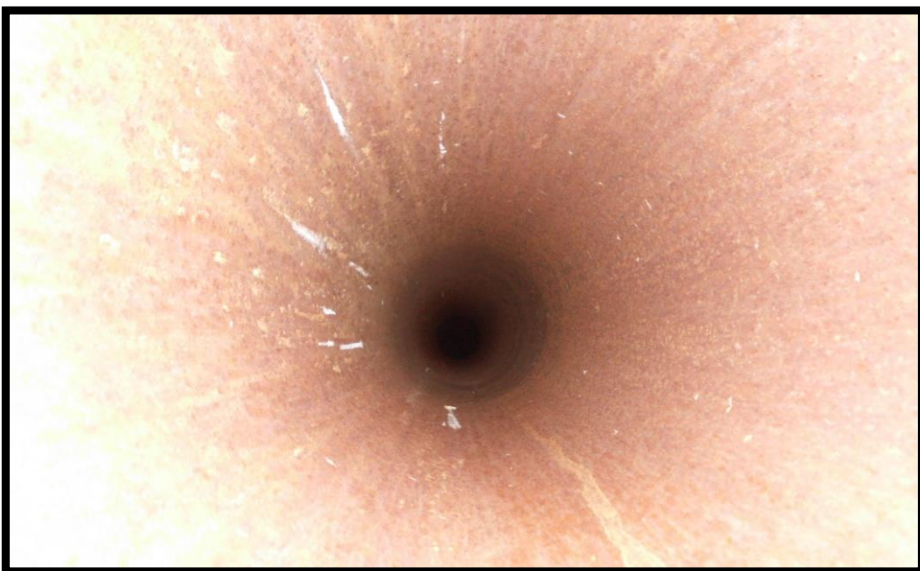
Snap-shot of wellbore casing interior.

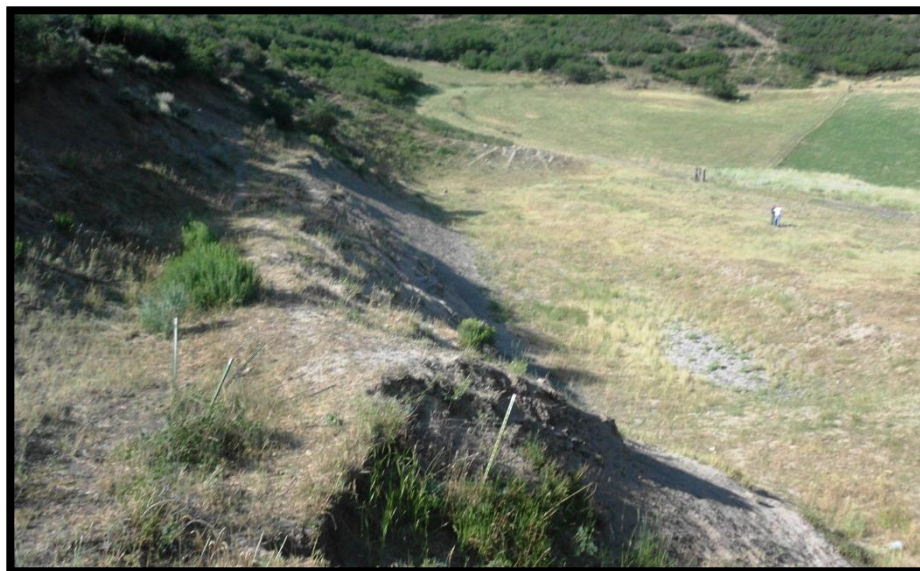
Viewing south: Cut slope and well pad.

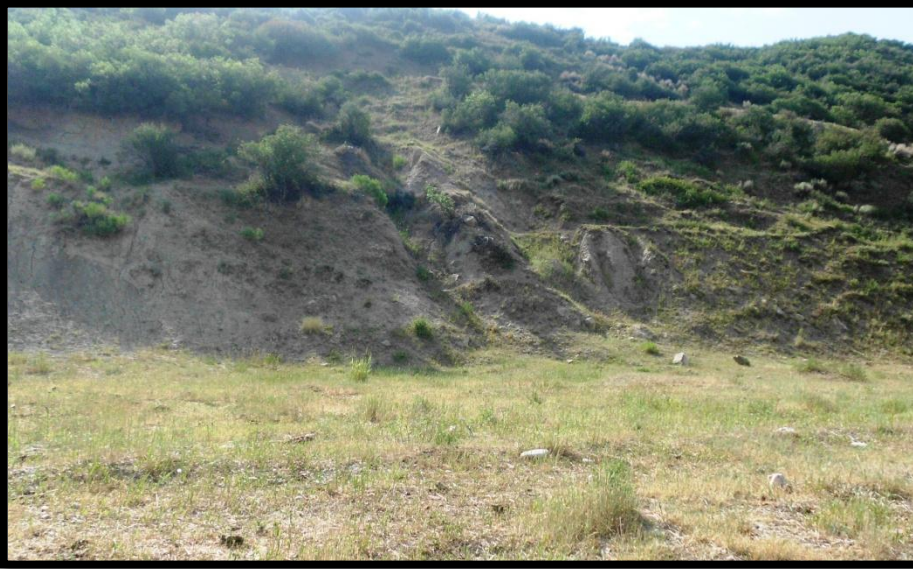
Viewing east: Gully erosion along cut slope.

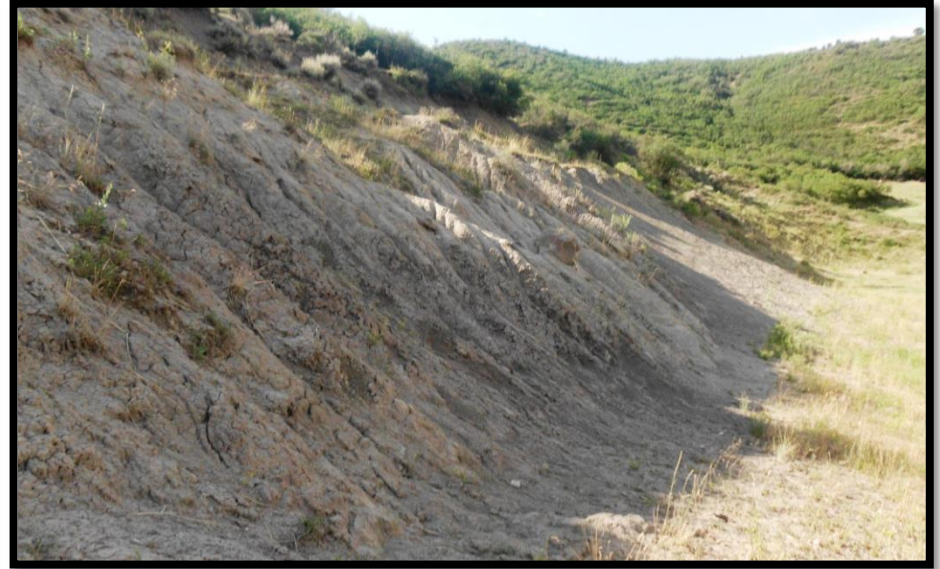
Viewing southeast: Rill formation along cut slope.

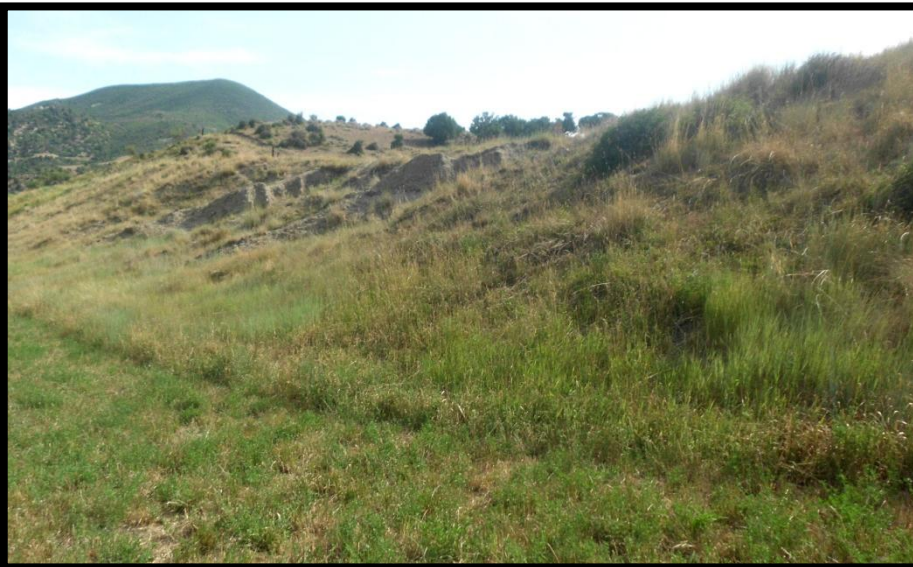
Viewing northeast: fill slope and adjacent irrigated lands.

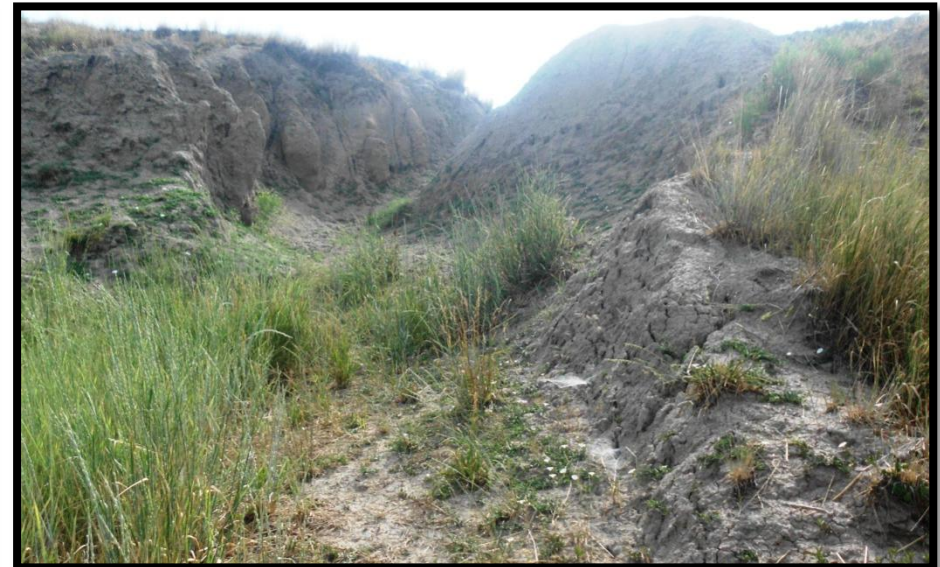
Viewing east: Large Gully wash that originated from top of fill slope.

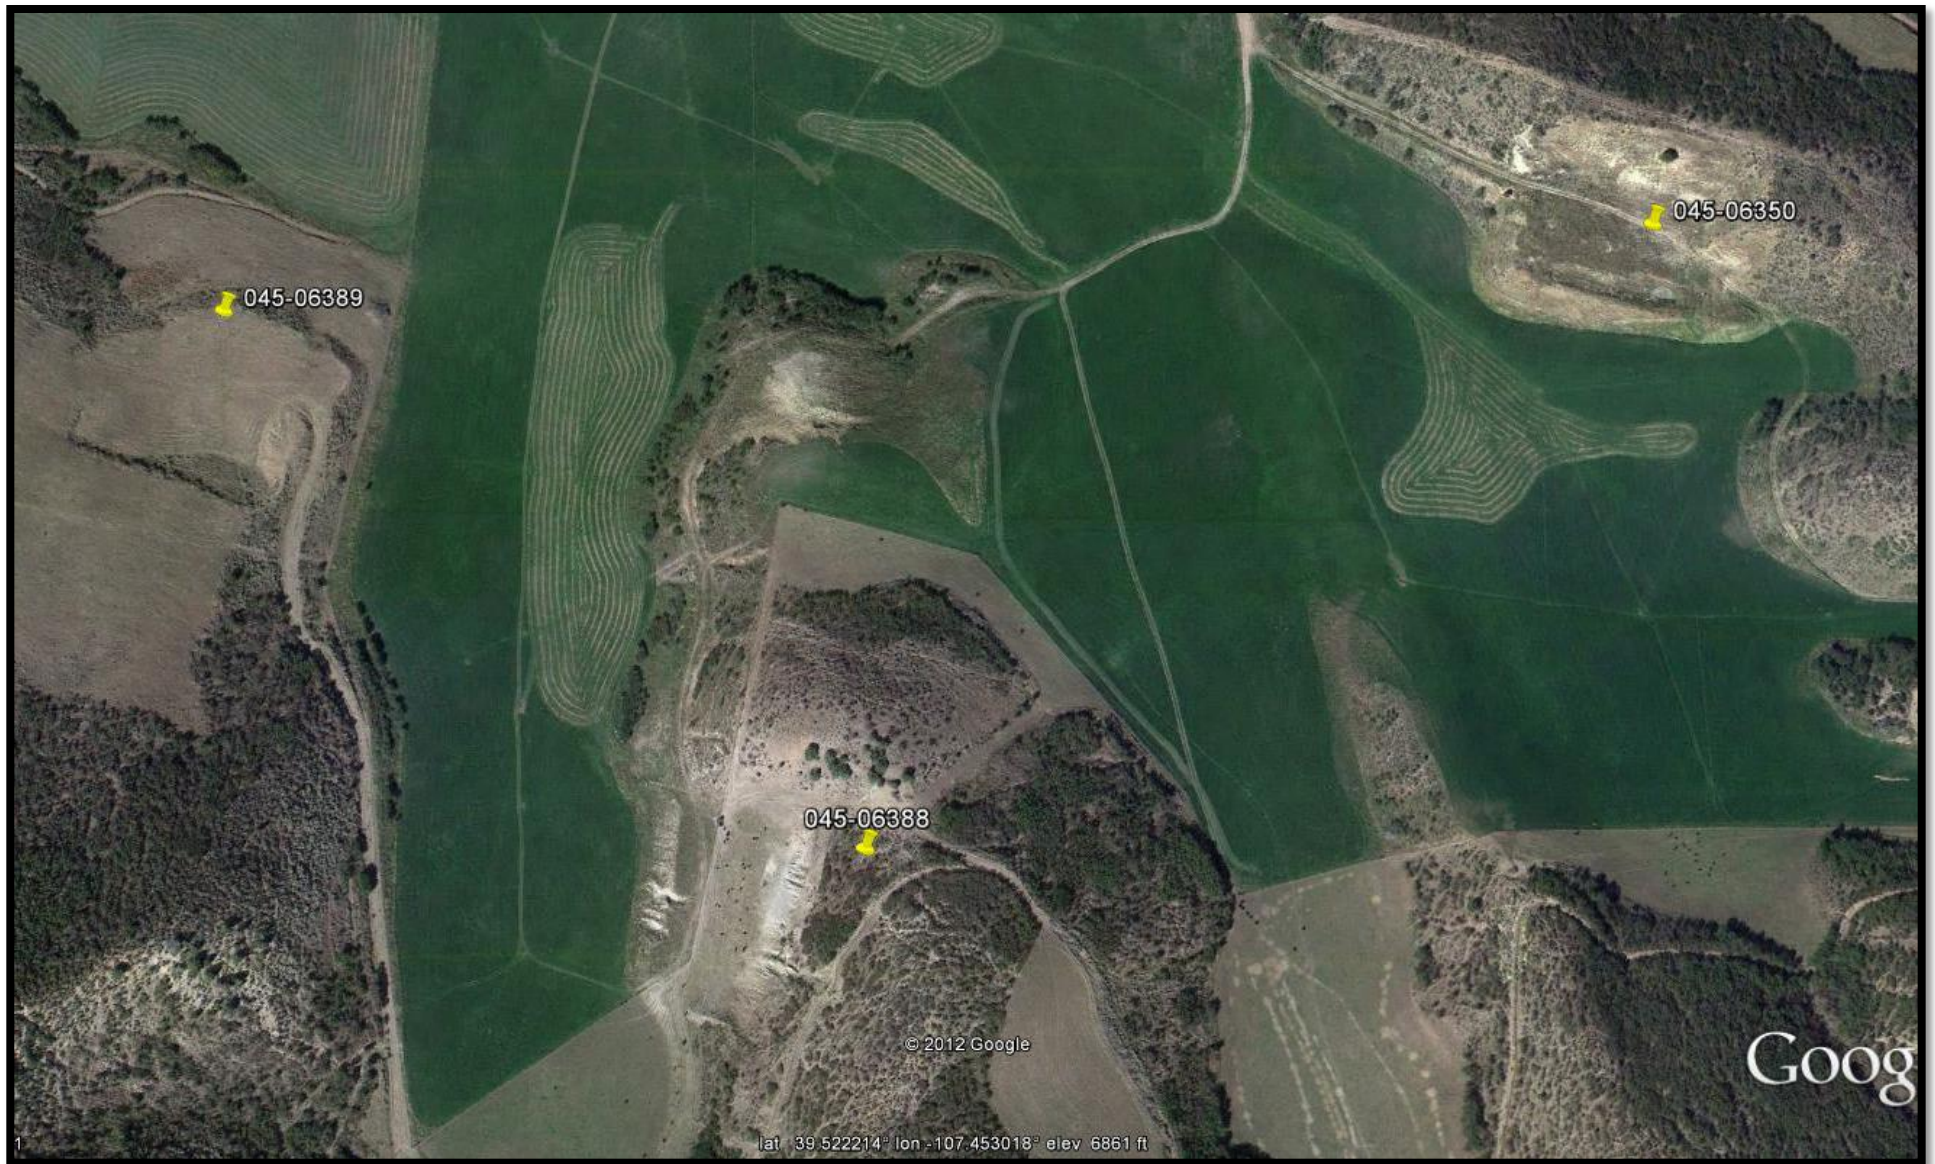
Google Maps Aerial Photo Date: September 22, 2011. View showing existing access roads and locations of two other un-reclaimed areas, (045-06389 & 045-06350).

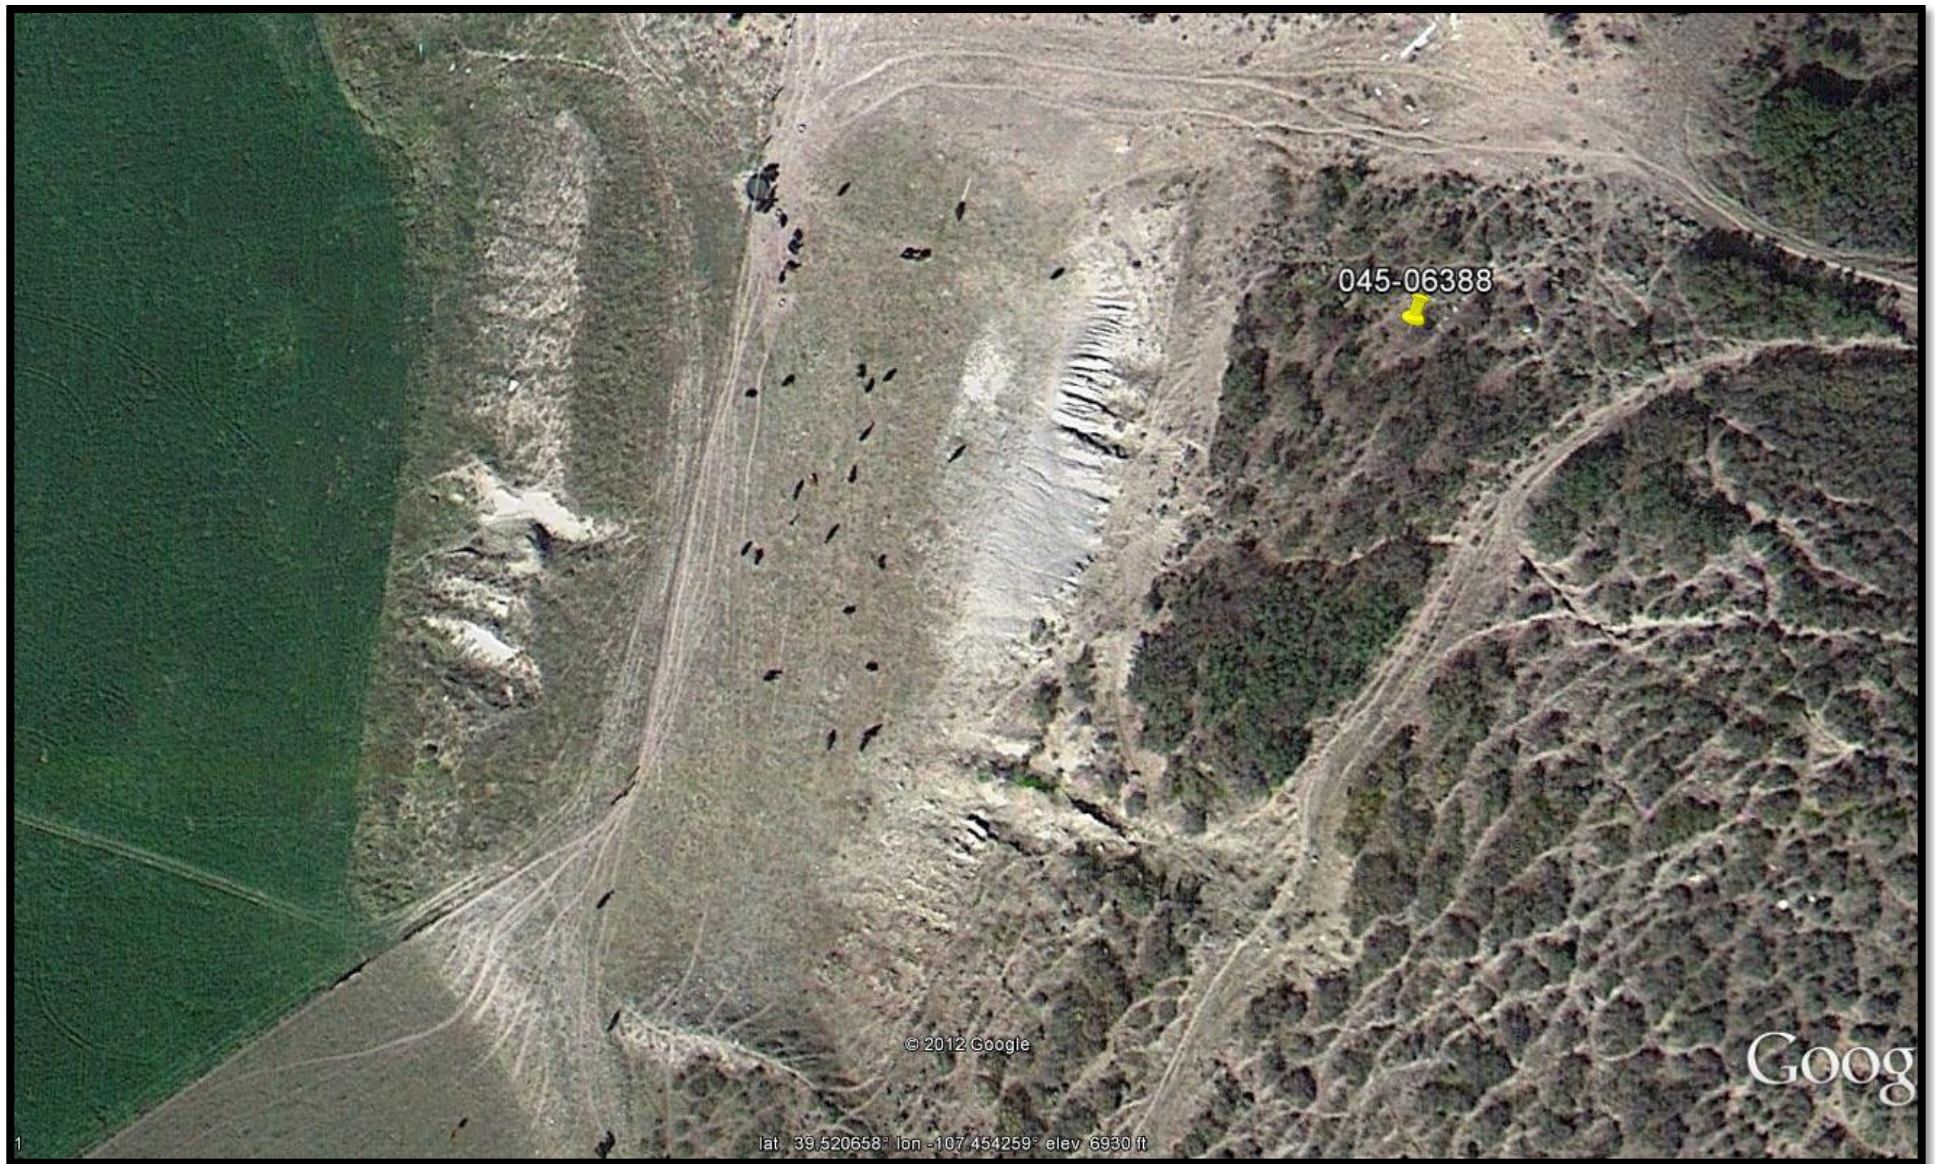
Google Maps Aerial Photo Date: September 22, 2011. Aerial view of the Snyder-Barton-Porter 2-21 location. Showing rills and gully on cut and fill slopes.

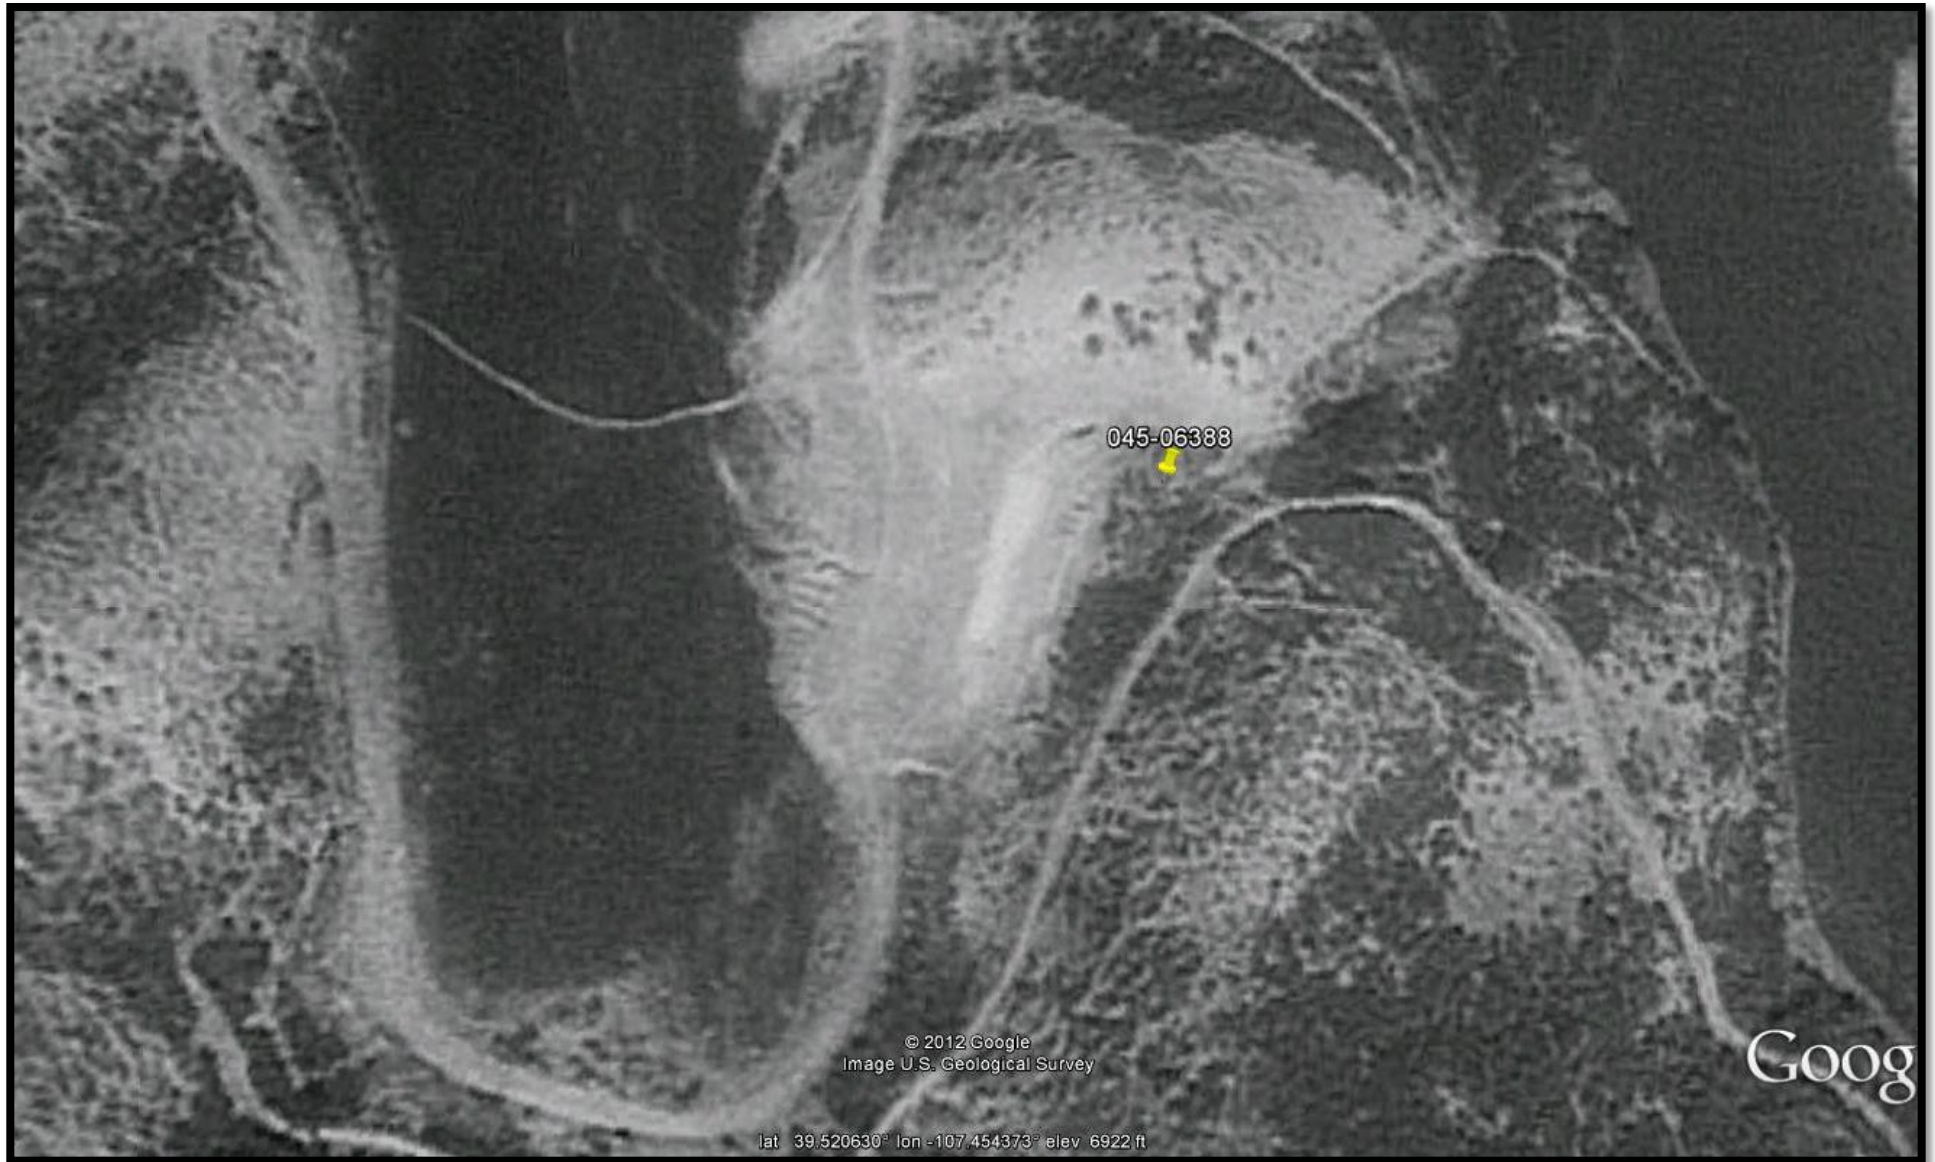
Google Maps Aerial Photo Date: September 02, 1993. Aerial view of Snyder Barton Porter 2-21 in 1993.
