July 17, 2012

Evaluation of Encana 12" Water Line or "CBM" – Poly Pipeline

Introduction:

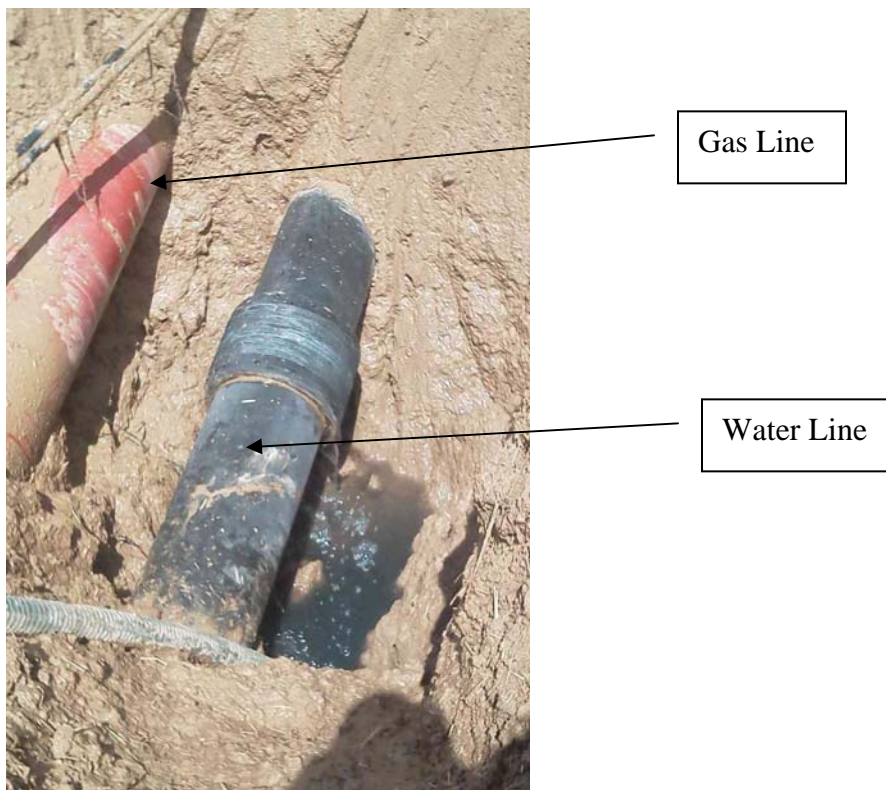
Fig 1

A failed coupling may have several possible factors for failure. Here is a picture of the failed coupling right after we exposed this area. (figure 1)

There is a gas gathering line and fiber-optic lines run in very close proximity to the water line. The evidence to evaluate proper backfill and soil conditions was lost in the result of the leak and the process of "pot hole" or "hydro-vac". This could be important if the coupling was put into a stress condition due to lack of support around this area.

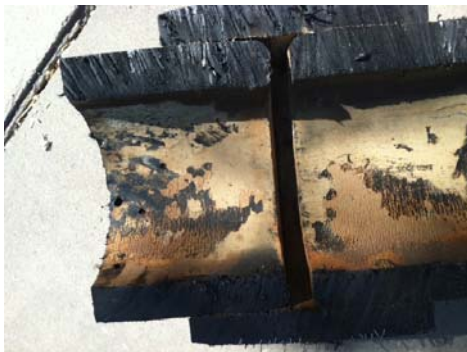
Fig 2 1" Gap on bottom

This evidence indicates improper installation of this coupling. A normal or proper connection should look like this. (figure 4)

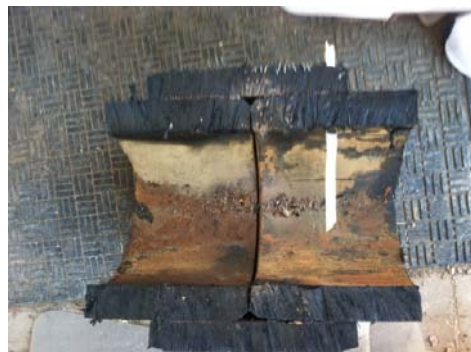
Fig 3 1/8" Gap on Top

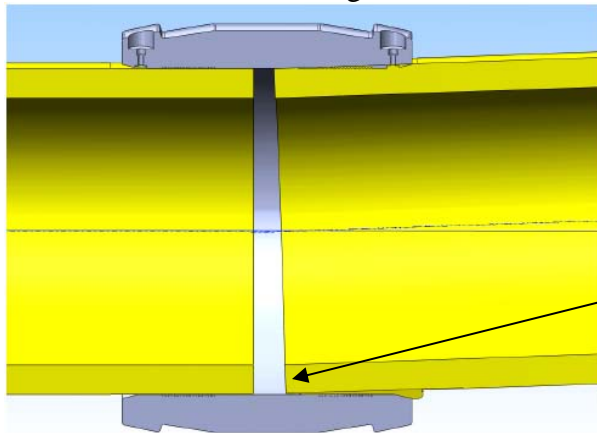
Fig 5

A connection that is misaligned will look like this (figure 5)

Increased Gap

Notice the larger gap on bottom

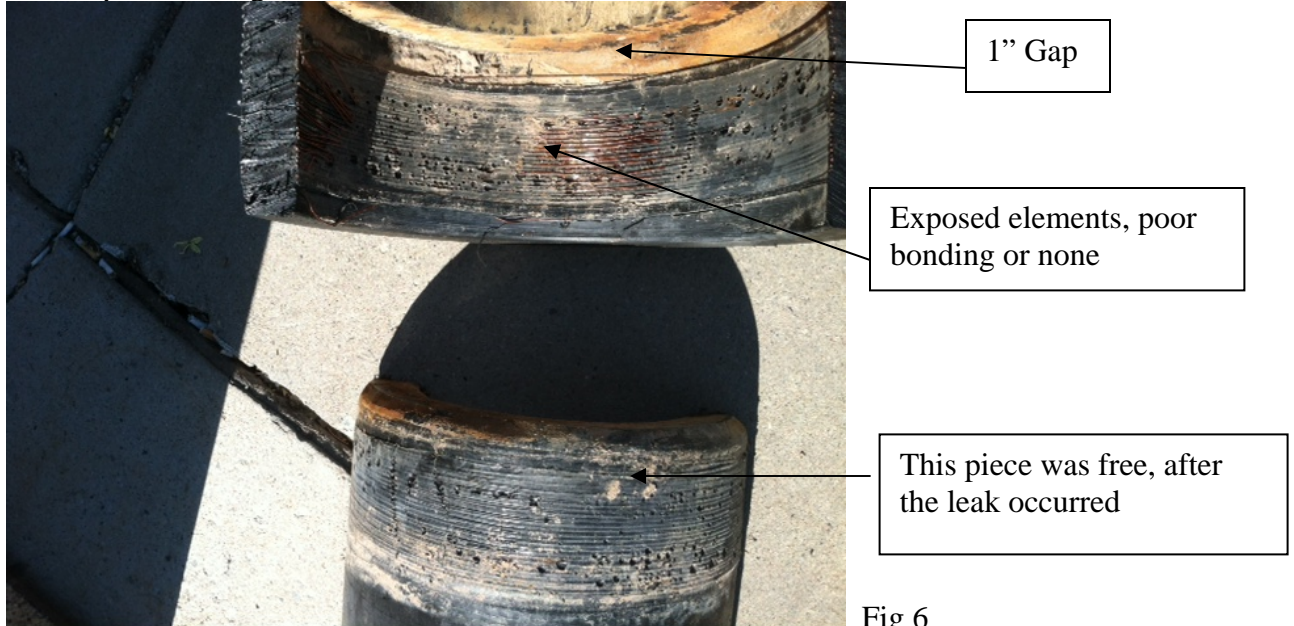
Other indications of this coupling failure was the lack of 100% bonding found in the coupling. (figure 6, 7)

Close up of bonding area – failure occurred in this section

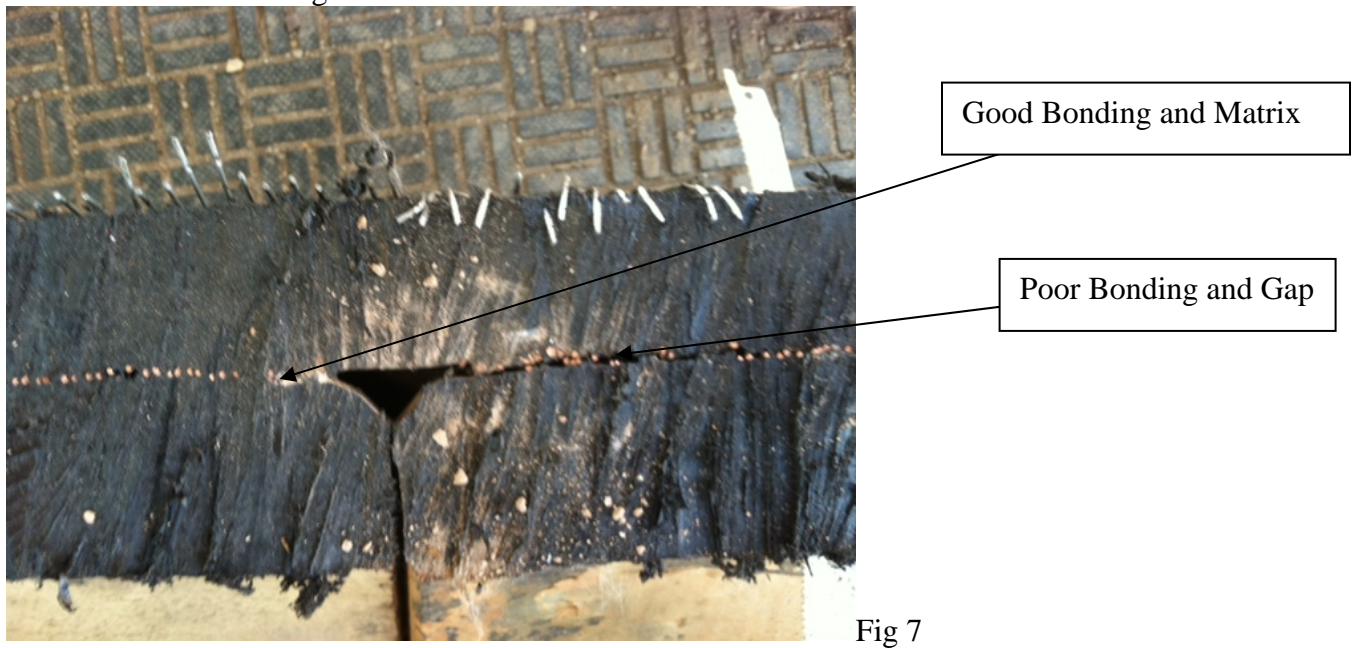
Cross-section of bonding

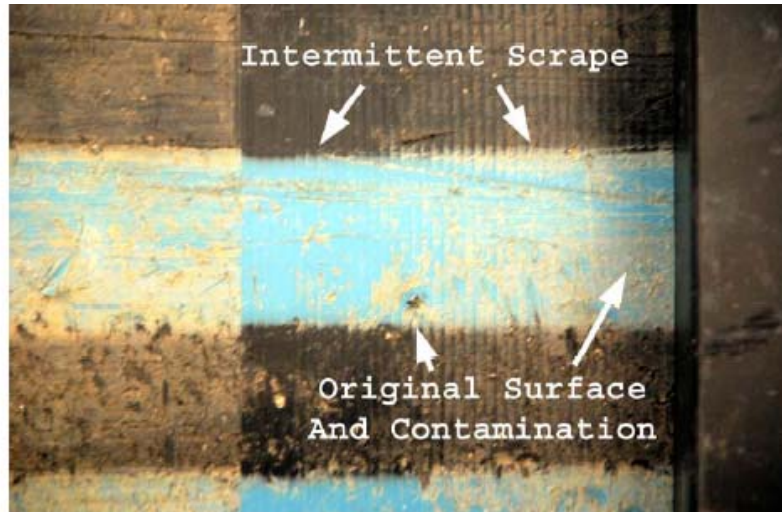
Fig 8

Here is an example of poor bonding from the Plastics Institute. This is very similar to what is seen in the coupling that failed.

Poor Scrape Unacceptable

Possible Causes: Incorrect Scraper, Poorly Maintained Scraper. Inadequate Number of Passed With Scraper, and Ineffective evaluation of Scraping

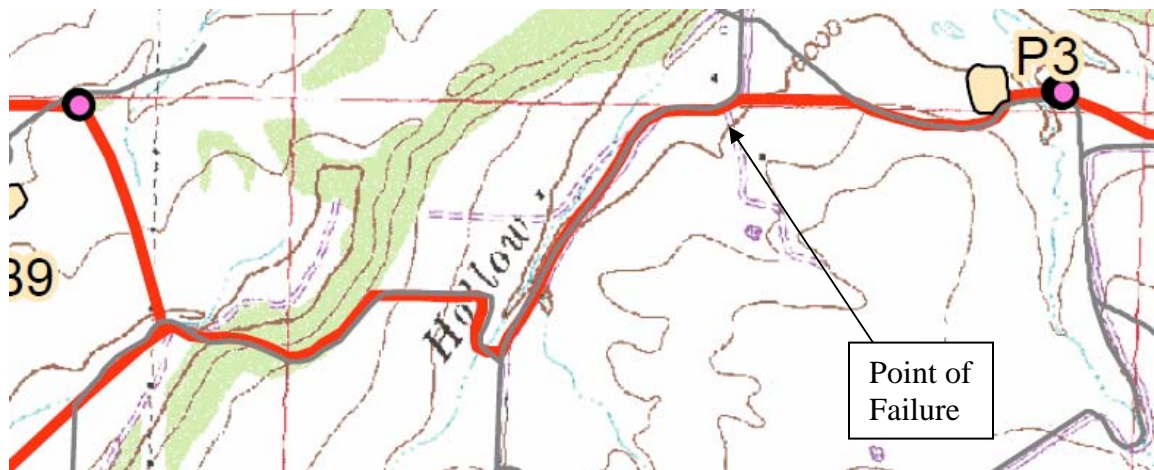
Fig 9

Map of the pipeline – Area with "Electro-Fusion" Couplings

From "pink dot to pink dot" Is the – 12" Poly pipeline
 Recommend that this section is replaced with steel or
 Upgrade the couplings

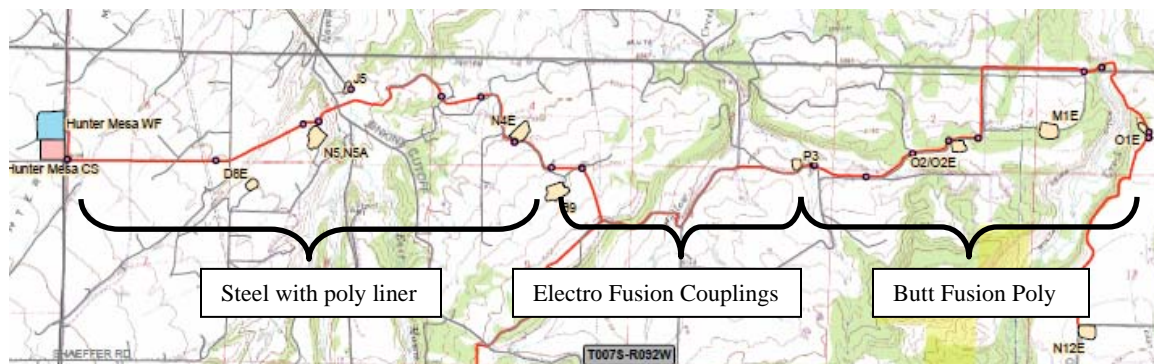
Fig 10

In the map of the entire water pipeline (figure 10), there is three different types of construction and pipe. The weakest section is in the middle or the Electro Fusion Couplings. The material used and confirmed in the removal of the failed coupling is stamped with a 200 psi rating. The rating of the 12" SDR 7 poly pipe used is a calculated number, but for this installation the design was for 250 psi. The area shown in figure 10 that says "Butt Fusion" is an expression for poly pipe that fused together end to end. This type of connection has the same properties of the pipe so the maximum internal pressure is the same of 250 psi. this would yield a higher rating than the area that has the electro-fusion couplings.

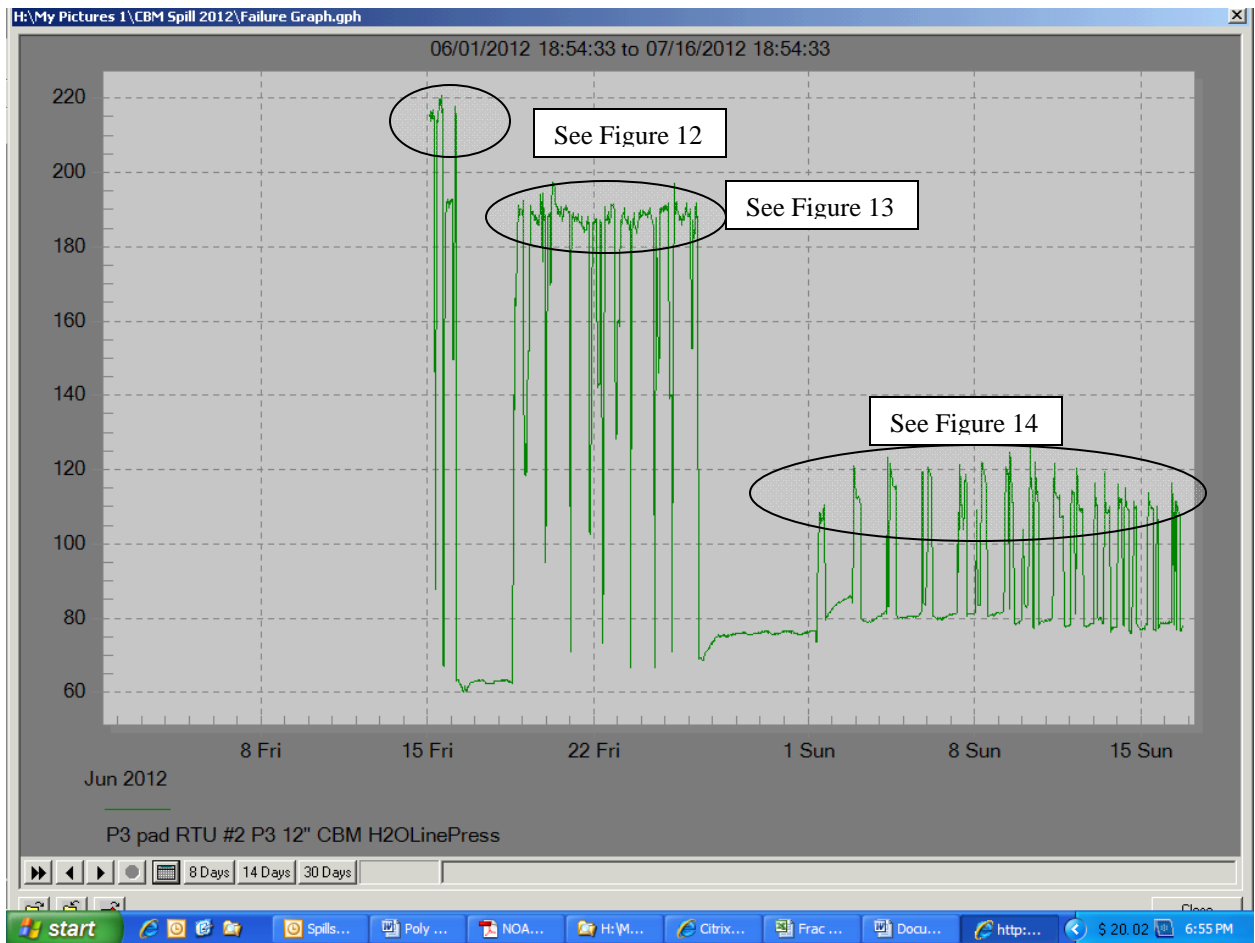
Fig 11

Chart of pressure at the "P3" point (see figure 9)

This chart shows the various operating conditions (pressure) at the closest point to the failure in the line. Next figures will look at the various operations in greater detail.

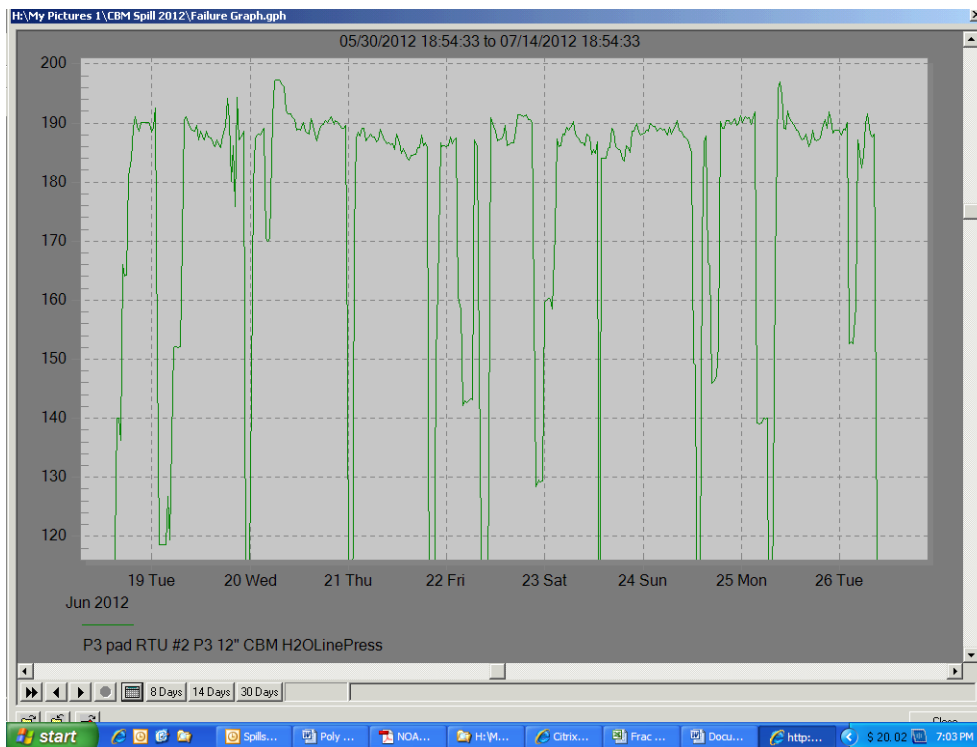
Fig 13

Resume operations after repairs – Finish Frac Operations on F12E

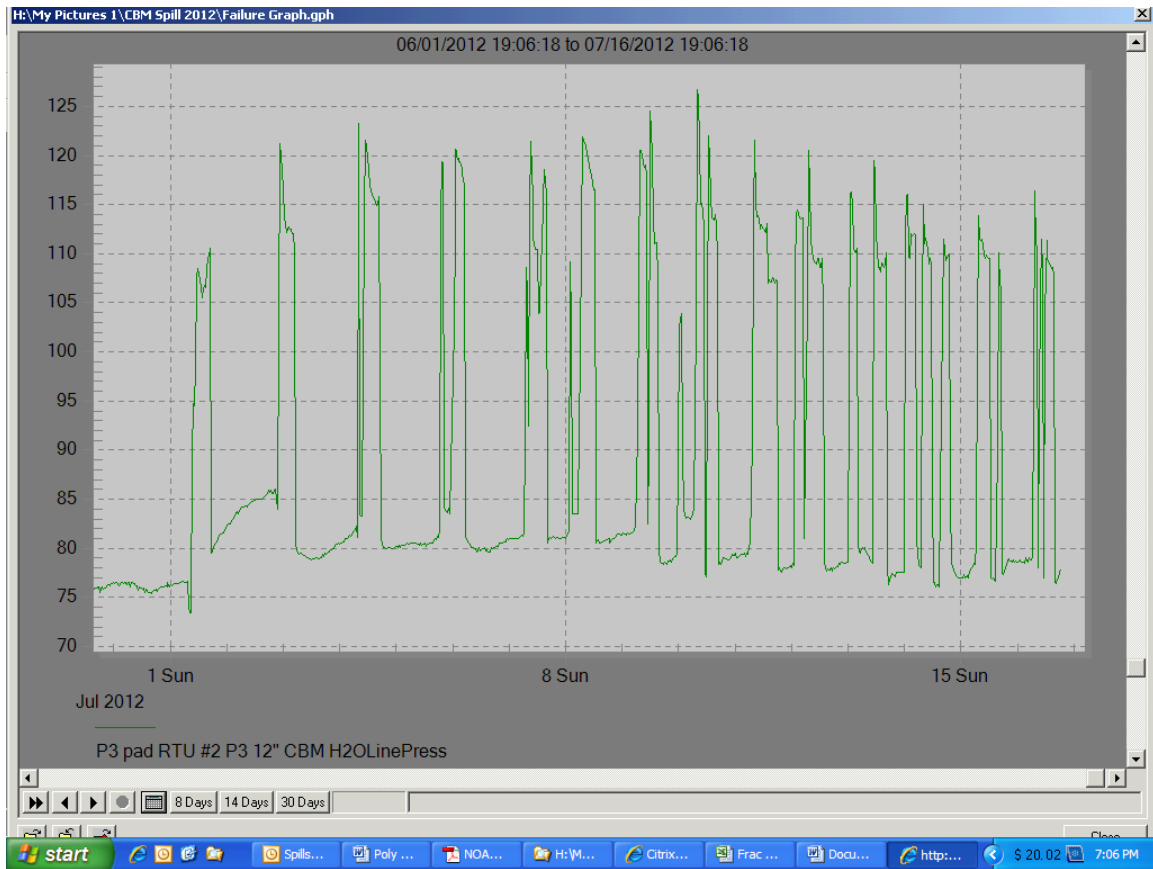
Fig 14

Chart of pressure to pump water back to Hunter Mesa
