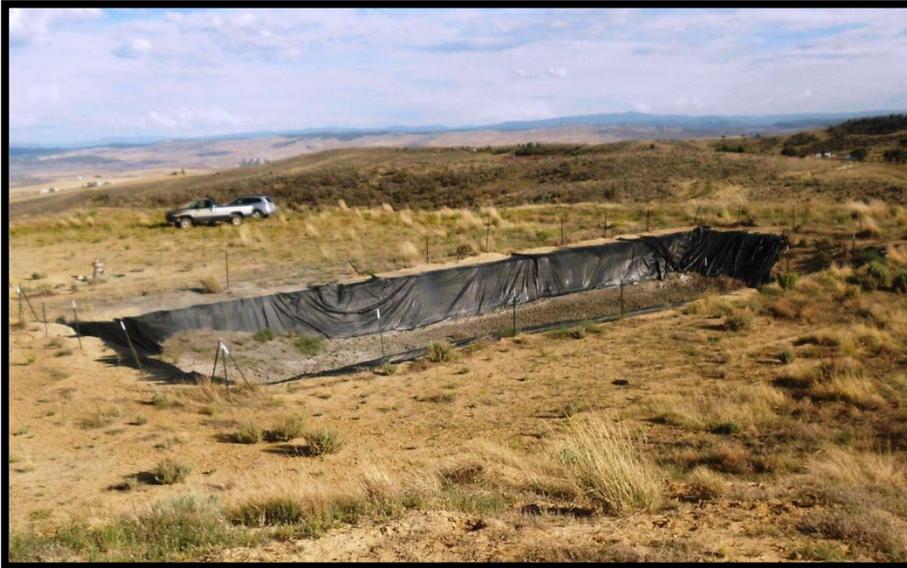
Viewing Southeast: well location with un-reclaimed drill cuttings pit & TA wellhead, (left in photo)

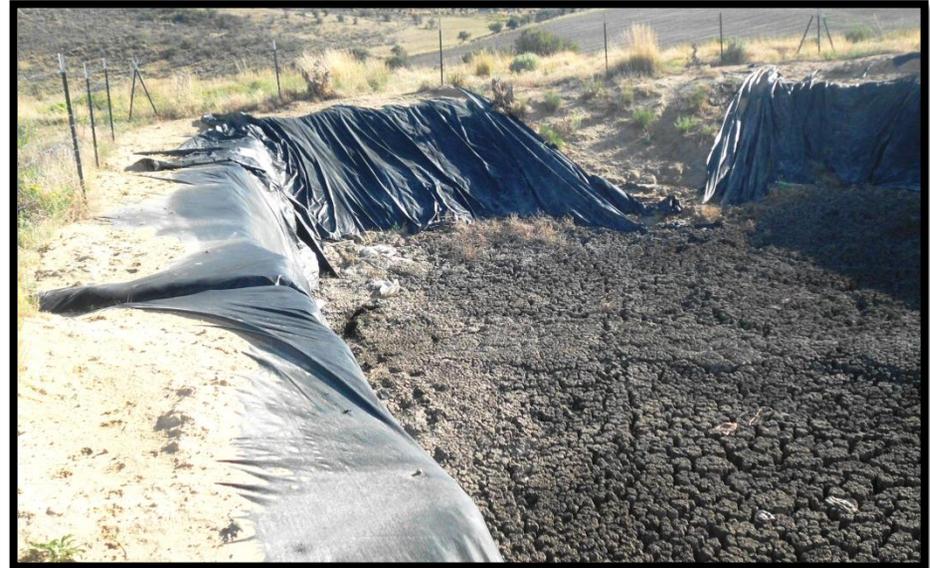
Viewing South: contents of pit & liner condition, which is dilapidated and sagging. Fencing in disrepair.

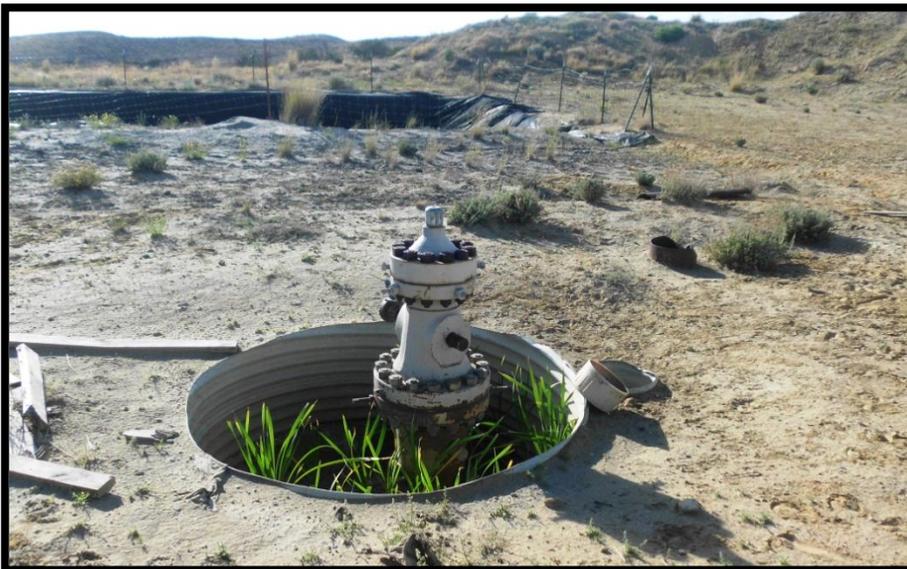
Temporarily abandoned wellhead, cellar & rathole.

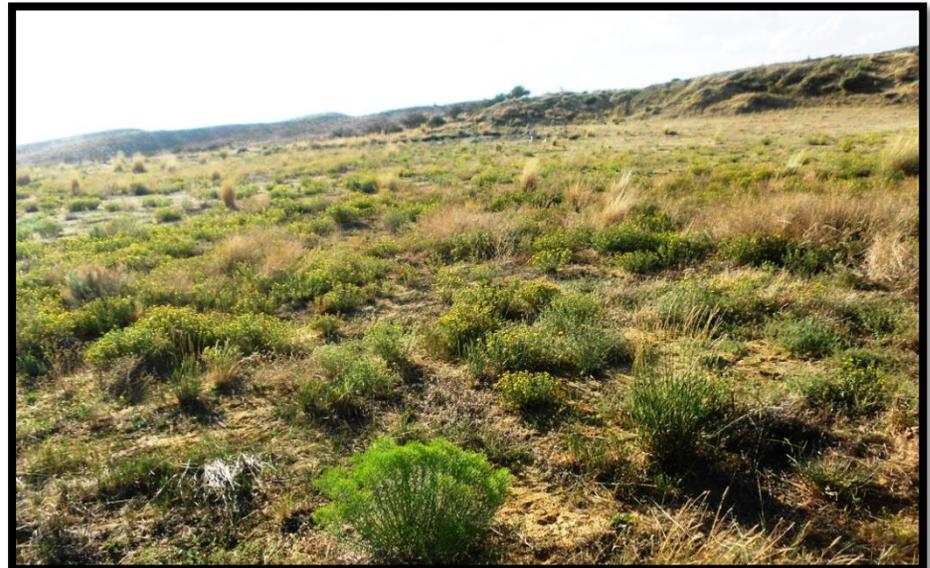
Viewing west: well pad location, general vegetation type & density, & excavated spoils pile bermed to the north & northwest

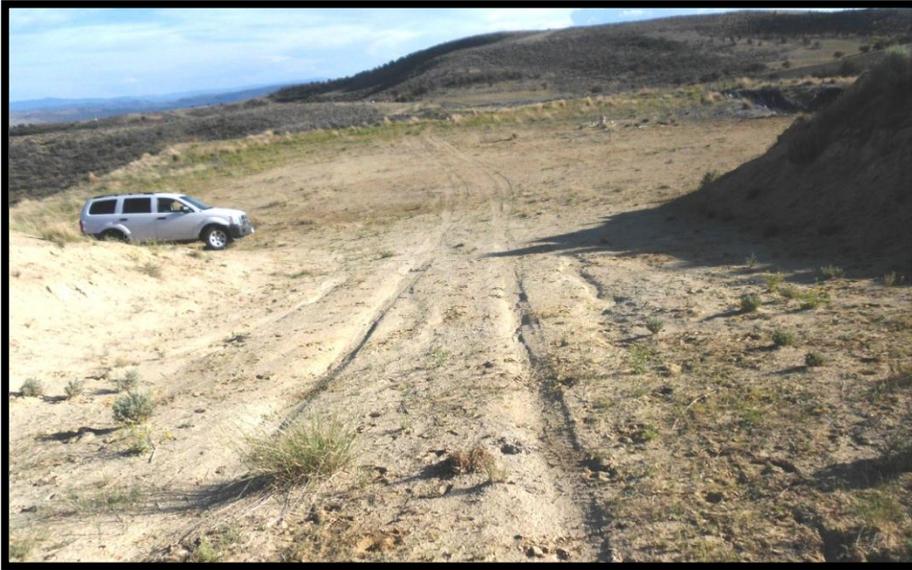
Southern view of location, (spoils pile to the right.)

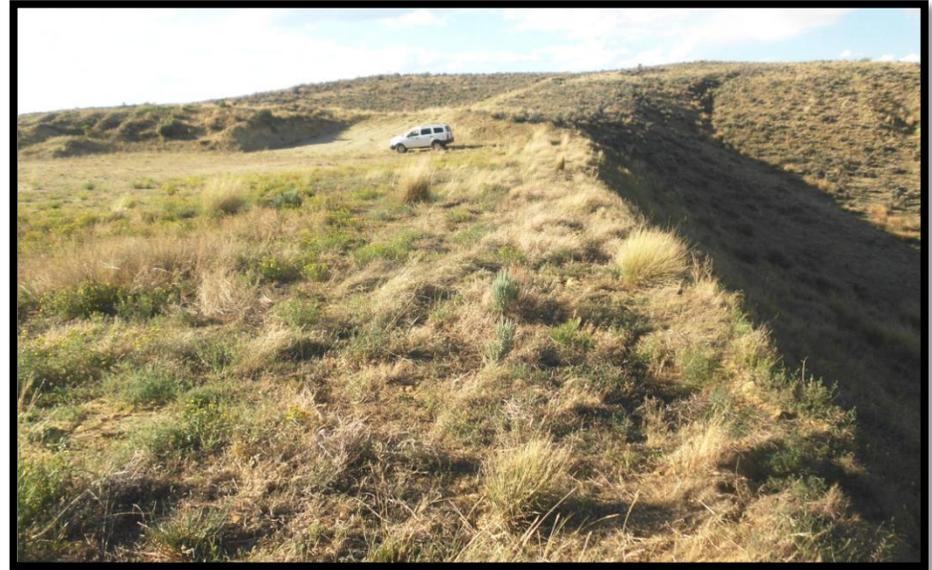
Viewing northerly, eastern portion of location

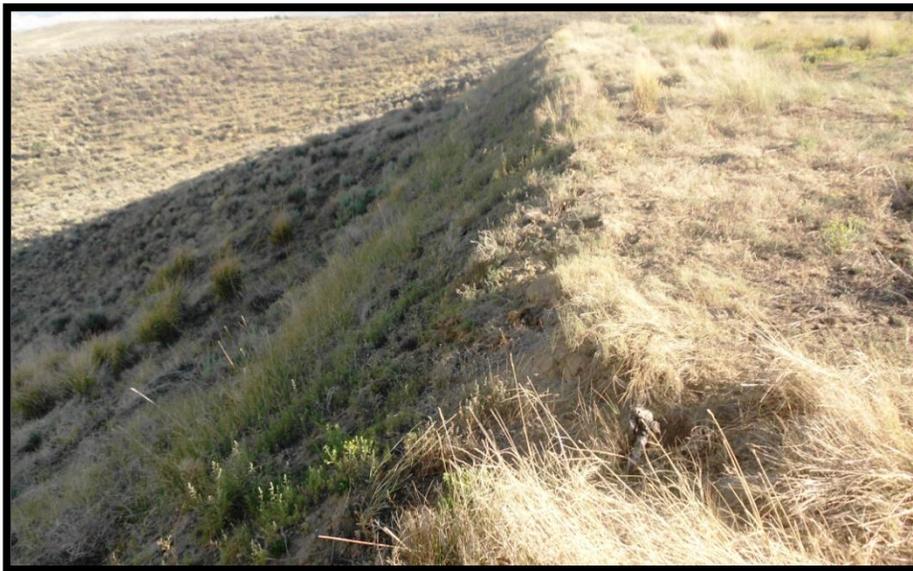
Viewing south along the eastern perimeter berm: localized erosion channels: even though they are well vegetated & appear stable.

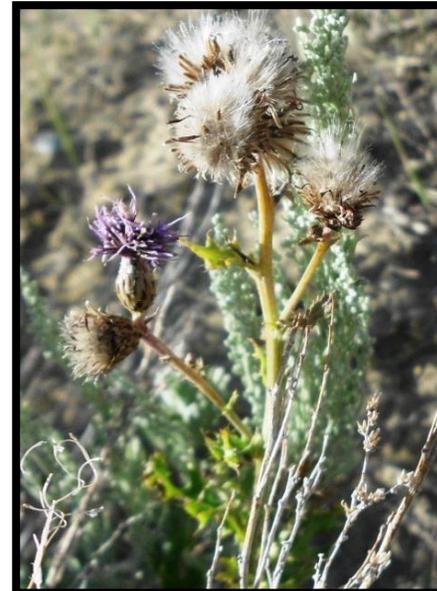
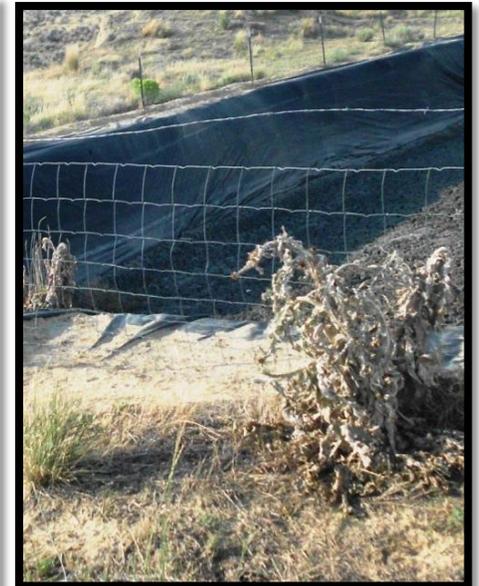
Class B Noxious weeds: Upper left: Spotted Knapweed, right: bull thistle.

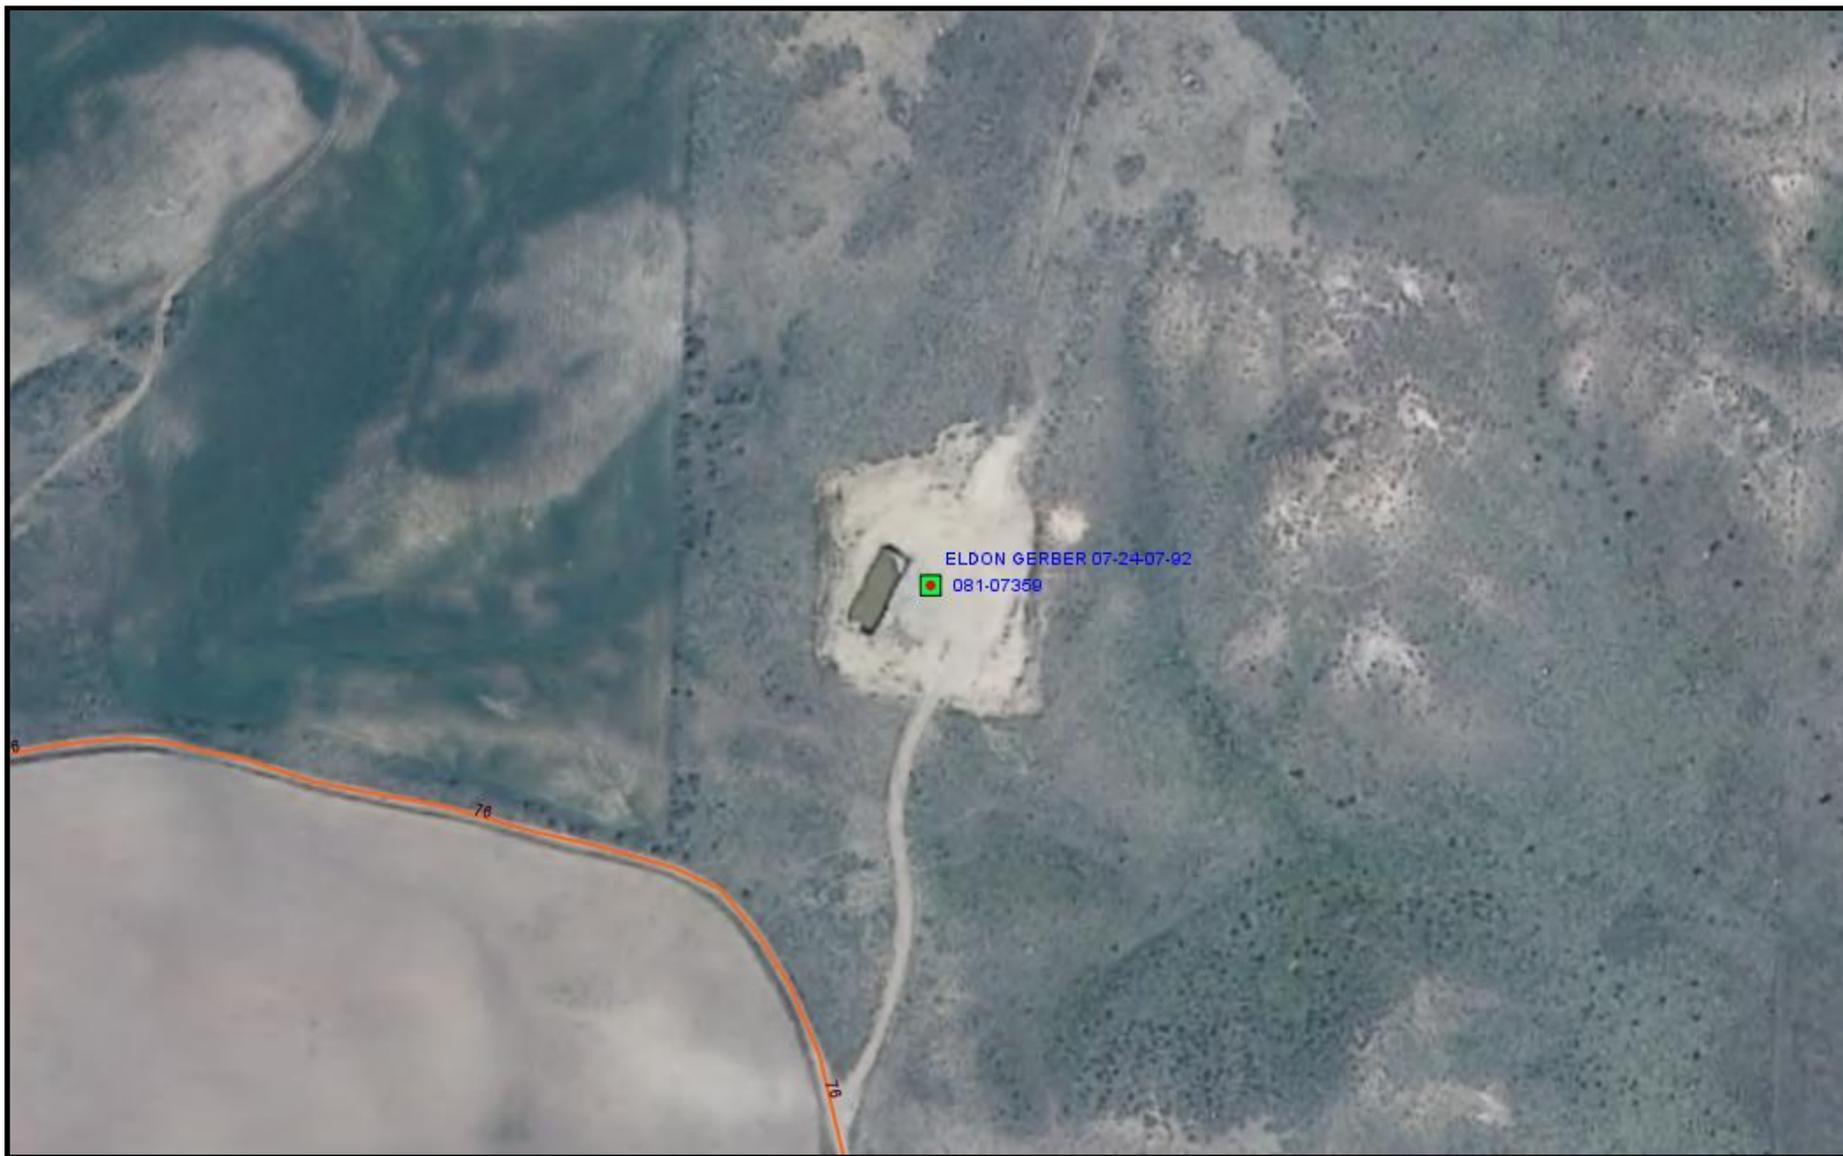
COGS GIS Online 2009 Aerial photo. Well pad, drill pit and access road.

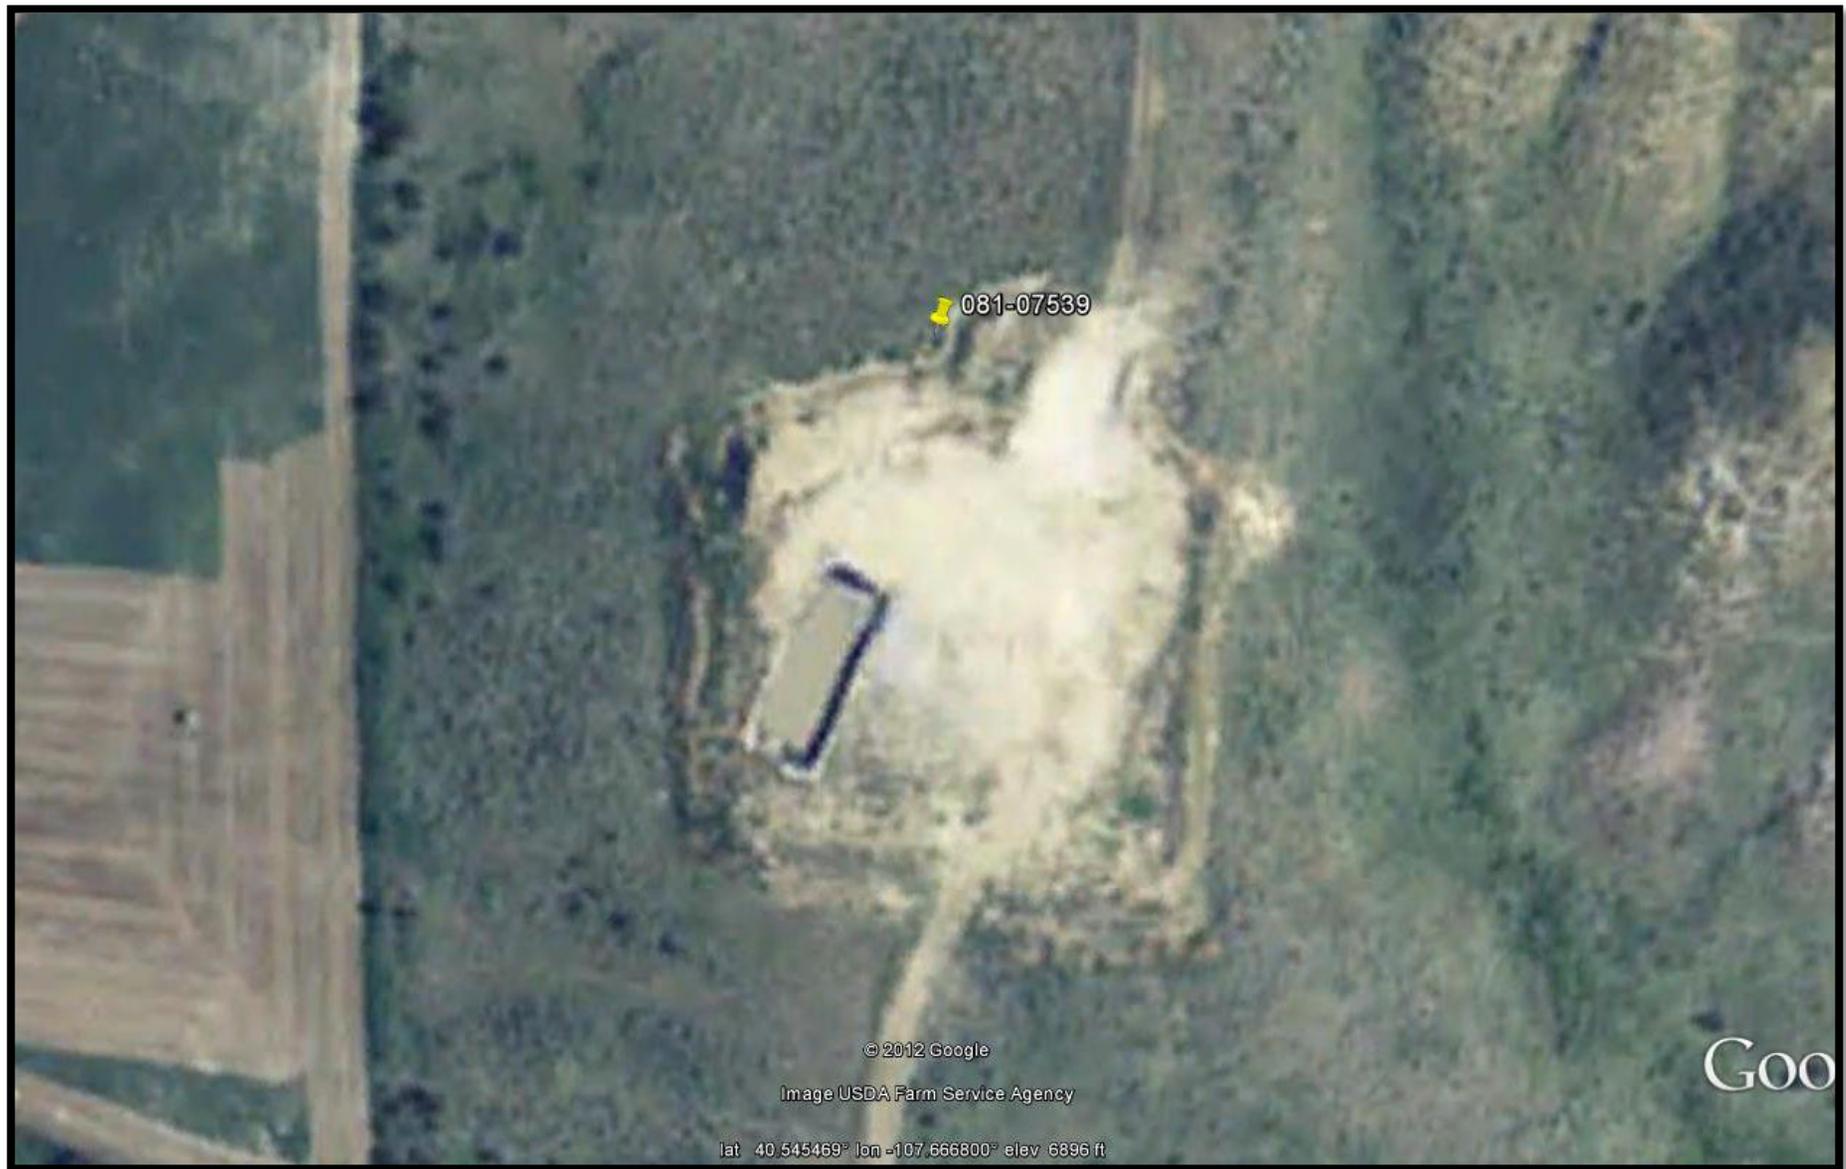
Google Maps Aerial Photo Date August 2011: well pad location & drill pit.
