**Morgan Creek Fee #1-43 Matagorda Production Co. API #081-07116**

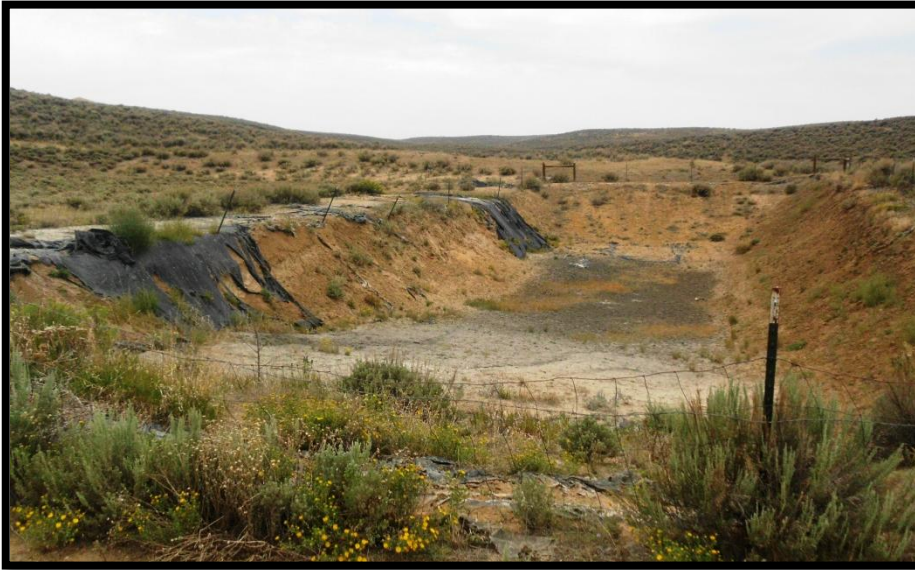
Viewing northwest: drill pit conditions & contents

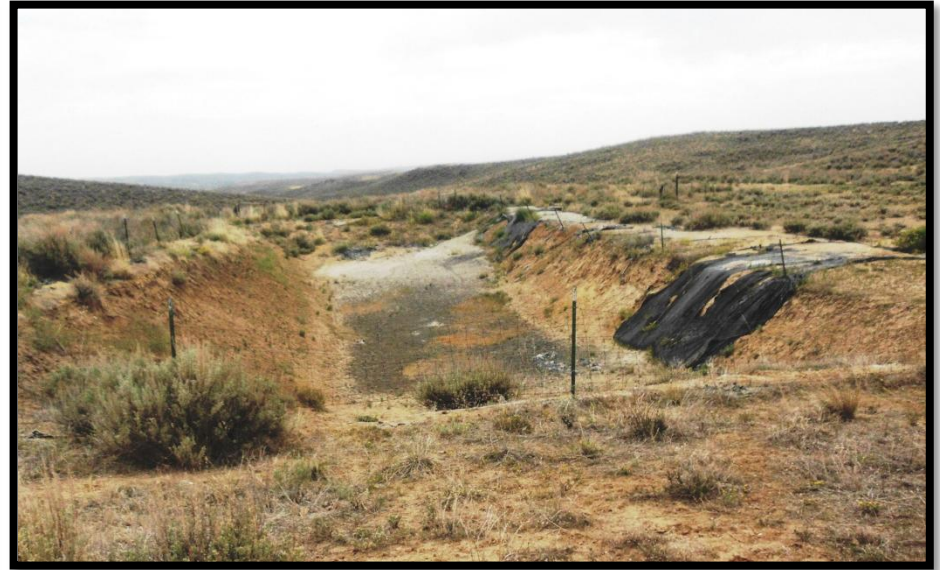
Viewing Southeast: drill pit, lining & fencing conditions

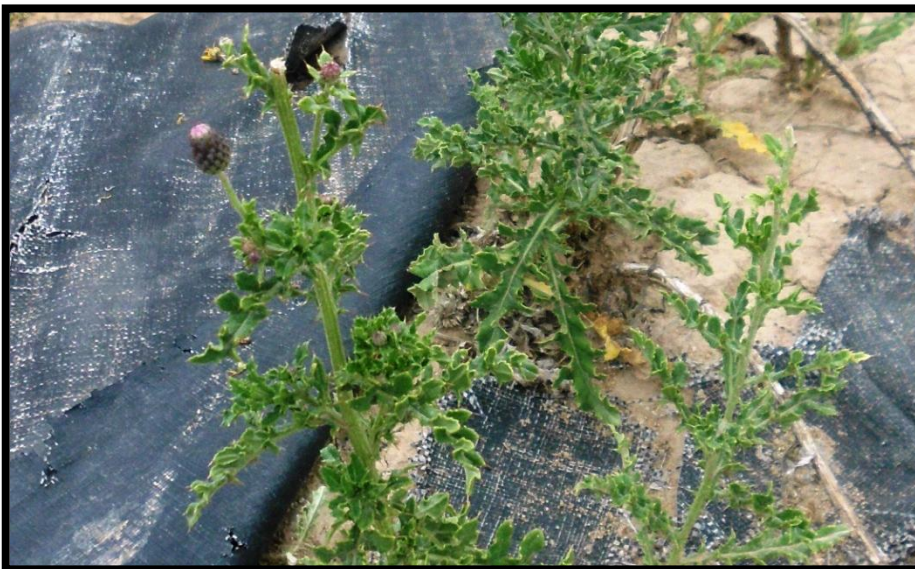
Appears to be Canadian Thistle. (Note infestation of Bull Thistle throughout. Both are B-List Noxious weeds

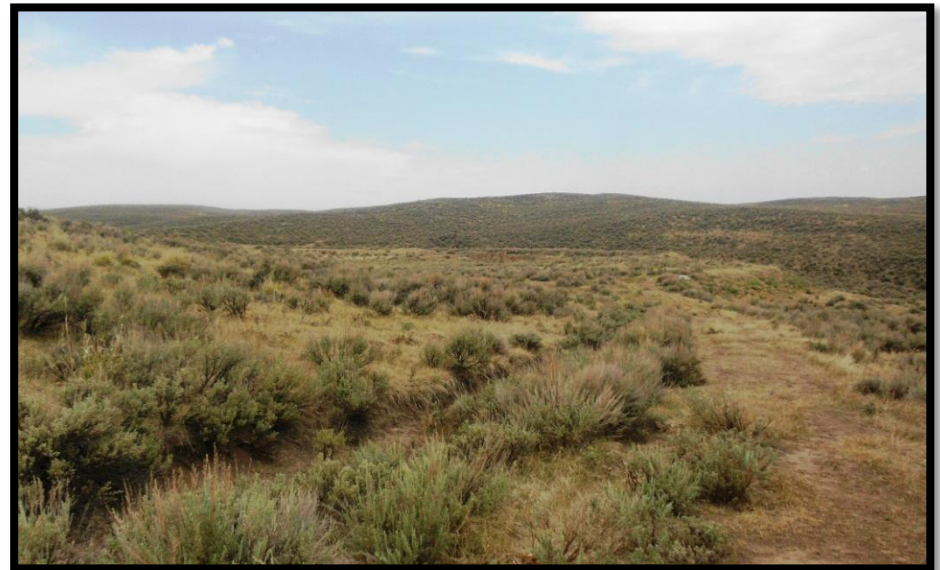
Viewing North: lease access road to location, which is a two-track primitive road.

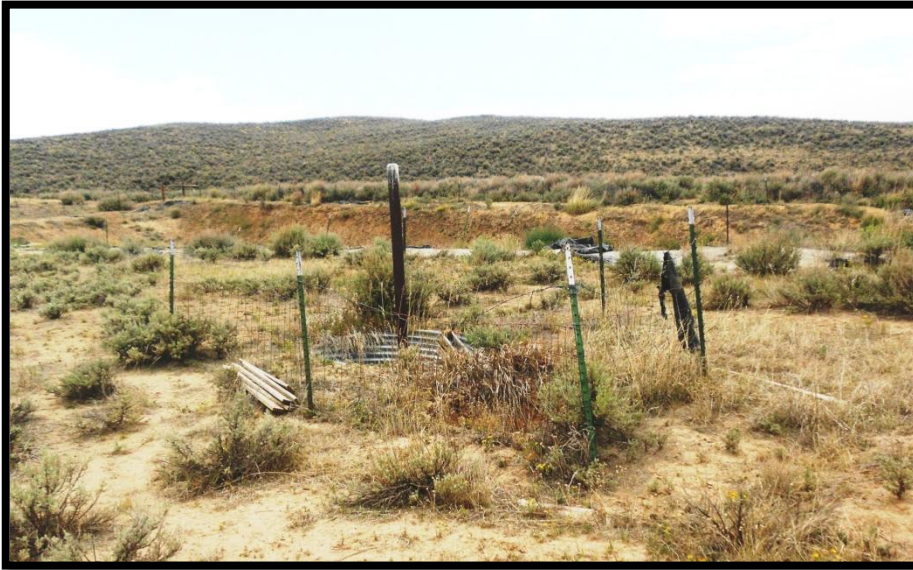
Viewing North. D&A well marker, cellar ring, and two open boreholes, (hidden from this view). Reserve pit in background

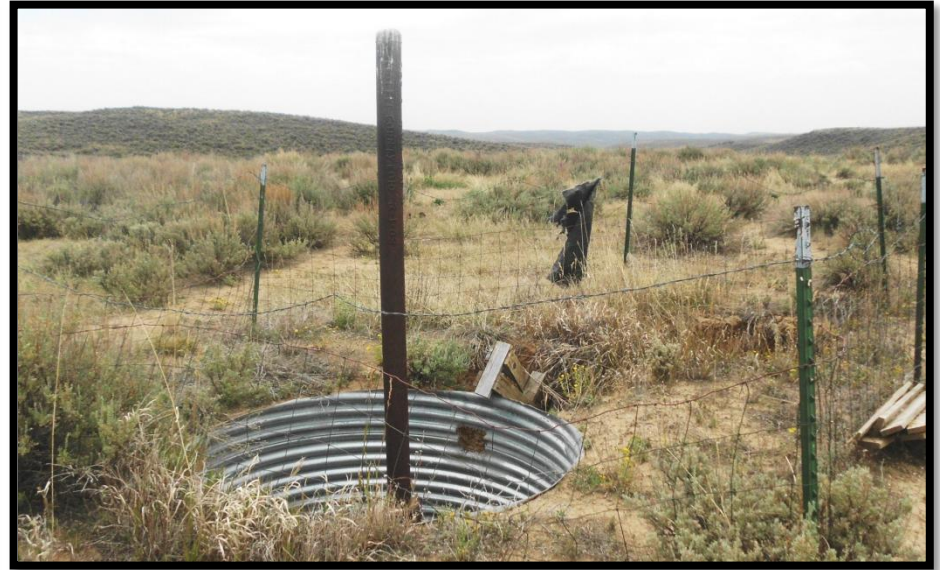
Eastern view of D&A well marker, cellar, fencing & lumber, "debris" near the borehole entrances.

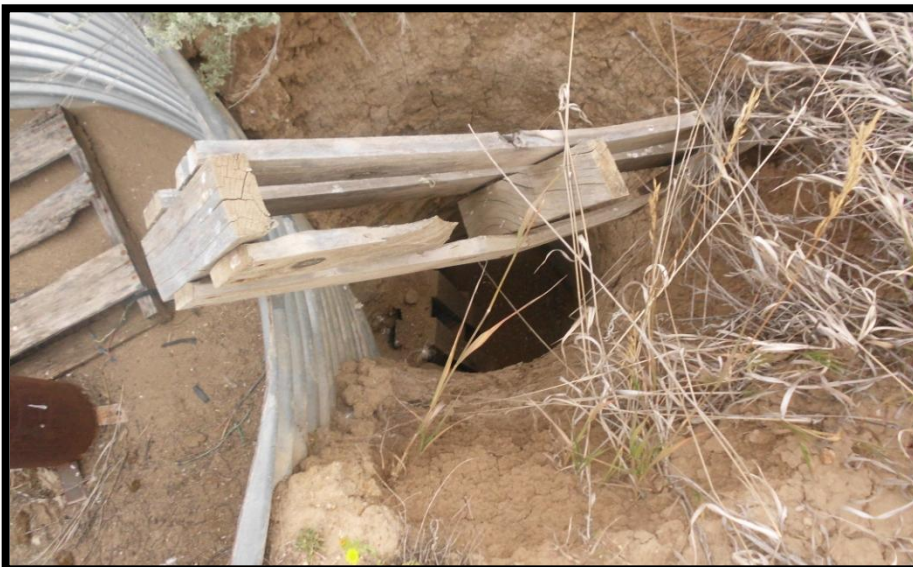
Partially caved-in (filled) rathole.

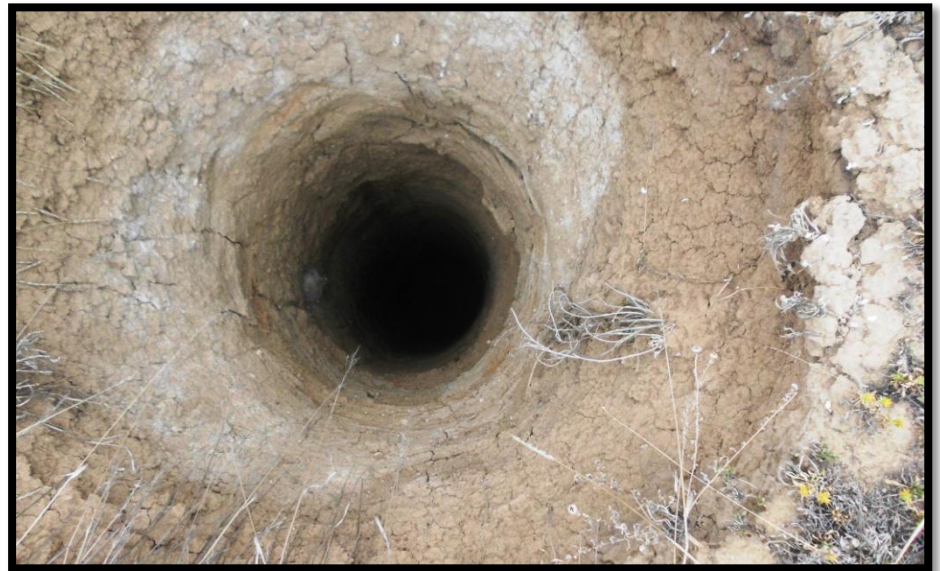
>2' dia. open borehole, estimated at approx. 20'. No groundwater or fluid was observed in the borehole @ the time of inspection.
