July 17, 2012

## Evaluation of Encana 12" Water Line or "CBM" – Poly Pipeline

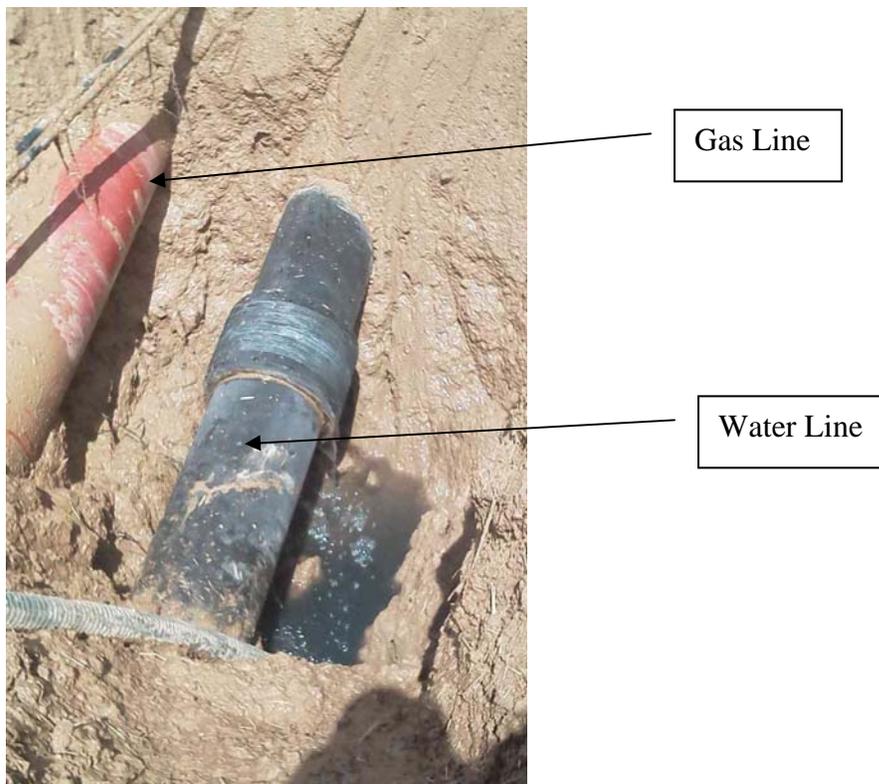
Fig 1

A failed coupling may have several possible factors for failure. Here is a picture of the failed coupling right after we exposed this area. (figure 1)

There is a gas gathering line and fiber-optic lines run in very close proximity to the water line. The evidence to evaluate proper backfill and soil conditions was lost in the result of the leak and the process of "pot hole" or "hydro-vac". This could be important if the coupling was put into a stress condition due to lack of support around this area.

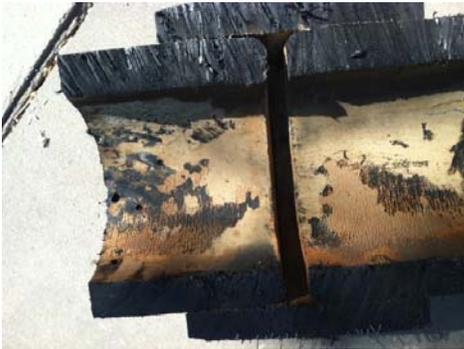
Fig 2 1" Gap on bottom

This evidence indicates improper installation of this coupling. A normal or proper connection should look like this. (figure 4)

Per our earlier conversation regarding the Electro Fusion coupler failures. After looking at these pictures all indication are directed at improper installation of these fittings. It appears that the pipe O.D. was not properly prepared and shows signs of contamination this contamination was also evident in the coupler.

It appears that the coupling was not put on the end of the pipe square this would account for the deviation in the center of the fitting. In other words the pipe was put in on one end at an angle which is improper. The pipe should have been marked to prevent this from Happening. Dale Electro Fuse couplers are rated for 200 PSI especially 6-8 years ago. To sum it up the failure was most likely caused from improper installation.

Replacement of the "Electro-Fusion" couplings will be required for future use, which is close to the limits of the poly section of this line. Until this is completed a reduced Maximum Allowable Operating Pressure (MAOP) for this line will be used. The couplings are rated to 200 psi, and will be kept at or below 150 psi in the area with the electro-fusion couplings.

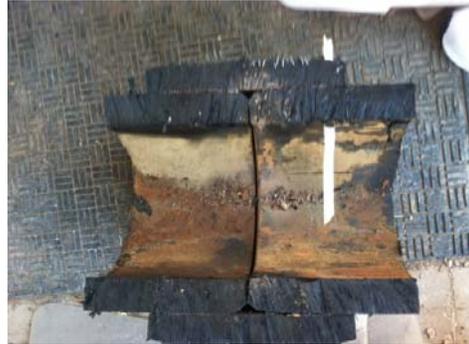
Fig 3 1/8" Gap on Top

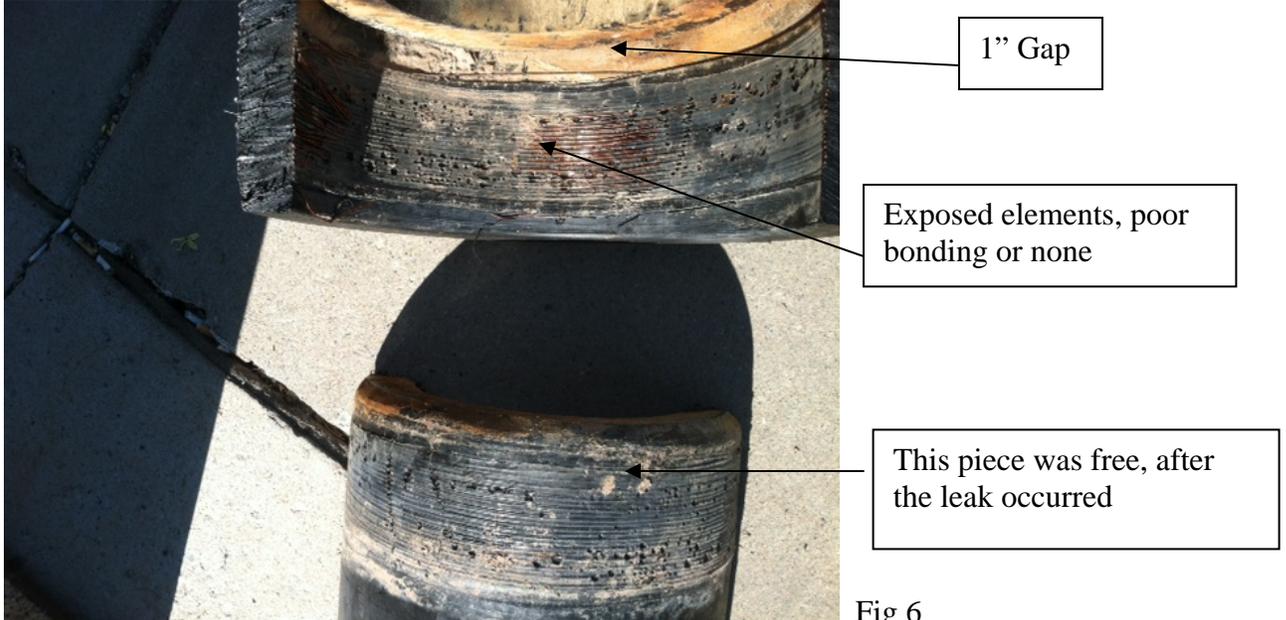
Fig 6

Other indications of this coupling failure was the lack of 100% bonding found in the coupling. (figure 6, 7)

Close up of bonding area – failure occurred in this section

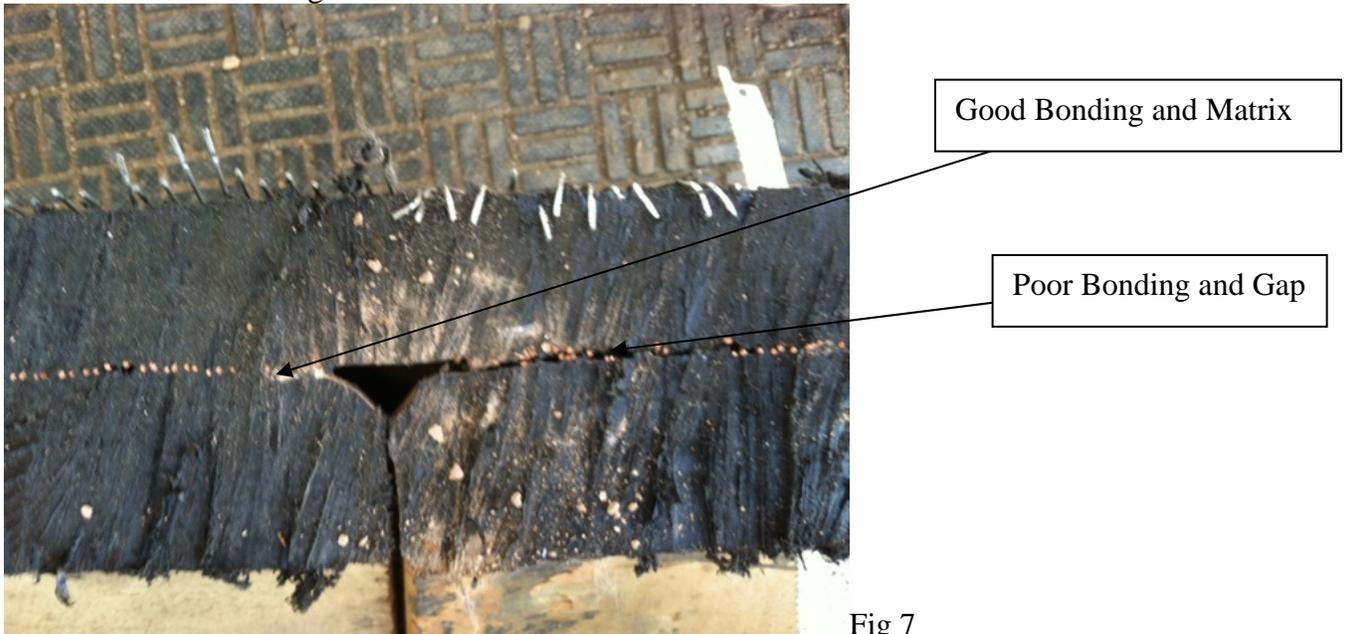
Fig 7

Cross-section of bonding

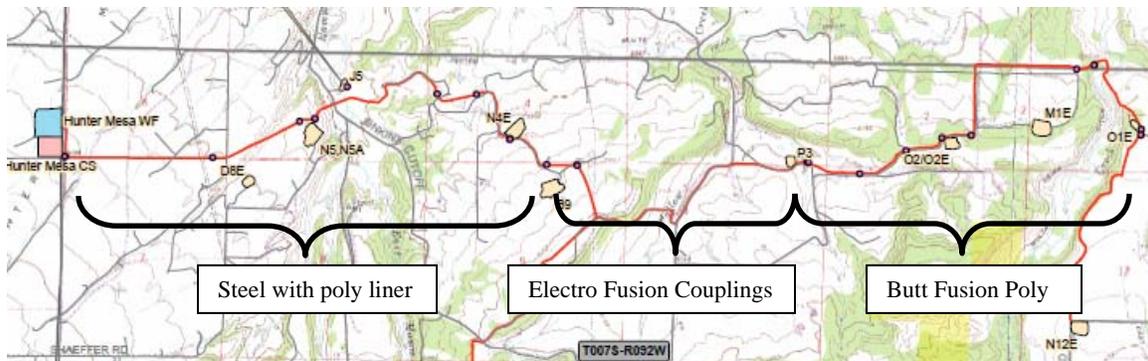
Fig 10

In the map of the entire water pipeline (figure 10), there is three different types of construction and pipe. The weakest section is in the middle or the Electro Fusion Couplings. The material used and confirmed in the removal of the failed coupling is stamped with a 200 psi rating. The rating of the 12" SDR 7 poly pipe used is a calculated number, but for this installation the design was for 250 psi. The area shown in figure 10 that says "Butt Fusion" is an expression for poly pipe that fused together end to end. This type of connection has the same properties of the pipe so the maximum internal pressure is the same of 250 psi. this would yield a higher rating than the area that has the electro-fusion couplings.

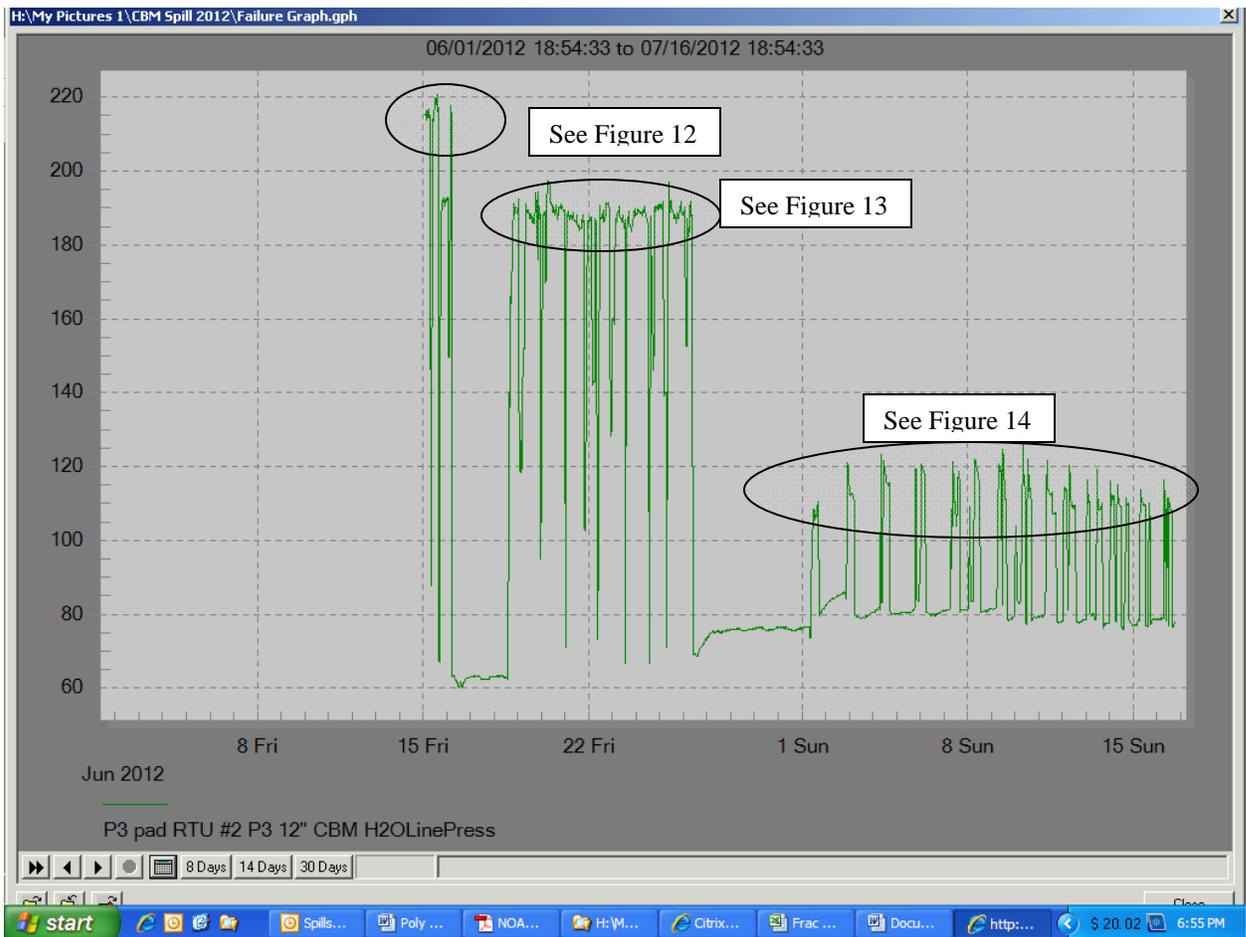
Fig 11

Chart of pressure at the "P3" point (see figure 9)

This chart shows the various operating conditions (pressure) at the closest point to the failure in the line. Next figures will look at the various operations in greater detail.
