Parachute Valley Gathering System Release, Project #2120

Date: 03-19-2013

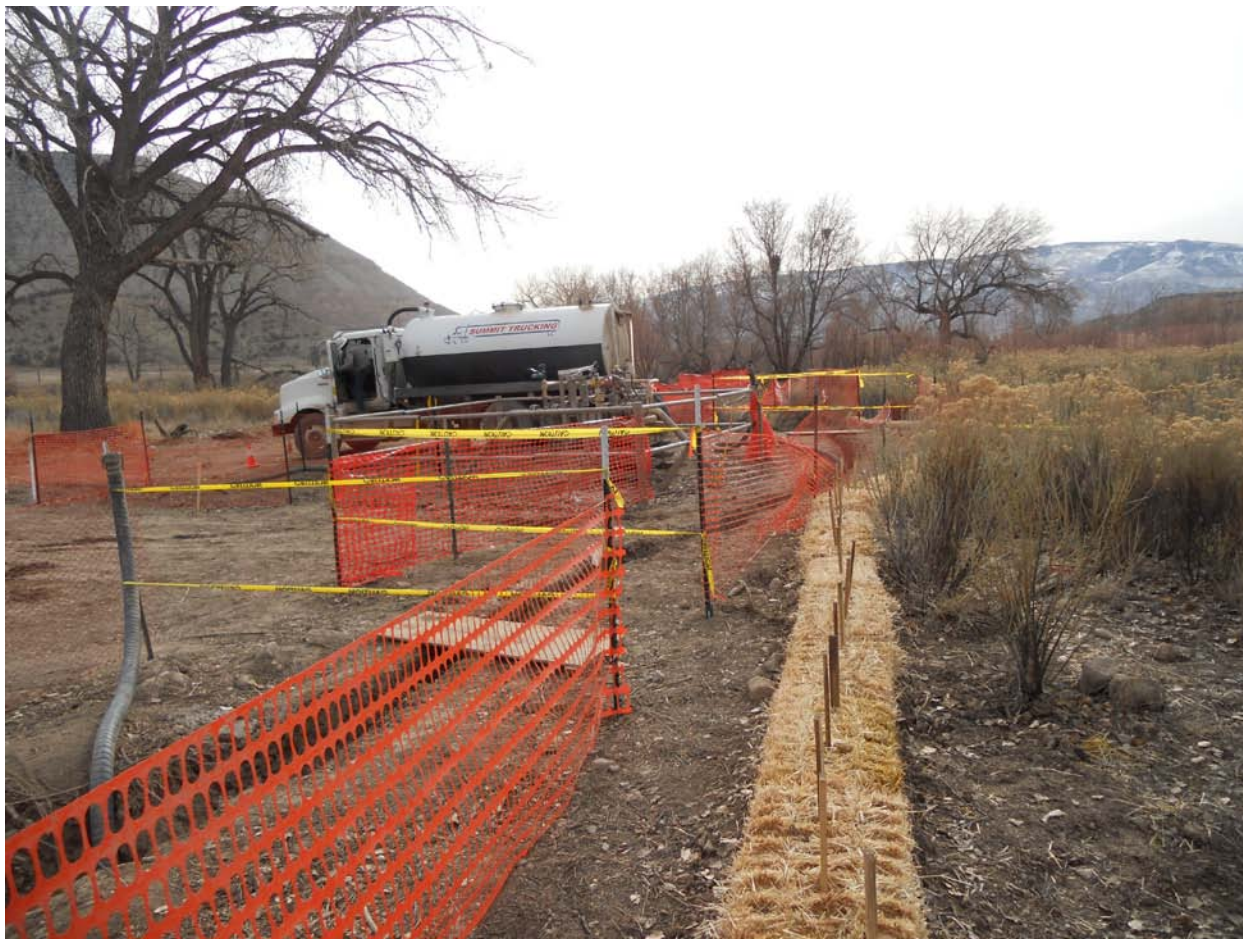
File Name: 2120_dda_03-19-2013-01

Description: Interceptor trench with fencing and stormwater BMP (hay bales); valve set (above-ground facilities, including piping, valves, and gauges associated with natural gas liquids [NGL] line) and vacuum truck in background; vacuum hose (not in use) in left foreground.

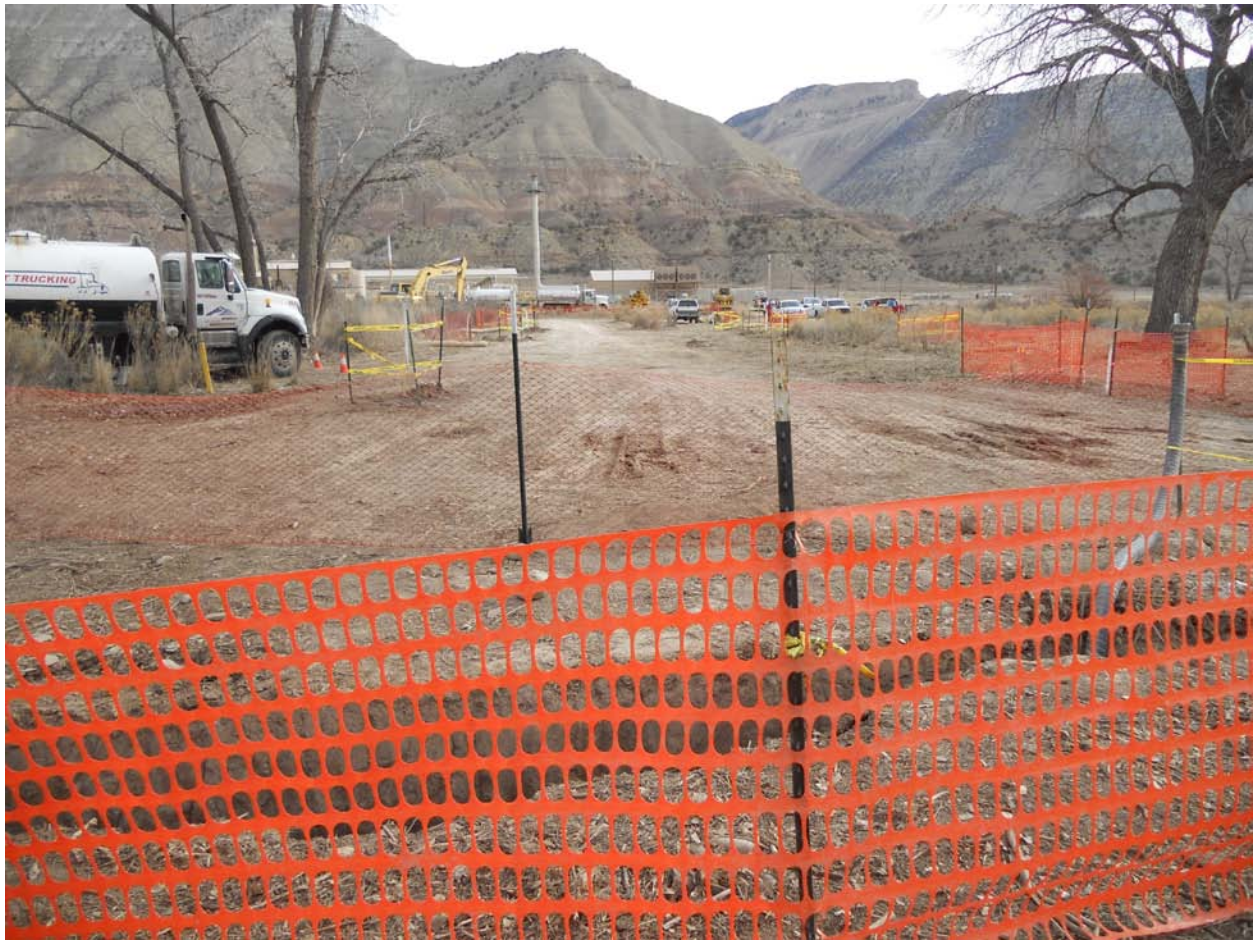
File Name: 2120_dda_03-19-2013-02

Description: View across interceptor trench, along access road to southern end of gas plant in background; pothole hydrojet excavations delineated with caution tape along both sides of access road; vacuum truck on the left; vacuum hose (not in use) on right.

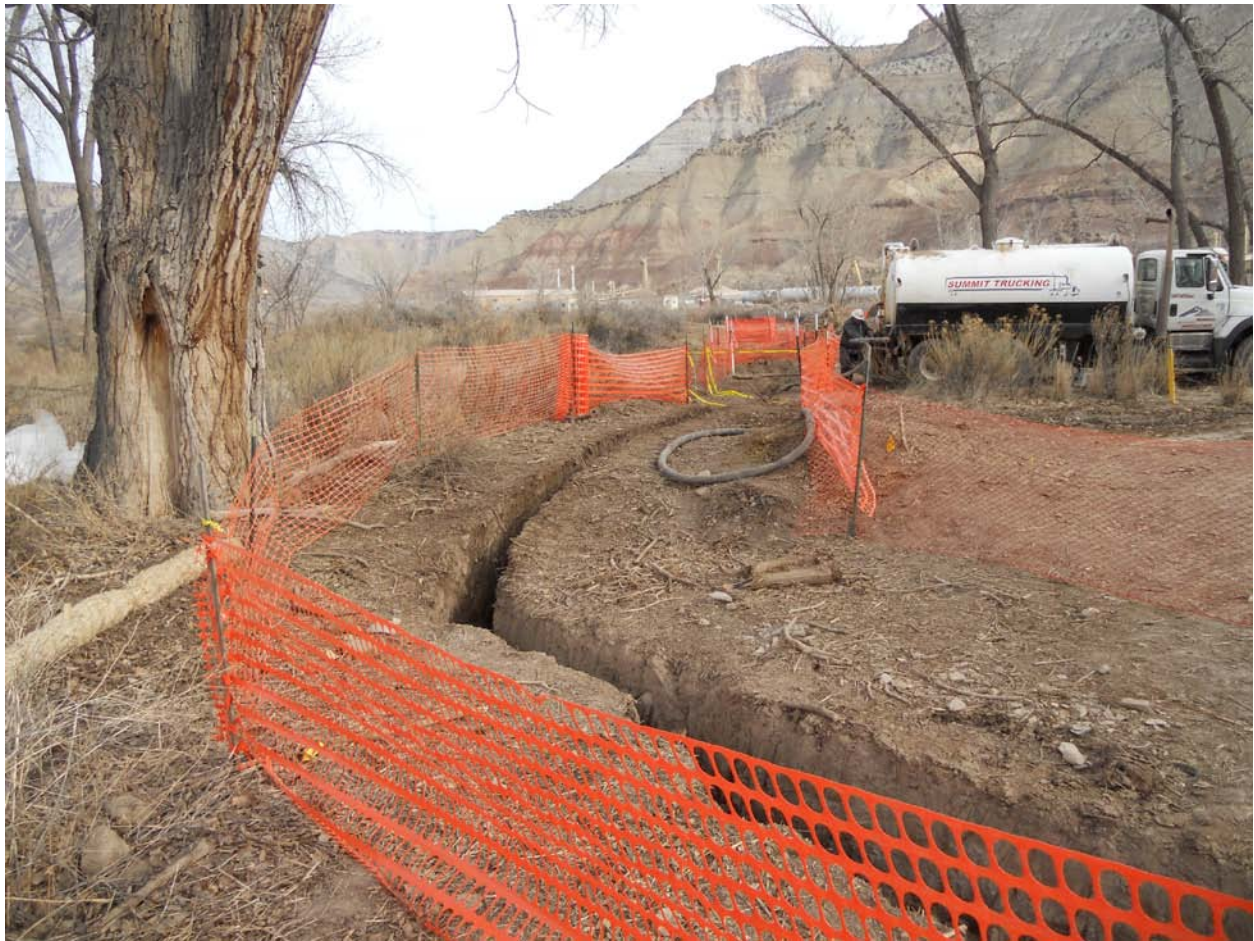
File Name: 2120_dda_03-19-2013-03

Description: View along interceptor trench, which changes direction from northwest-southeast (in foreground) to north-south (in background); distant view of north end of gas plant; vacuum truck on right.

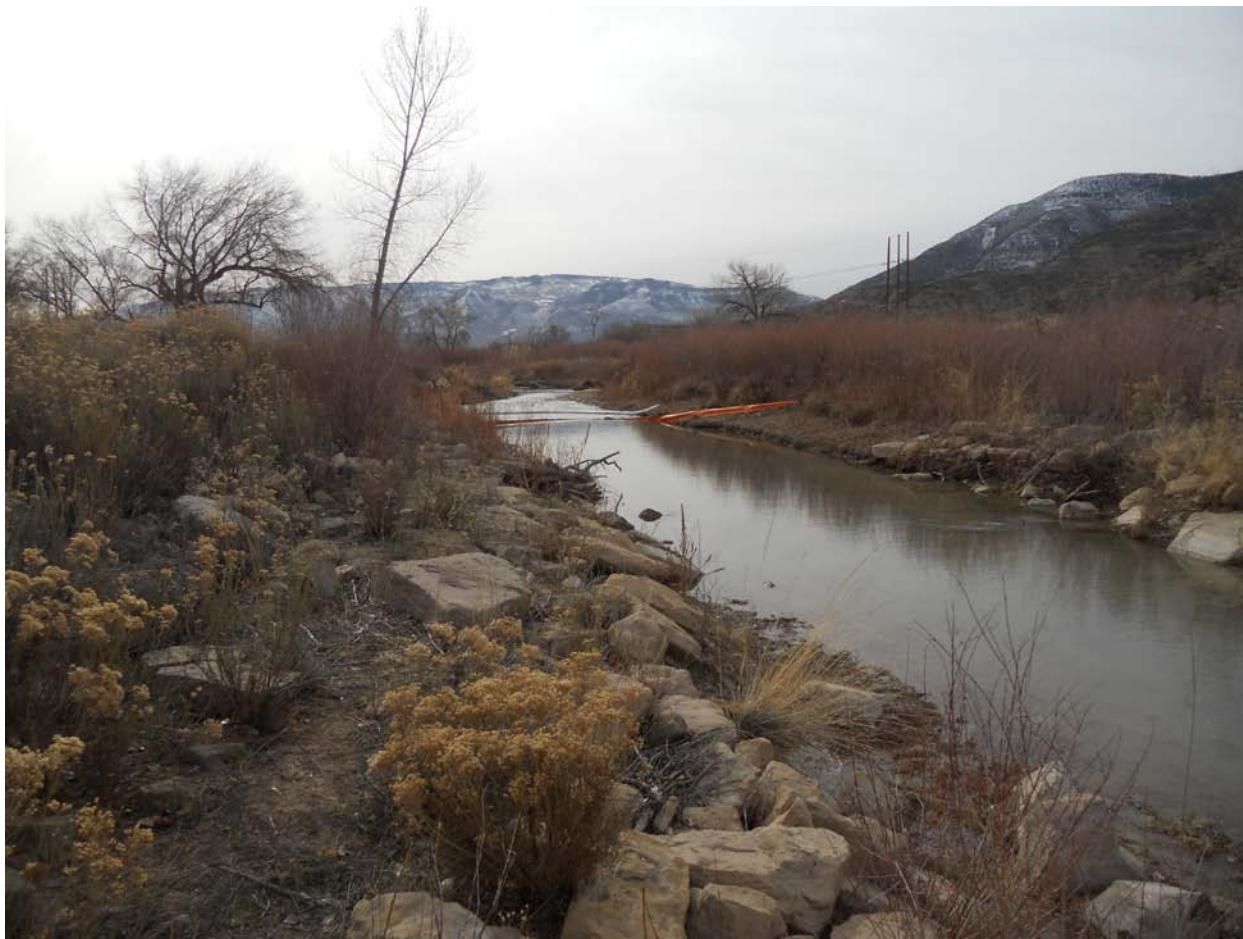
File Name: 2120_dda_03-19-2013-04

Description: View of Parachute Creek, looking downstream at precautionary absorbent booms.

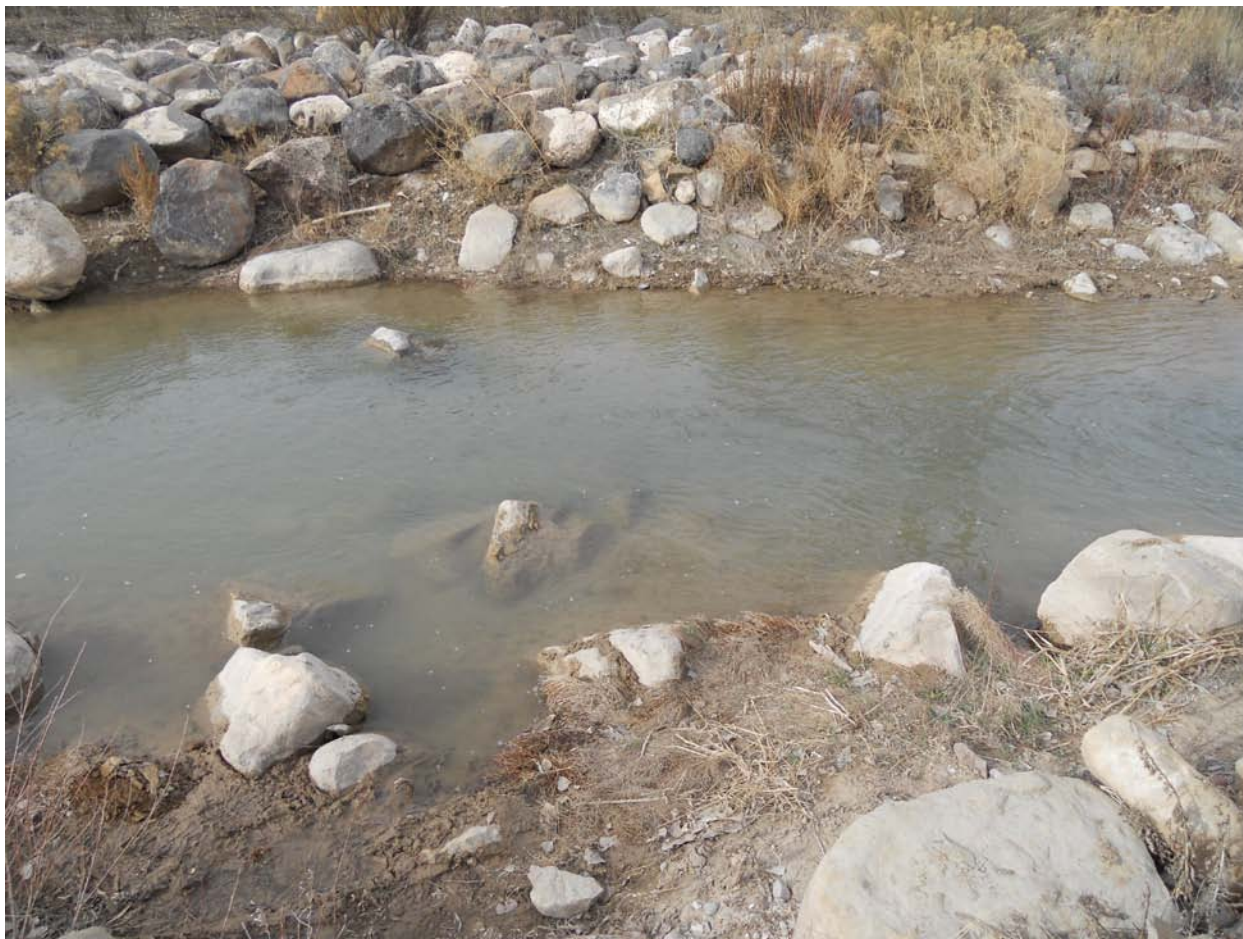
File Name: 2120_dda_03-19-2013-05

Description: View of Parachute Creek, adjacent to active remediation area. No visual indications of impact.

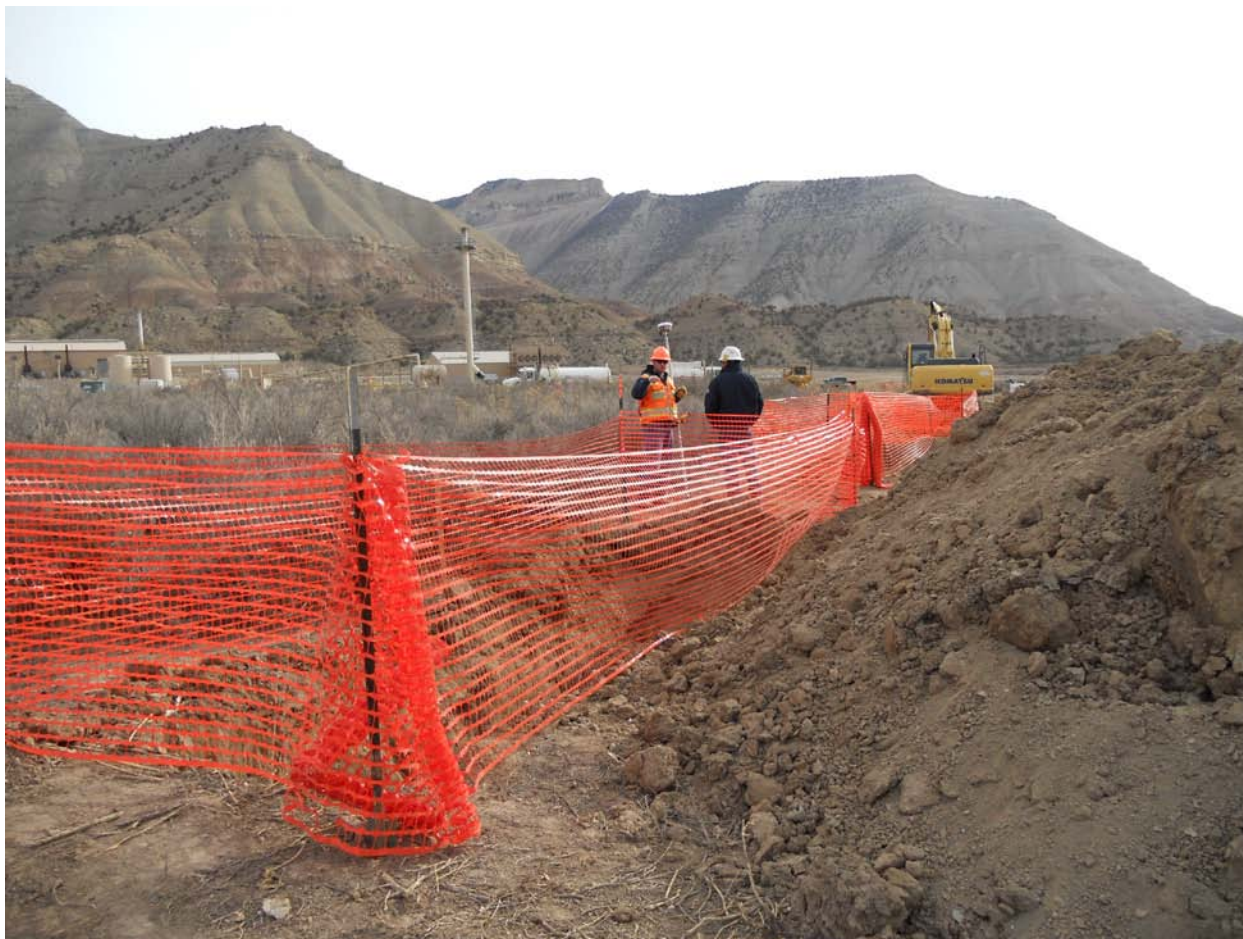
File Name: 2120_dda_03-19-2013-06

Description: View of newest delineation trenches, located north of active remediation area; surveyor standing between trenches; southern portion of gas plant in background.

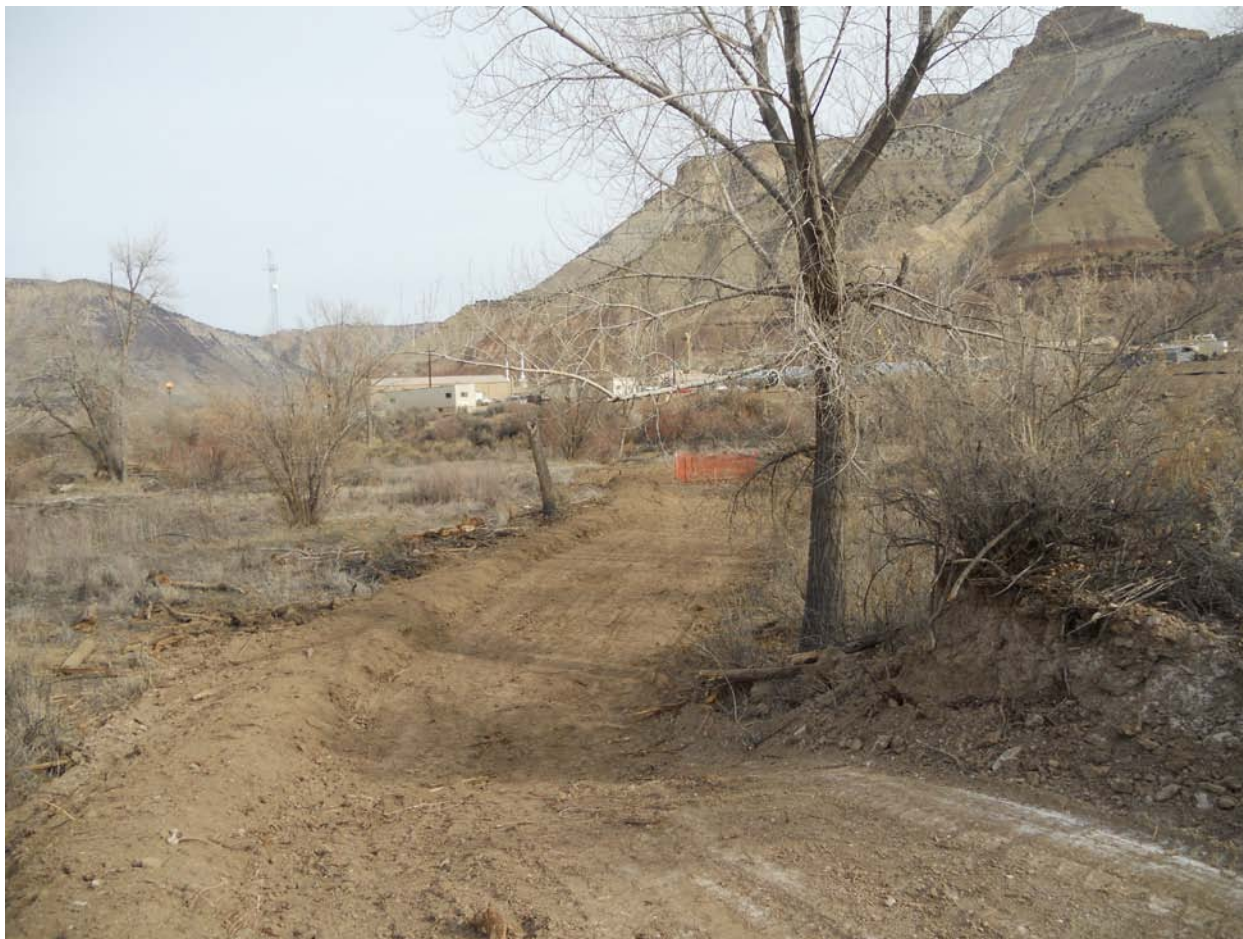
File Name: 2120_dda_03-19-2013-07

Description: View of northernmost trench, located in a low-lying area, a few hundred feet north of active remediation area; northern end of gas plant in background.

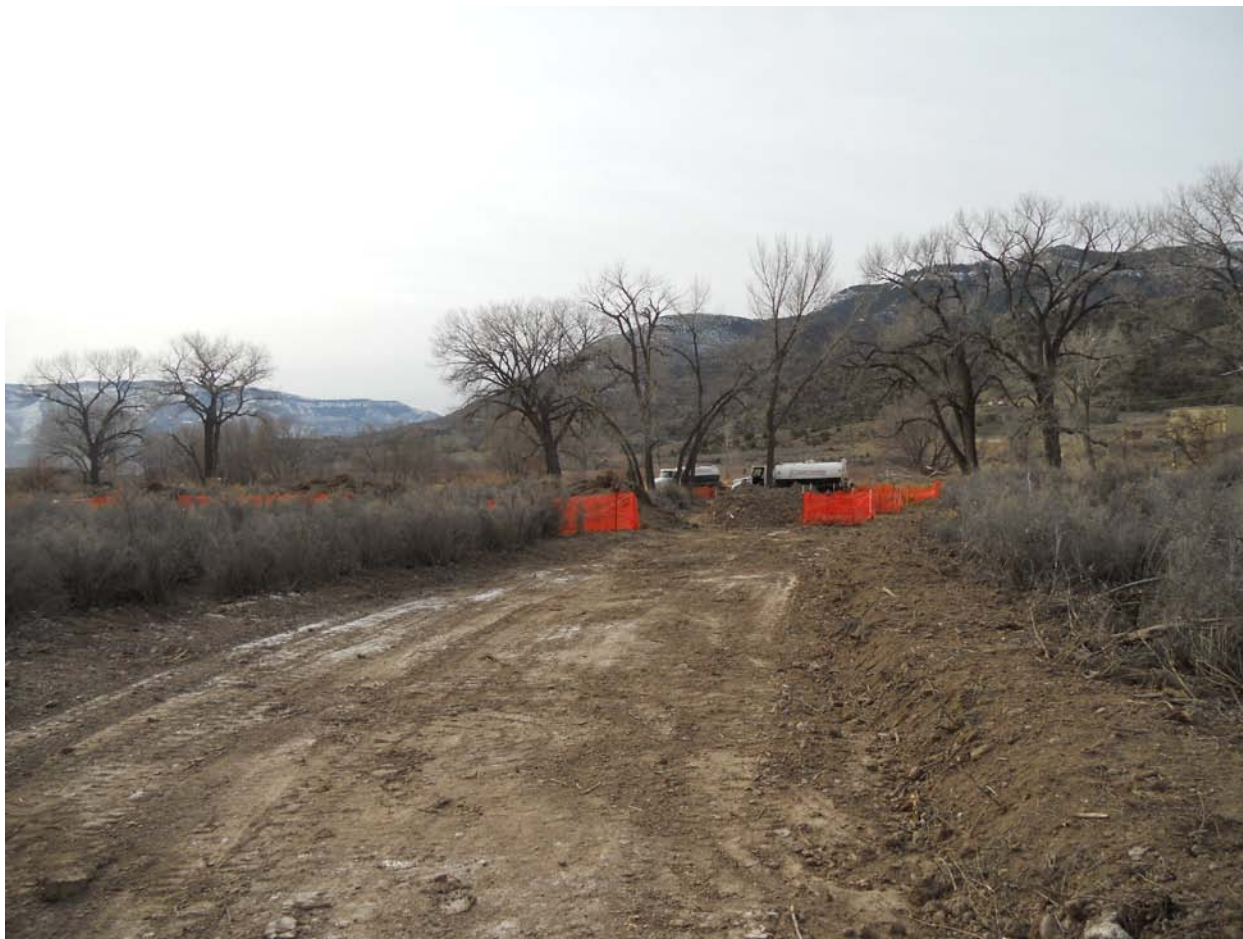
File Name: 2120_dda_03-19-2013-08

Description: Distant view of delineation trenches and active remediation area.

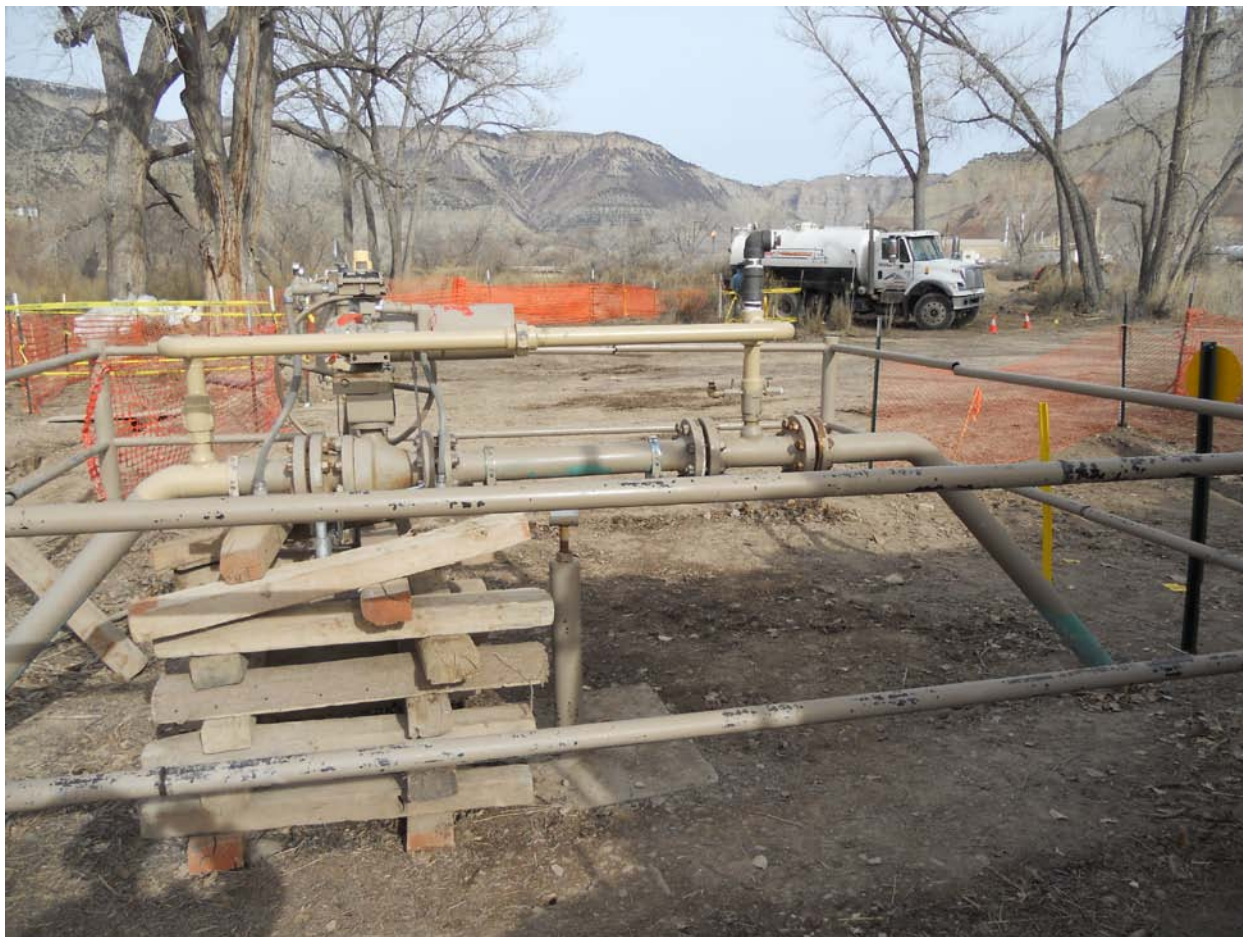
File Name: 2120_dda_03-19-2013-09

Description: Valve set, located adjacent to interceptor trench; gauge connection, which was the source of a non-reportable release, located below the black elbow in the upper right; protective barrier pipes have been cut, and flanged connections (on left) have been blocked and supported in preparation for excavation below flanged connections on right; vacuum truck in background.

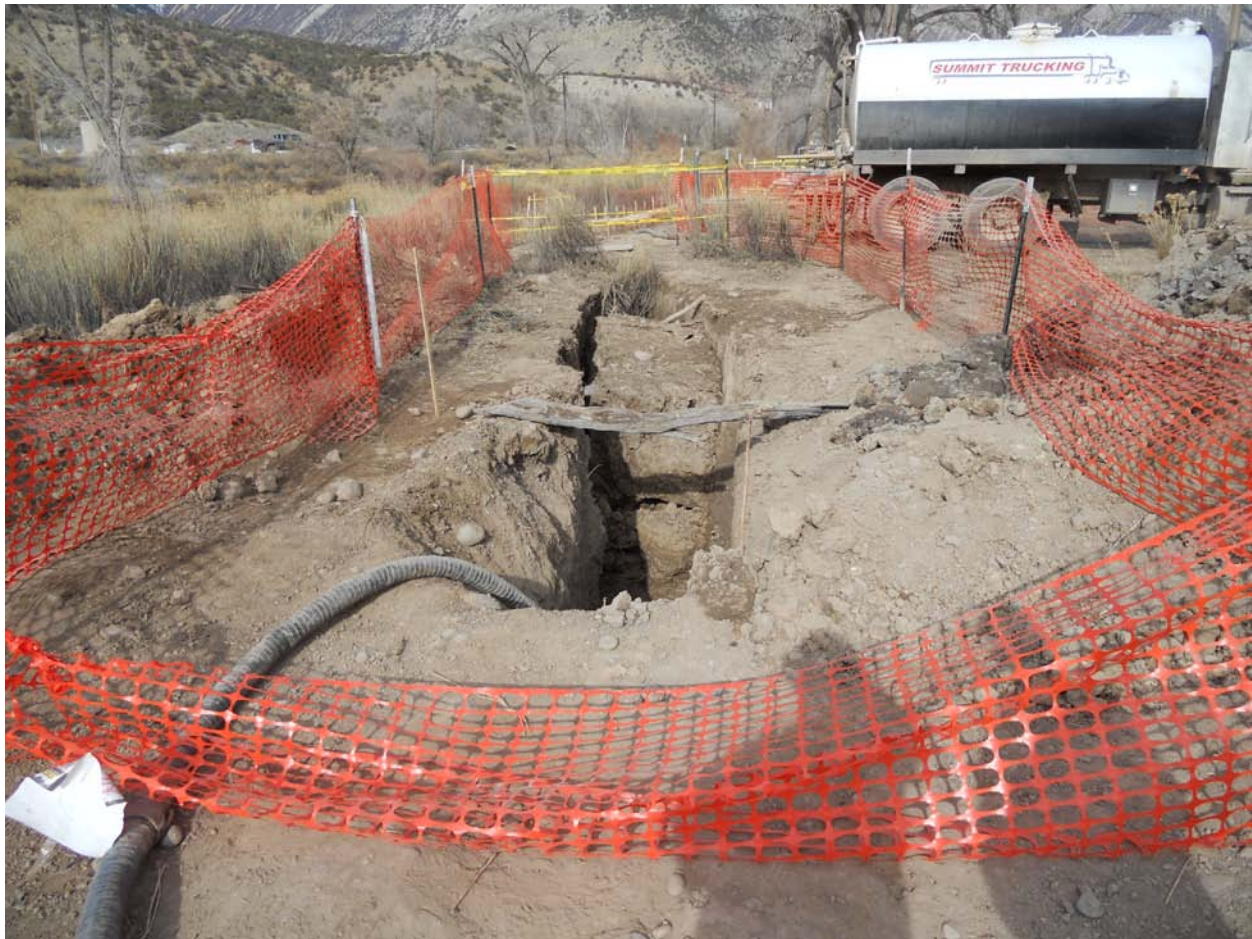
File Name: 2120_dda_03-19-2013-10

Description: View of slump block in interceptor trench at southern end of active remediation area; vacuum truck in background on right.

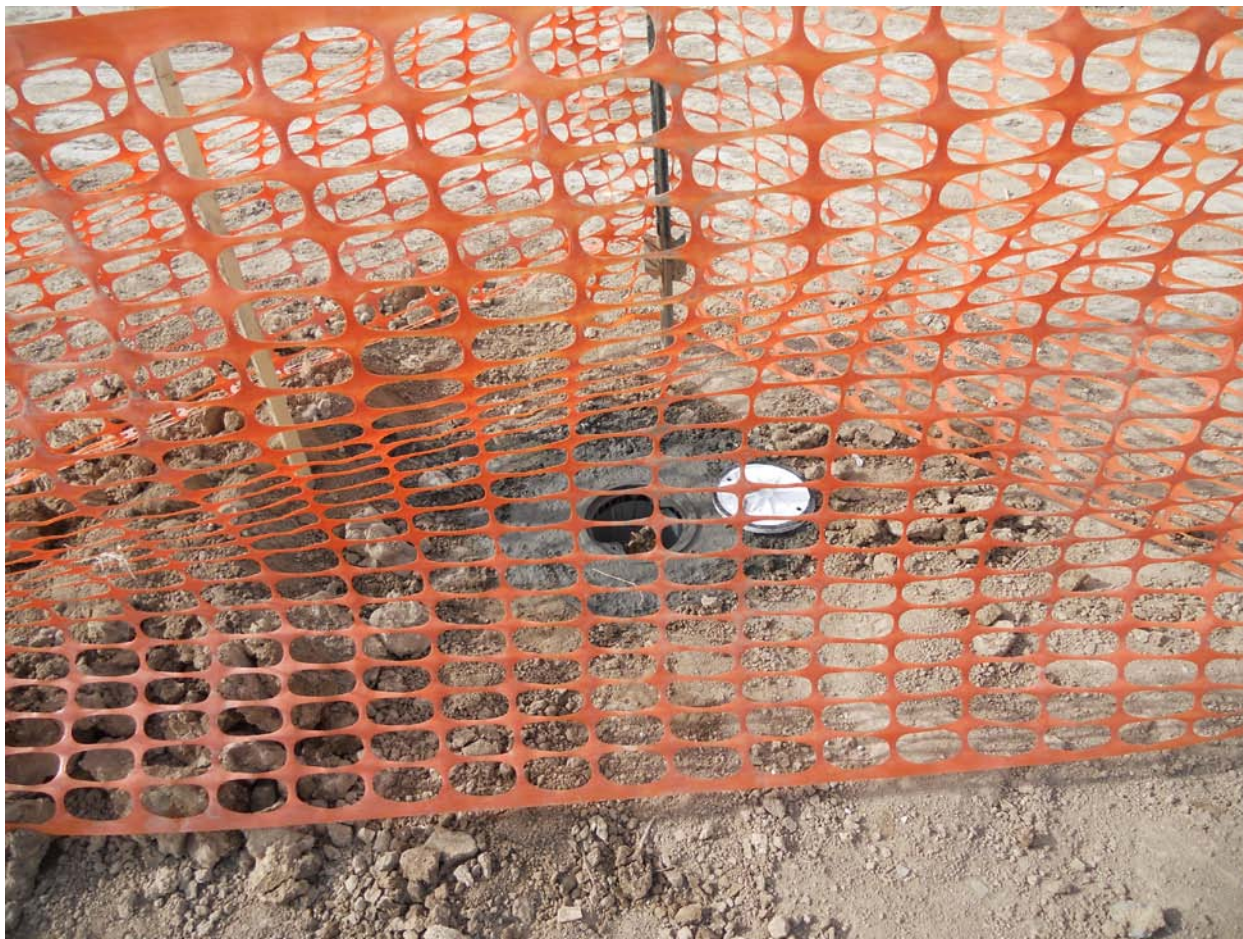
File Name: 2120_dda_03-19-2013-11

Description: View of newly installed groundwater monitoring well, located up-gradient of active remediation area, near well pad and tank battery.
