LoanPine field inspection
12/20/2011

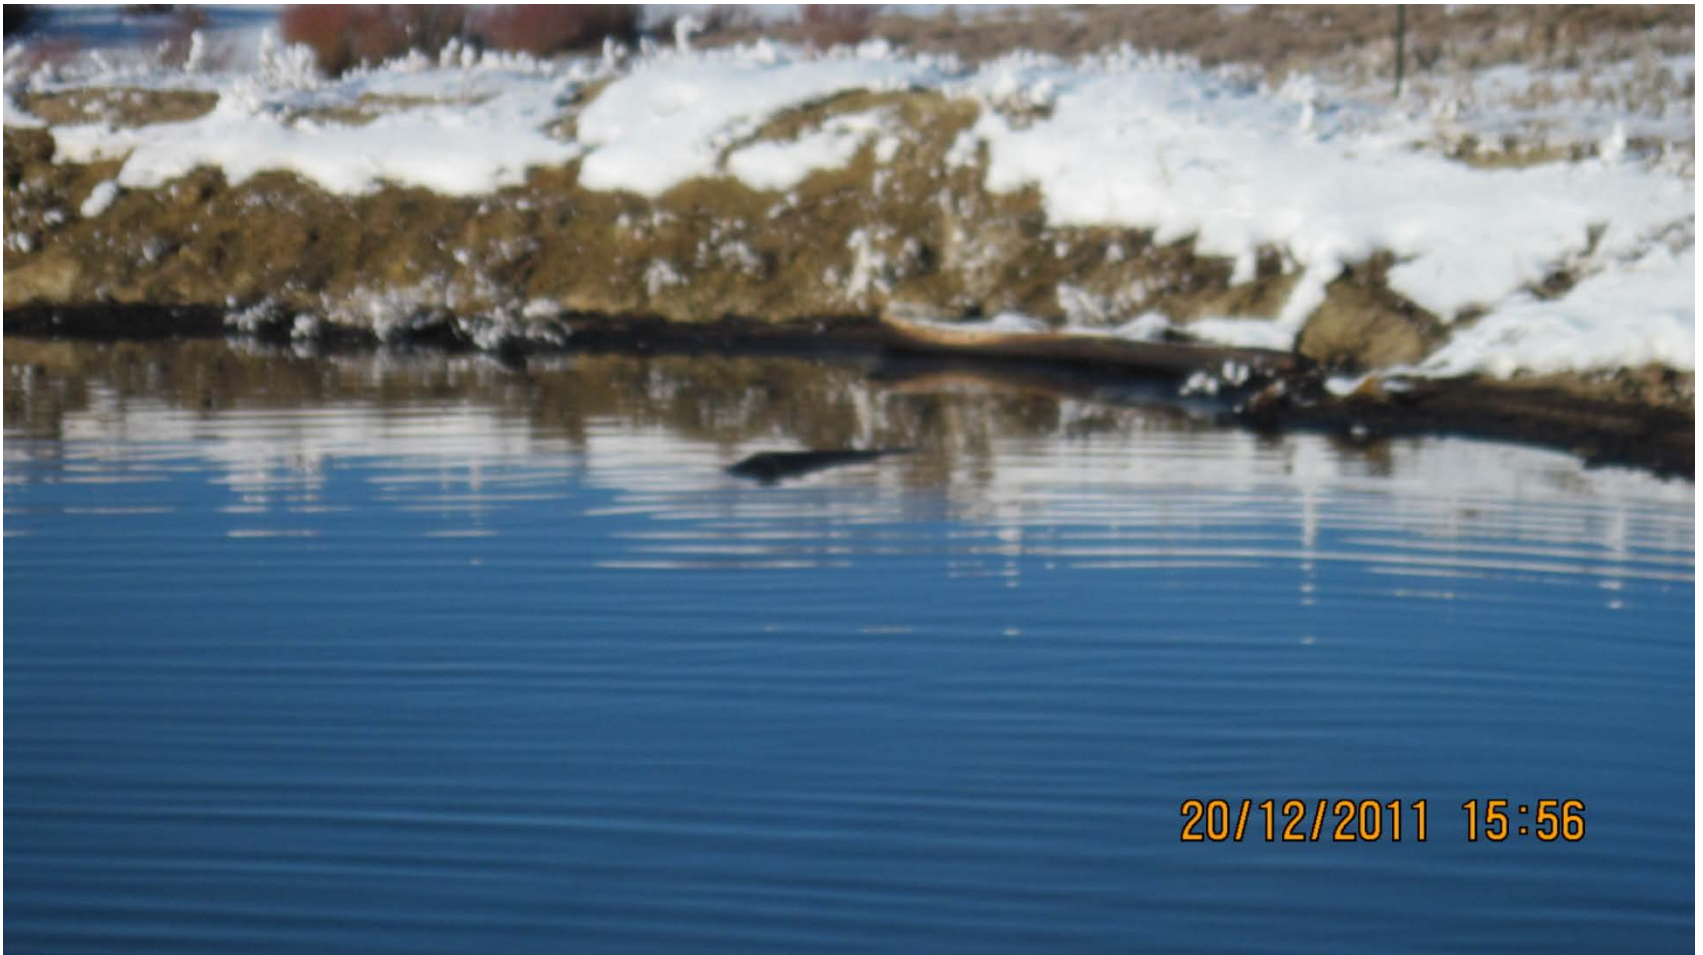
Last pond; note booms at discharge
coated with oil.

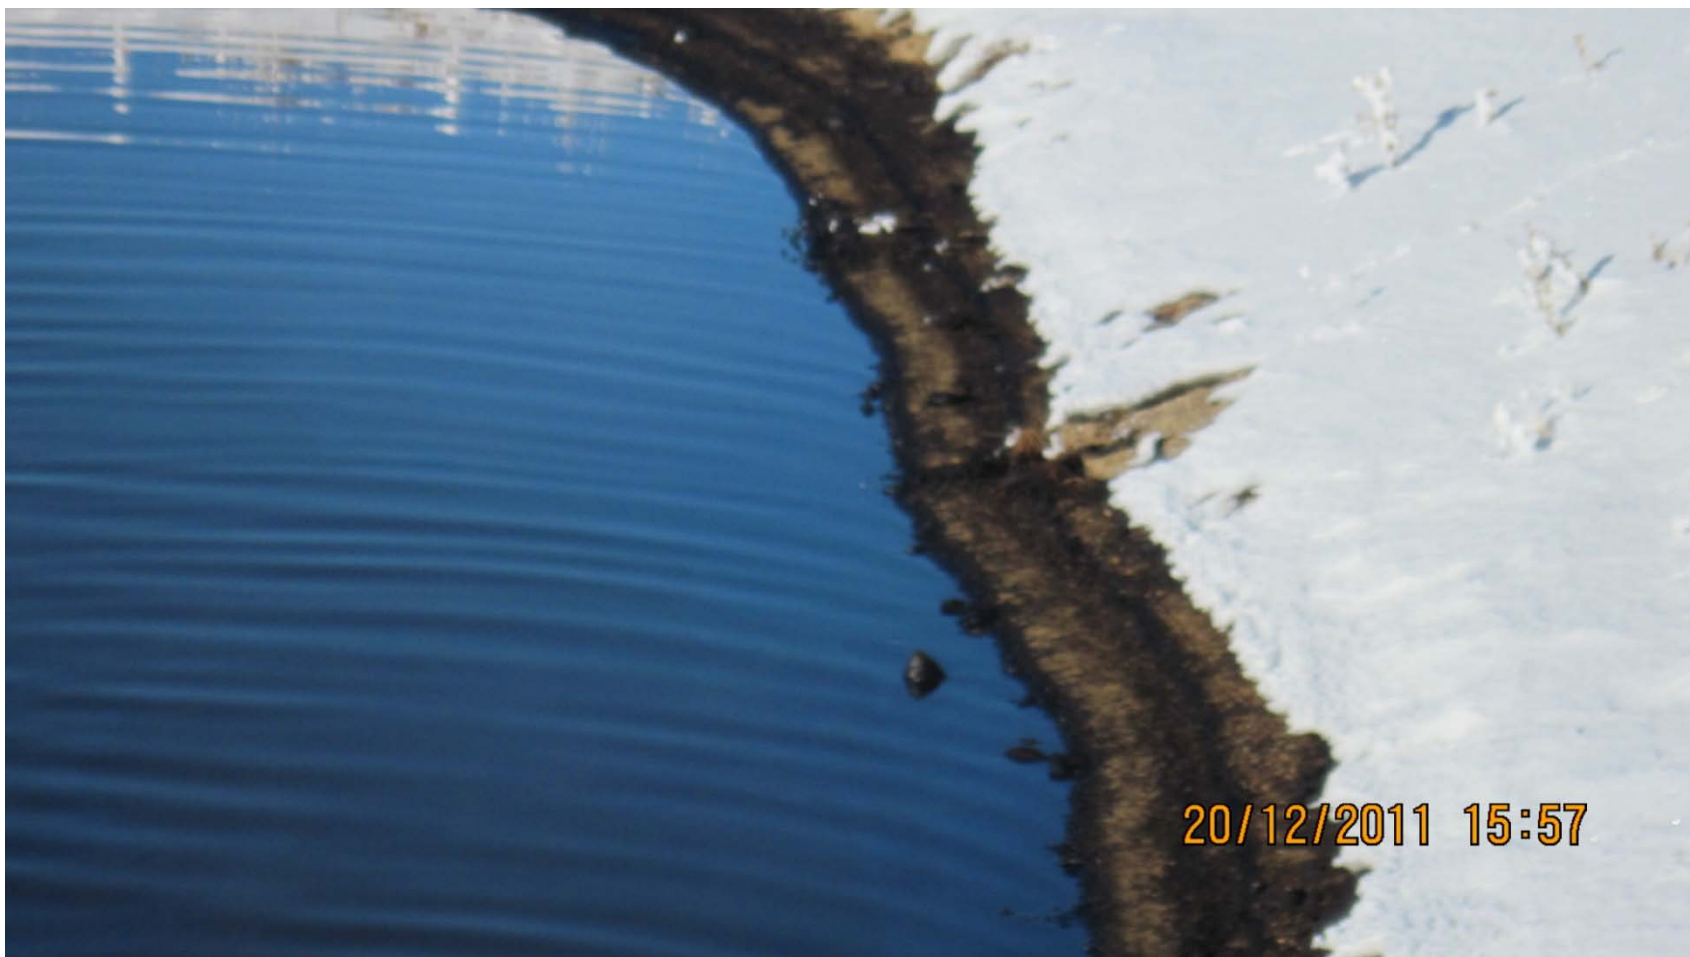
Last pond; edge of pond.

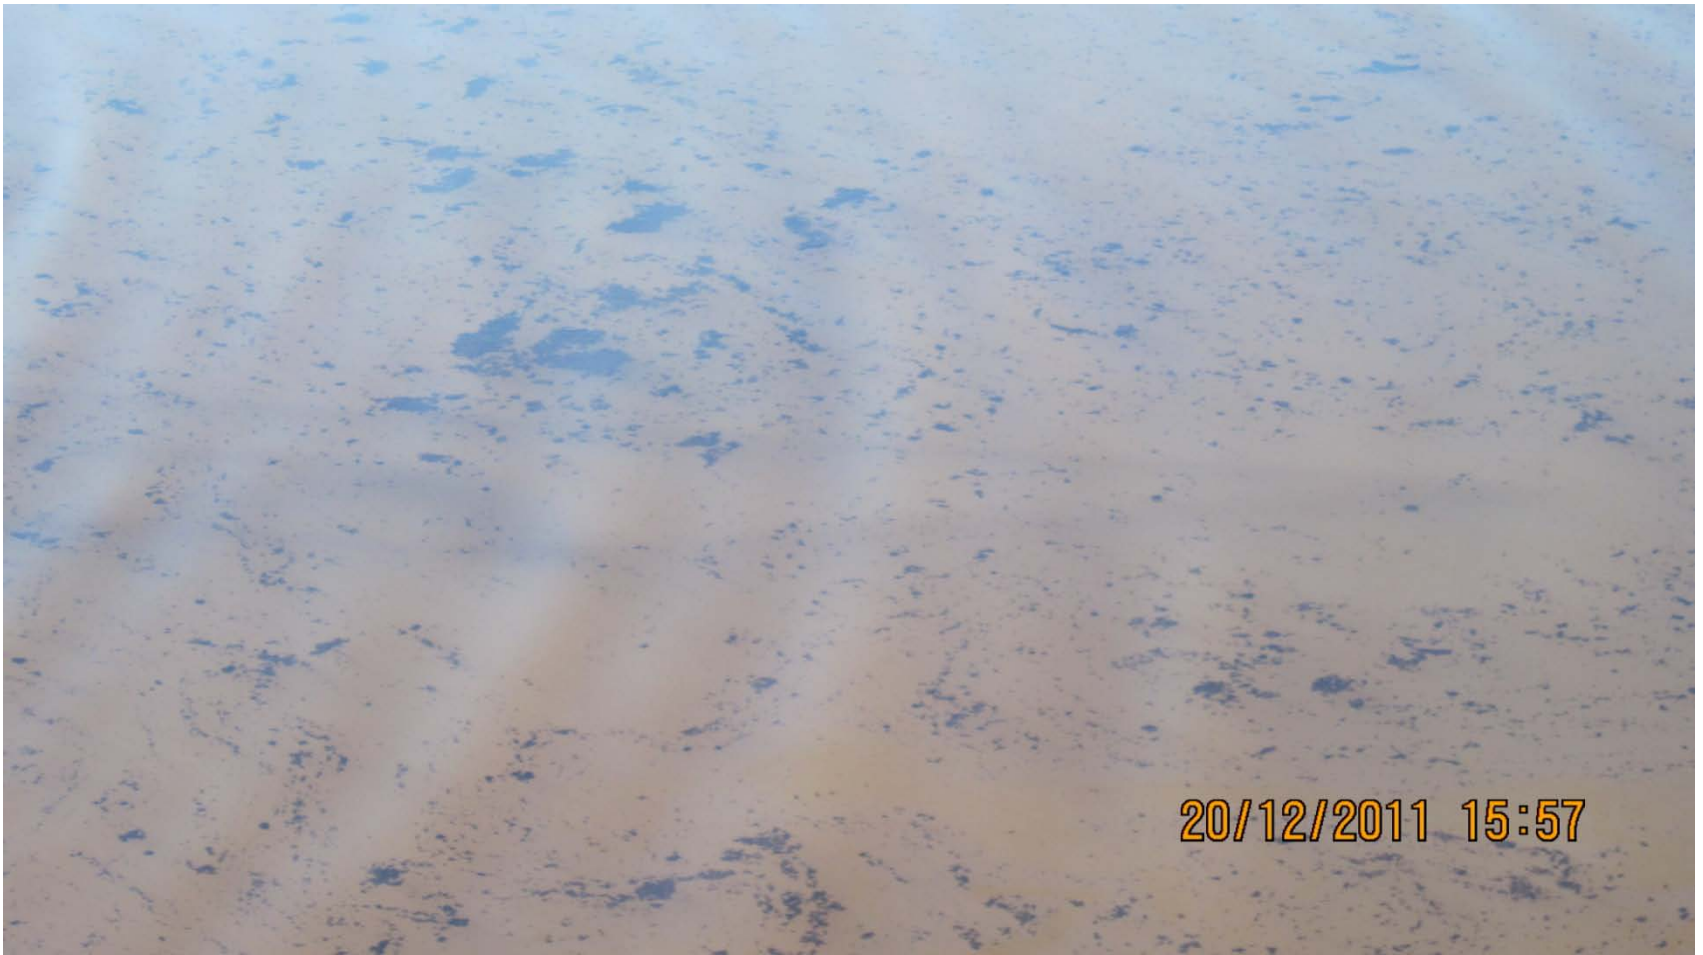
Last pond; oil on surface of water

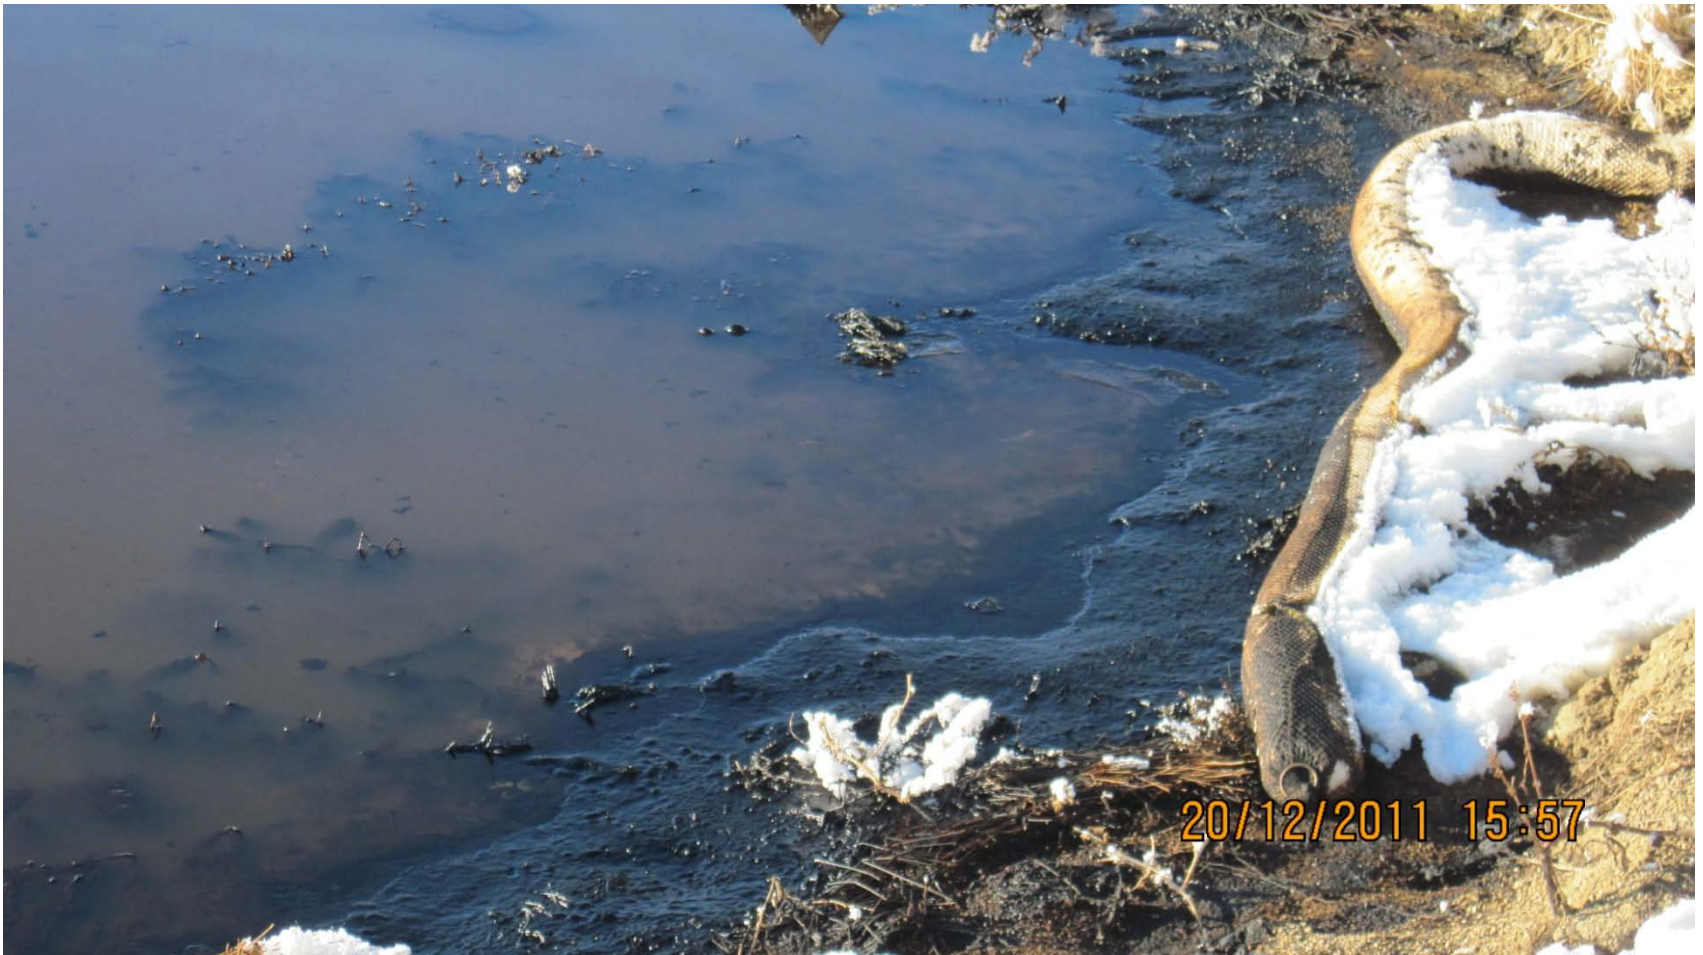
Last pond; discharge point from pond

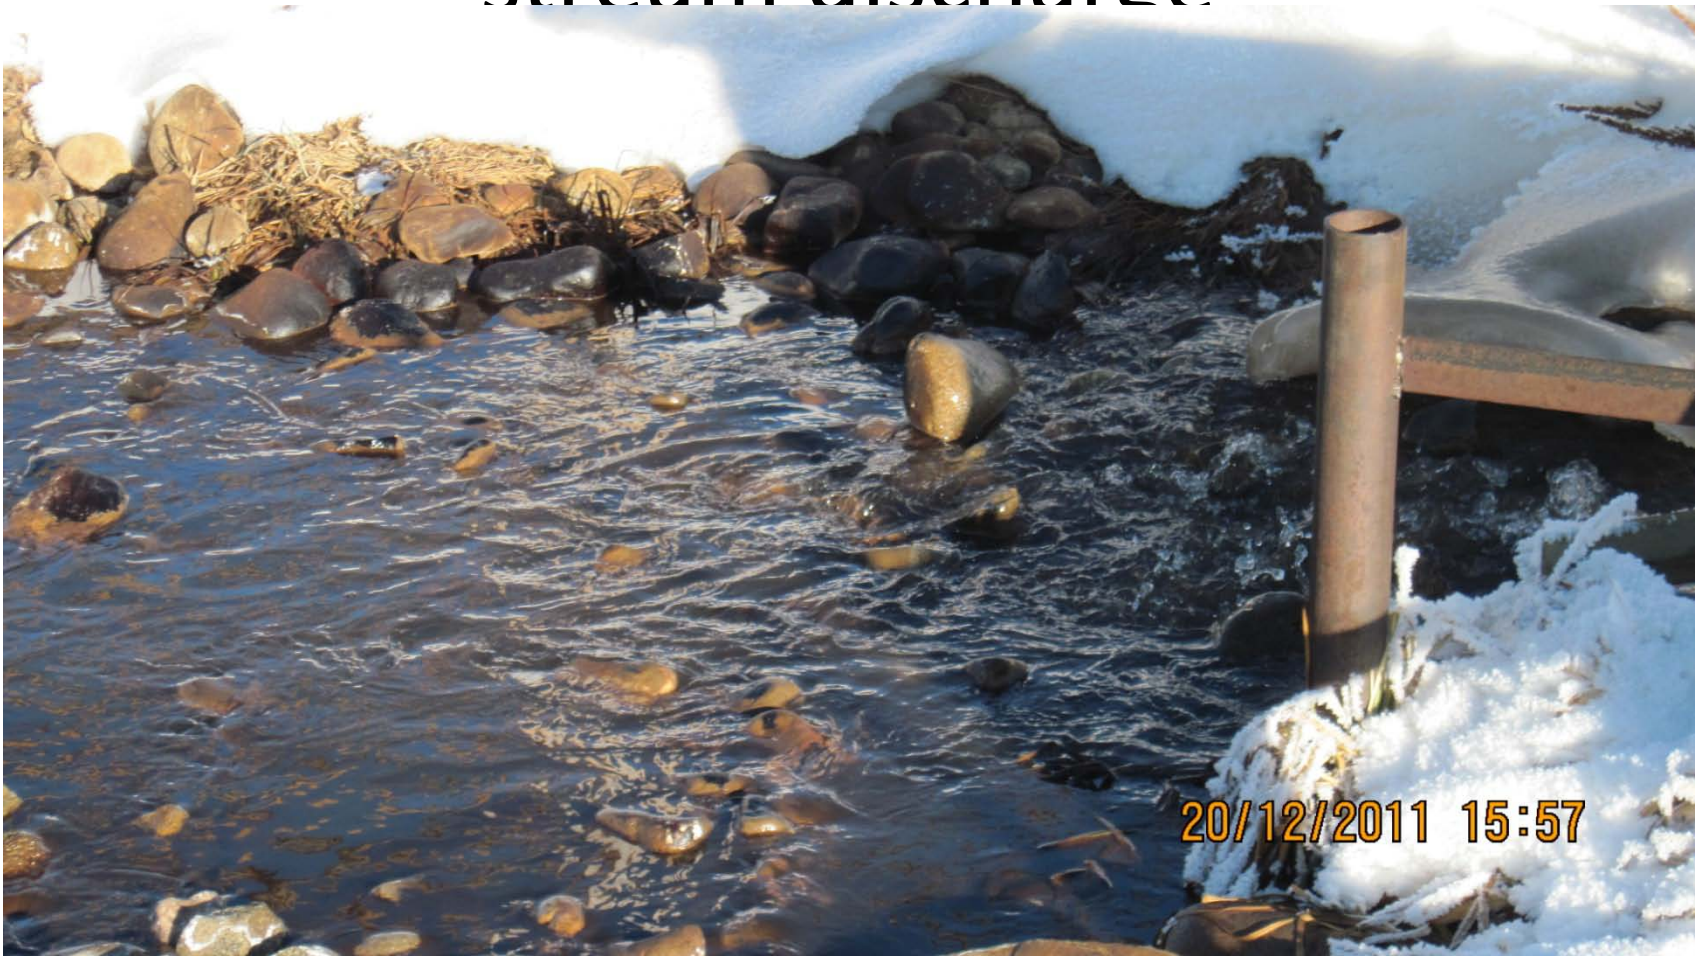
Inside pen area that operator uses to
take iron samples, this is beginning of
stream discharge

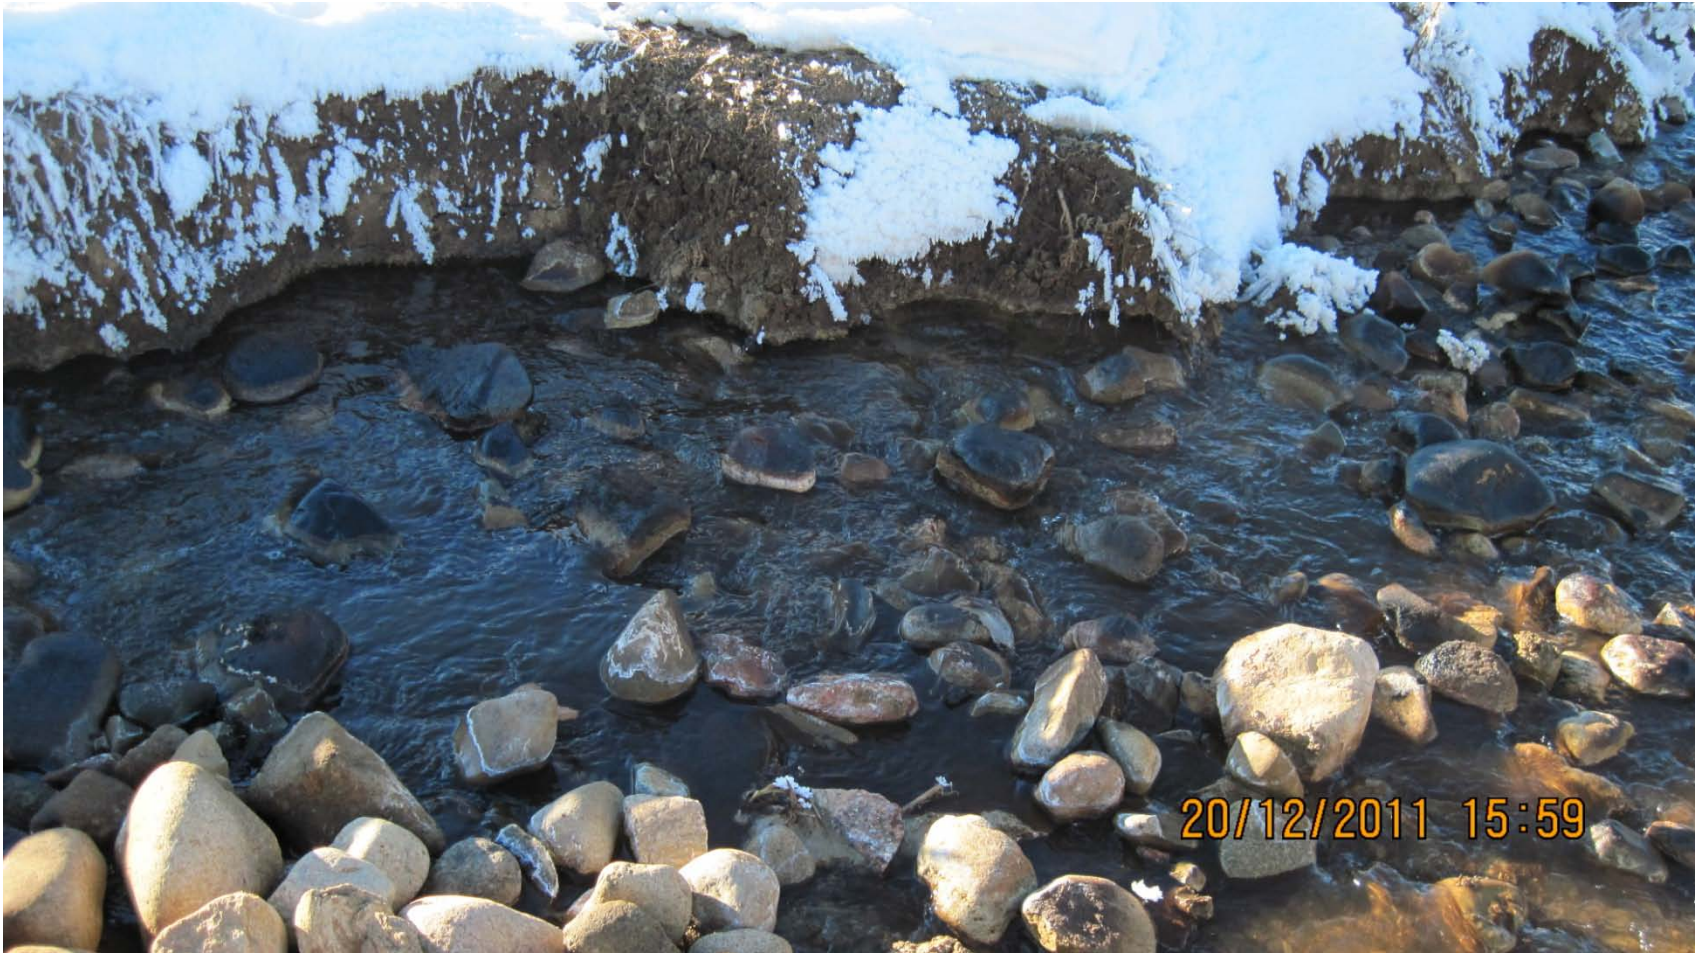
In stream, aprox 15' from sample pen
