State of Colorado  
Oil and Gas Conservation Commission

## SPILL/RELEASE REPORT

Date of Incident: <u>8/20/2013</u>	Facility Name & No: <u>NORCROSS-66S93W13NESW</u>	County: <u>Garfield</u>
Type of Facility (well, tank battery, flow line, pit): <u>Well Pad</u>		QtrQtr: <u>NESW</u> Section: <u>13</u>
Well Name and Number: <u>Norcross A</u>		Township: <u>6S</u> Range: <u>93W</u>
API Number: <u>05-045-15166</u>		Meridian: <u>6th</u>

Spill/Release Tracking No: 2145907

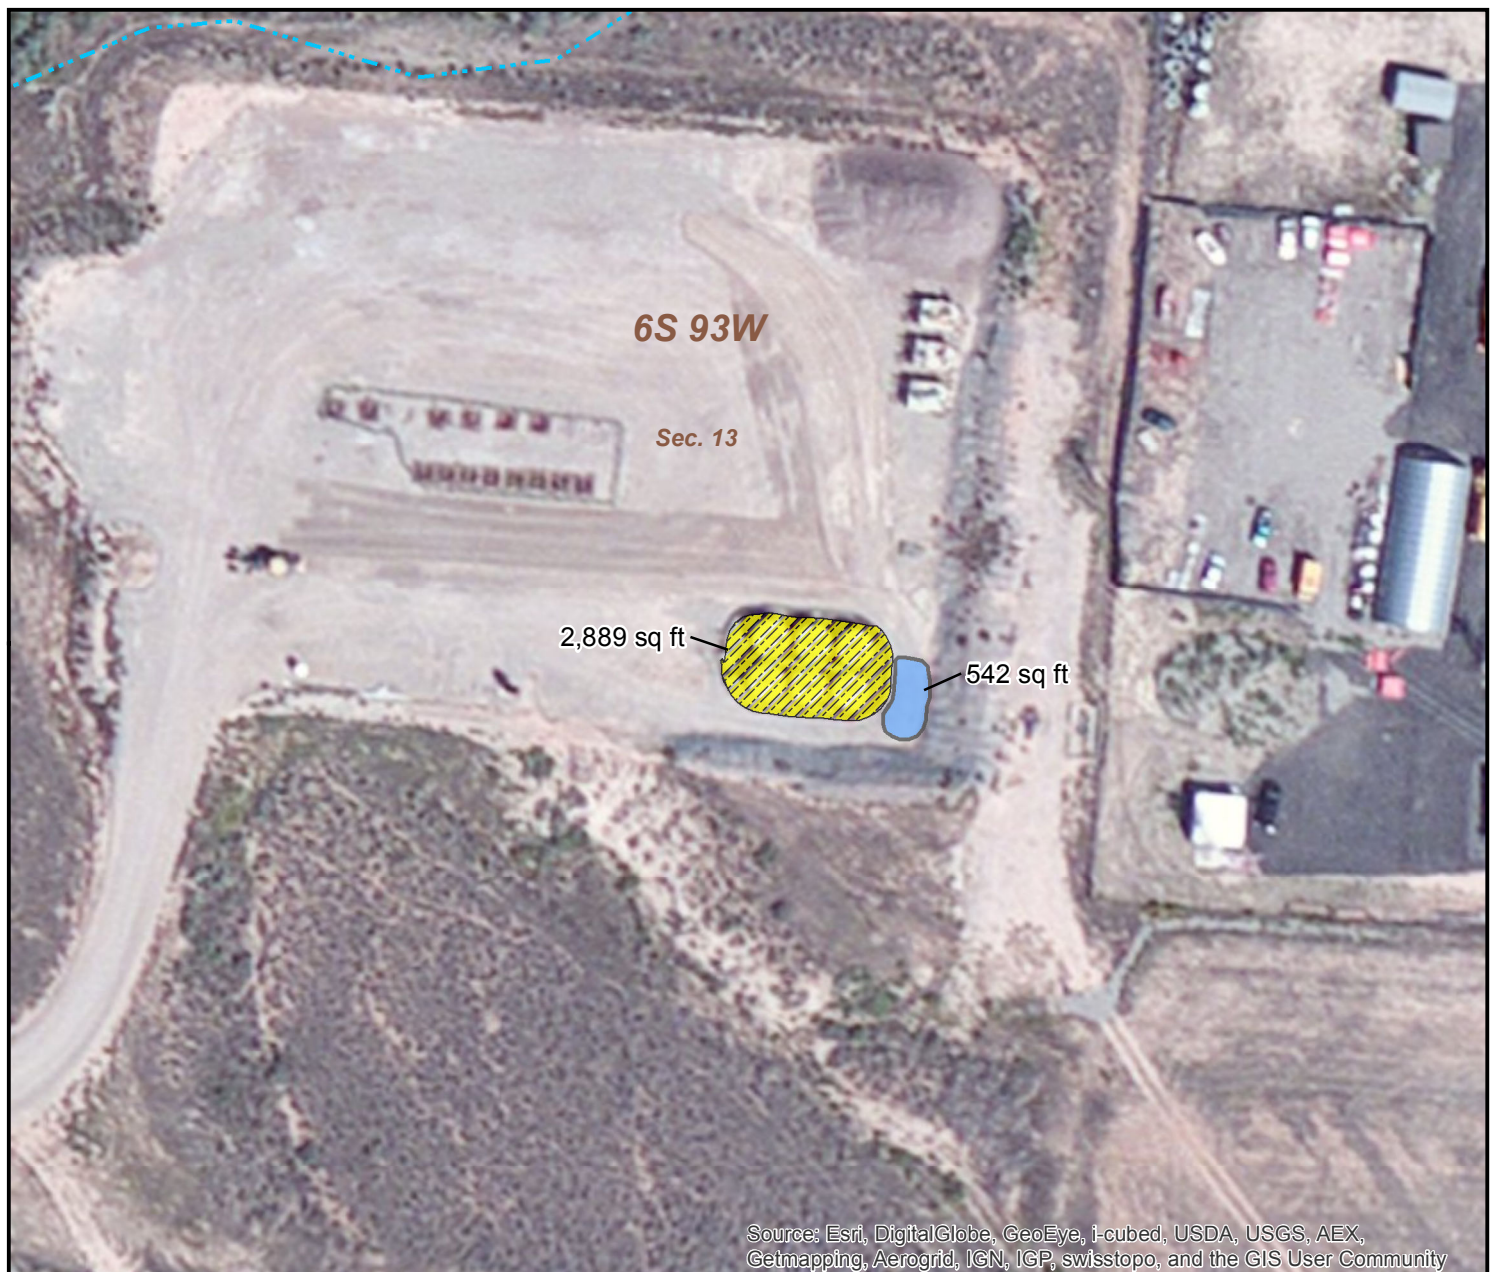
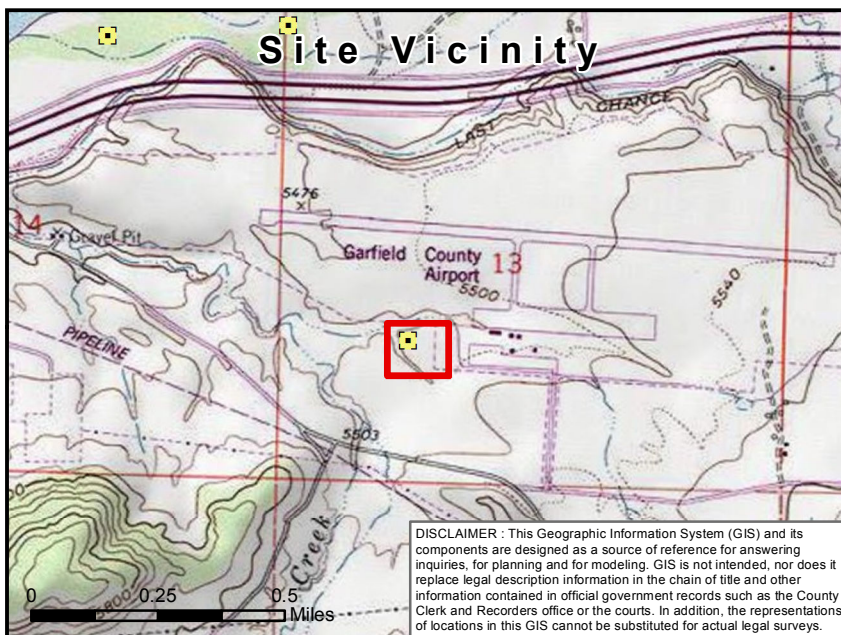
**Norcross A**  
Attachment A - Spill Location  
39.522937 -107.728996  
T6S R93W Sec 13 NW SW

Describe immediate response (how stopped, contained and recovered): Flow to the tank stopped and directed to the sales line and spill response personnel were contacted. Approximately 2.25 bbls of produced water migrated outside of the containment and approximately 0.5 bbls misted the surrounding area. It was estimated that 2 bbls was captured within the lined steel containment around the tanks.

Secondary Containment
-

Excavated Area

Further remediation activities proposed (attach separate sheet if needed): The impacted soils outside of the containment were excavated and stockpiled on location to be profiled for disposal at an accredited and properly permitted landfill. A hydrovac truck was used to remove the remaining water present within the containment.
