June 18, 2013

Re: Form 27 Update of the Subsurface Investigation
Walden Water Flood Facility
COGCC Facility ID 428915
SENW & NESW 2-T9N-R79W
Jackson County, Colorado

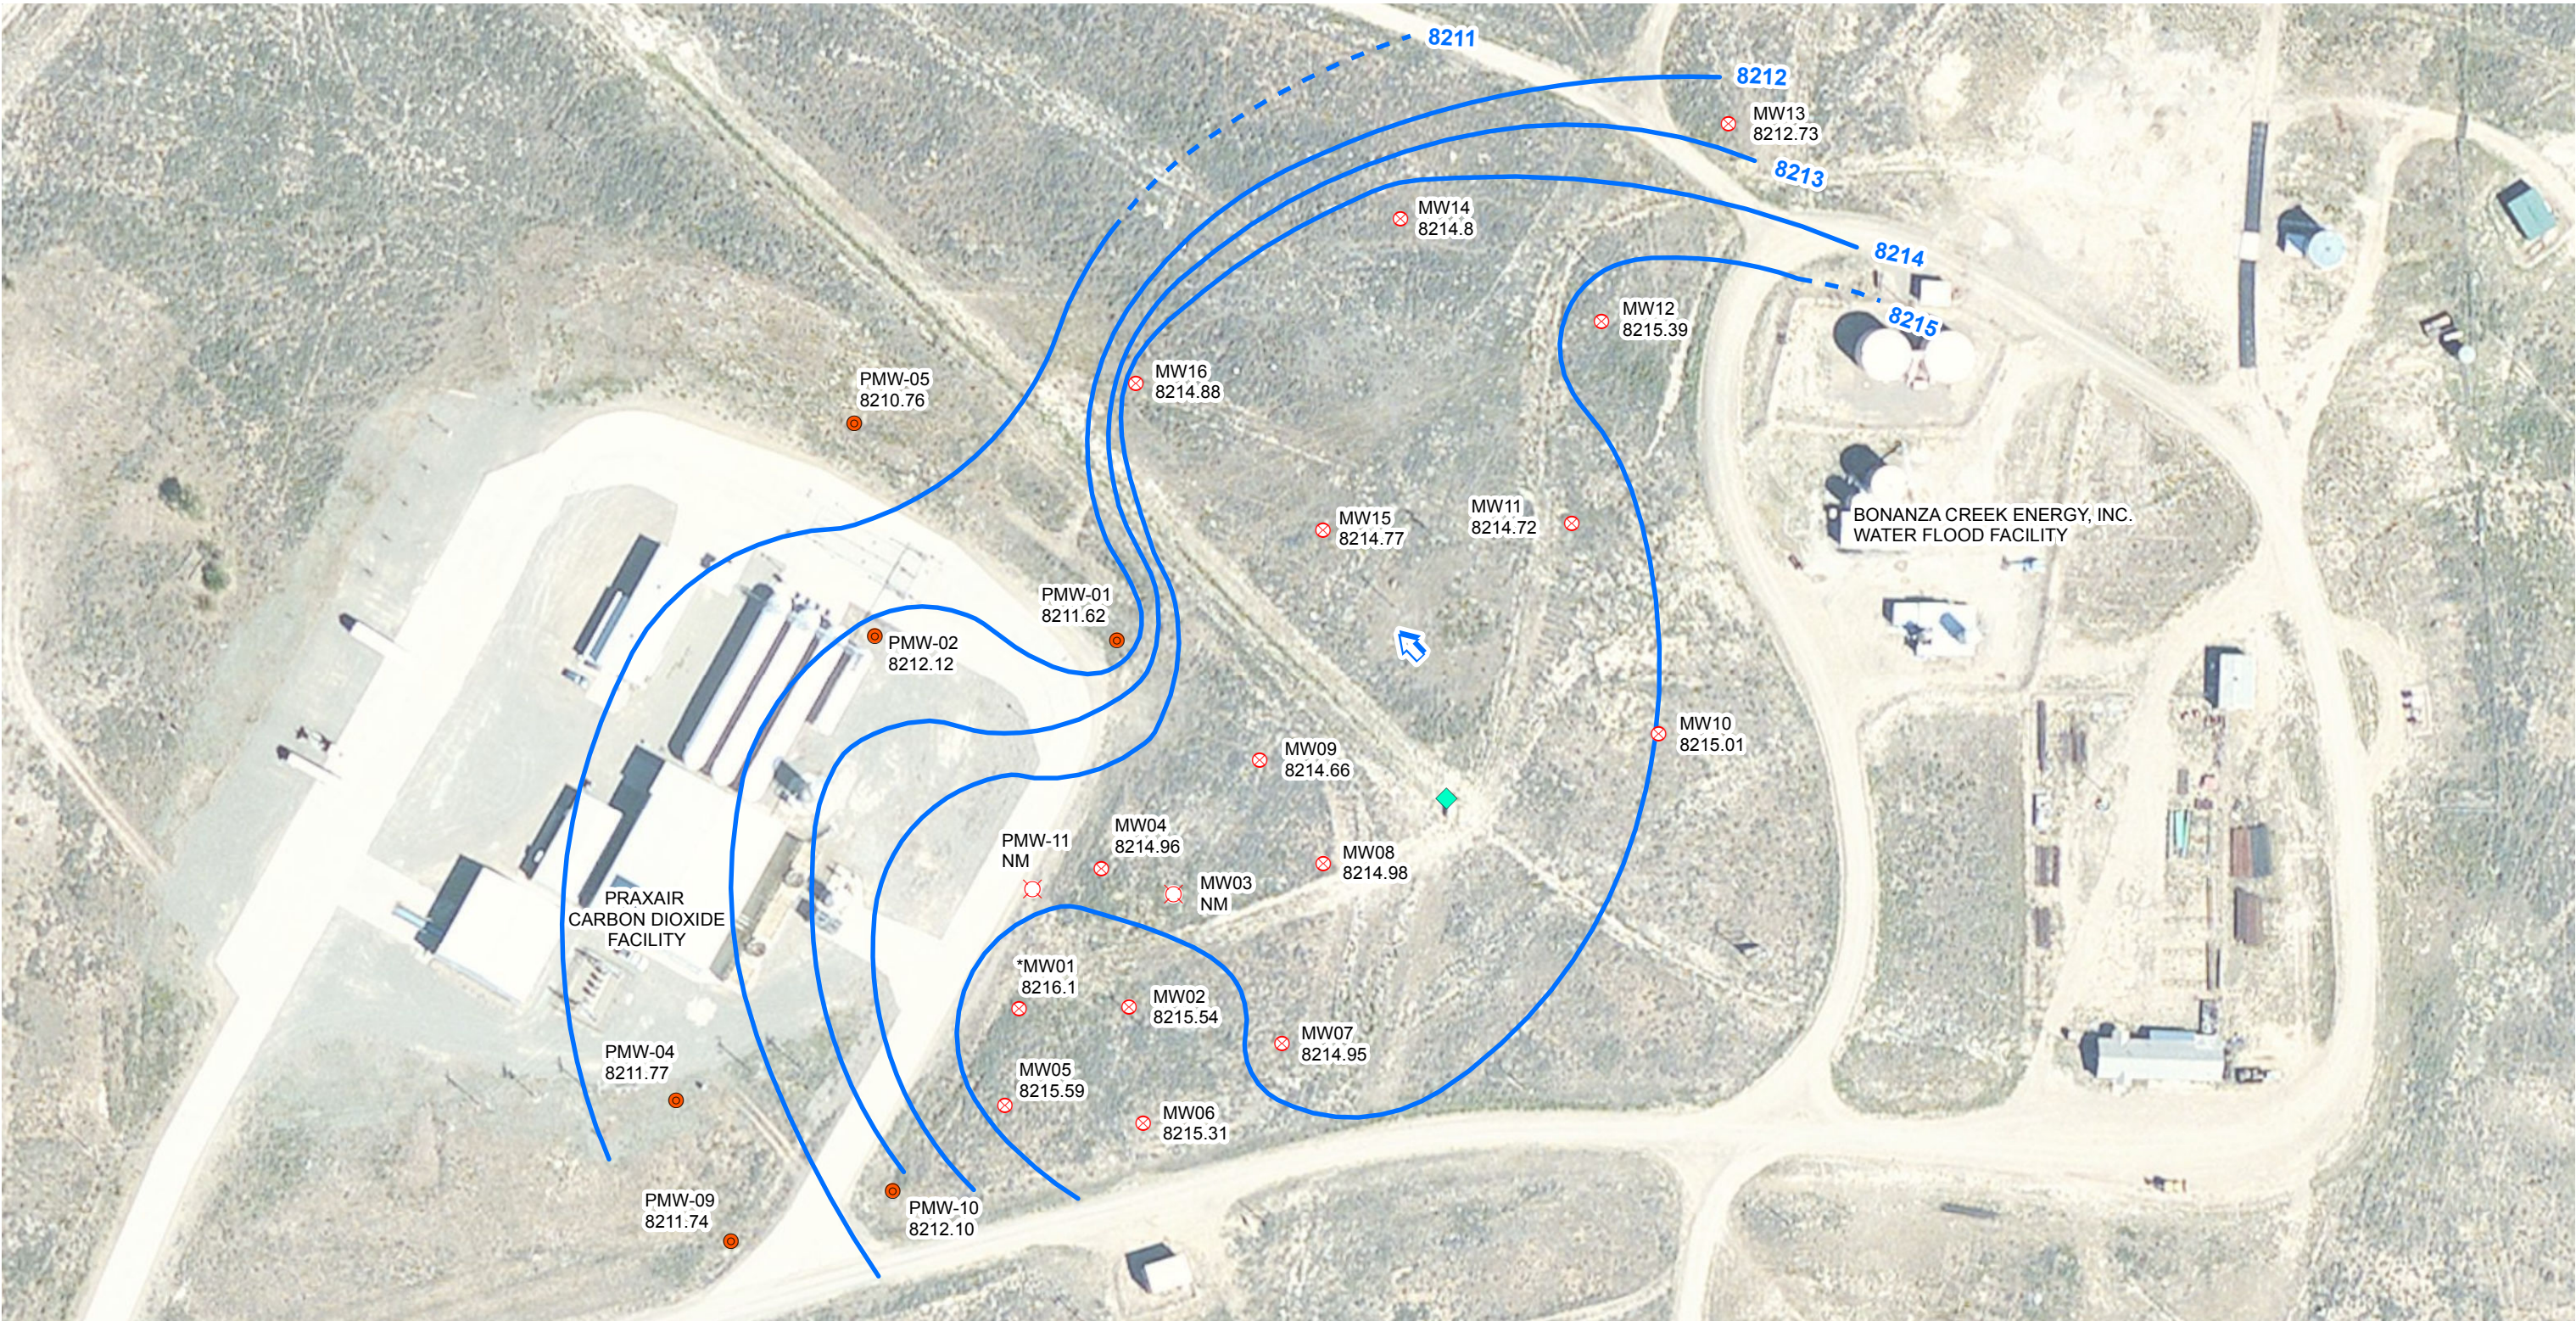
Figure 1 – Groundwater Elevation Map

The static groundwater level measurements collected on May 20, 2013 (Praxair wells) and May 21, 2013 (Bonanza Creek wells) were used to generate a groundwater elevation map (see Figure 1). During the May 2013 monitoring event, the depth to groundwater in

the Bonanza Creek monitoring wells ranged from 6.62 feet below ground surface (bgs) in monitoring well MW12 to 10.01 feet bgs in monitoring well MW06. Based on the groundwater elevation contour map, groundwater flow at the Site is predominantly to the northwest. The hydraulic gradient ranges from approximately 0.00035 feet per foot (ft/ft) across the northern half of the Site to approximately 0.00786 ft/ft across the southern half of the Site.

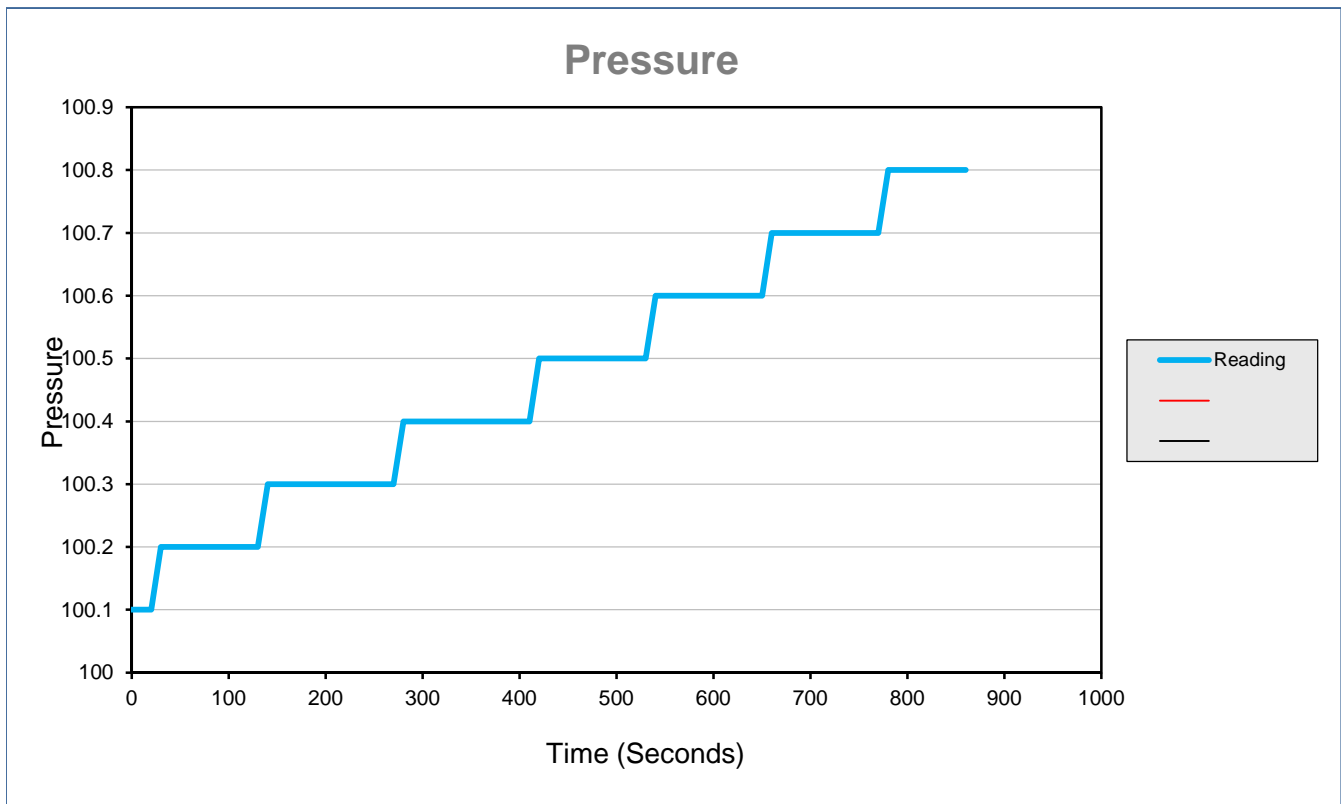
FIGURE 5
INJECTION WELL #57
PRESSURE TEST
WALDEN WATER FLOOD FACILITY
BONANZA CREEK ENERGY INC.

Bonanaza Creek conducted pressure testing on underground lines at the water flood facility on April 4 and April 5, 2013 for the DAK-LAK dump line, injection well 57 line, and the south 1 main injection line. All three lines passed their pressure test and showed no indication of a leak or loss in pressure. The locations of the underground lines are depicted on Figure 3 and the results of the pressure tests are presented in Figure 3 through Figure 6, respectively.
