Subject:      **Produced Water Pit Replacement Closure Report**  
                 Armstrong 2-16G5  
                 API # 05-123-18603  
                 Kersey, Colorado  
                 Fremont Project No. C013-026

**PRODUCED WATER PIT REPLACEMENT**

**ARMSTRONG 2-16G5**

**FREMONT PROJECT NO. C013-026**

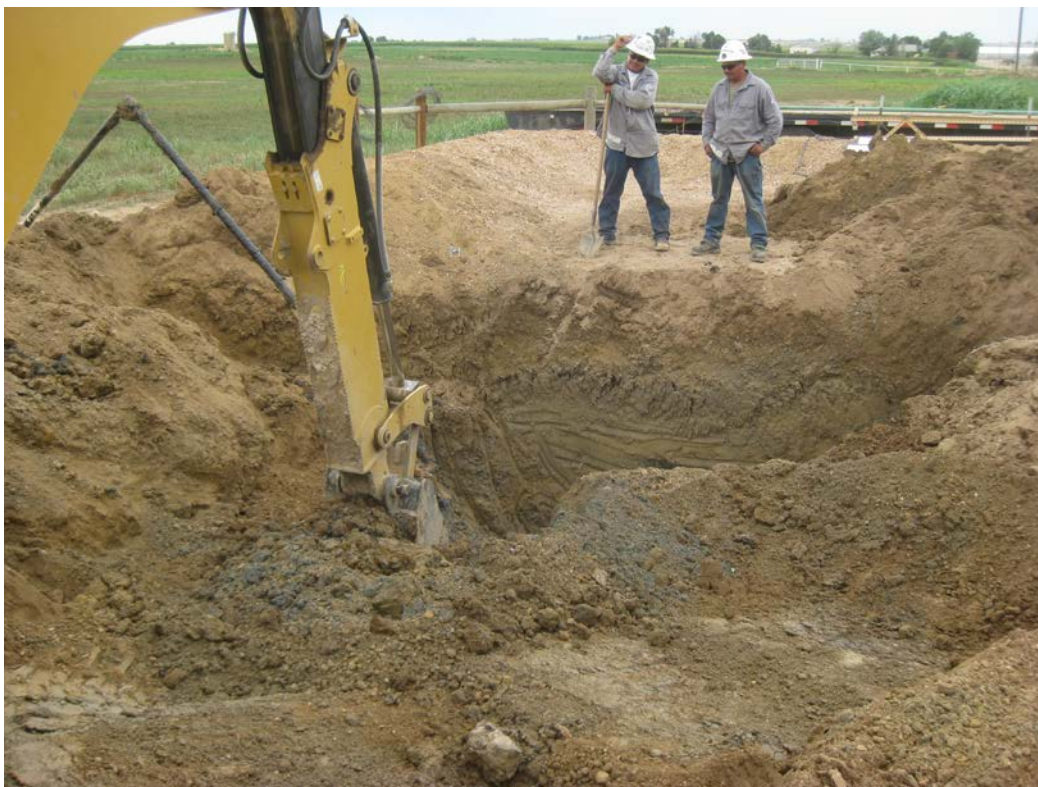
During the excavation and pit removal process, petroleum impacted soil was observed adjacent to the pit to the north and west. Upon further investigation, it was determined that one of the pipe fittings on the dump line had failed. Approximately 25 yards of impacted soil were removed from the location and disposed of as non-hazardous waste.

**Looking northwest at pit excavation after most of the impacted soil was removed.**

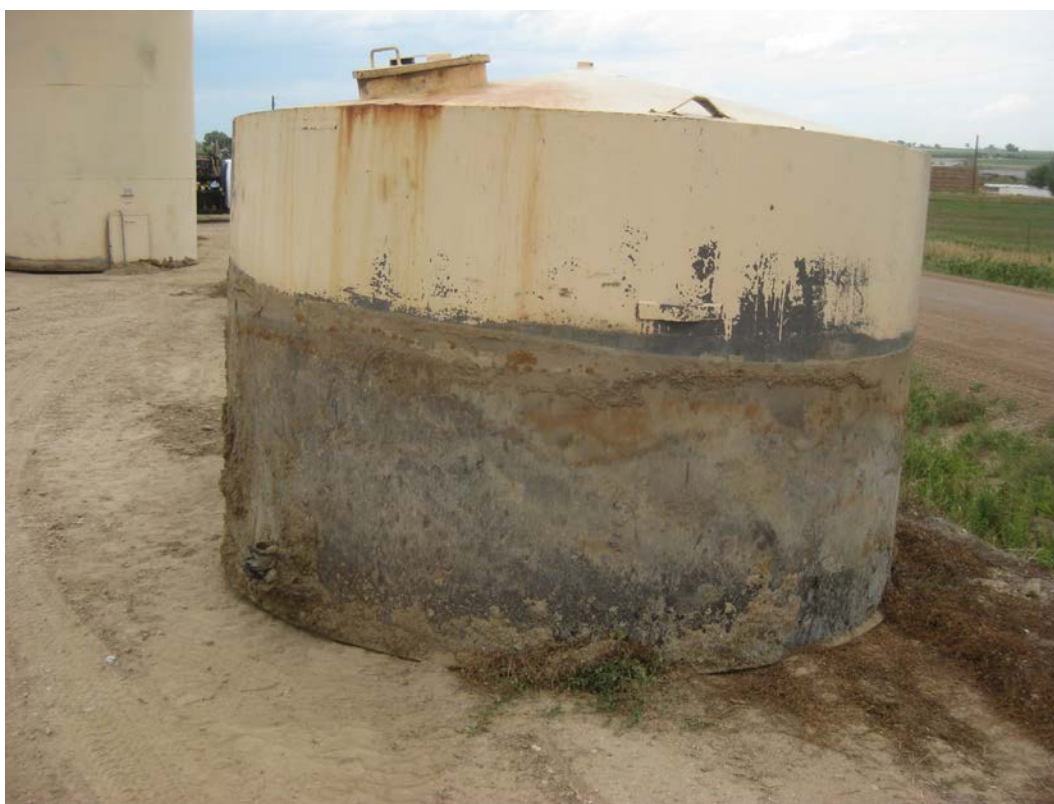
On August 1, 2013, a crew from Ochoa Trucking Services excavated the produced water pit immediately south of the oil storage tank at the site. The steel water pit was removed and inspected for damage. No obvious indication of failure was observed. Regardless, the steel pit was replaced with a new, concrete water pit. Photos of the pit excavation are provided.

**Steel water pit after removal. No indication of failure was observed.**

The steel pit was replaced by a new concrete pit at this same location and the facility was placed back in operation. Fremont personnel did not oversee that portion of the project.
