SPILL/RELEASE REPORT

Date of Incident: <u>8/30/2013</u> Facility Name & No.: <u>Buffalo Ditch #1-32H</u>	County: <u>Jackson</u>
Type of Facility (well, tank battery, flow line, pit): <u>flow line</u>	QtrQtr: <u>SENE</u> Section: <u>32</u>
Well Name and Number: <u>Buffalo Ditch #1-32H</u>	Township: <u>7N</u> Range: <u>80W</u>
API Number: <u>05-057-06463</u> <i>Location ID: 524749</i>	Meridian: <u>6th</u>
Specify volume spilled and recovered (in bbls) for the following materials: Oil spilled: <u>20</u> Oil recov'd: <u>15</u> Water spilled: <u>-</u> Water recov'd: <u>-</u> Other spilled: <u>-</u> Other recov'd: <u>-</u>	
Ground Water impacted? <input type="checkbox"/> Yes <input checked="" type="checkbox"/> No	Surface Water impacted? <input type="checkbox"/> Yes <input checked="" type="checkbox"/> No
Contained within berm? <input type="checkbox"/> Yes <input checked="" type="checkbox"/> No	Area and vertical extent of spill: <u>(200' x 10') Area</u> x <u>.04'</u> vertical

Buffalo Ditch 1-32H (05-057-06463), Jackson County, CO

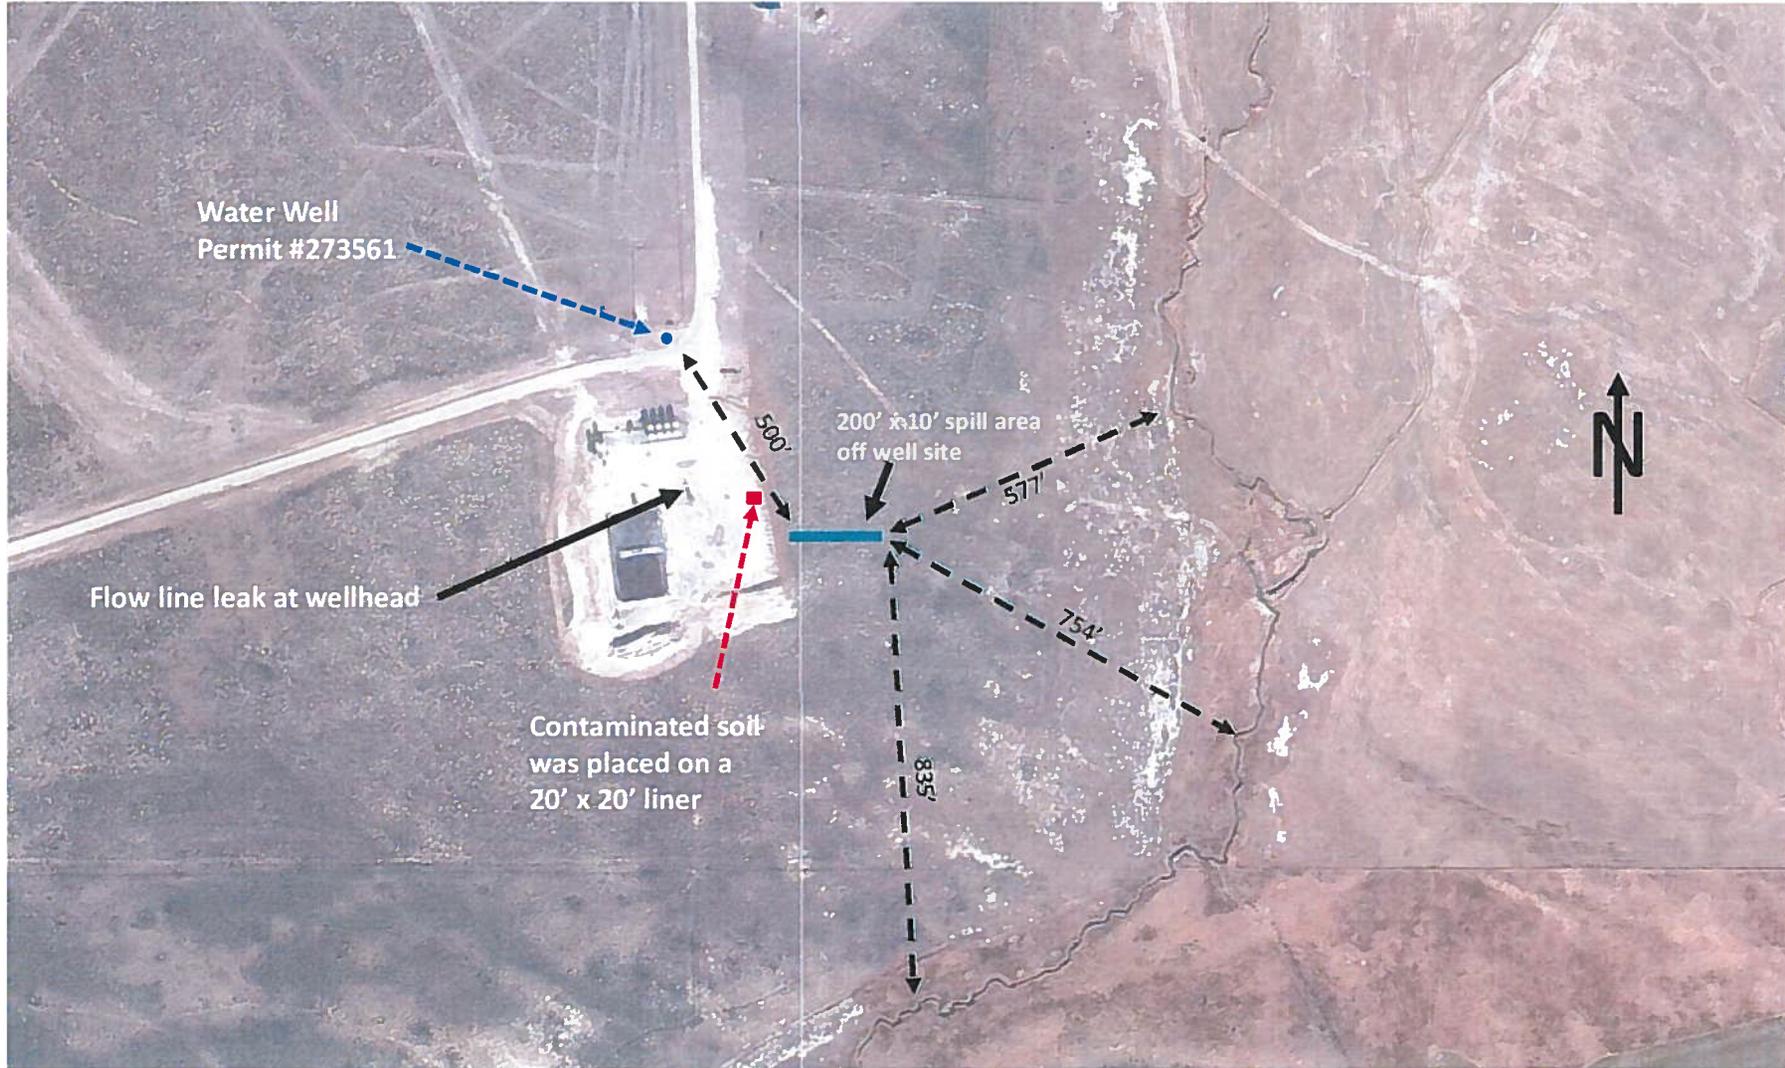
20 barrel spill occurred on 8/30/2013 from a flow line at the wellhead. The affected area off the well site is approximately 200' x 10'. Free oil was removed with a vac truck (15 bbls). The affected soil was removed, mixed with Eco-Sponge (enzymes) and placed on a (20x20) plastic liner on the pad within 12 hrs. The nearest open water is 577' to the east-northeast and was not impacted. The nearest water well is approximately 500' NE of the affected soil and also was not impacted.

The surface flow line at the wellhead developed an erosional failure in the wall of the pipe. The failure occurred from the inside and was undetectable by visual inspection. The failure occurred during the night and was noticed when our pumper visited location the next morning. It was noted that oil had left the SE corner of the location and had flowed onto range land, an area approximately 200' x 10'.

The well was shut-in and a vac truck called to pick up the free oil. It is estimated that approximately 20 barrels had been spilled and 15 barrels were recovered via the vac truck.

The land owner was notified within an hour and a plastic liner placed on the well pad. Oil stained soil was mixed with Eco-sponge, a wood shaving & enzyme product and the mixture placed on an impermeable liner placed on the well pad. The volume of the mixture is 20'x20'x3'.

The soil & Eco-sponge mixture will be tested to ensure that it meets COGCC guidelines before being returned to the location.

Containment berms will be placed around all wellheads that utilize down hole jet pumps.

Surface flow lines on these wells will be pressure tested annually to 4,000 psig. Charts of these pressure tests will be kept in the company well files and provided to the COGCC upon request.
