Subject:     **Produced Water Pit Replacement Closure Report**  
              UPRC 23-3 NWSE Sec 23, T5N, R64W  
              API # 05-123-18089  
              Kersey, Colorado  
              Fremont Project No. C013-018

**PRODUCED WATER PIT REPLACEMENT**

**UPRC 23-3**

**FREMONT PROJECT NO. C013-018**

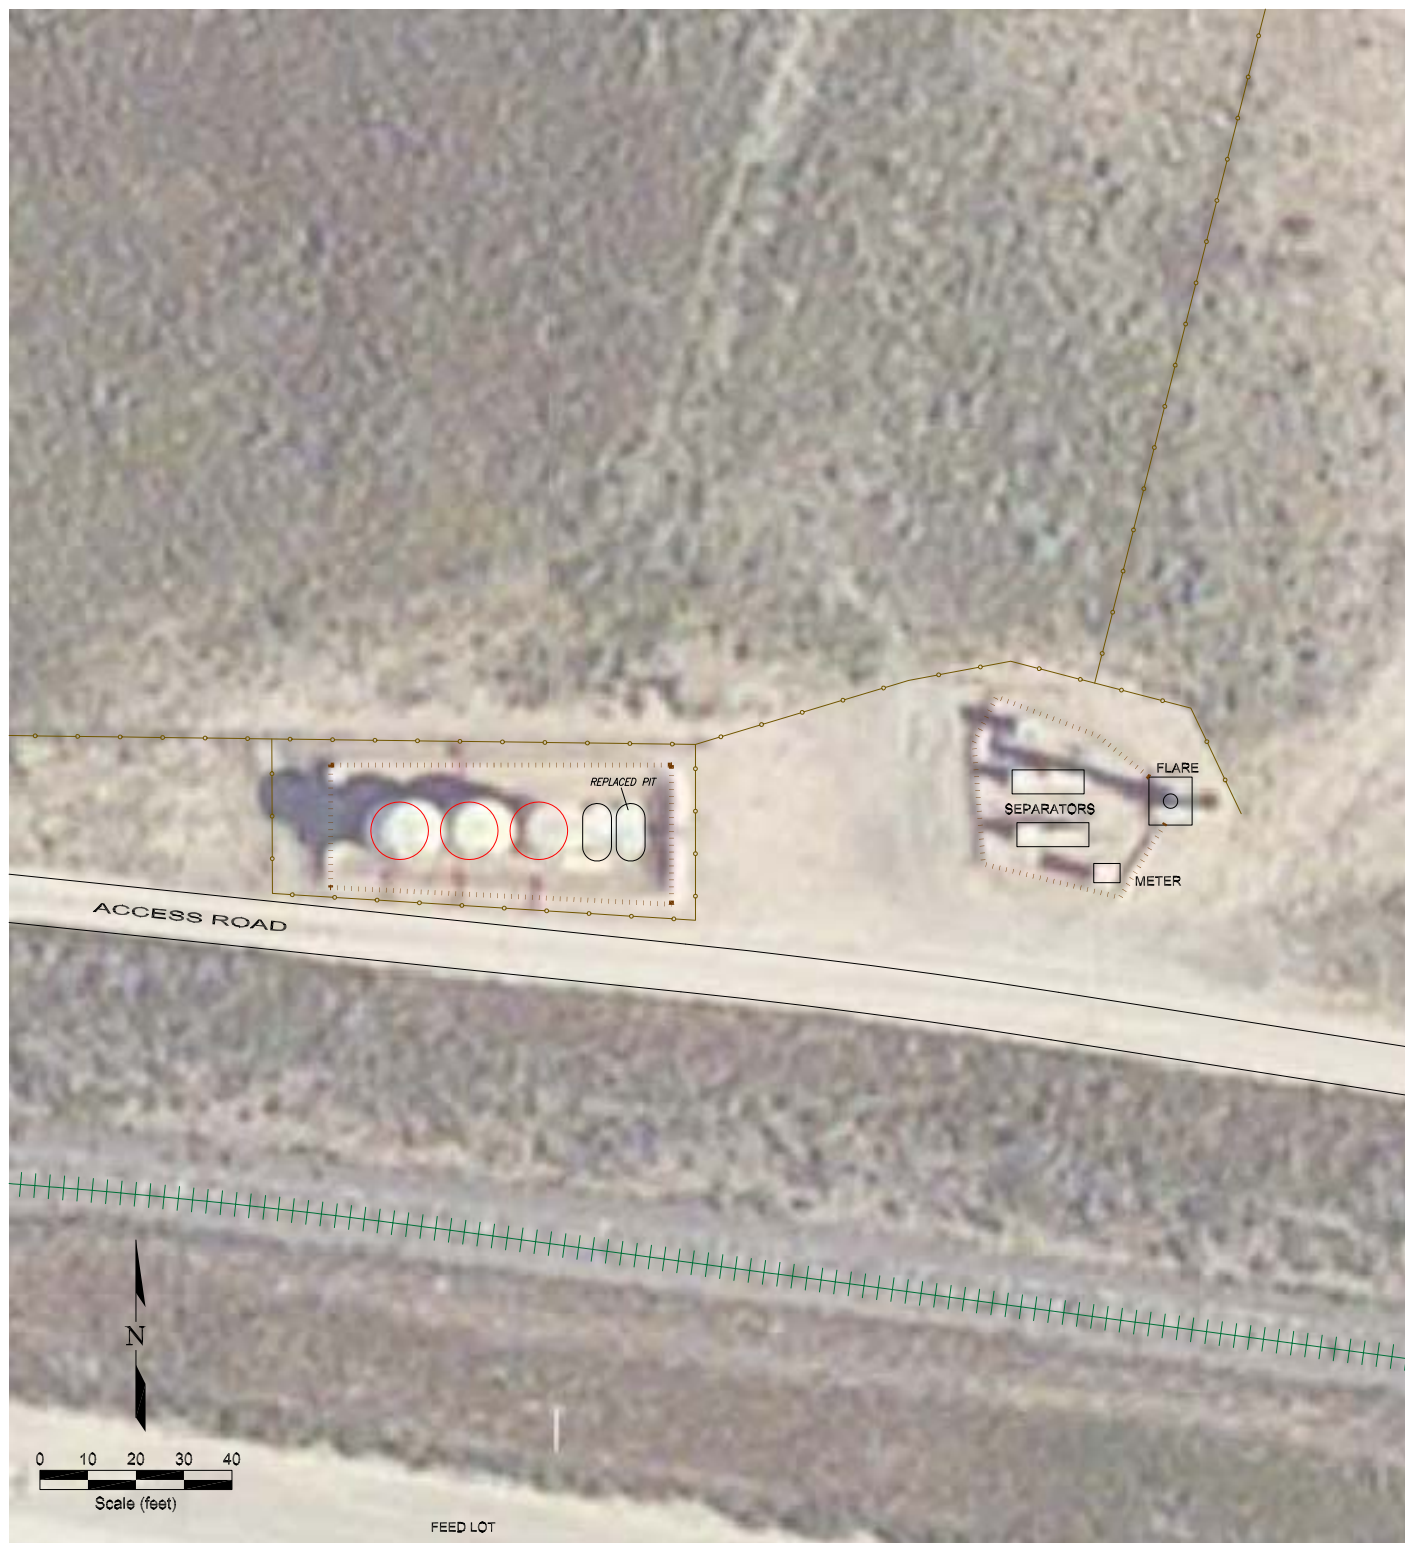
Figure 2

The site is a natural gas production and oil storage facility for the UPRC 23-3 and CPC Ferguson wells as shown on Figure 2, Site Map. This well was drilled in 1994 to a depth of approximately 7,650 feet. In July 2013, it was determined that the produced water concrete pit was unable to maintain its water level indicating a potential problem with the pit.

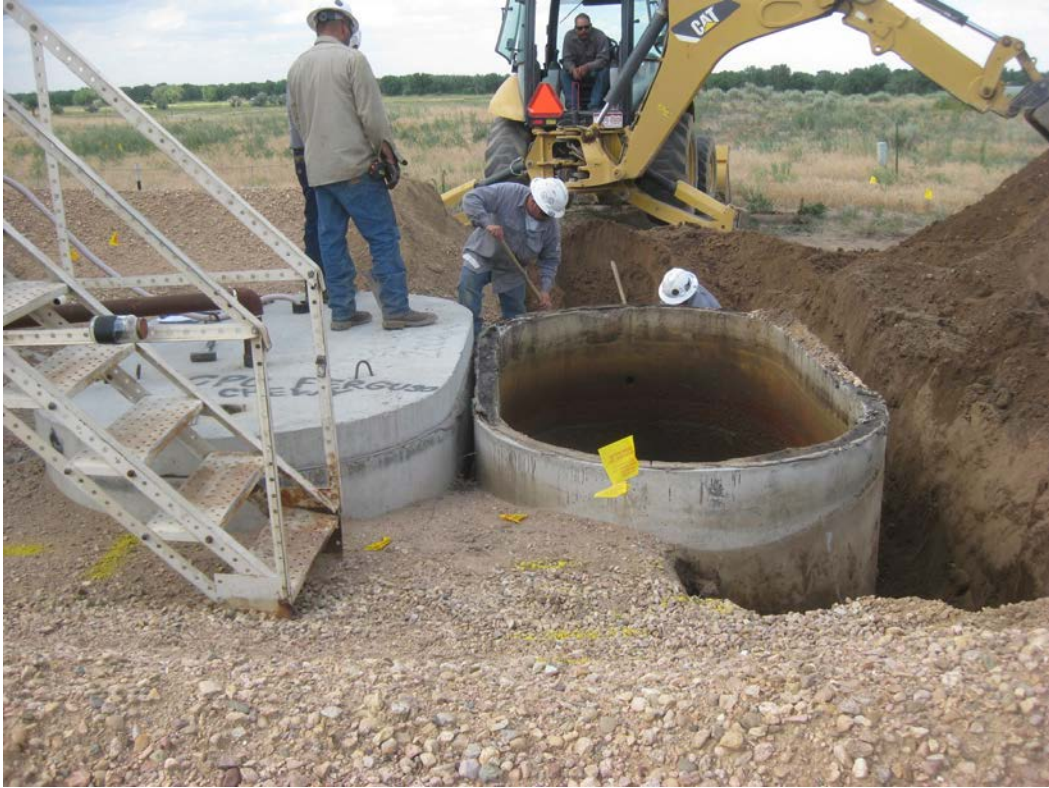
**Looking north at produced water pit to be replaced (right side of photo)**

The concrete pit was replaced by a new pit at this same location. Fremont personnel did not oversee that portion of the project.

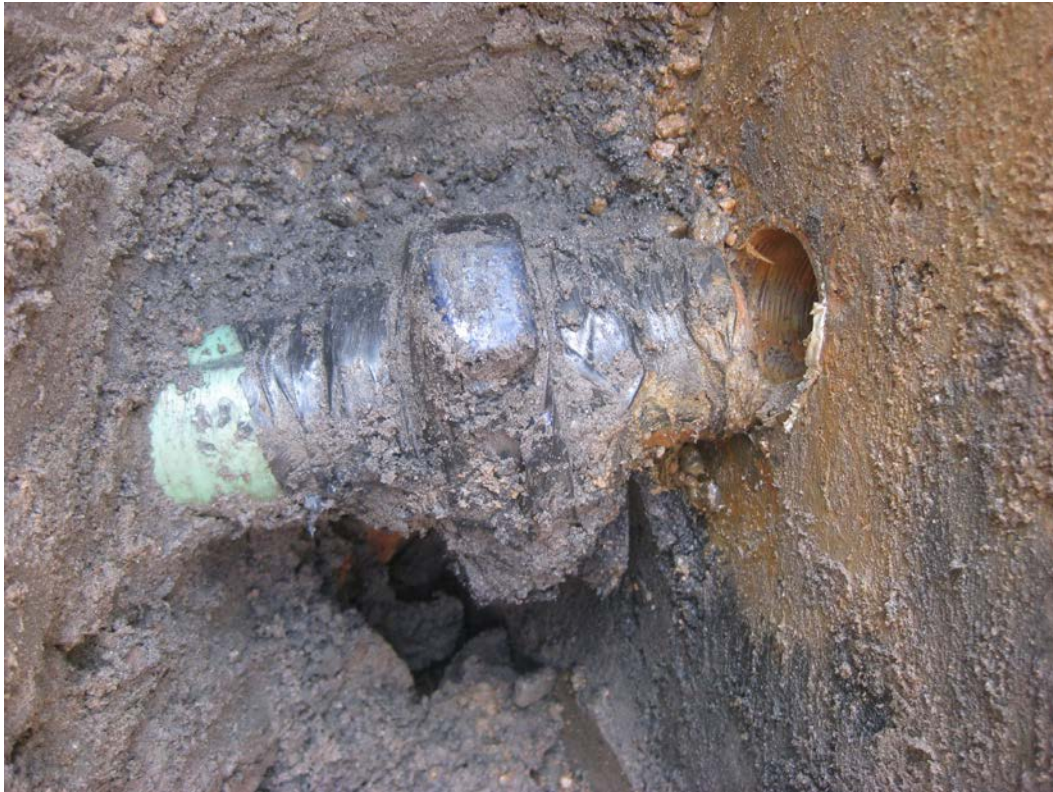
During excavation, it was noted that the dump line nipple had failed on the south end of the produced water pit. This inlet to the pit was approximately one foot above the bottom of the pit. Therefore, the pit was unable to maintain a higher level than this elevation. Photos of the pit excavation and broken nipple are provided.

A soil sample was collected immediately adjacent to the broken nipple on the side wall of the excavation at a depth of approximately 3.5 feet. This soil sample was submitted to eAnalytics Laboratory, Inc. (eAnalytics) in Loveland, Colorado for the analyses of benzene, toluene, ethylbenzene and xylenes (BTEX), naphthalene, Total Petroleum Hydrocarbons-Gasoline Range Organics (TPH-GRO) by EPA Method 8260C and TPH-Diesel Range Organics (TPH-DRO). In addition, this side wall sample was also analyzed for three inorganic parameters including sodium absorption ratio (SAR), electrical conductivity (EC) and pH.

The laboratory data indicated that the BTEX, TPH-GRO, TPH-DRO and naphthalene constituents were below their respective laboratory detection limits for both soil samples. However, an elevated value of SAR was present in the side wall sample. The SAR concentration was 29.3 (unitless) compared to the Colorado Oil and Gas Commission's (COGCC's) Table 910-1 limit of 12 (unitless). A copy of the laboratory reports, quality control data, and chain-of-custody documentation are presented in Appendix A.

**The dump line nipple failed where it was attached to the concrete pit**
