Praxair Walden CO2 Plant

October 22, 2013

CO2 Plant Operations

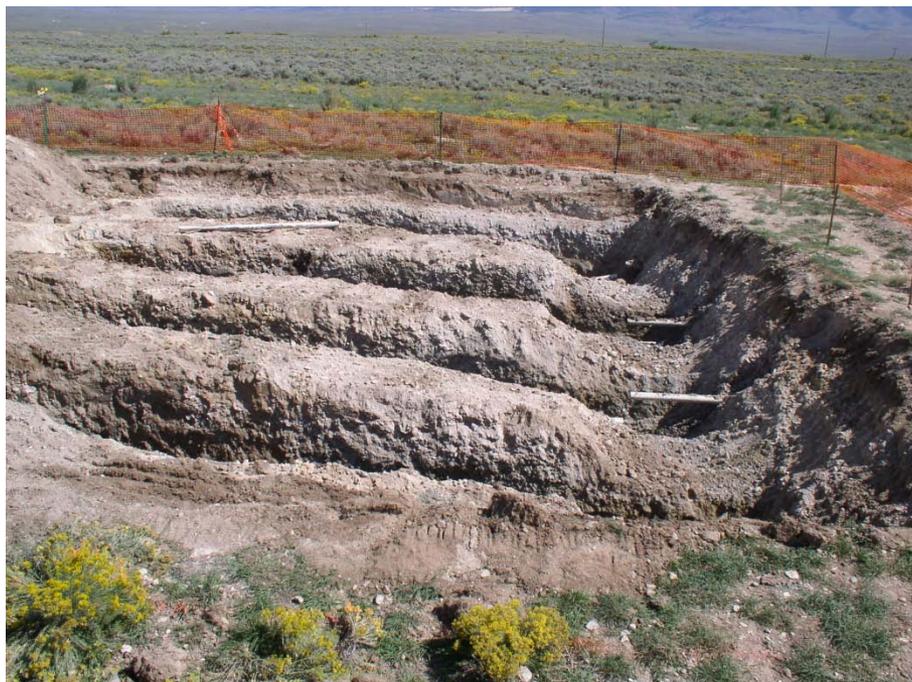
- Discovered high concentrations in May 2008
 - No historical data from surrounding area to pinpoint source
- Installed up gradient MW-9 and MW-10 in Aug 2009
- No indication of release in those wells
- Conducted extensive investigation in May 2010
 - 15 borings and groundwater samples collected
 - Source appeared to be near SE corner of plant
 - DP-7 and DP-8 on eastern property boundary
 - Benzene concentrations: 2,000 and 1,100 ug/L
 - DP-14 near vent pipes
 - Benzene concentration: <5 ug/L
- Concluded vent pipes were not source
- Plume migrating onsite from east
 - Installed MW-11 in Aug 2011 to confirm

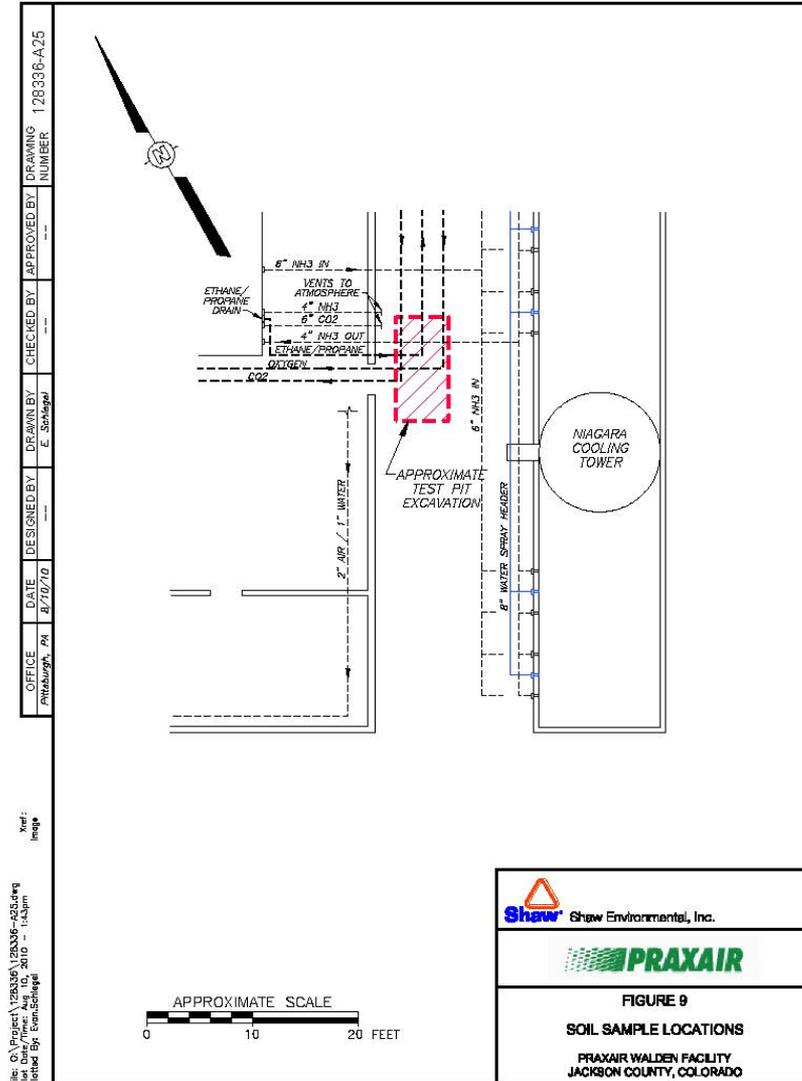
- Focused investigation on underground piping where pipes elbow coming out of plant
- June 2010
- Hand digging to uncover pipes
- Hand augering
 - collect samples below pipes
- No petroleum impacts
 - No odors
 - No staining
 - No hits on PID

- Oct 2010 - CCTV on ethane/propane return line for 50' including three elbows
 - All other lines active so no test could be conducted
- No breaches or holes visible; bottom half of pipe in good condition
- Concluded MW-4 impact not from underground lines
- Installed iSOC unit in MW-4 in Nov 2010
- Significant drop in BTEX concentration after 6 months of operating
 - 1,450 ug/L to 1.1 ug/L
- Concentrations have rebounded after initial decline

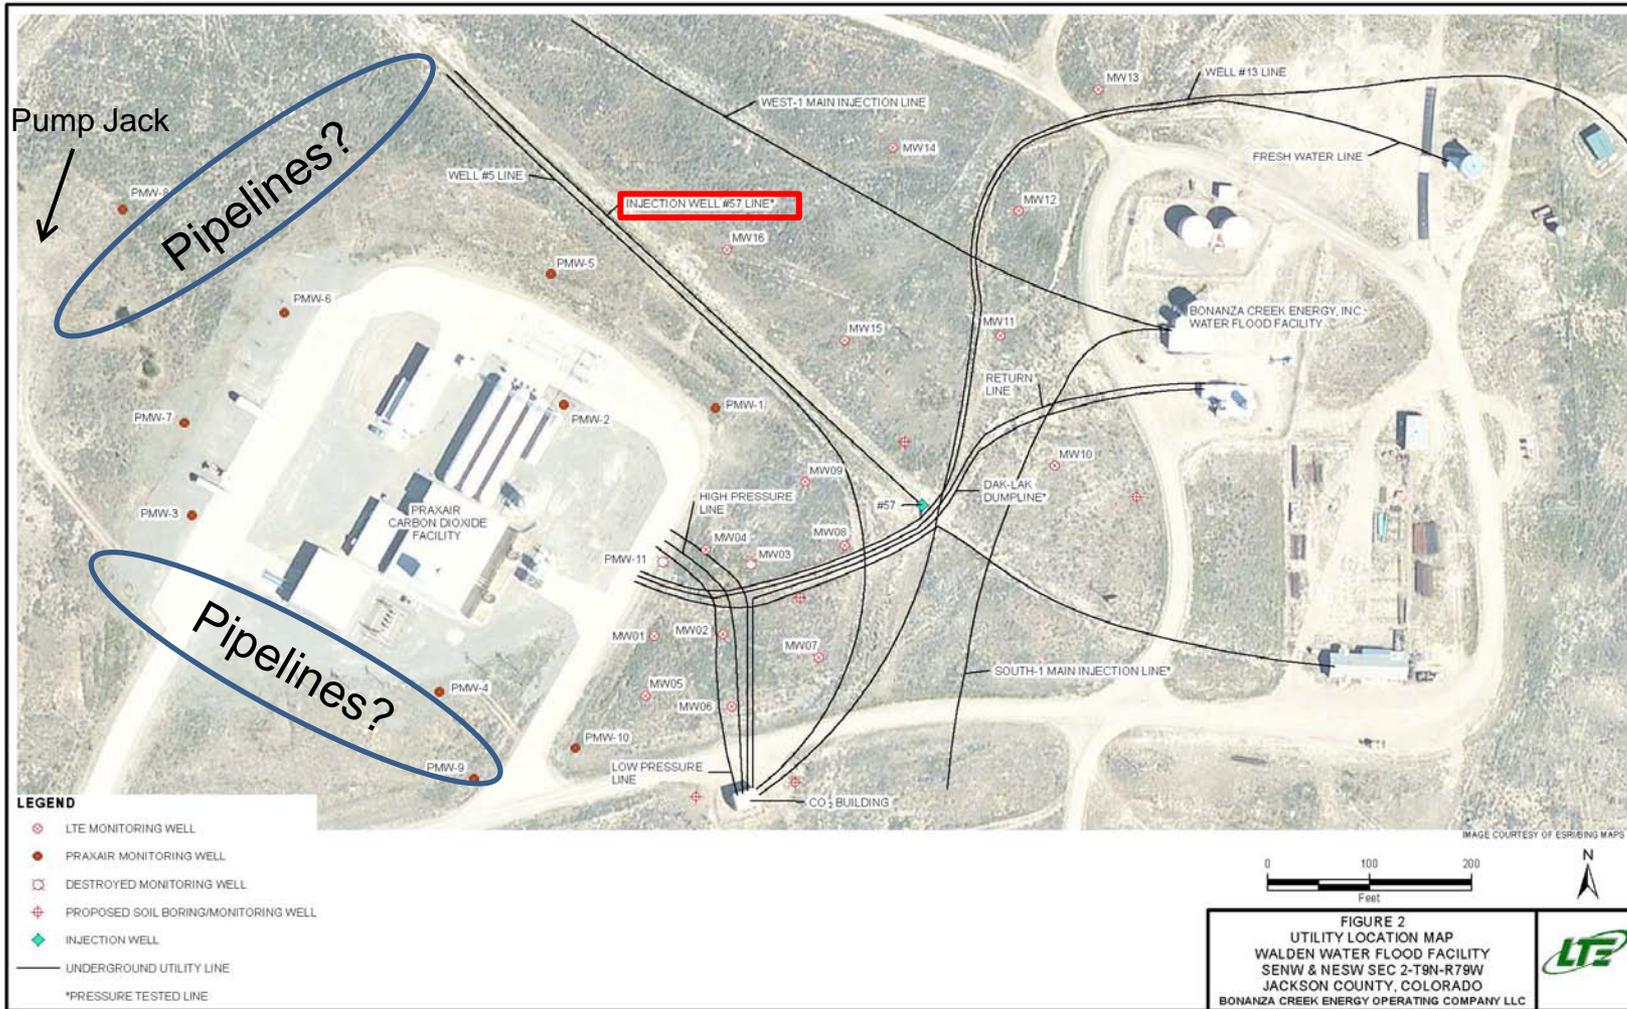
Pump Jack

- Offsite plume based on groundwater flow
 - Impacted MW-11
- Pockets of petroleum in groundwater in oil field from historical operations?
 - Seep approximately ¼- mile north of MW-8
- Injection well #57 and/or conveyances?
- Pump jack near MW-8?
- All plant equipment on concrete slab with no visible signs of cracking
