**Damage Investigation
Crescent 3D**

March 13, 2013

Subject: Turley Water well, 16423 CR 20 Ft Lupton, Colorado

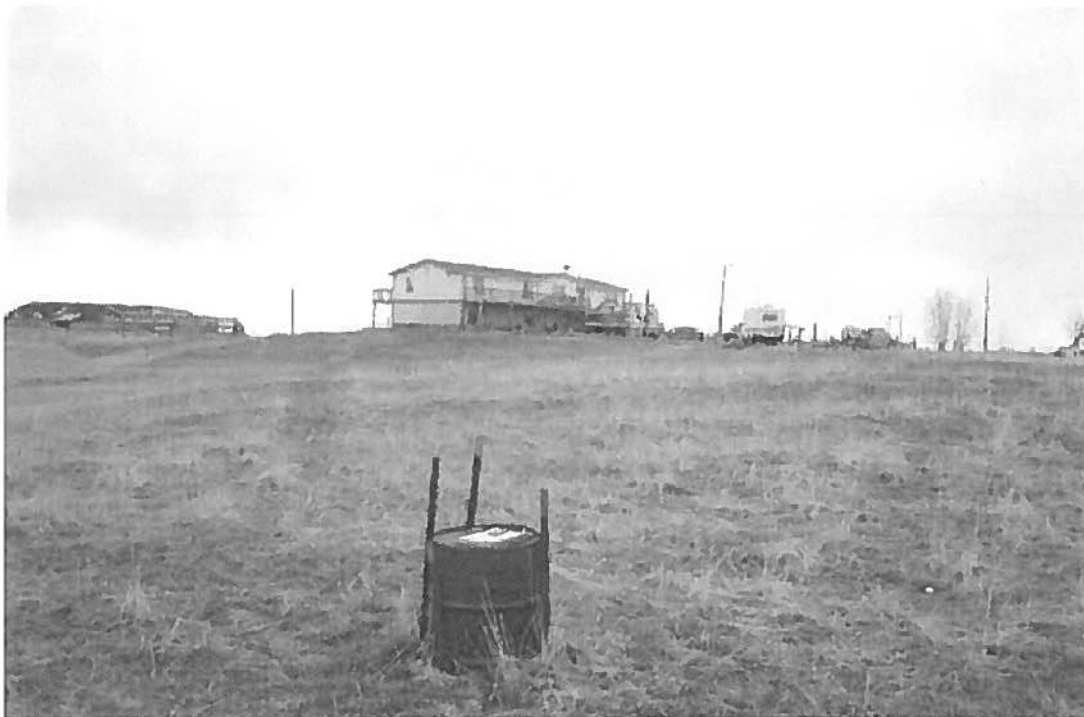
Figure 2 Turley water well and residence.

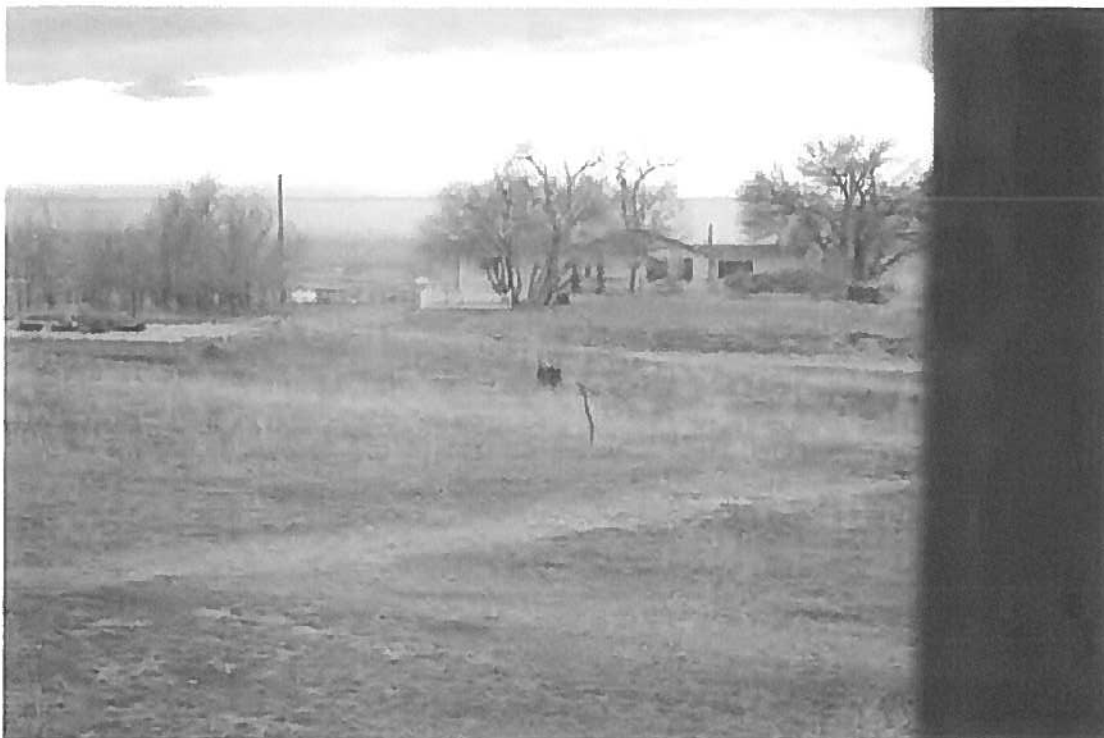
Figure 3 View of water well from Turley residence.

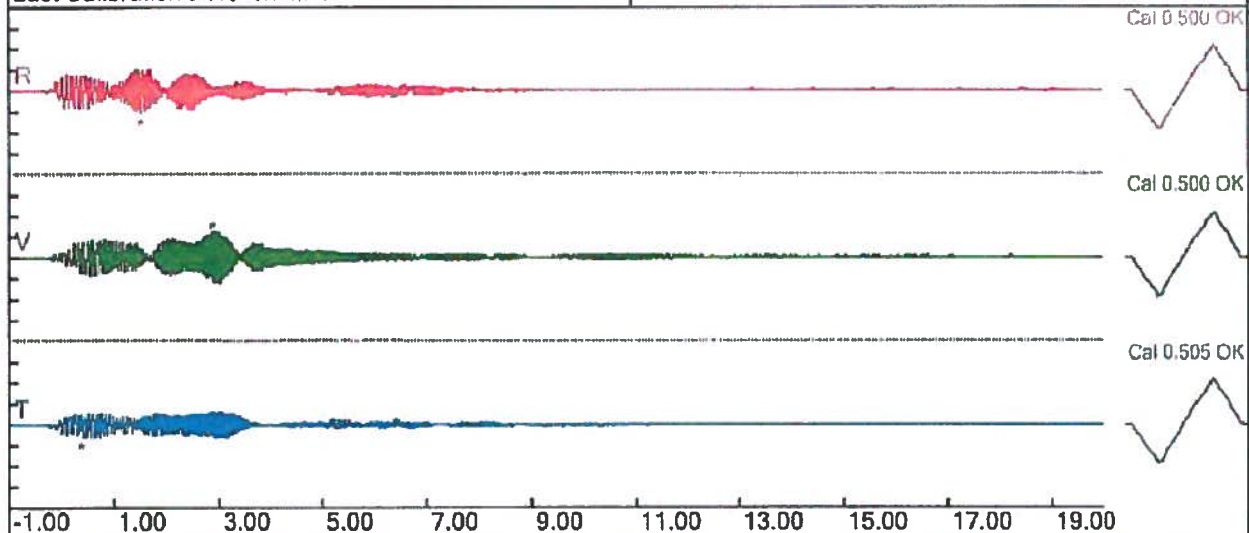
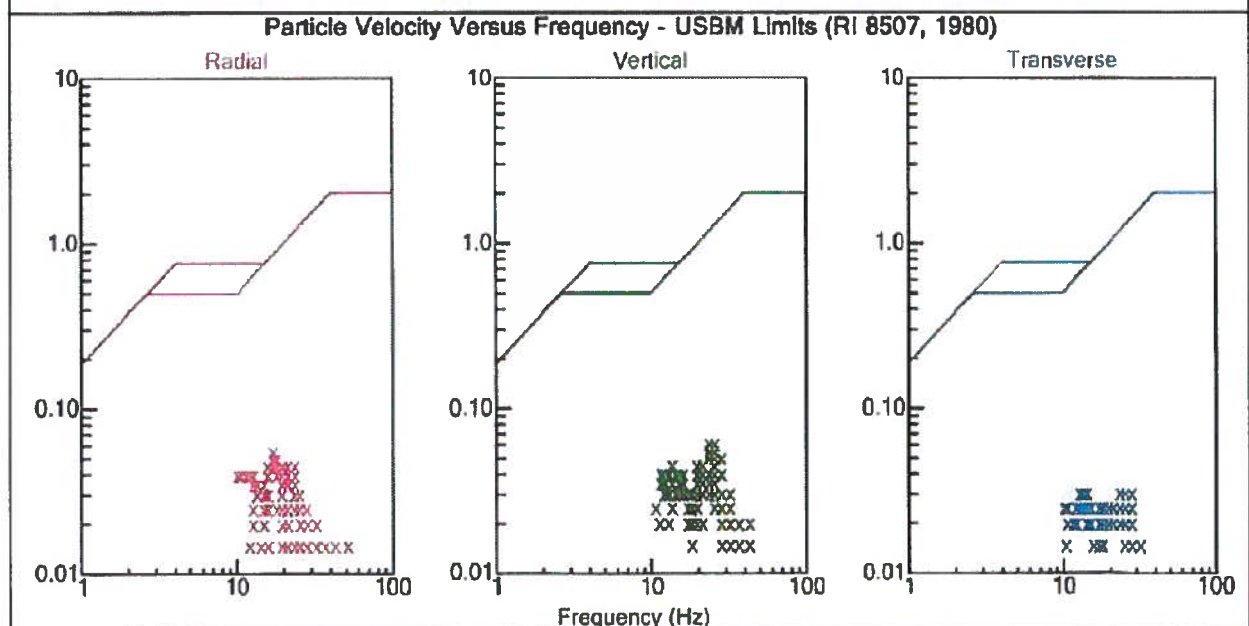
Crescent 3D - Monitor Record Summary **Set up in Pasture 264 ft NW of NW corner** **of White Two story house w/ green Trim**

Source Point: 54631622
Distance: 135 ft.
Number of Vibes: 3
Drive Level: High

Peaks and Frequencies	Graph Information
PPV Maximum: 0.060 in/sec (2.8867 sec)	Duration: -1.000 s To: 20.000 s
Radial: 0.055 in/sec @ 17.0Hz (1.5215 sec)	Seismic Scale: 0.20 in/sec (0.050 in/sec/div)
Vertical: 0.060 in/sec @ 25.6Hz (2.8867 sec)	Time Intervals: 2.00 sec
Transverse: 0.030 in/sec @ 28.4Hz (0.3848 sec)	
Last Calibration Date: 9/21/2011

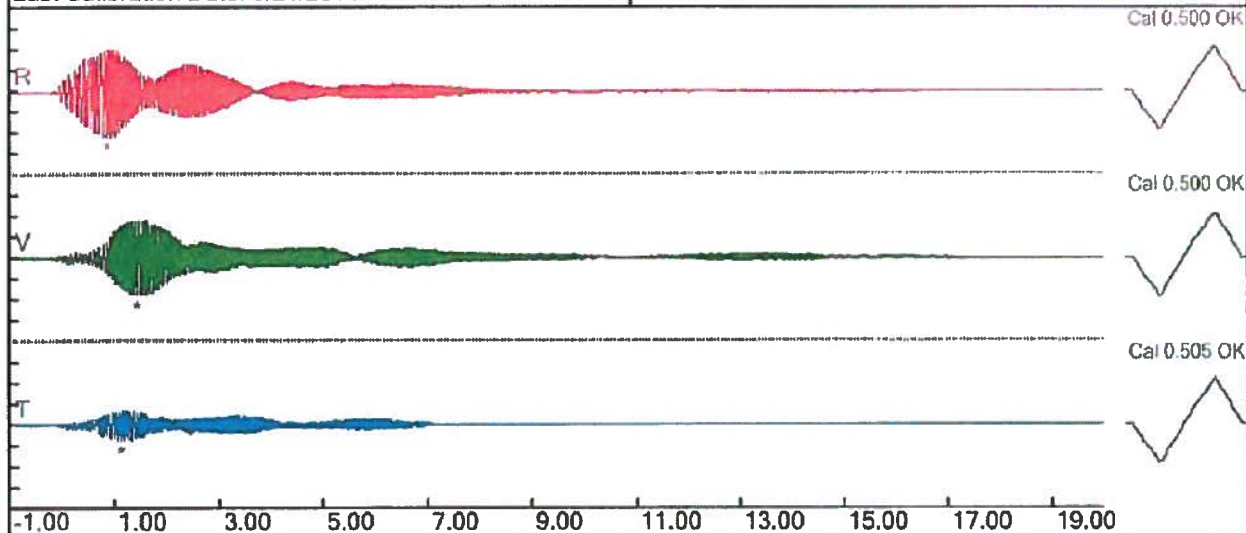
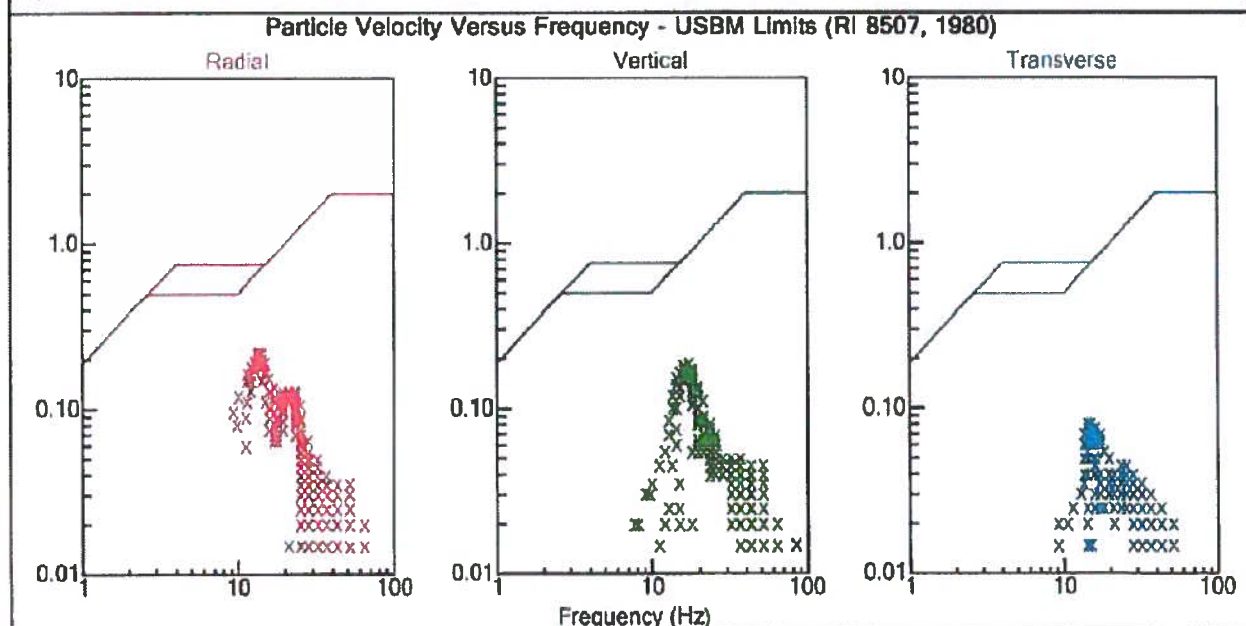
Crescent 3D - Monitor Record Summary **Set up in Pasture 234 ft NW of NW corner** **of White Two story house w/ green Trim**

Source Point: 54631623
Distance: 102 ft.
Number of Vibes: 3
Drive Level: High

Peaks and Frequencies	Graph Information
PPV Maximum: 0.220 in/sec (0.8828 sec)	Duration: -1.000 s To: 20.000 s
Radial: 0.220 in/sec @ 13.4Hz (0.8828 sec)	Seismic Scale: 0.40 in/sec (0.100 in/sec/div)
Vertical: 0.185 in/sec @ 17.0Hz (1.4531 sec)	Time Intervals: 2.00 sec
Transverse: 0.080 in/sec @ 15.0Hz (1.1504 sec)	
Last Calibration Date: 9/21/2011

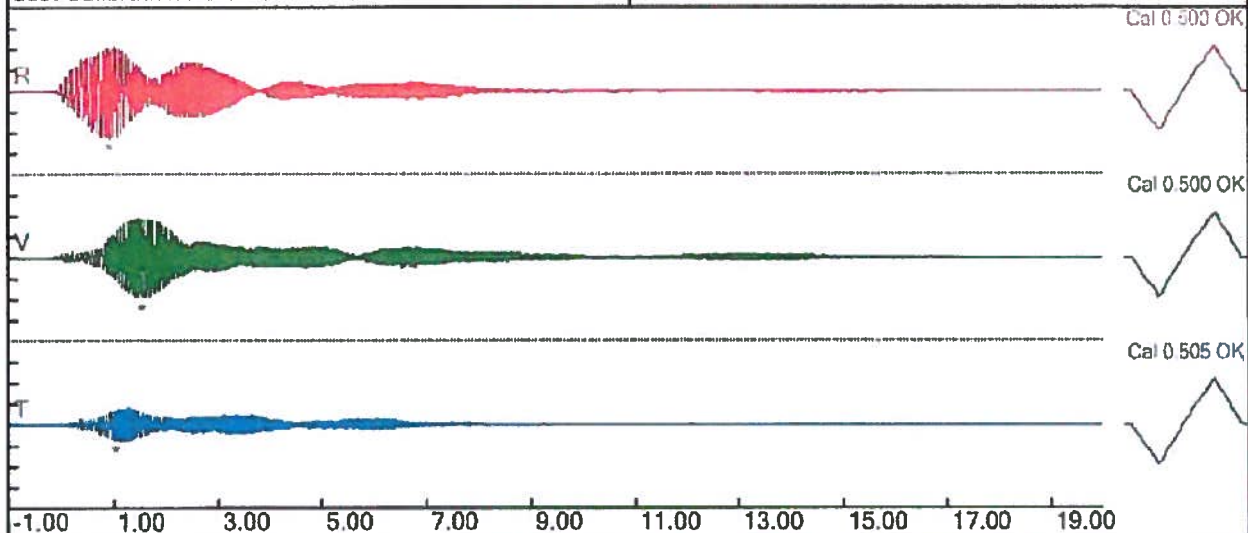
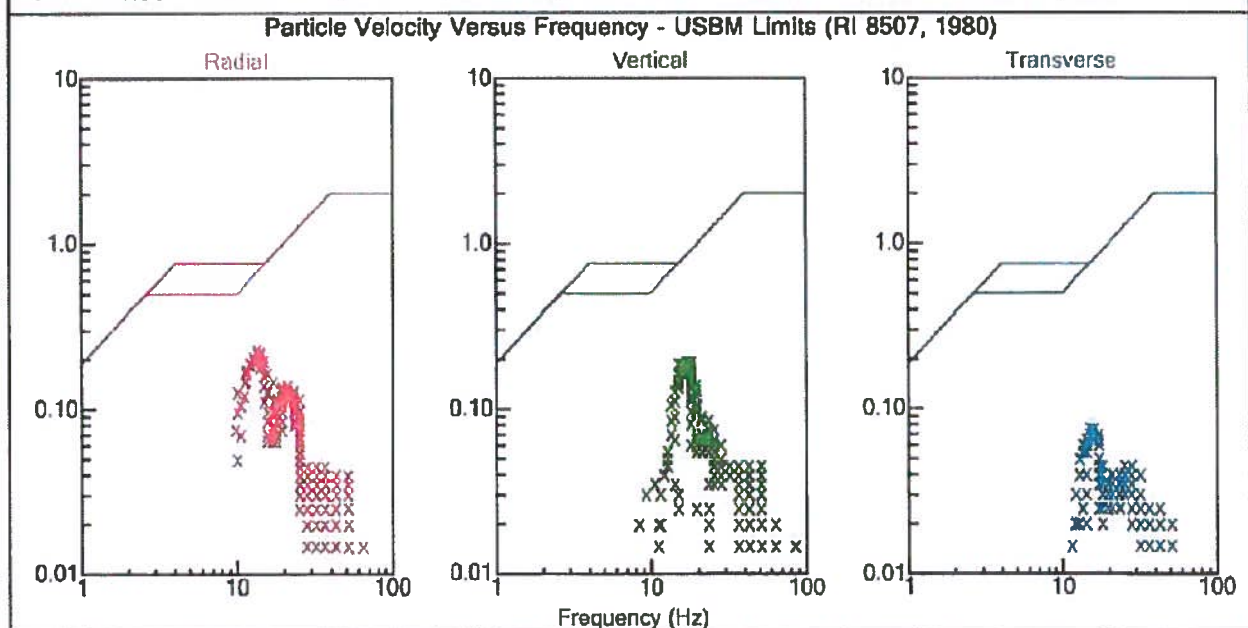
Crescent 3D - Monitor Record Summary
Set up in Pasture 234 ft NW of NW corner
of White Two story house w/ green Trim

Source Point: 54631623
Distance: 102 ft.
Number of Vibes: 3
Drive Level: High

Peaks and Frequencies	Graph Information
PPV Maximum: 0.225 in/sec (0.9258 sec)	Duration: -1.000 s To: 20.000 s
Radial: 0.225 in/sec @ 14.2Hz (0.9258 sec)	Seismic Scale: 0.40 in/sec (0.100 in/sec/div)
Vertical: 0.195 in/sec @ 17.0Hz (1.5566 sec)	Time Intervals: 2.00 sec
Transverse: 0.075 in/sec @ 15.1Hz (1.0547 sec)	
Last Calibration Date: 9/21/2011
