SPILL/RELEASE REPORT

Date of Incident: <u>14-Nov-11</u>	Facility Name & No: <u>Rangely Weber Sand Unit</u>	County: <u>Rio Blanco</u>
Type of Facility (well, tank battery, flow line, pit): <u>Injection System / Injection Line</u>		QtrQtr: <u>SWNW</u> Section: <u>23</u>
Well Name and Number: <u>AC McLaughlin 52X</u>		Township: <u>2N</u> Range: <u>103W</u>
API Number: <u>05-103-0642500</u>		Meridian: <u>6PM</u>
Specify volume spilled and recovered (in bbls) for the following materials:		
Oil spilled: <u>0</u>	Oil recov'd: <u>0</u>	Water spilled: <u>159.15 bbl</u> Water recov'd: <u>148.10 bbl</u> Other spilled: <u>0</u> Other recov'd: <u>0</u>
Ground Water impacted? <input type="checkbox"/> Yes <input checked="" type="checkbox"/> No	Surface Water impacted? <input type="checkbox"/> Yes <input checked="" type="checkbox"/> No	
Contained within berm? <input type="checkbox"/> Yes <input checked="" type="checkbox"/> No	Area and vertical extent of spill: <u>2610 X 159 feet</u>

Chevron-AC McLaughlin 52X

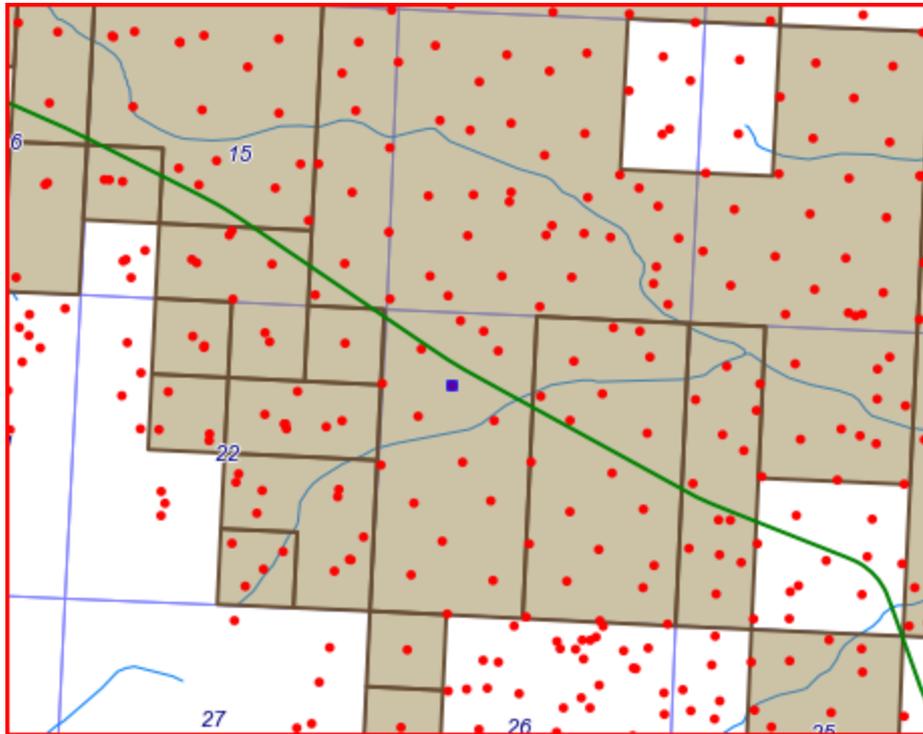
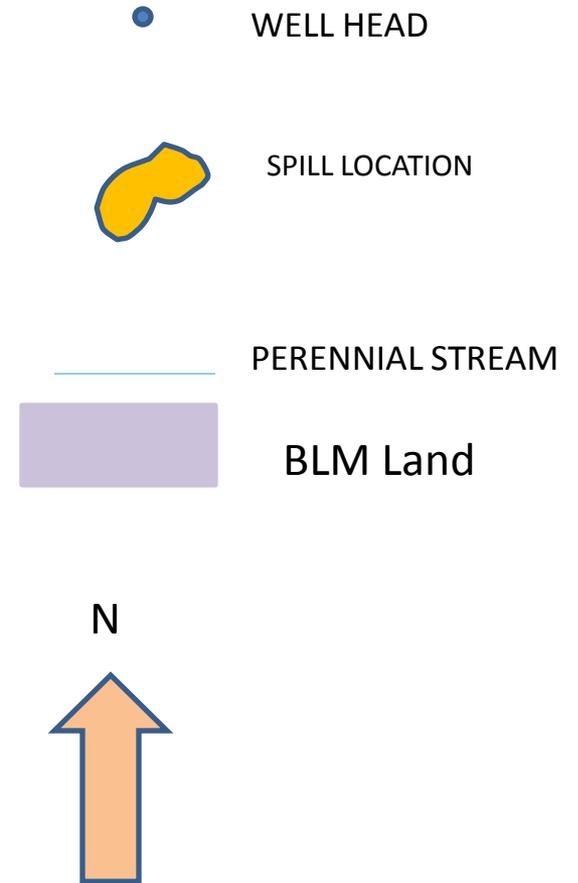
Current land use: <u>Non Crop Land</u>	Weather conditions: <u>55 Degrees F and Sunny</u>	
Soil/geology description: <u>Silty Clay</u>		
IF LESS THAN A MILE, report distance IN FEET to nearest ... Surface water: <u>N/A</u> wetlands: <u>N/A</u> buildings: <u>N/A</u>		
Livestock: <u>N/A</u> Water wells: <u>N/A</u> Depth to shallowest ground water: <u>N/A</u>		
Cause of spill (e.g. equipment failure, human error, etc.): <u>Threads separated from the line.</u> Detailed description of the spill/release incident:		
<u>A leak occurred on a three inch fiberglass pipe approximately 200 feet East of AC McLaughlin 52X. Approximately 159.15 bbls of brine water and 0 bbls of crude oil were released.</u>

Describe immediate response (how stopped, contained and recovered): The line was shut in immediately upon detection. Vacuum trucks removed all of the free fluid, estimated recovery is approximately 148.10 bbls of brine water and 0 bbls of crude oil. The fluids that were picked up, were taken to the truck unloading facility at the Main Water Plant for recycling.

Describe measures taken to prevent problem from reoccurring: Line will be repaired and returned to service.
