SPILL/RELEASE REPORT

Date of Incident: 16-Aug-11	Facility Name & No: Rangely Weber Sand Unit	County: Rio Blanco
Type of Facility (well, tank battery, flow line, pit): Injection Well		QtrQtr: SWNW Section: 29
Well Name and N Fee 114X		Township: 2N Range: 102
API Number: 05-103-080311		Meridian: 6PM
Specify volume spilled and recovered (in bbls) for the following materials:		
Oil spilled: 0	Oil recov'd: 0	Water spilled: 105.65
Water recov'd: 104	Other spilled: 0	Other recov'd: 0
Ground Water impacted? <input type="checkbox"/> Yes <input checked="" type="checkbox"/> No	Surface Water impacted? <input type="checkbox"/> Yes <input checked="" type="checkbox"/> No	
Contained within berm? <input type="checkbox"/> Yes <input checked="" type="checkbox"/> No	Area and vertical extent of spill: 596.2 X 2.5	
Current land use: Non Crop Land	Weather conditions: 60 Degrees Cloudy	
Soil/geology description: Silty Clay		
IF LESS THAN A MILE, report distance IN FEET to nearest ... Surface water: N/A wetlands: N/A buildings: N/A

CHEVRON –FEE 114X

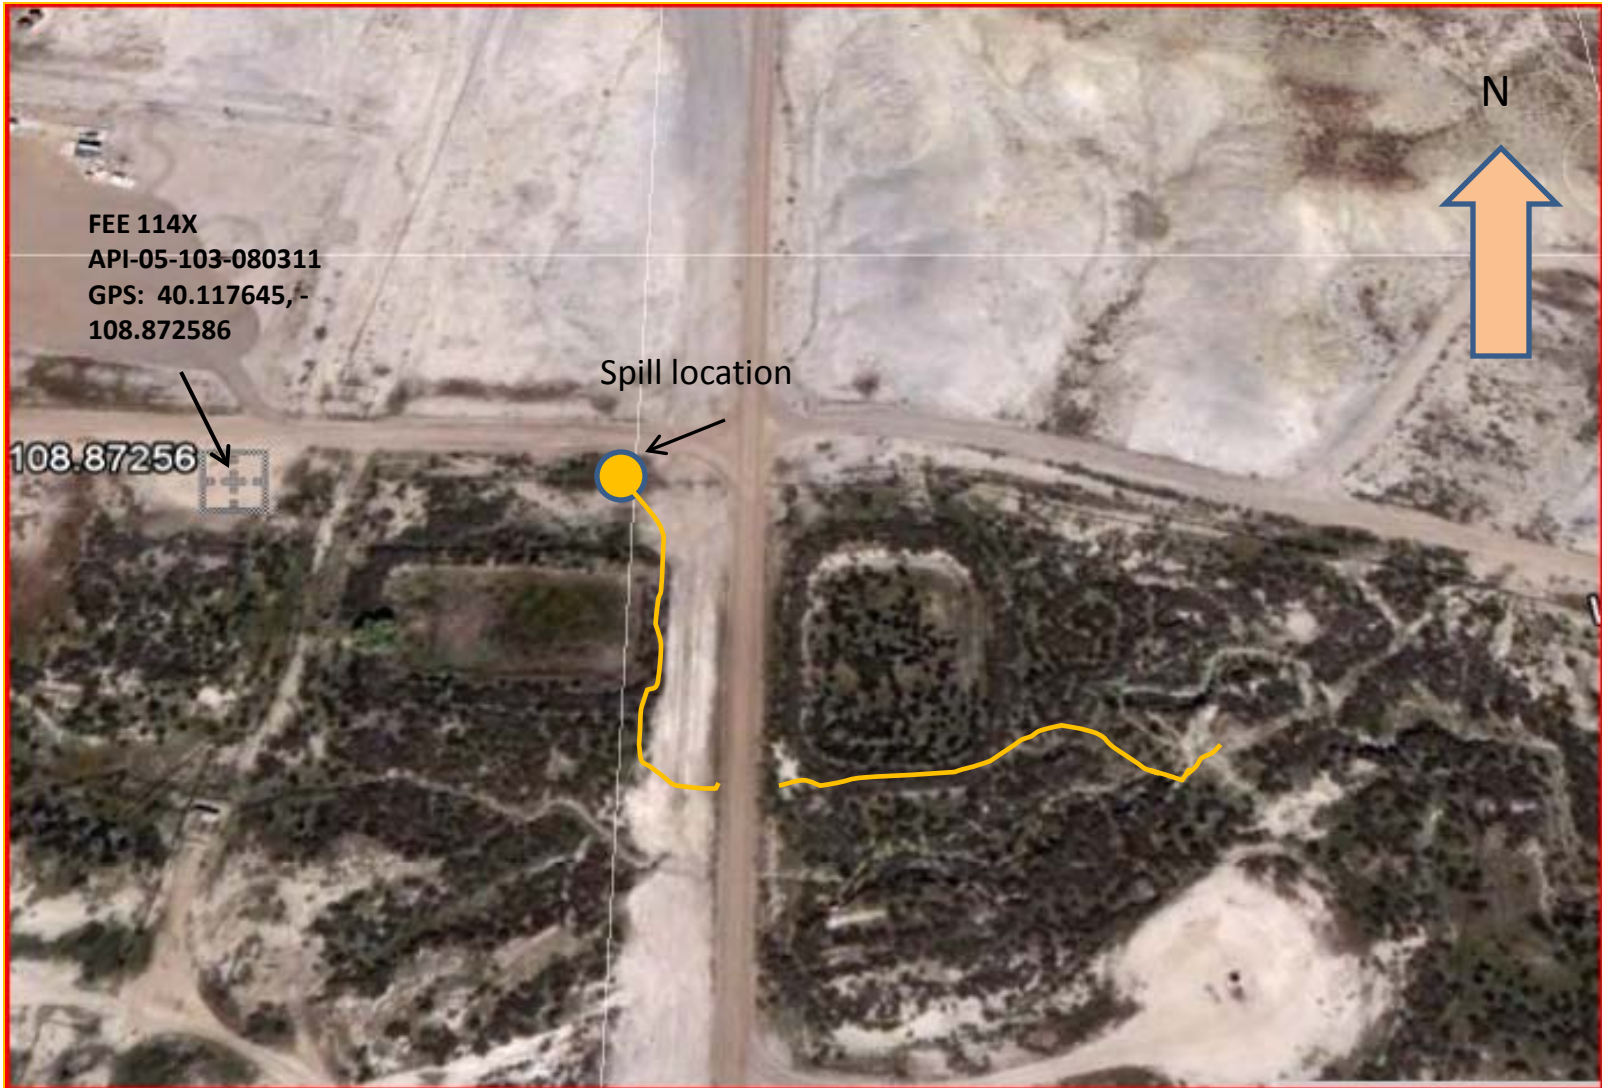
CHEVRON – FEE 114X

Livestock: N/A Water wells: N/A Depth to shallowest ground water: N/A		
Cause of spill (e.g. equipment failure, human error, etc.): Internal Corrosion		
Detailed description of the spill/release incident: A leak occurred on a 10 inch steel pipe approximately 450 feet west of Well Fee 114X. Approximately 105.65 bbls of brine water were released.

Describe measures taken to prevent problem from reoccurring: The damaged section of pipe (270 feet) will be replaced.
