SPILL/RELEASE REPORT

Date of Incident: <u>04/01/2014</u> Facility Name & No: <u>Vassar/Heath-66S94W27NWSW (COGCC # 324124)</u>	County: <u>Garfield</u>
Type of Facility (well, tank battery, flow line, pit): <u>RMV 229-27 Tank Battery</u>	QtrQtr: <u>NWSW</u> Section: <u>27</u>
Well Name and Number: <u>Vassar/Heath RMV 229-27</u>	Township: <u>6S</u> Range: <u>94W</u>
API Number: <u>05-045-07610</u>	Meridian: <u>6th</u>
Specify volume spilled and recovered (in bbls) for the following materials:	
Oil spilled: <u>unknown</u> Oil recov'd: <u>0</u> Water spilled: <u>unknown</u> Water recov'd: <u>0</u> Other spilled: _____ Other recov'd: _____	
Ground Water impacted? <input type="checkbox"/> Yes <input checked="" type="checkbox"/> No	Surface Water impacted? <input type="checkbox"/> Yes <input checked="" type="checkbox"/> No
Contained within berm? <input type="checkbox"/> Yes <input checked="" type="checkbox"/> No	Area and vertical extent of spill: <u>~1,744 sq. feet x ~30 feet deep</u>

Spill/Release Tracking No: 2148514

**WPX ENERGY** Form 19 Map  
RMV 229-27

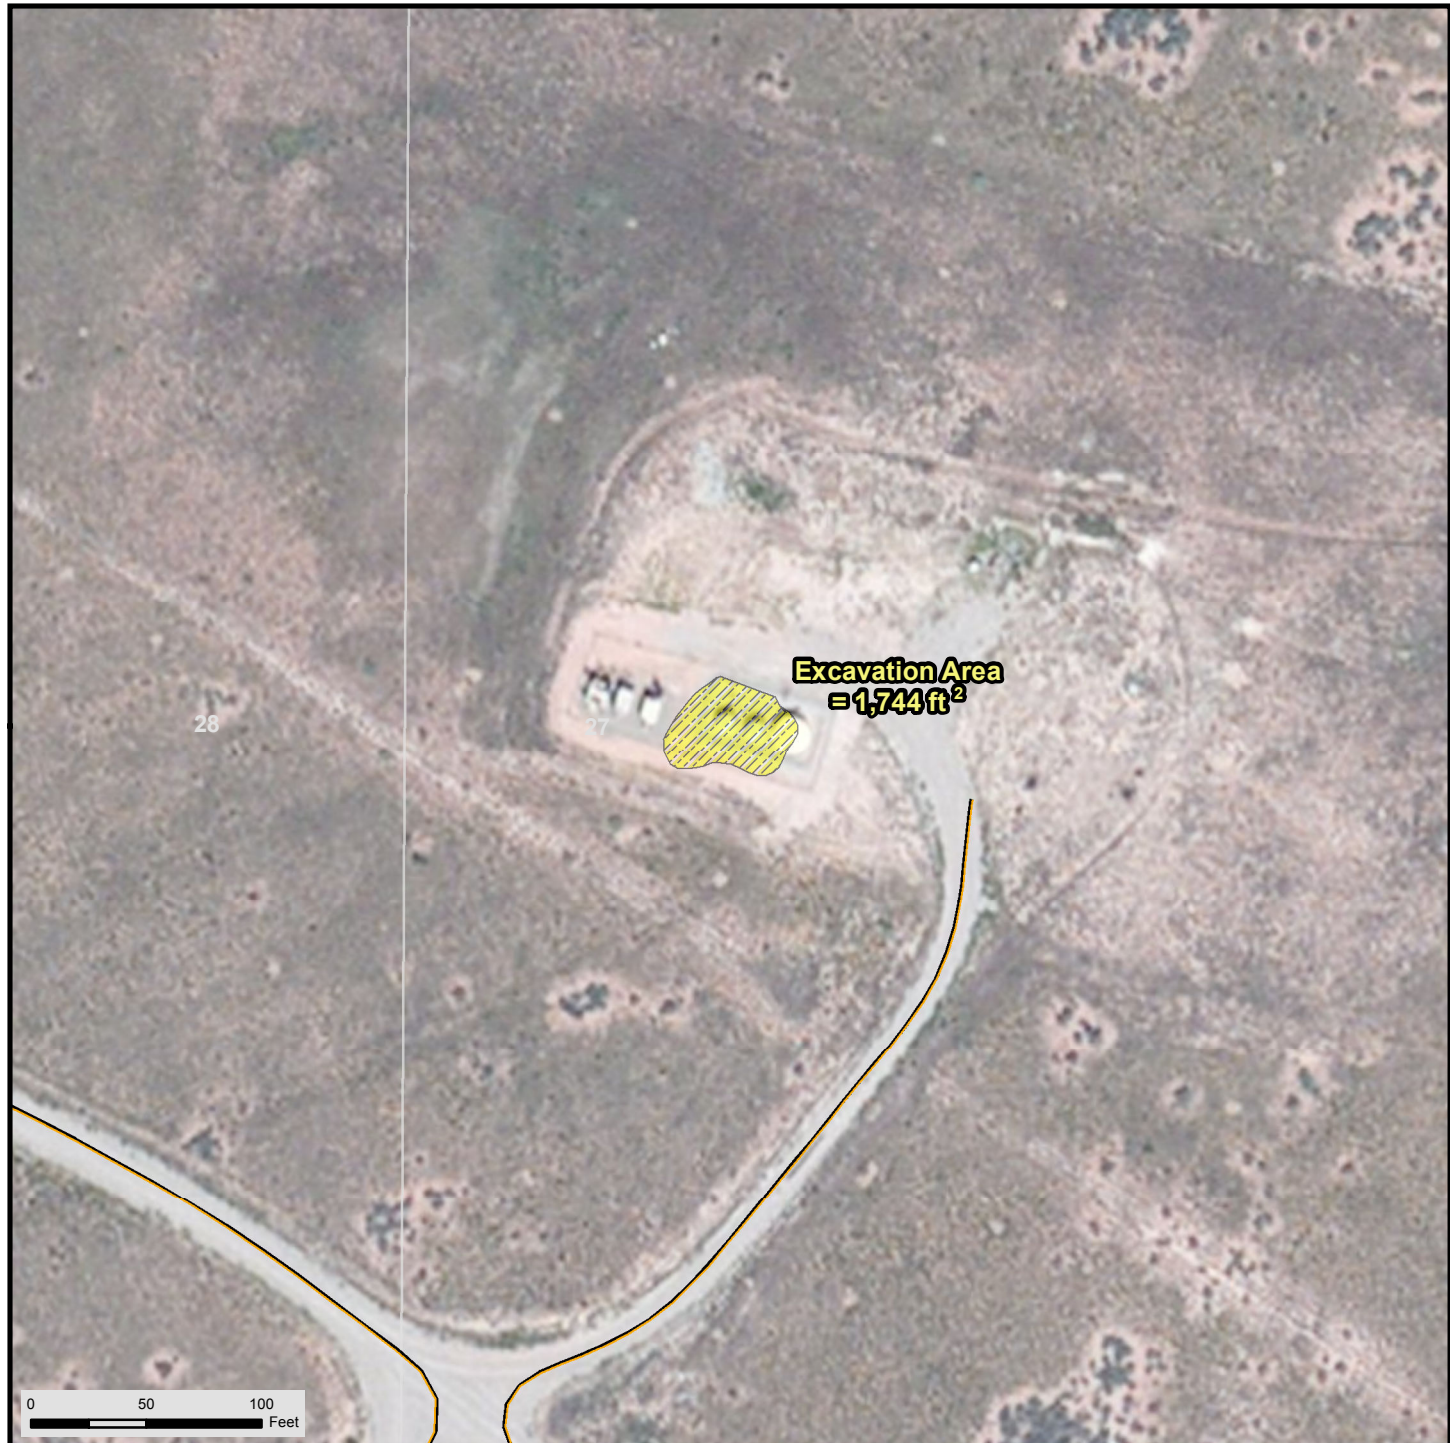
Current land use: <u>Non-Irrigated Cropland</u>	Weather conditions: <u>Partly cloudy, some showers, moist soil conditions</u>
Soil/geology description: <u>Arvada loam - loam to silty clay loam</u>	
<b>IF LESS THAN A MILE</b> , report distance <b>IN FEET</b> to nearest ... Surface water: <u>~1,945 feet</u> wetlands: <u>None</u> buildings: <u>None</u>	
Livestock: <u>None</u> Water wells: <u>~2,935 feet</u> Depth to shallowest ground water: <u>&gt;50 feet</u>	
Cause of spill (e.g. equipment failure, human error, etc.): <u>Equipment Failure/Historical Release</u> Detailed description of the spill/release incident:	
The release was caused by corrosion of the metal on a buried condensate dump line. It was discovered during a quarterly pressure test to check the integrity of the line. The leaking line allowed produced water to migrate out into the subsurface soils.

Further remediation activities proposed (attach separate sheet if needed): The impacted area was excavated to a depth of approximately 4 feet. At that depth, stained soil was encountered indicating a historical release. In addition to the current release, the area of stained soil (historical release) was excavated as well. Confirmation soil samples have been collected from the walls and from the bottom of the excavation. The samples were analyzed for the entire Table 910-1 analytical suite. If the excavated area complies with COGCC Table 910-1 standards, the excavation will be backfilled with clean material to the original pad grade. The impacted soil will be treated on-site to levels below Table 910-1 with a bio remediation product.

Describe measures taken to prevent problem from reoccurring: Due to corrosion of metal piping throughout the field, all newly installed and repaired lines are being replaced with lines with an epoxy type coating on the inside of the pipe which greatly reduces potential corrosion of the metal and subsequent line failures. In addition all dump lines will be pressure tested on a monthly basis.
