Reference Area Photographs

Inspection Conducted on April 23, 2014

**Linn Energy LLC
Chevron 13-16D
Garden Gulch Rd
Location ID #335616**

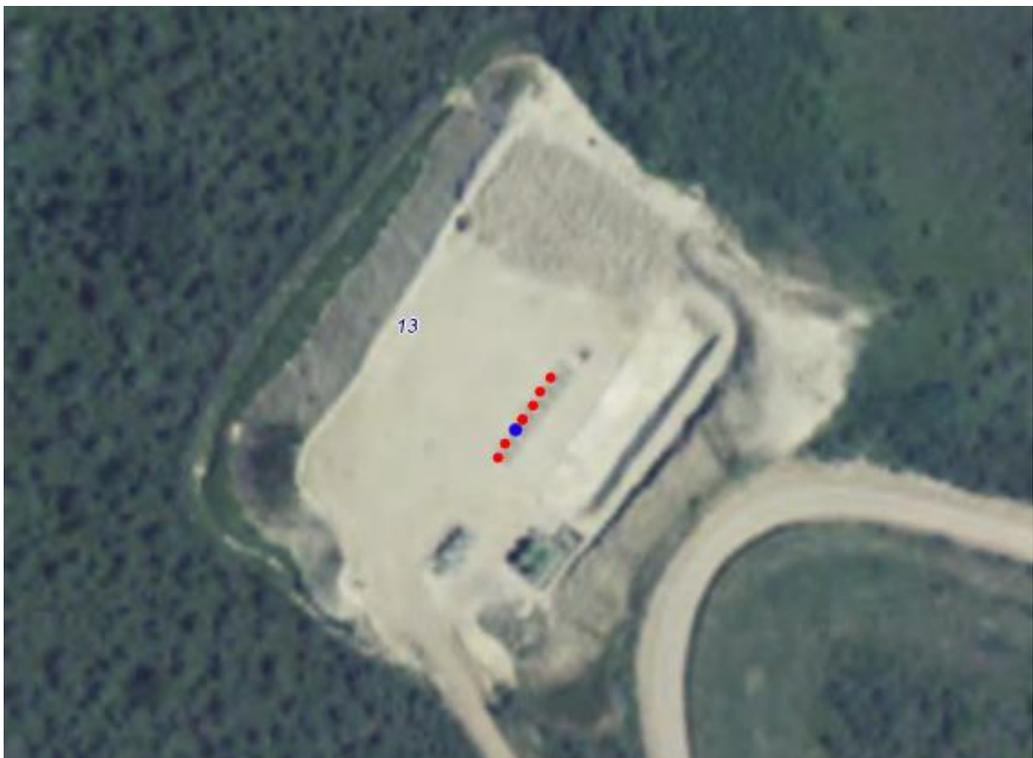
Aerial Photo from COGIS Map – Year 2011
Pit 280 x 60 feet approximately.

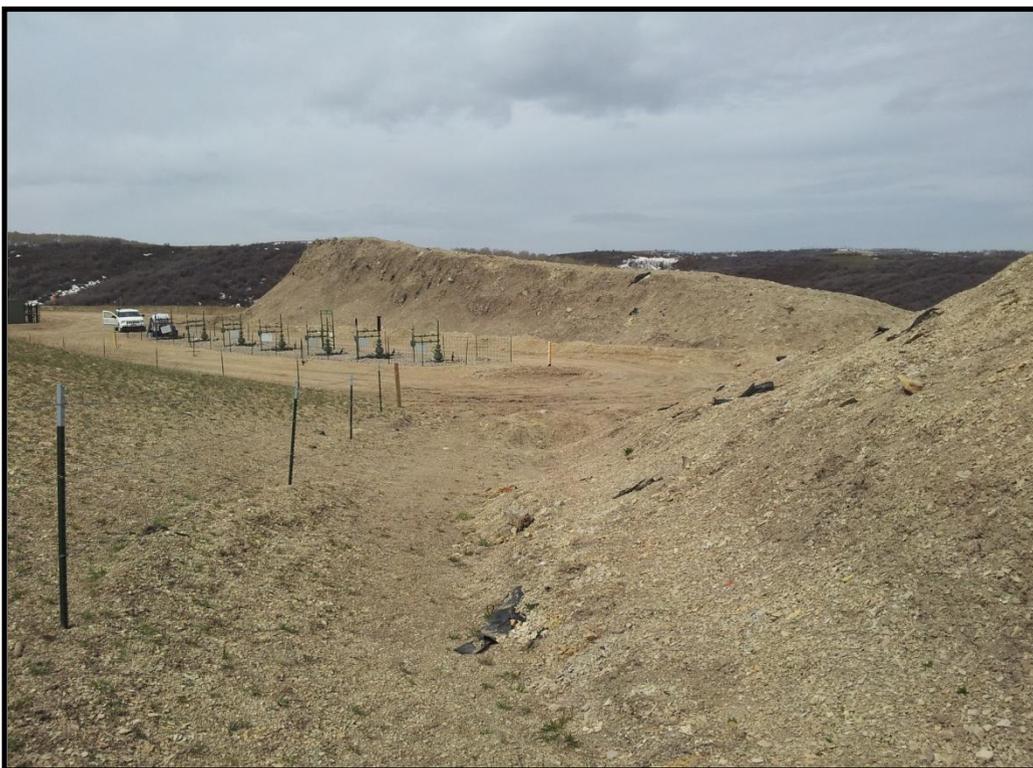
From the Southeast to the Northwest. Two large stockpiles that were not present in 2011 occupy now half of the pad area, on the downgradient side (northwest).

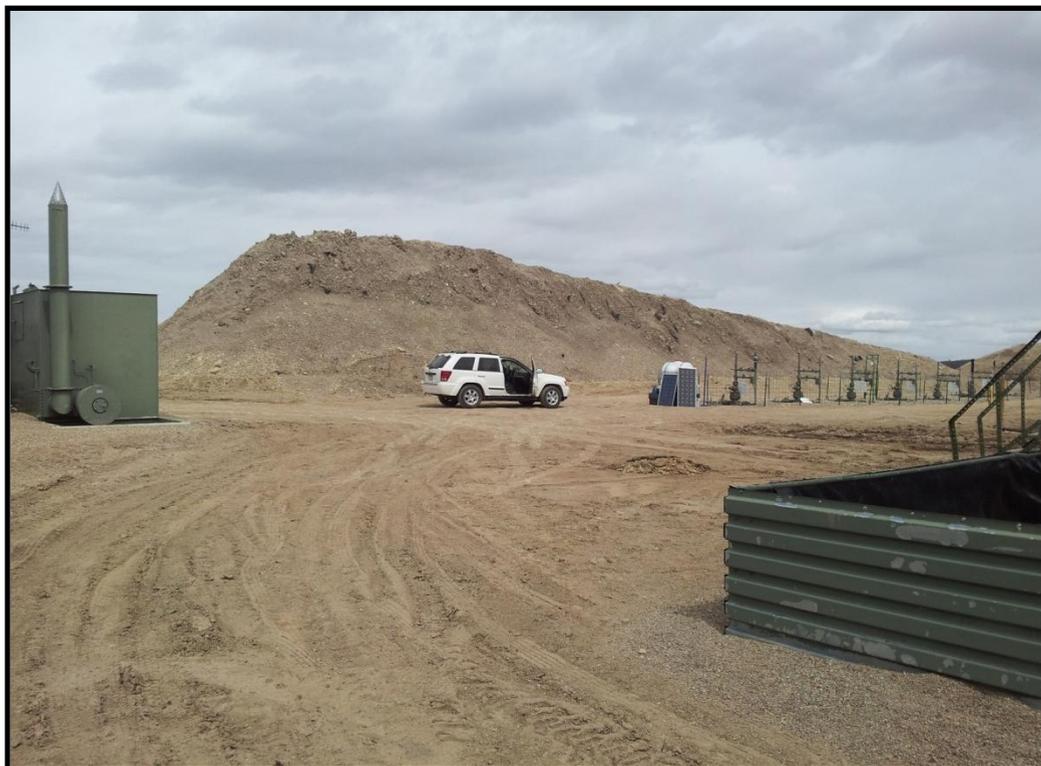
Large stockpile, about 15 feet high and 45 feet long.

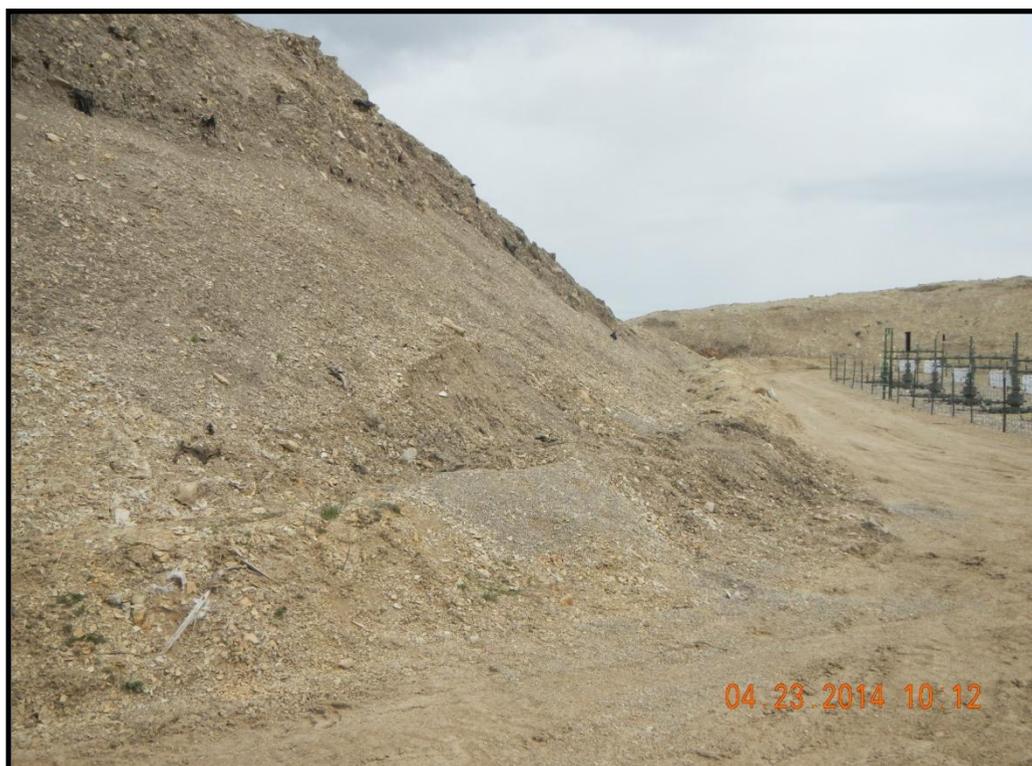
Pieces of liner mixed with the stockpiled material.

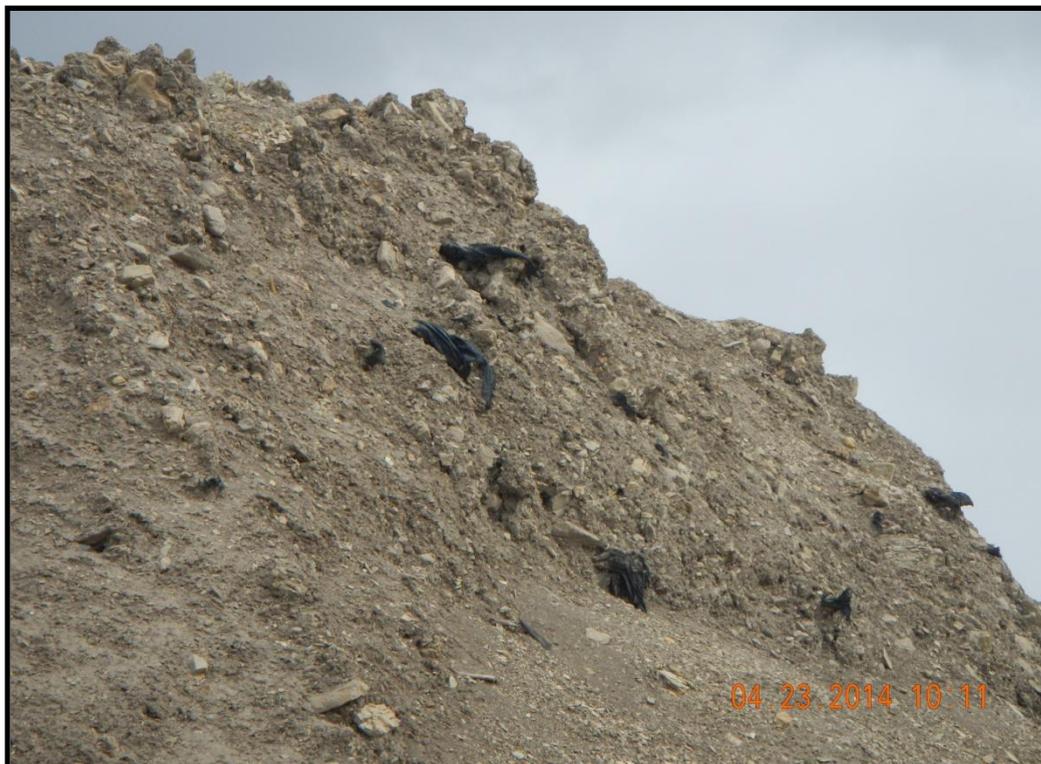
Pieces of liner.

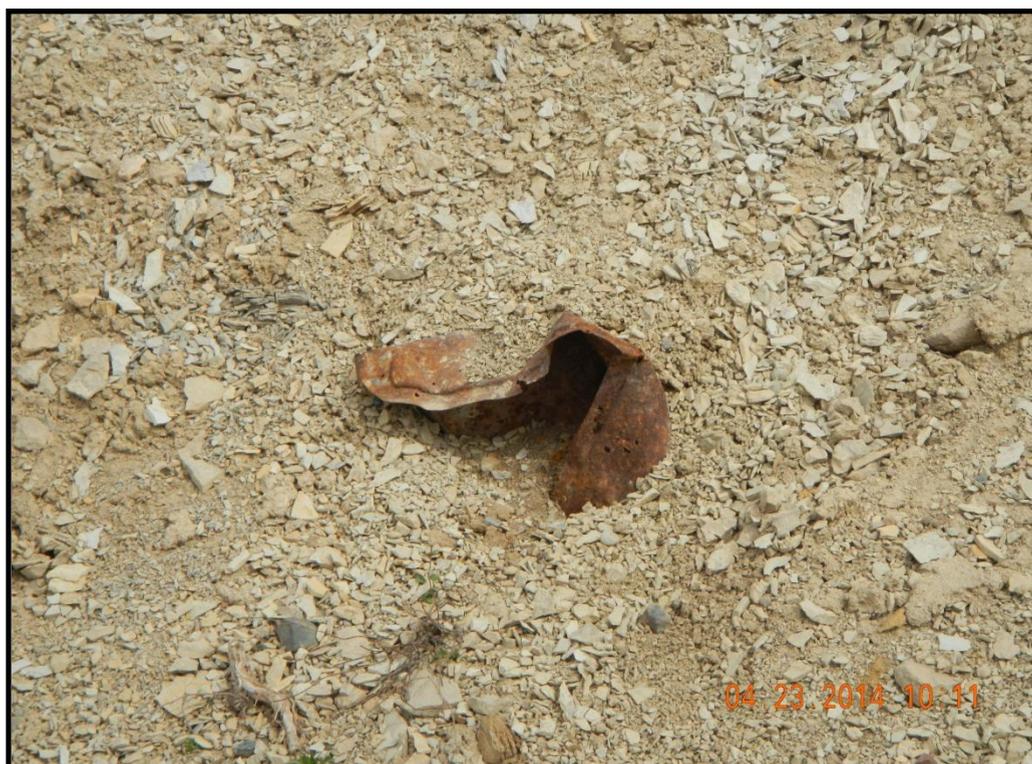
Junk in the stockpile

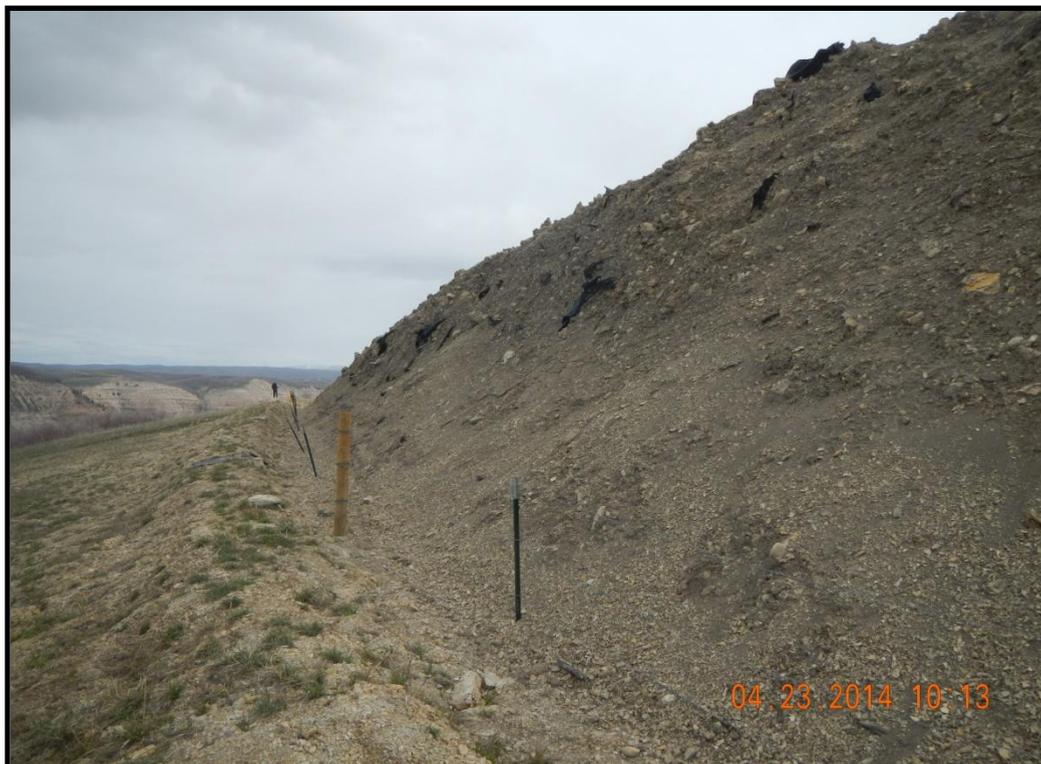
Stockpile at the edge of the slope.

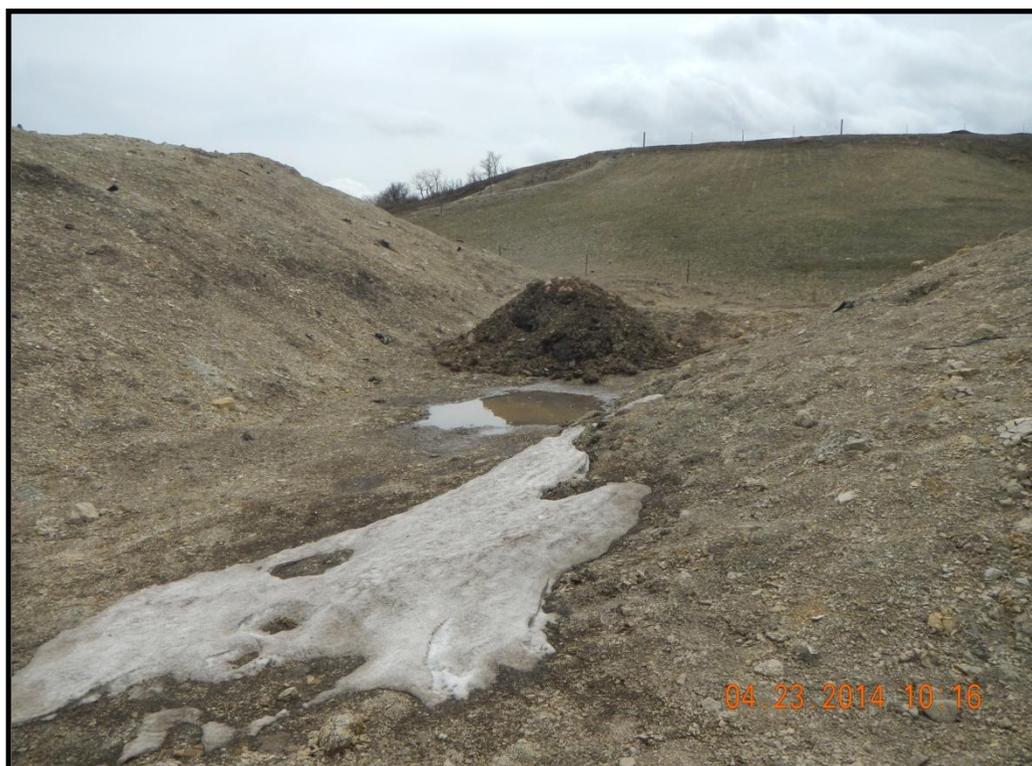
More stockpiled material.

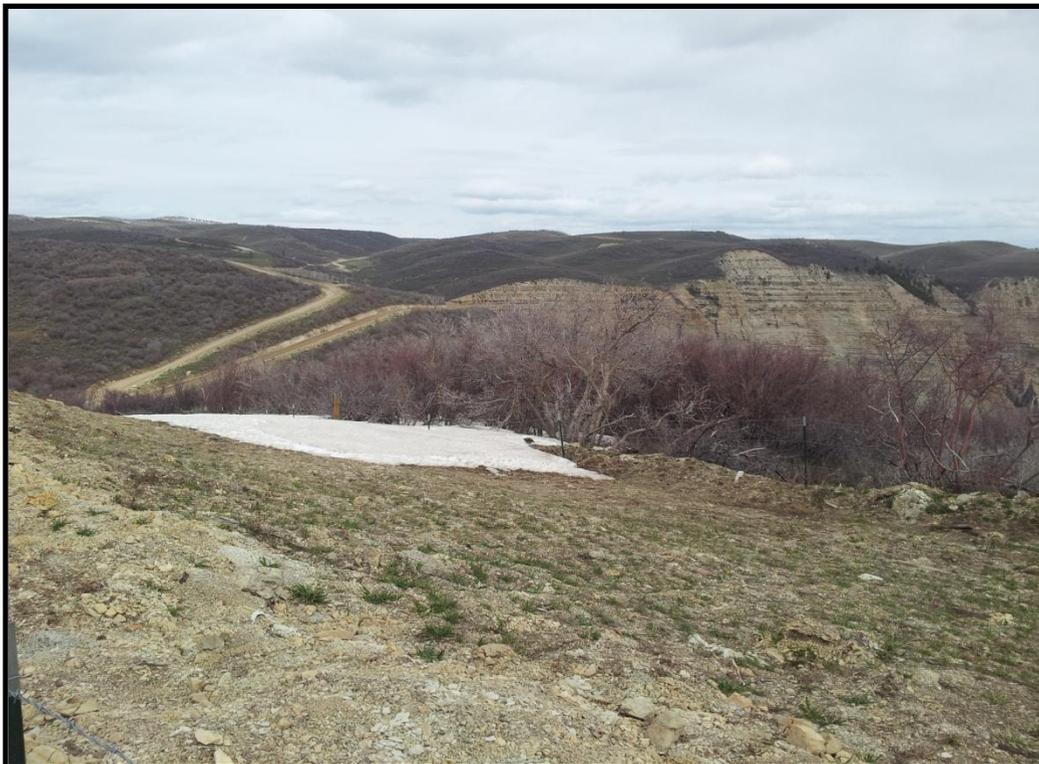
Natural drainage at the bottom. Site is located in the Roan Rim Area .

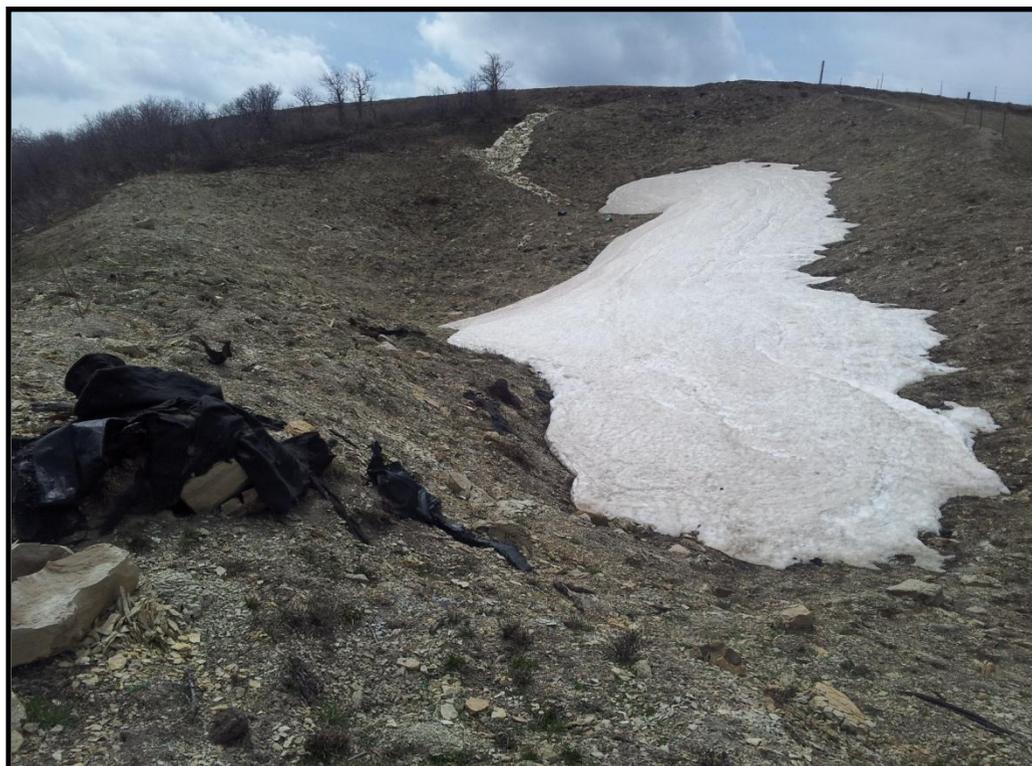
Stormwater Management. Reclaimed area.
Pieces of liner incorporated into the soil.

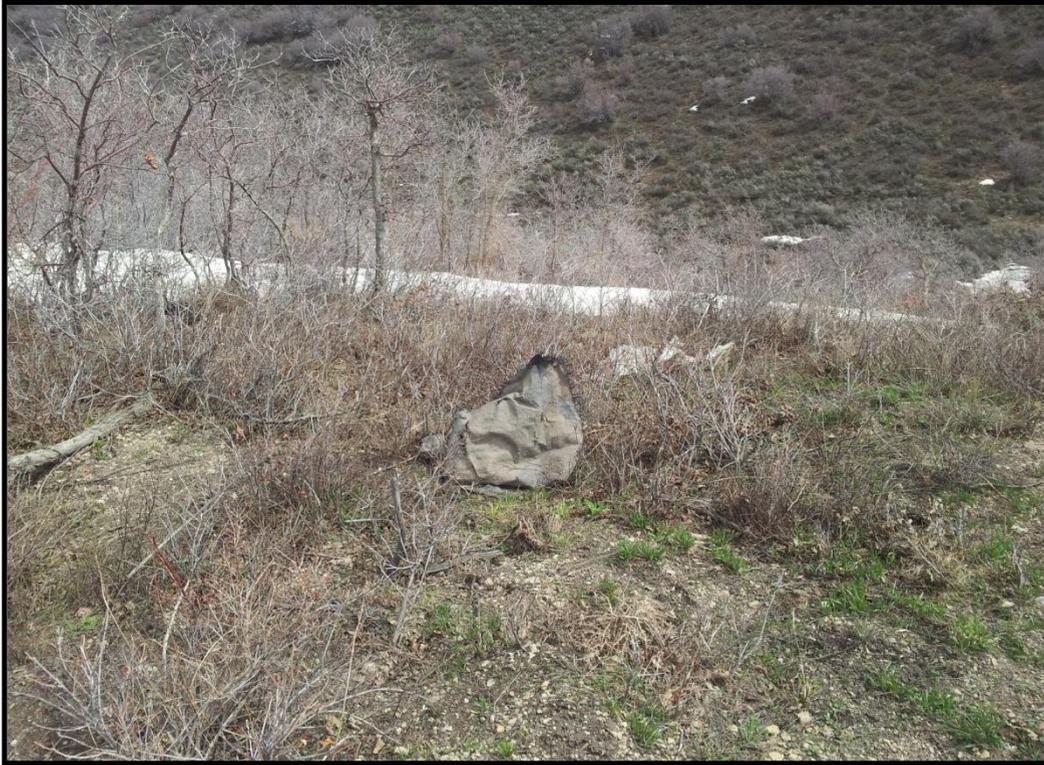
Pieces of liner blown by the wind, impacting (what should be) undisturbed areas.

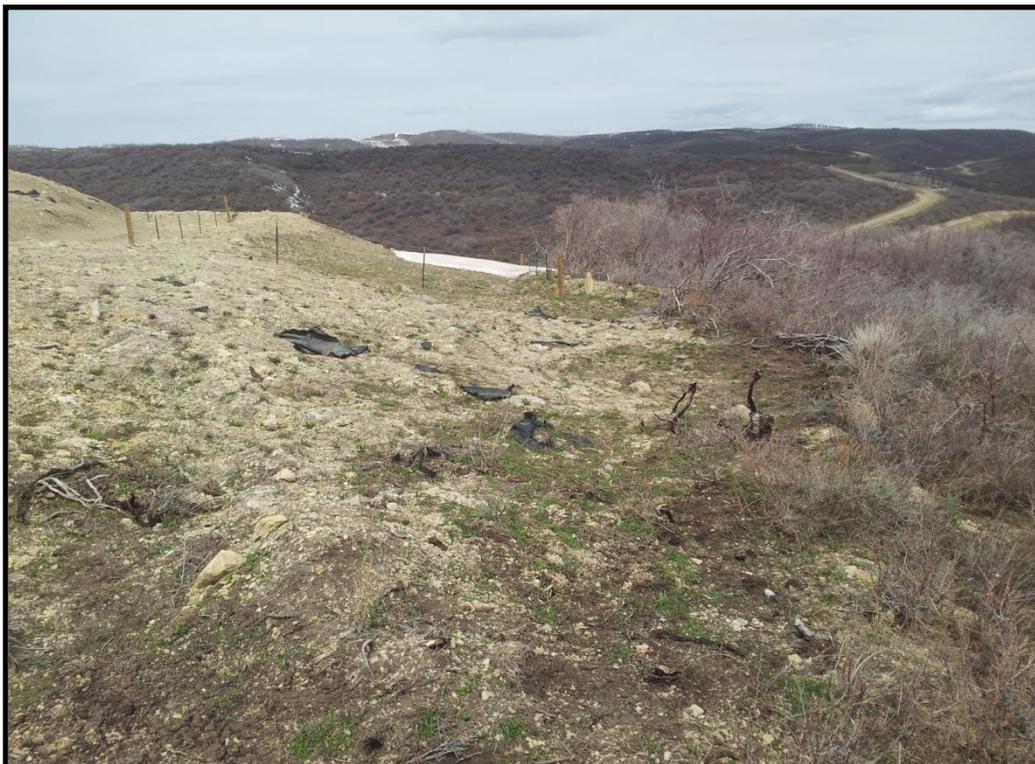
Pieces of liner and garbage incorporated into the soil (interim reclamation) and outside of the pad.

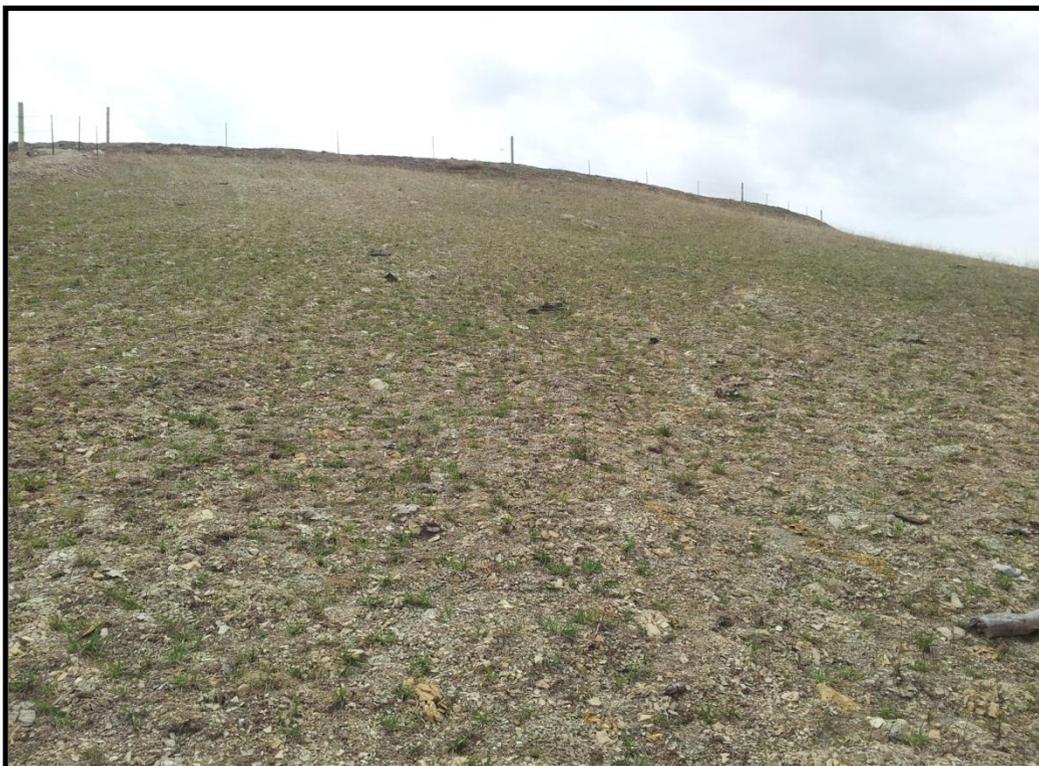
Interim Reclamation. Reclaimed area with pieces of liner incorporated into the soil.

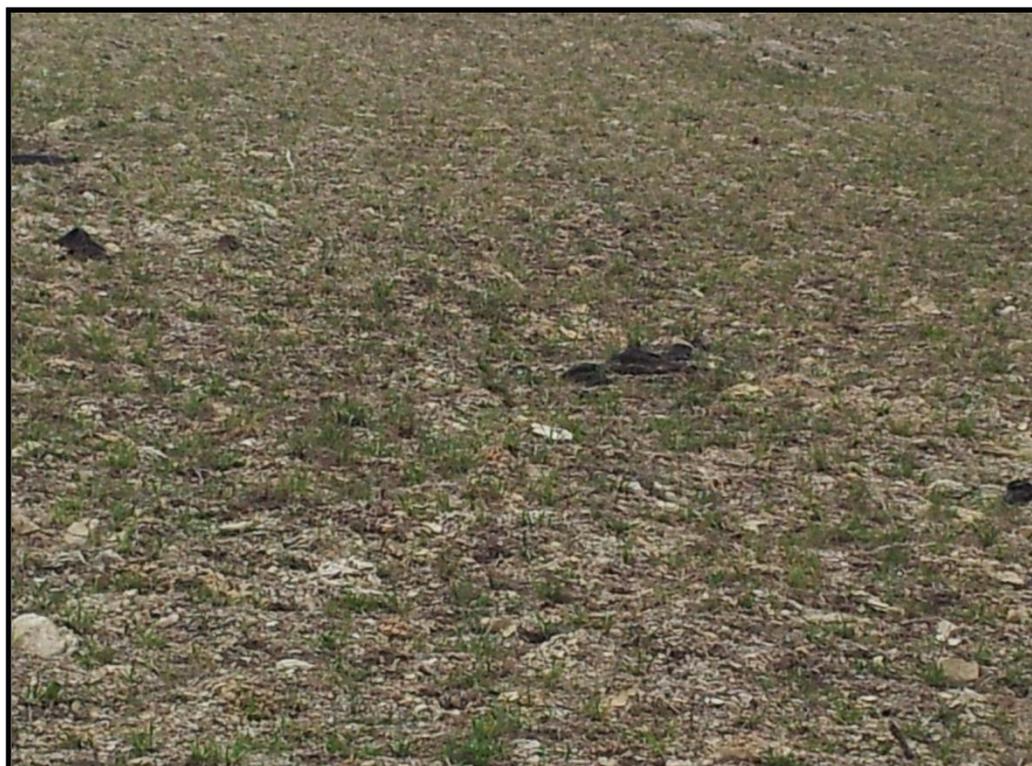
Reclaimed area: Close-up of soil with pieces of liner half-buried in the ground.

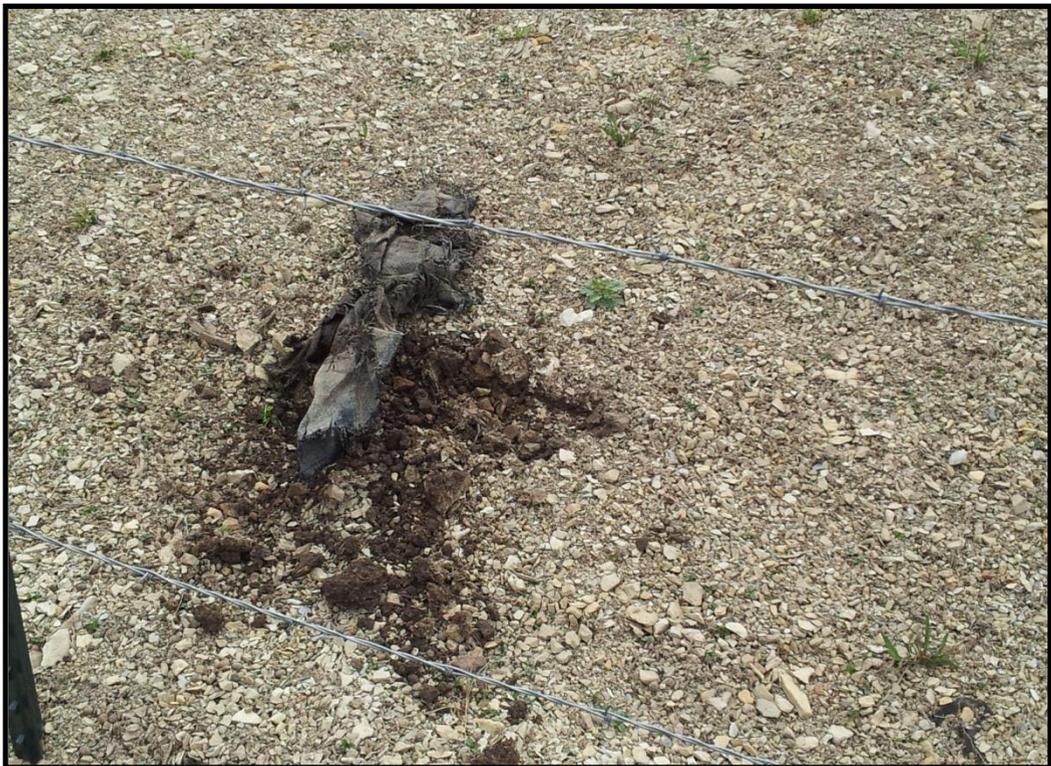
Piece of liner pulled from the ground.

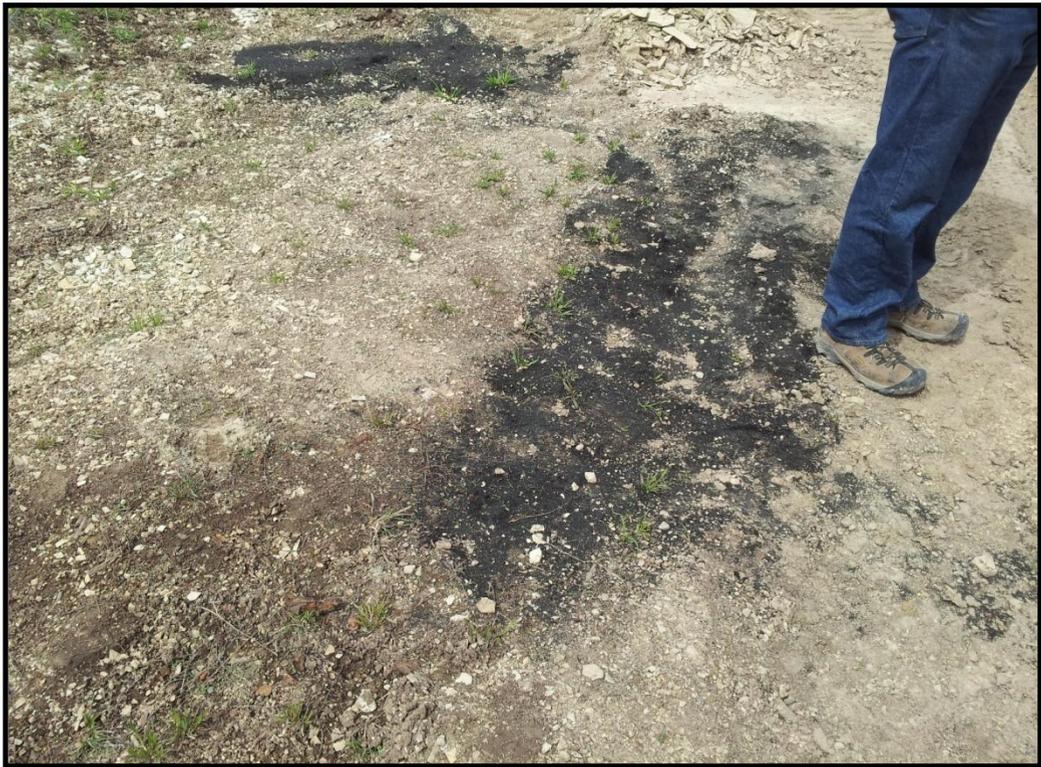
This is apparently sand blasting sand used for maintenance of nearby tank .
