FEDERAL LAND BANK #15-4C, API No. 05-081-06700

Date: 06-03-2014

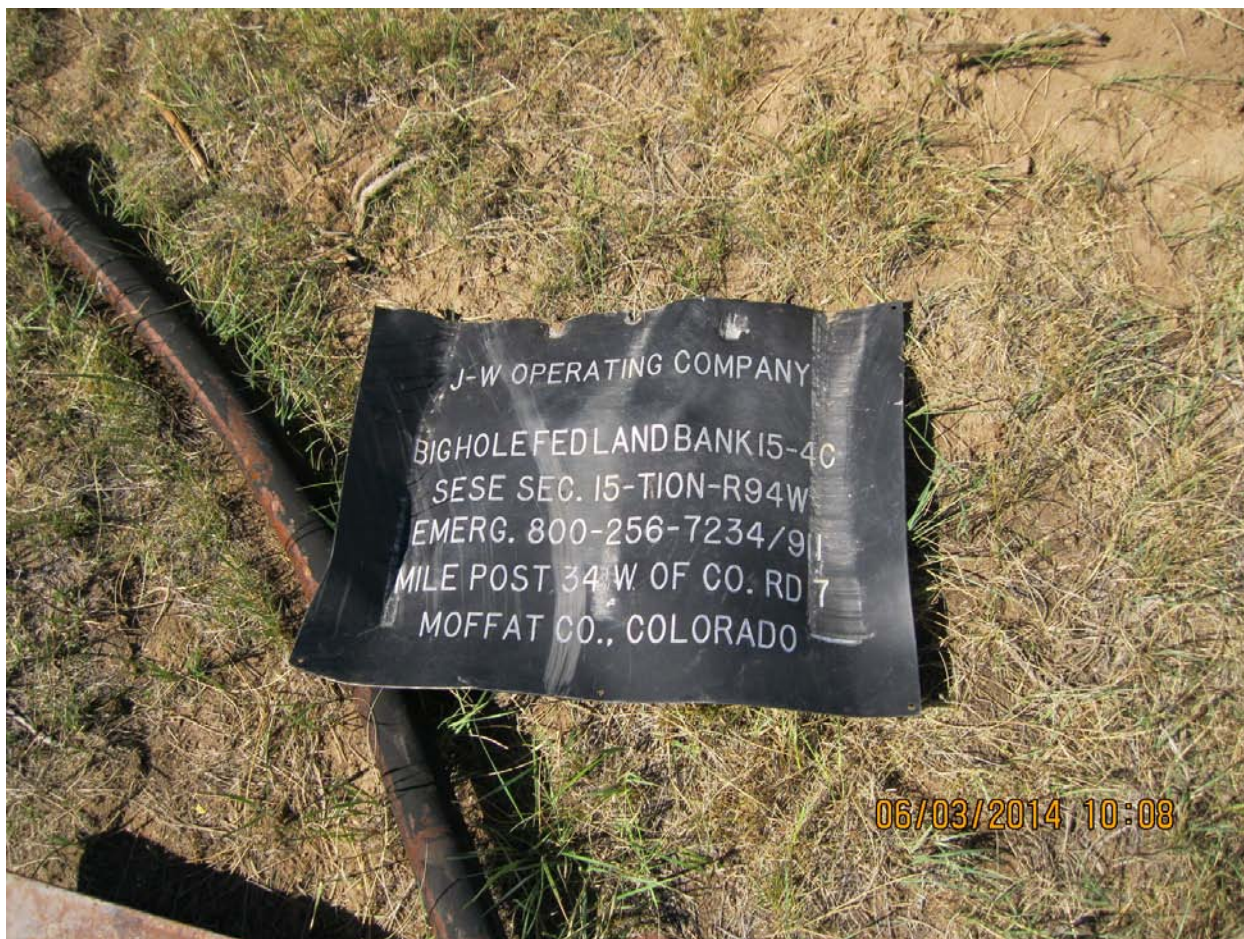
File Name: 20140603-1_JW_dda

Description: Well Sign

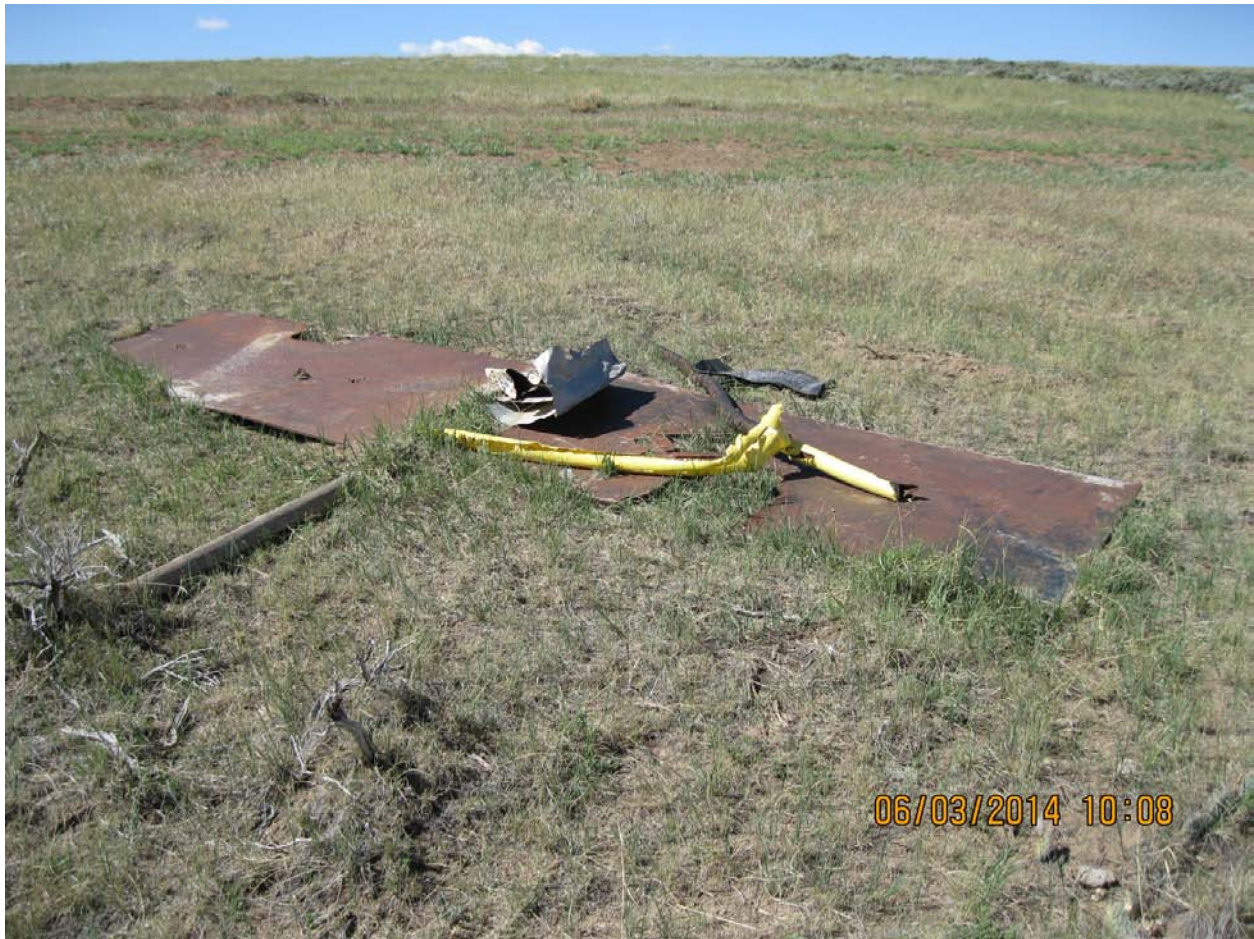
File Name: 20140603-2_JW_dda

Description: Well sign, junk and debris near entrance of the pad.

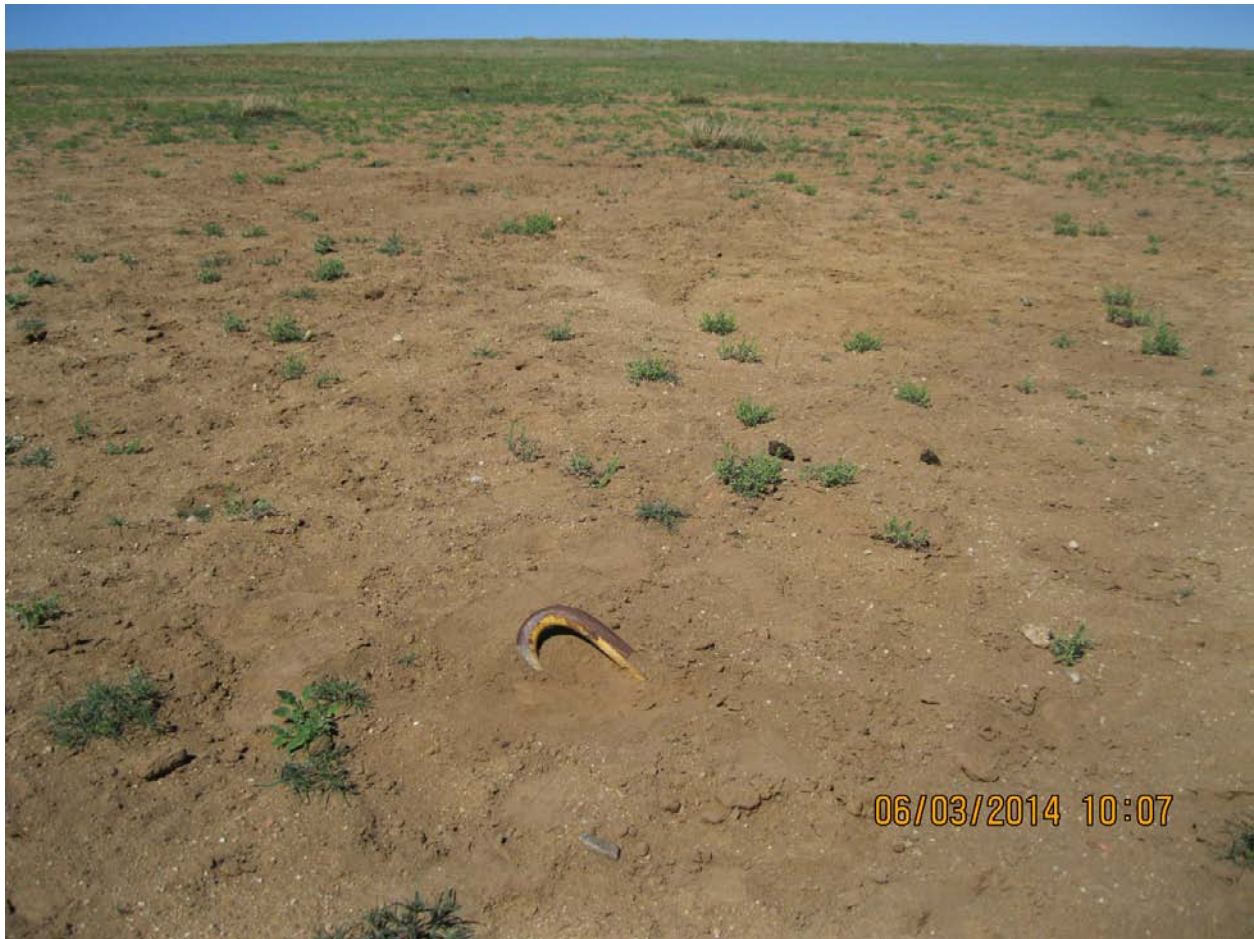
File Name: 20140603-3_JW_dda

Description: Unmarked guy line anchor.

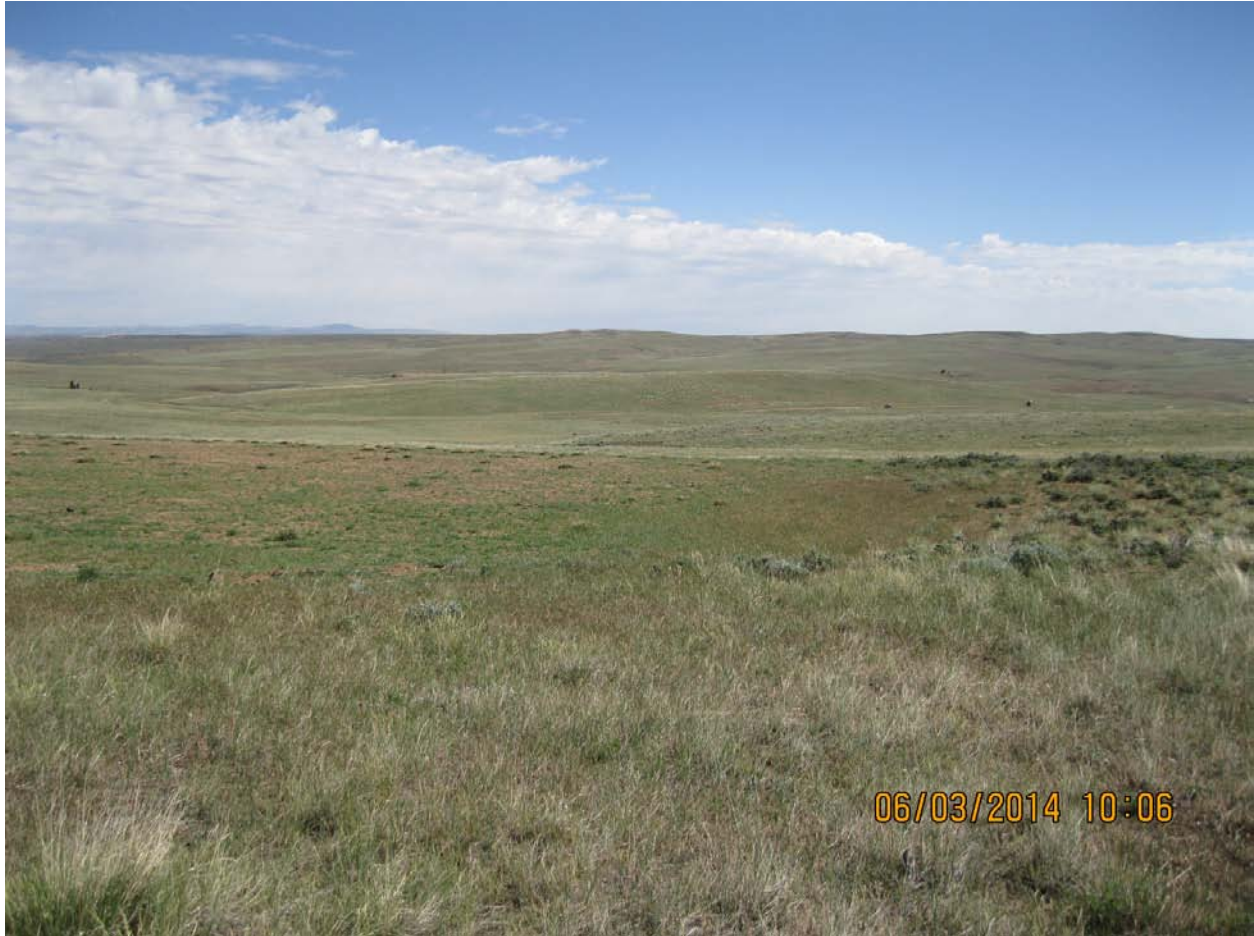
File Name: 20140603-4_JW_dda

Description: View of revegetation in progress on the pad. No surface indication of the plugged well.

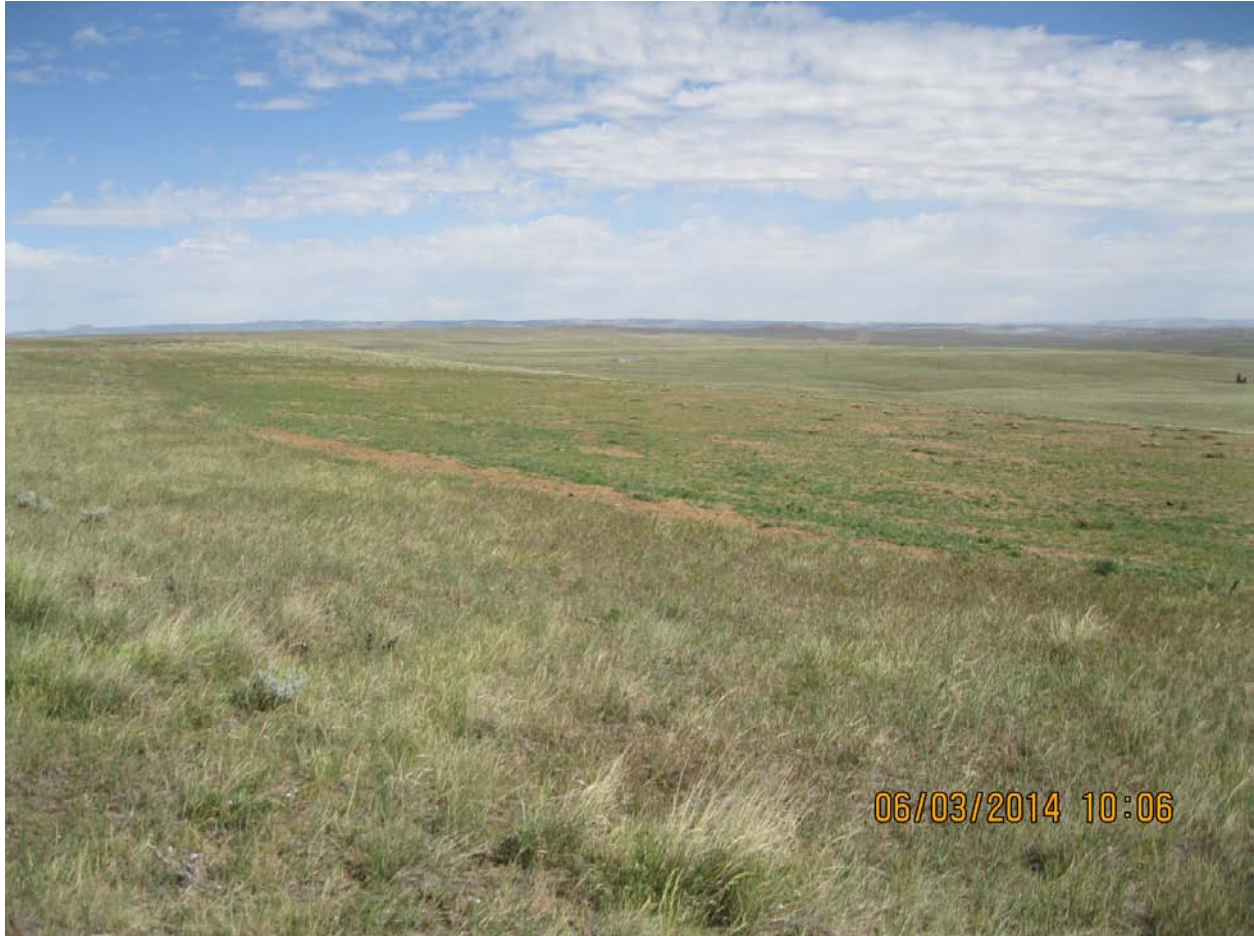
File Name: 20140603-5_JW_dda

Description: View of revegetation in progress on the pad. No surface indication of the plugged well.

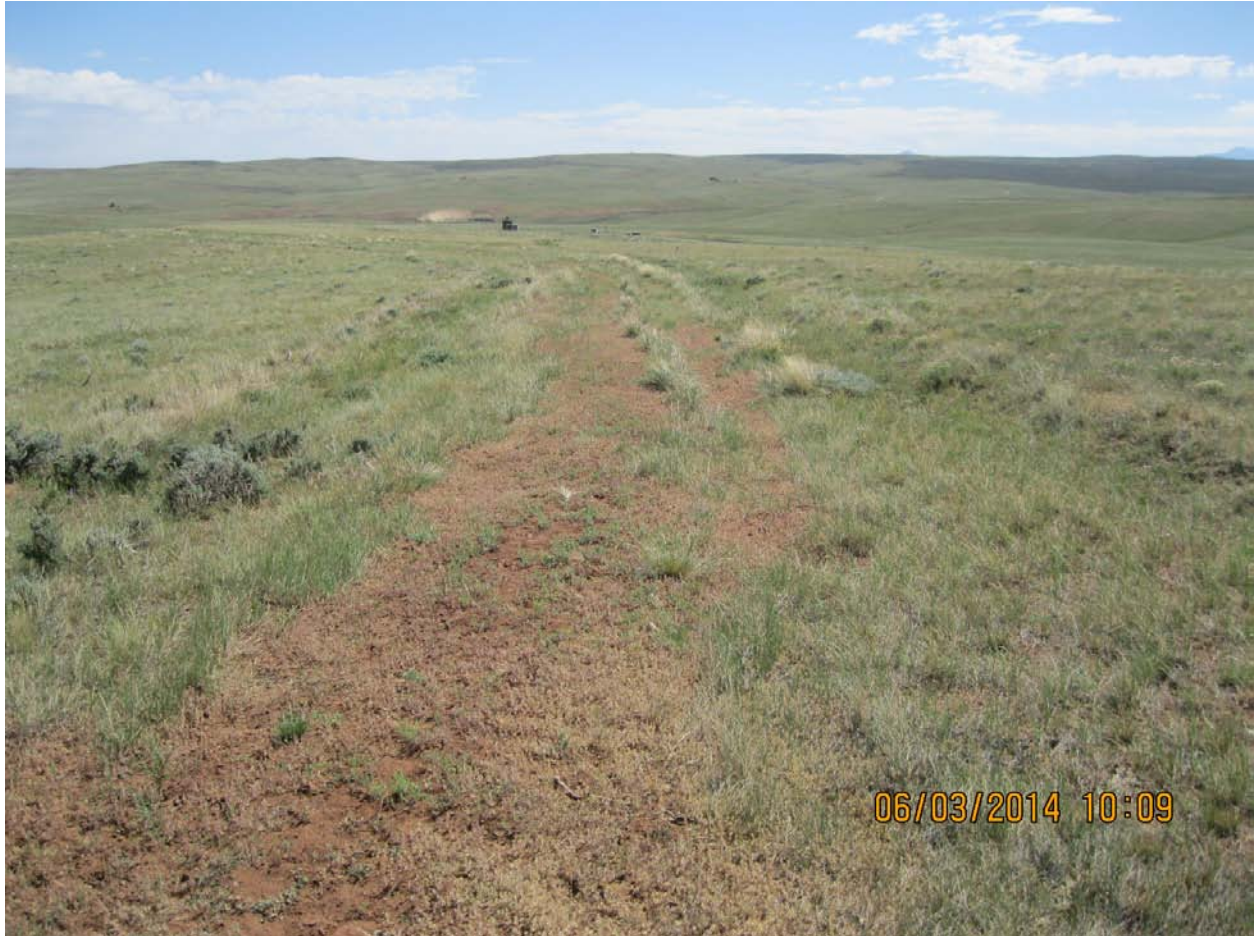
File Name: 20140603-6_JW_dda

Description: View of revegetation in progress on access road.

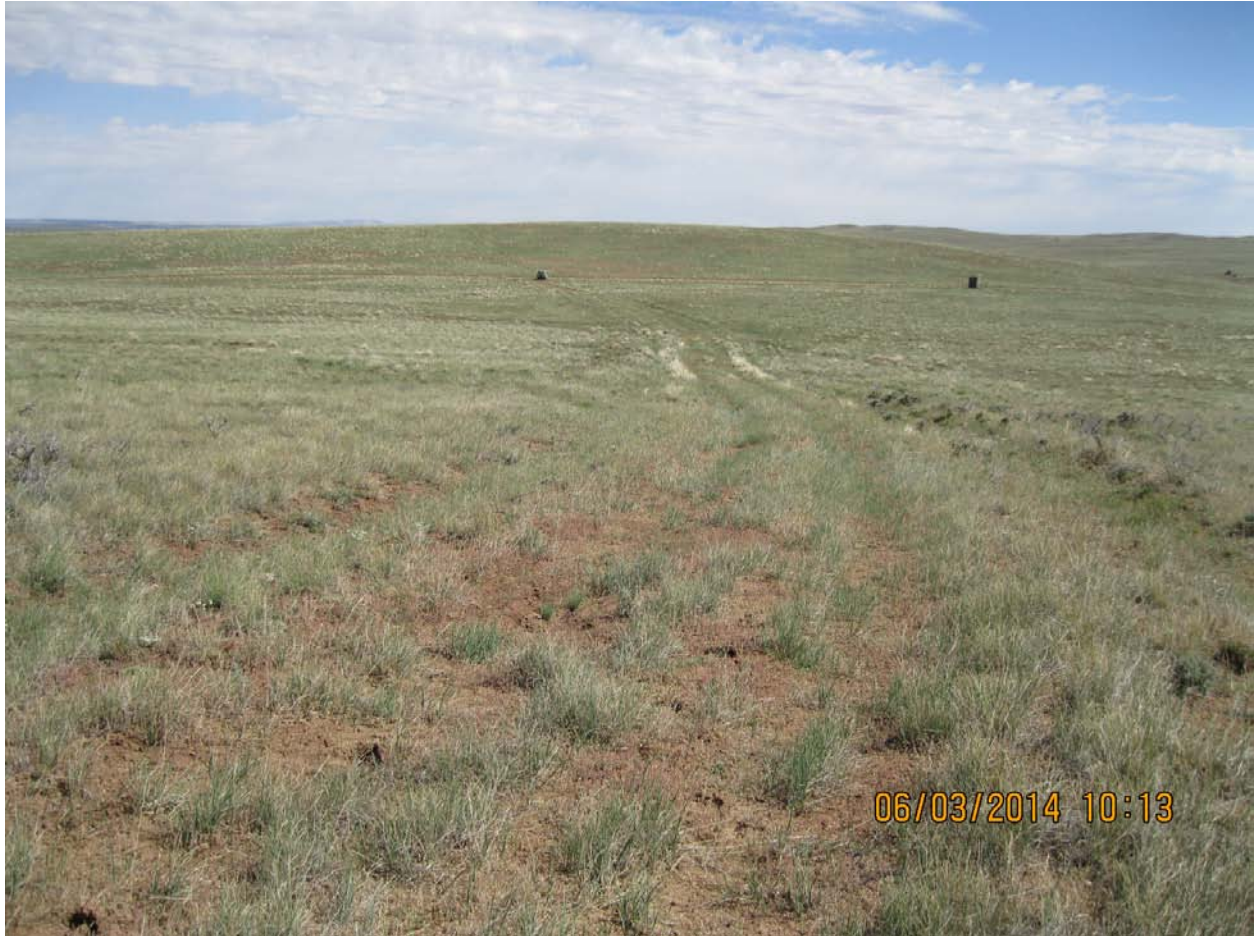
File Name: 20140603-7_JW_dda

Description: View of revegetation in progress on access road.
