**F L B UT/BIGHOLE DEEP #23-2, API No. 05-081-06413**

Date: 06-03-2014

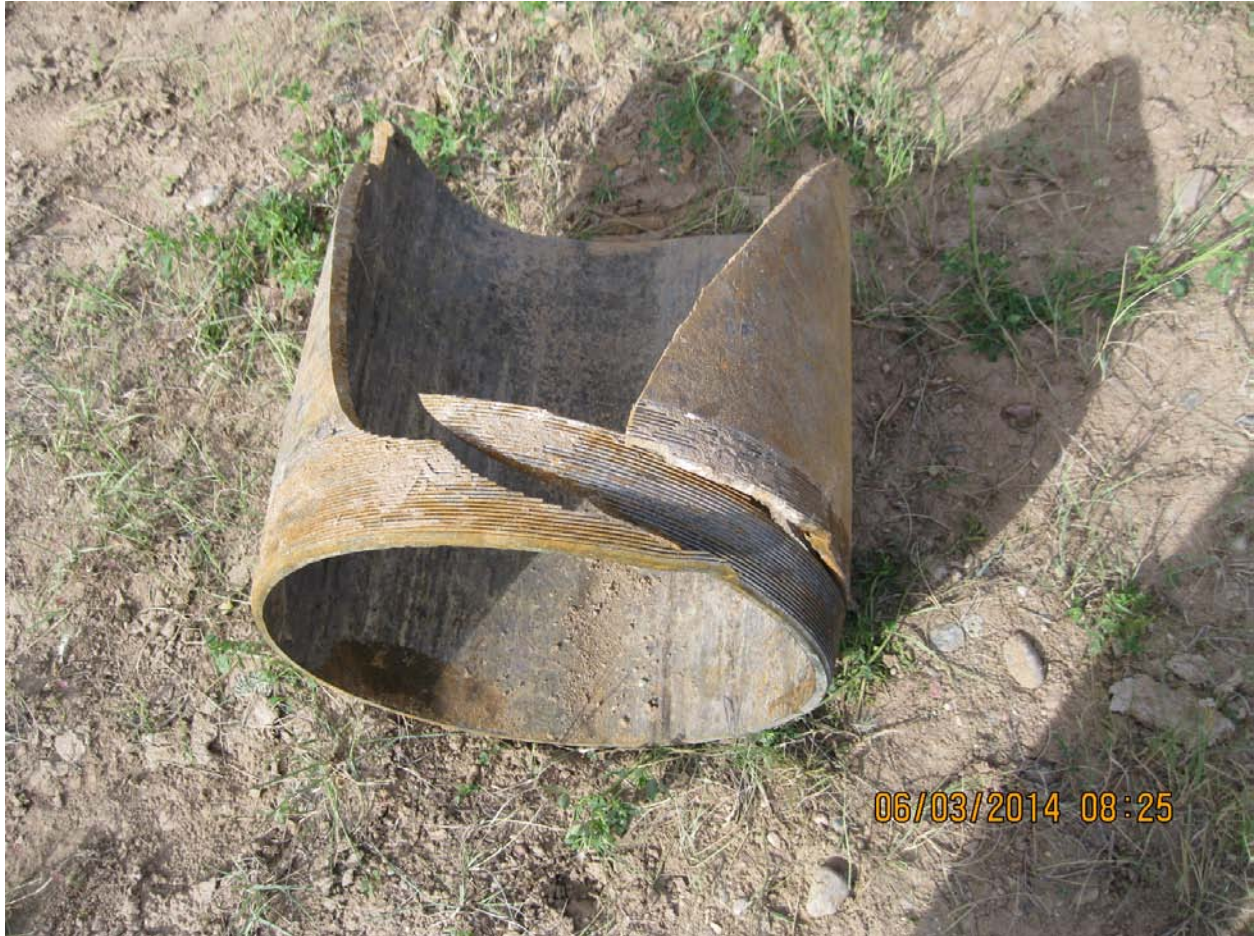
File Name: 20140603-1\_HRM\_dda

Description: Damaged piece of 20" surface casing

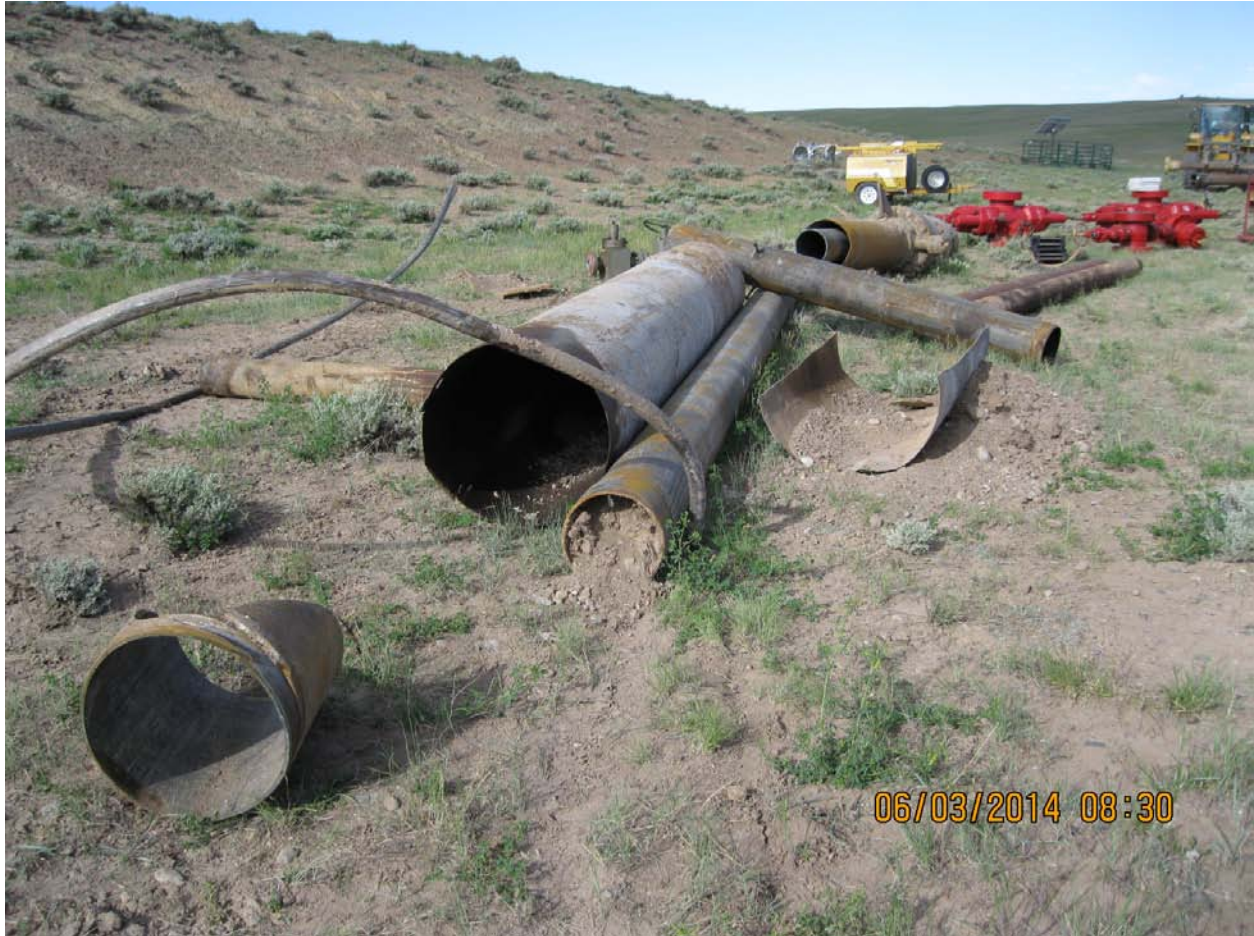
File Name: 20140603-2\_HRM\_dda

Description: Damaged piece of 20" surface casing (foreground to the left), 30" conductor pipe, and 13-5/8" intermediate casing. Damaged wellhead and new BOPE in the background.
