Jolley –KP 11-16

Inspection # 675200103

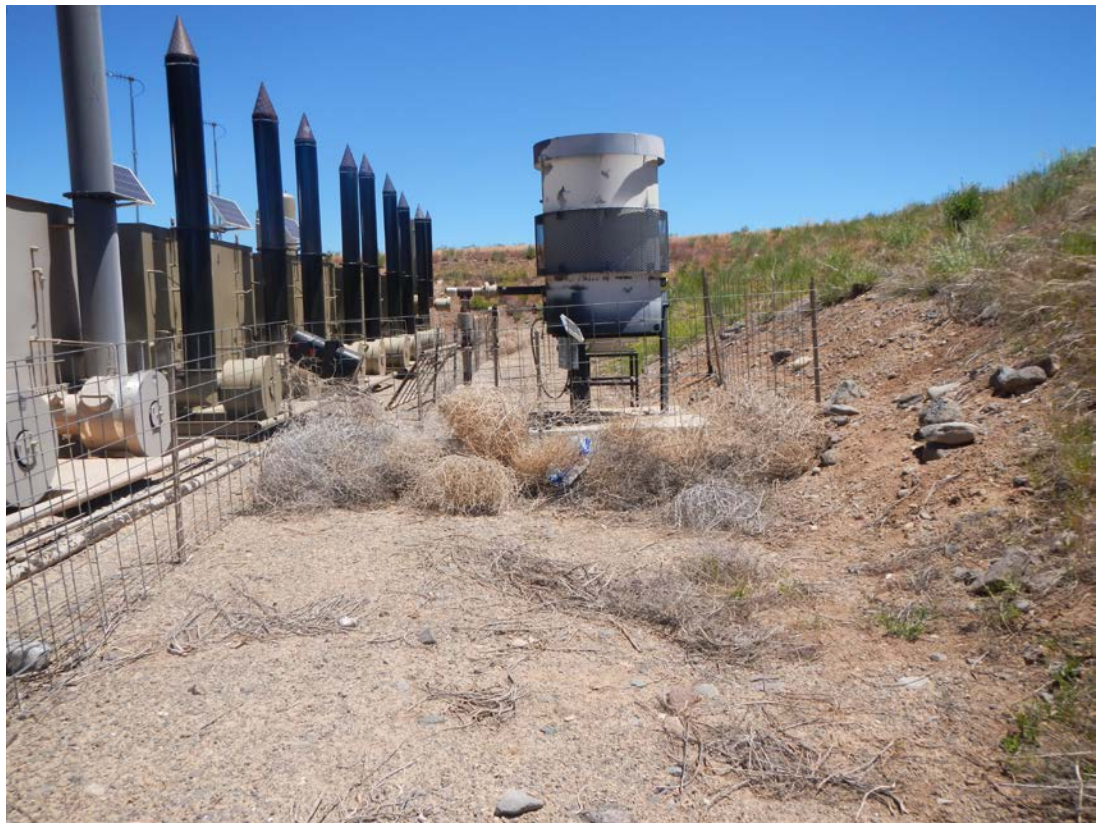
Debris near  
ECU.

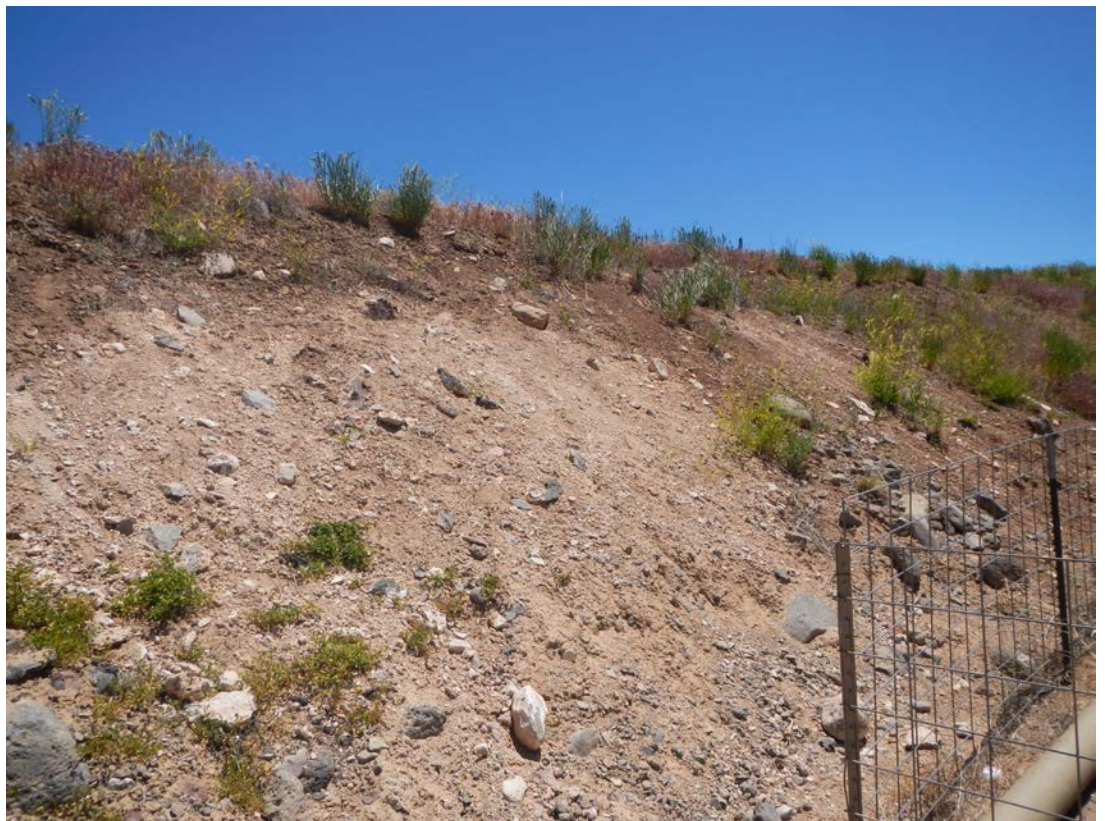
Rilling and  
erosion on cut  
slope.

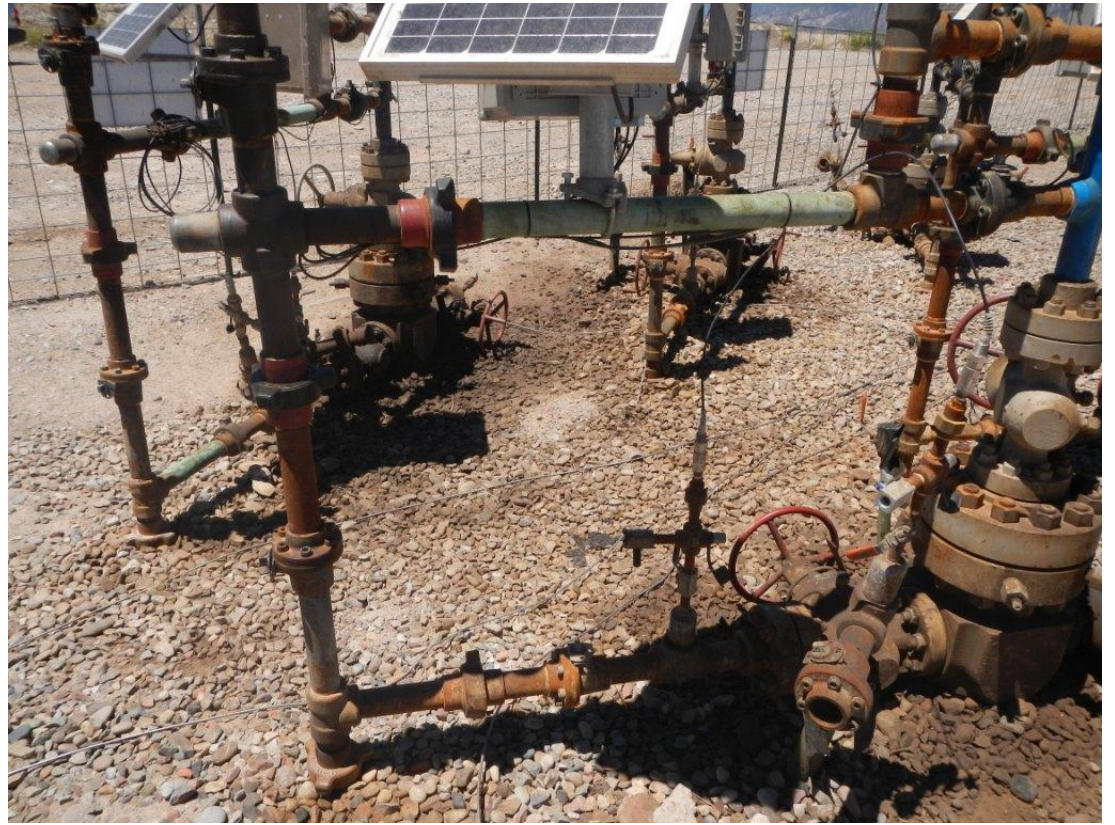
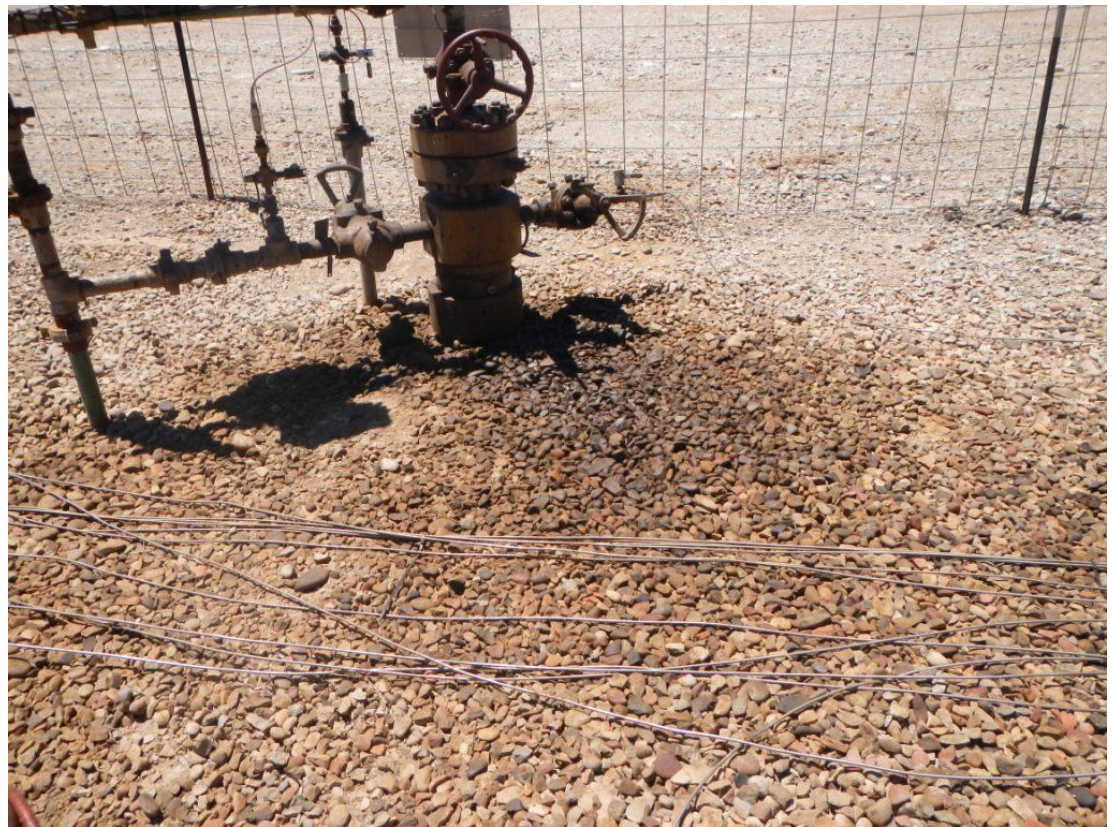
Staining  
around  
wellheads

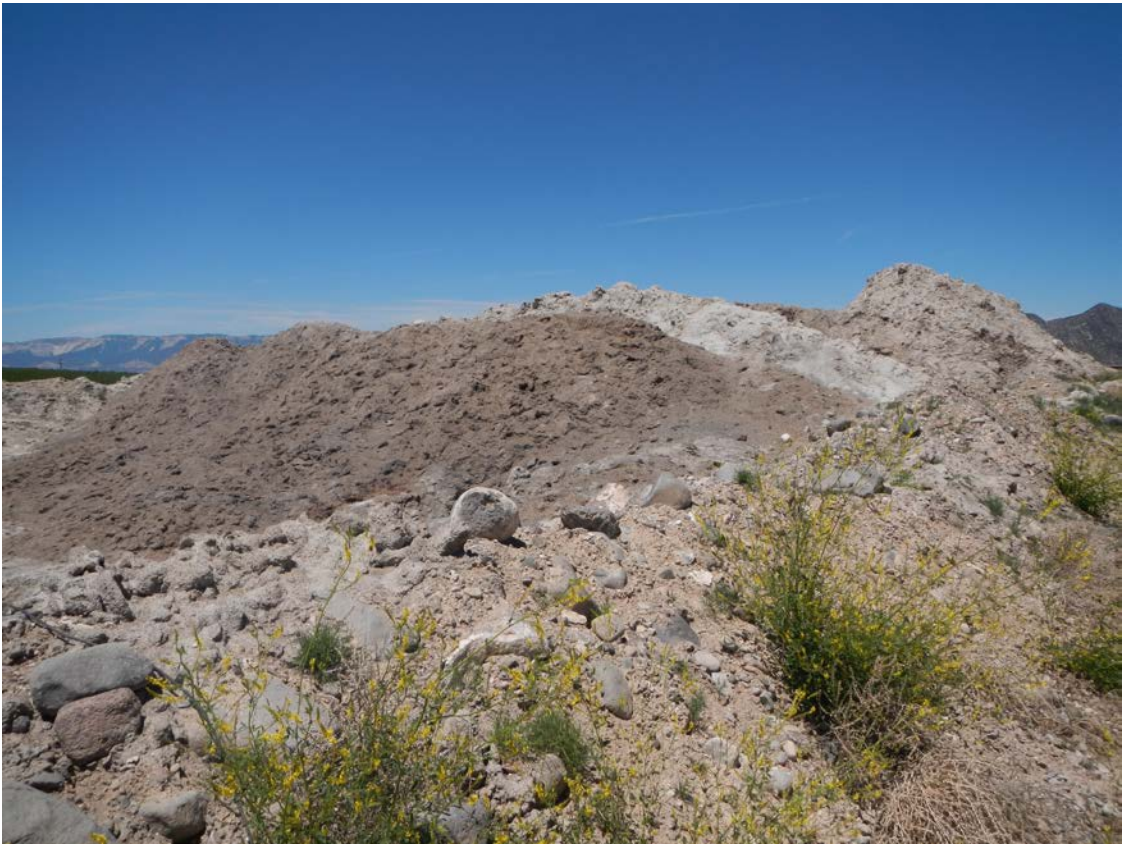
Cuttings pile
