Advanced Cement Evaluation and Casing Inspection

CAST-M Circumferential Acoustic Scanning Tool – Monoconductor

Client: WPX ENERGY
Well: STRAIT SG 332-22
Field: GRAND VALLEY
#31290
County: GARFIELD
State: CO

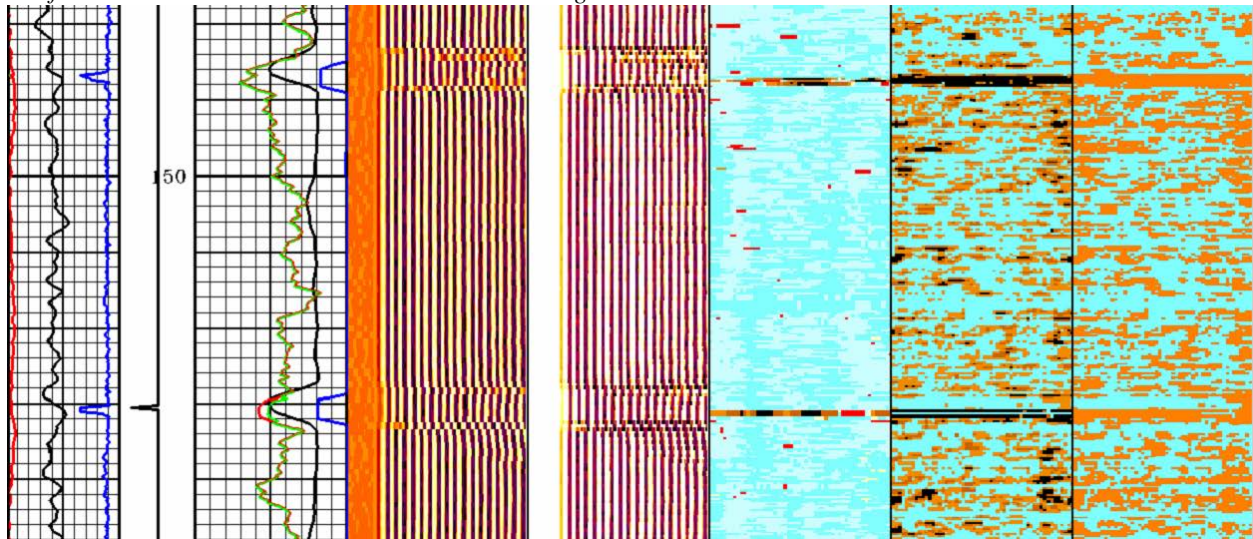
There is free pipe from surface to 226' (Figure 1). Top of cement occurs at 226' (Figure 2). The contact between lead and tail cements seems to occur at 3900' (figure 3). The bond from top of cement to the lead/tail contact seems to be fairly good while below the lead tail there is very good bond.

Figure 1: Free pipe

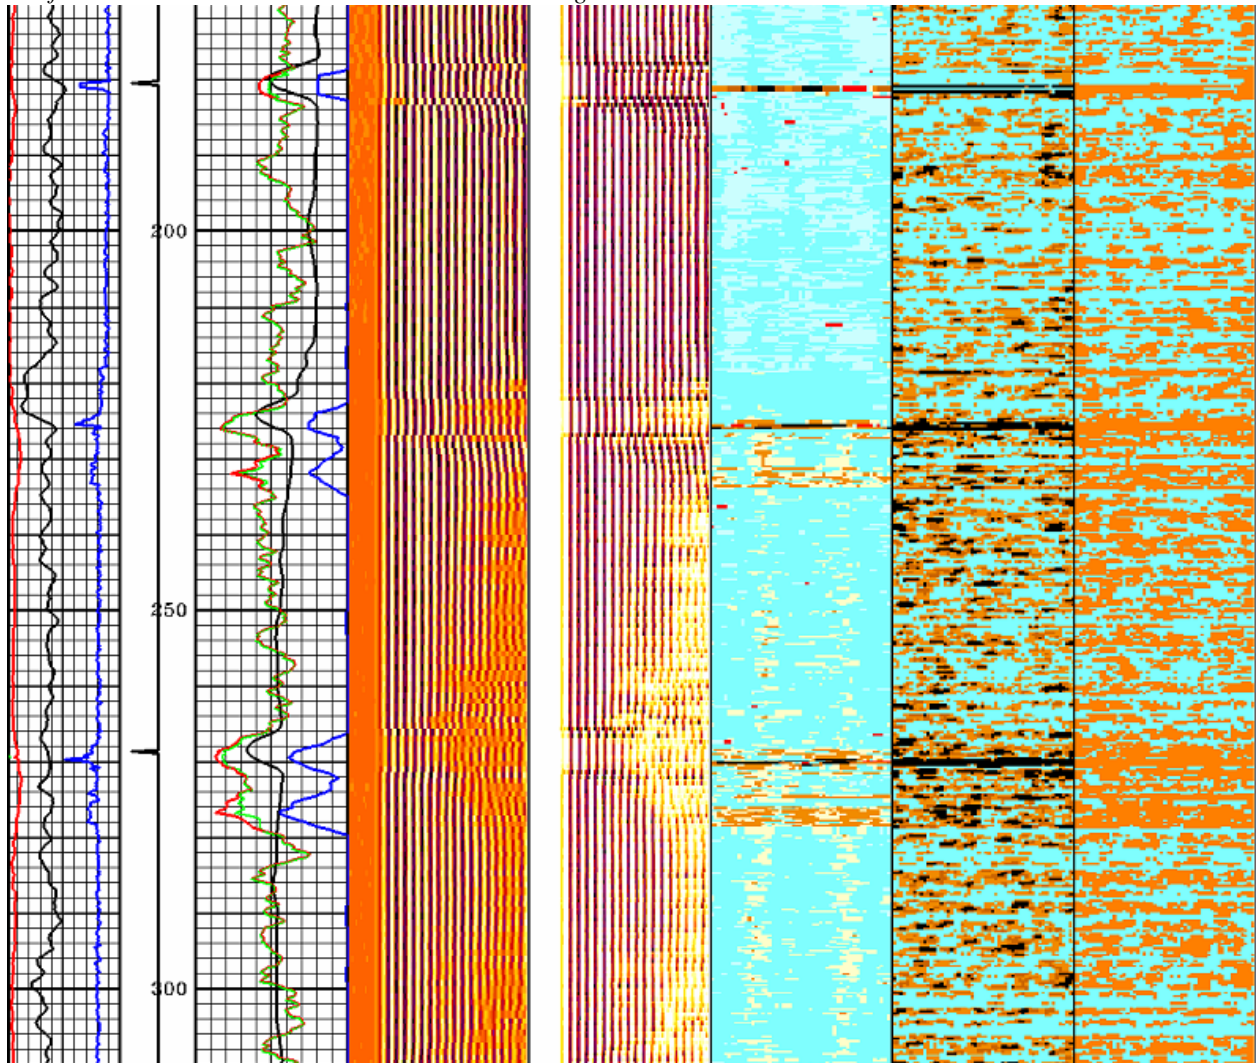
Figure 2: Top of cement

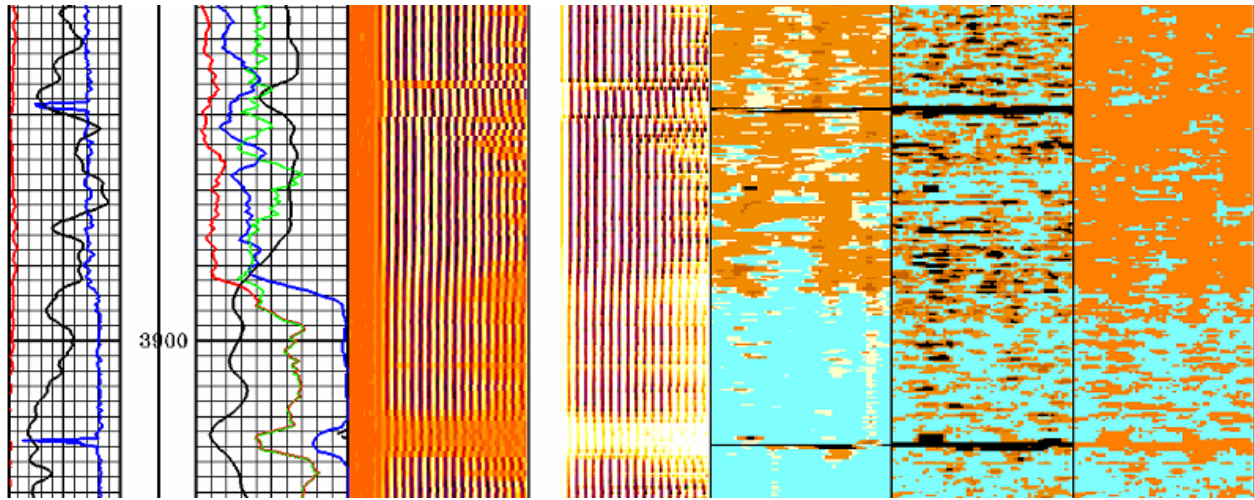
Figure 3: Lead and tail contact zone
