API: 057- 06094

06/18/2014

Site Inspection pictures (total)

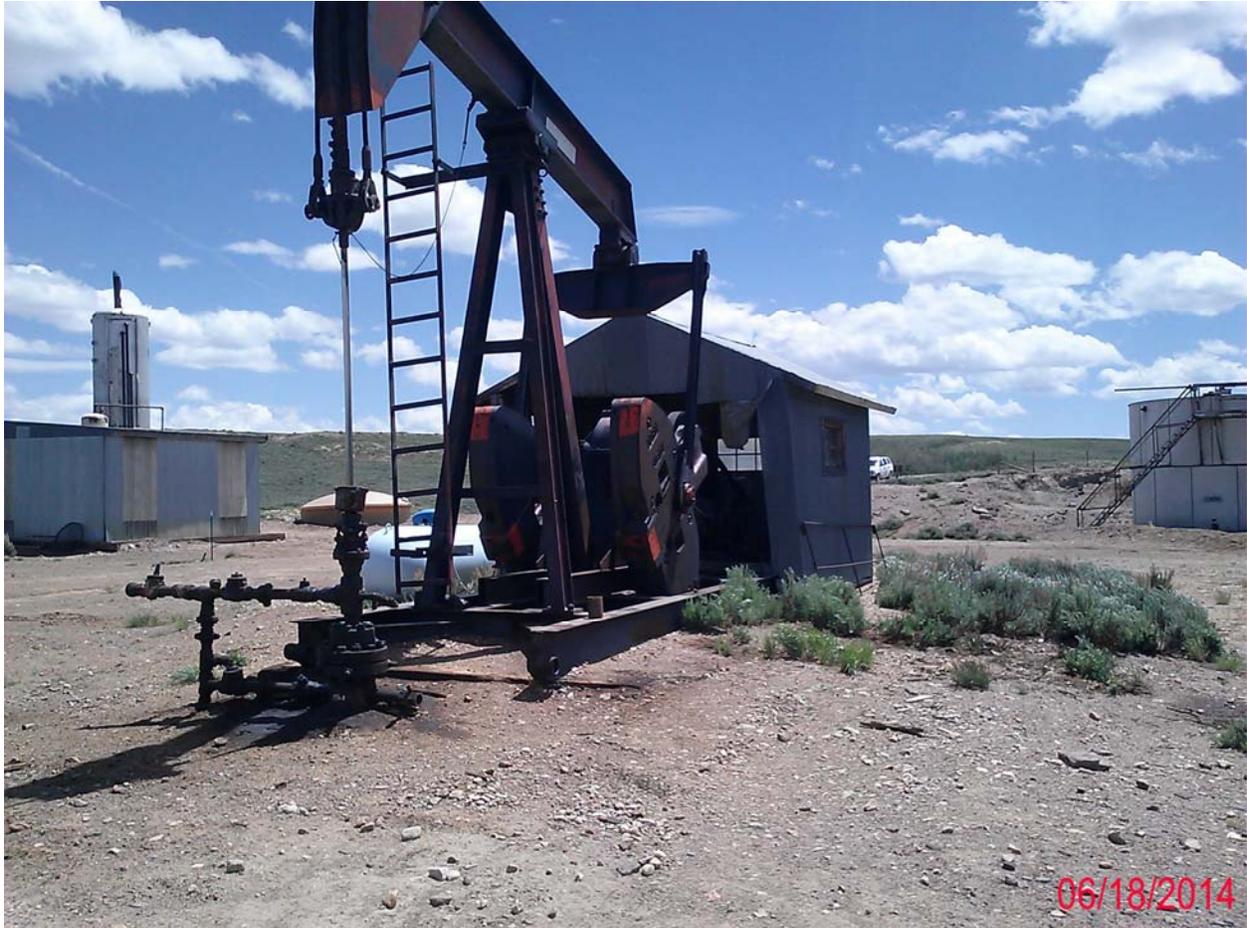
Leak at well head.

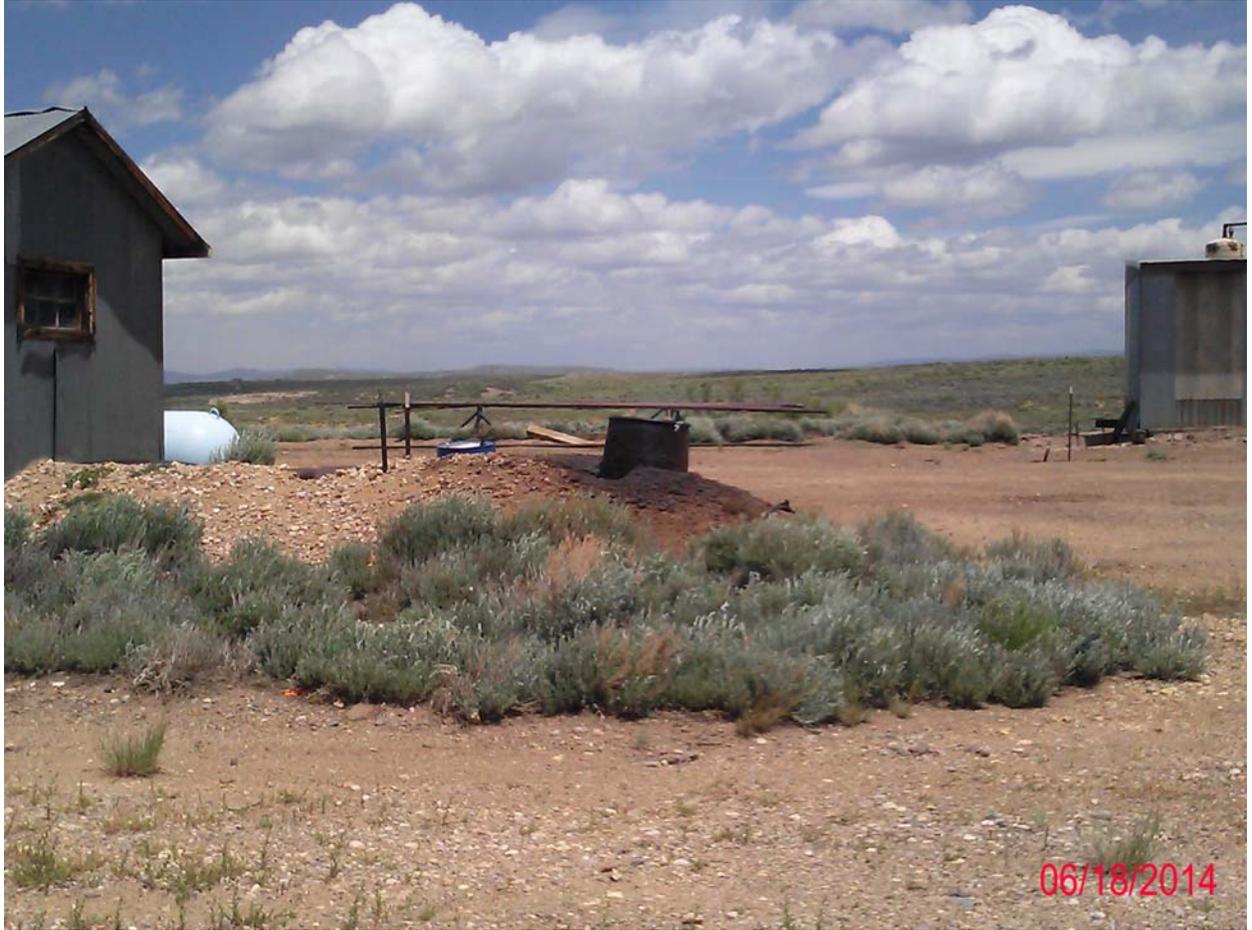
Leak from barrel behind well head.

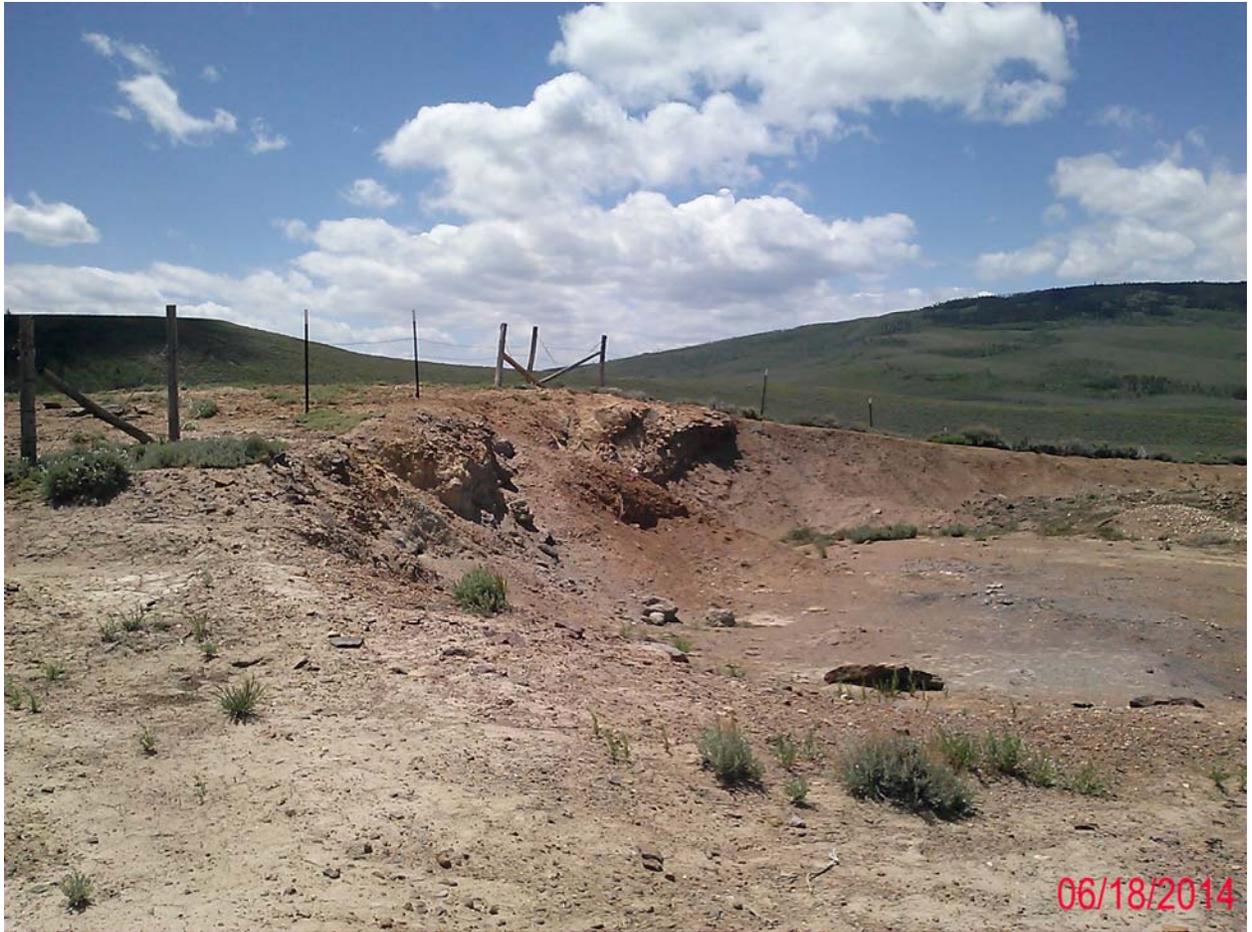
Erosion from cut on location.

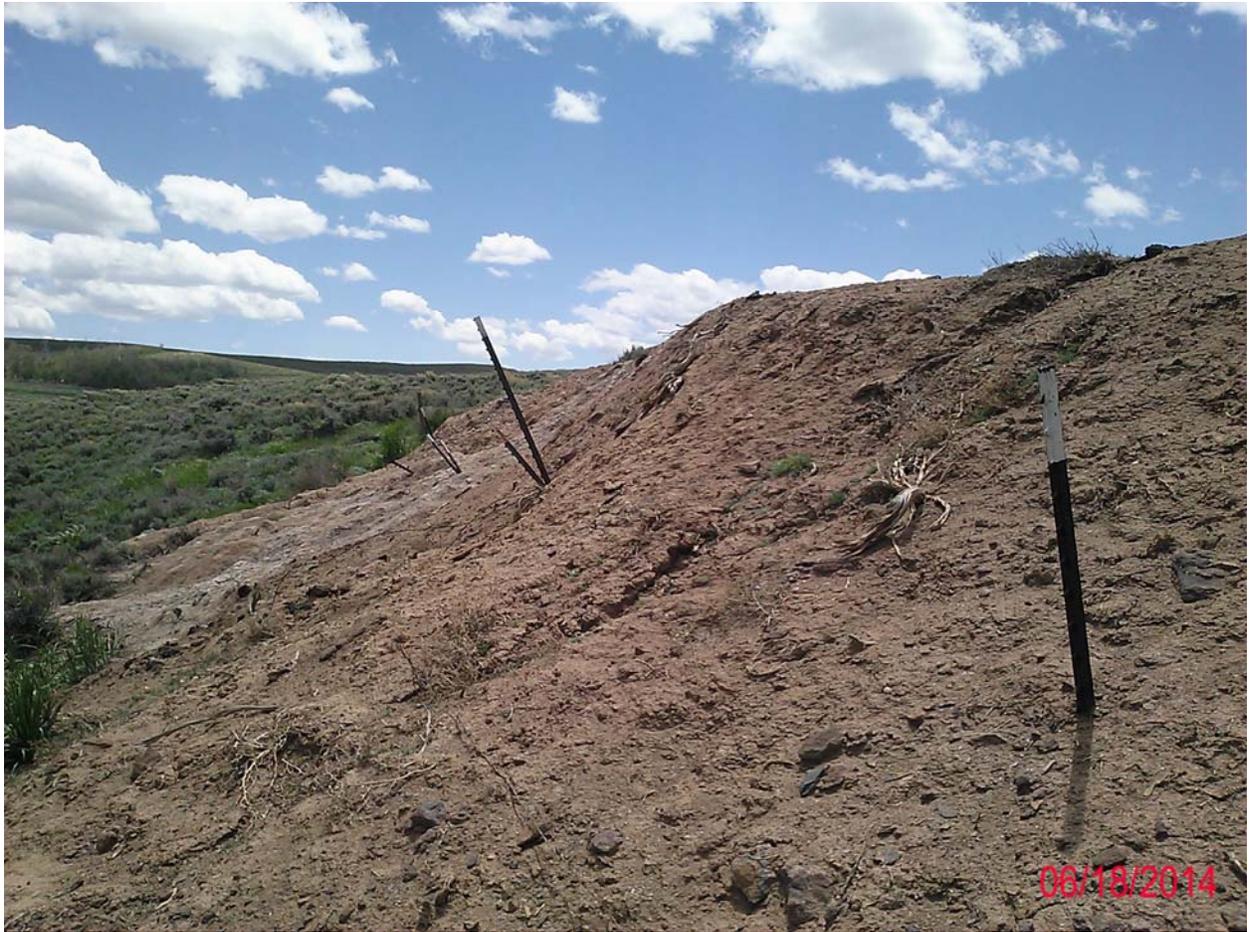
Sediment run-off, by pit and fencing down (1).

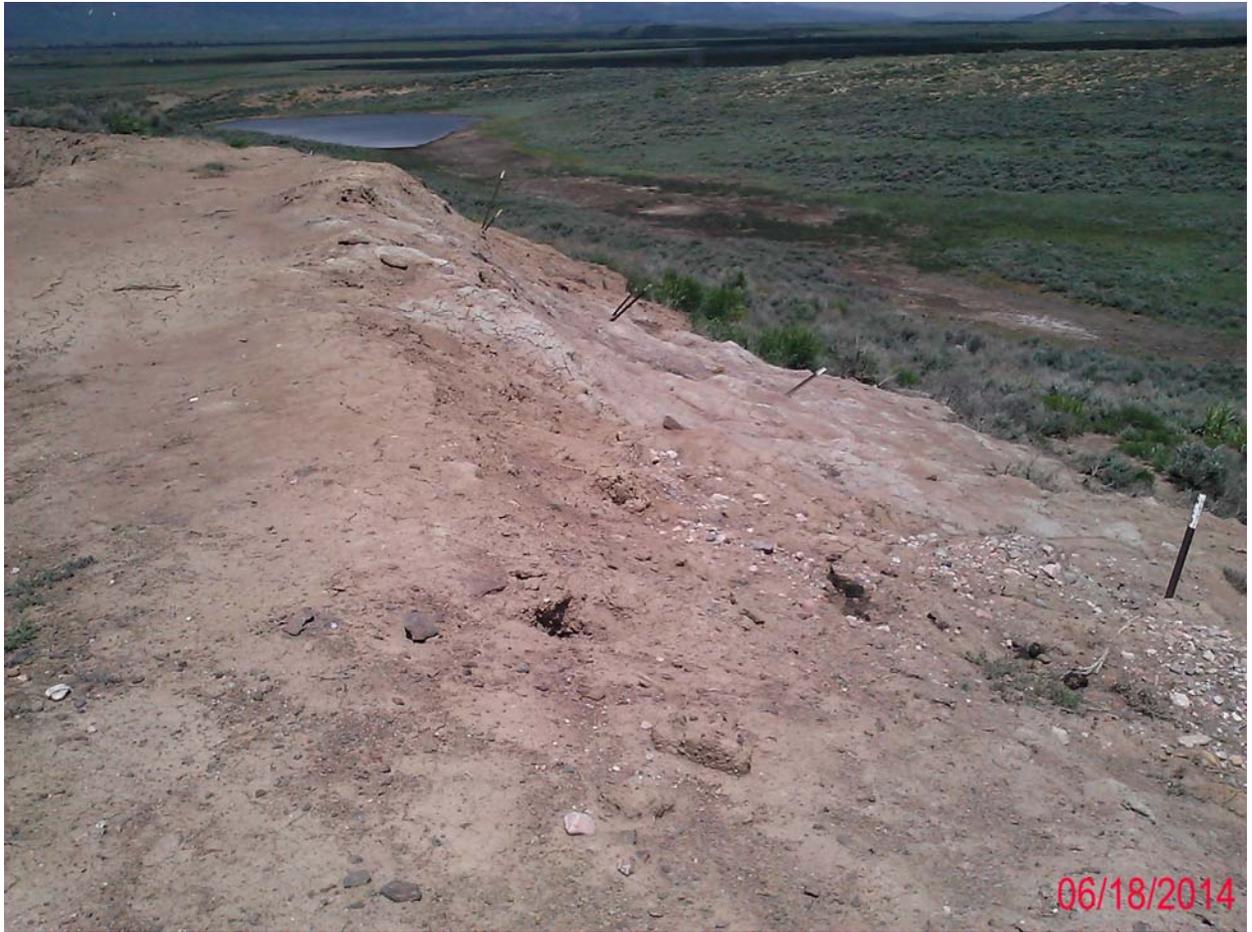
Sediment run-off, by pit and fencing down (2).

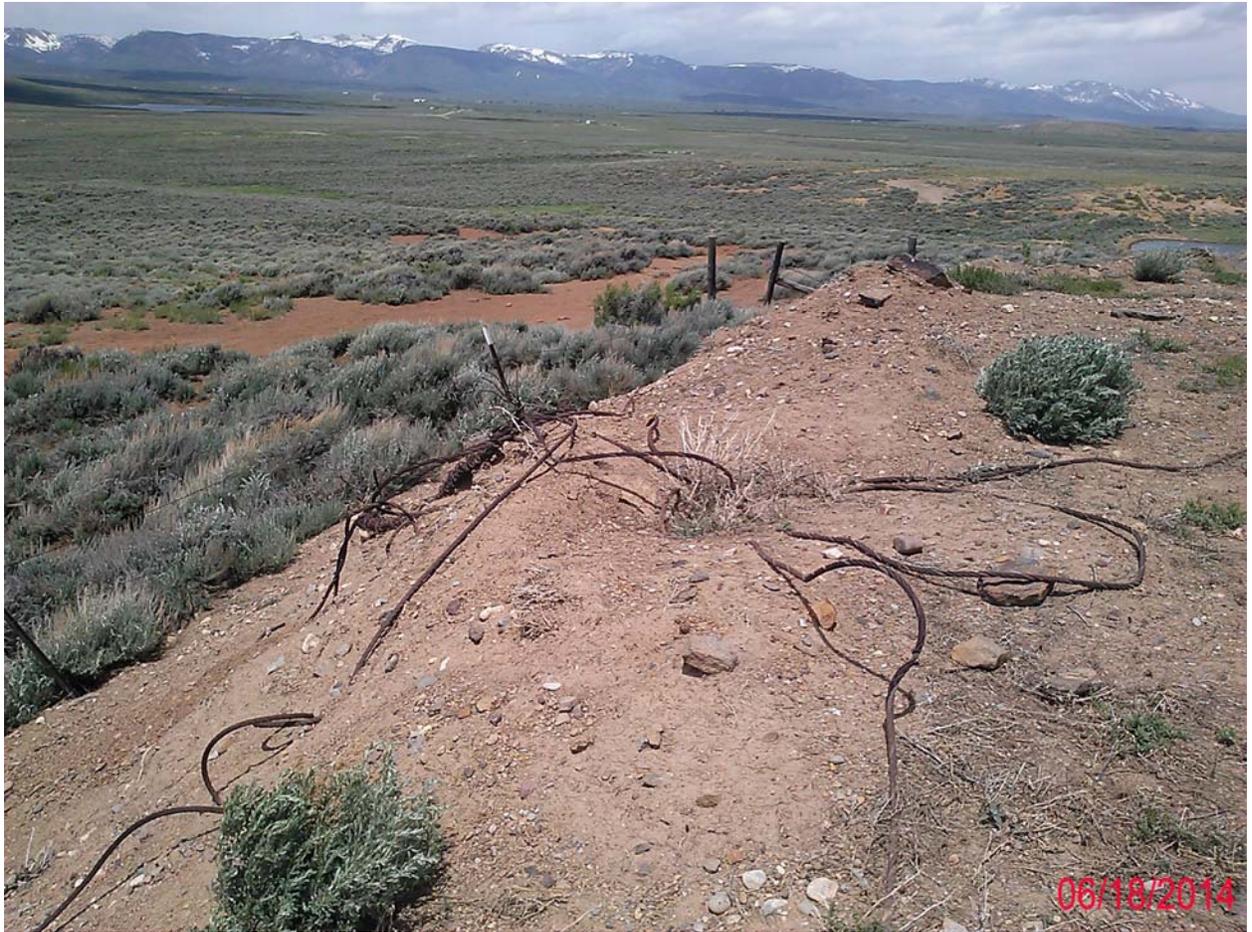
Debris on site.
