API: 057- 06065

06/18/2014

Site Inspection pictures (4 total)

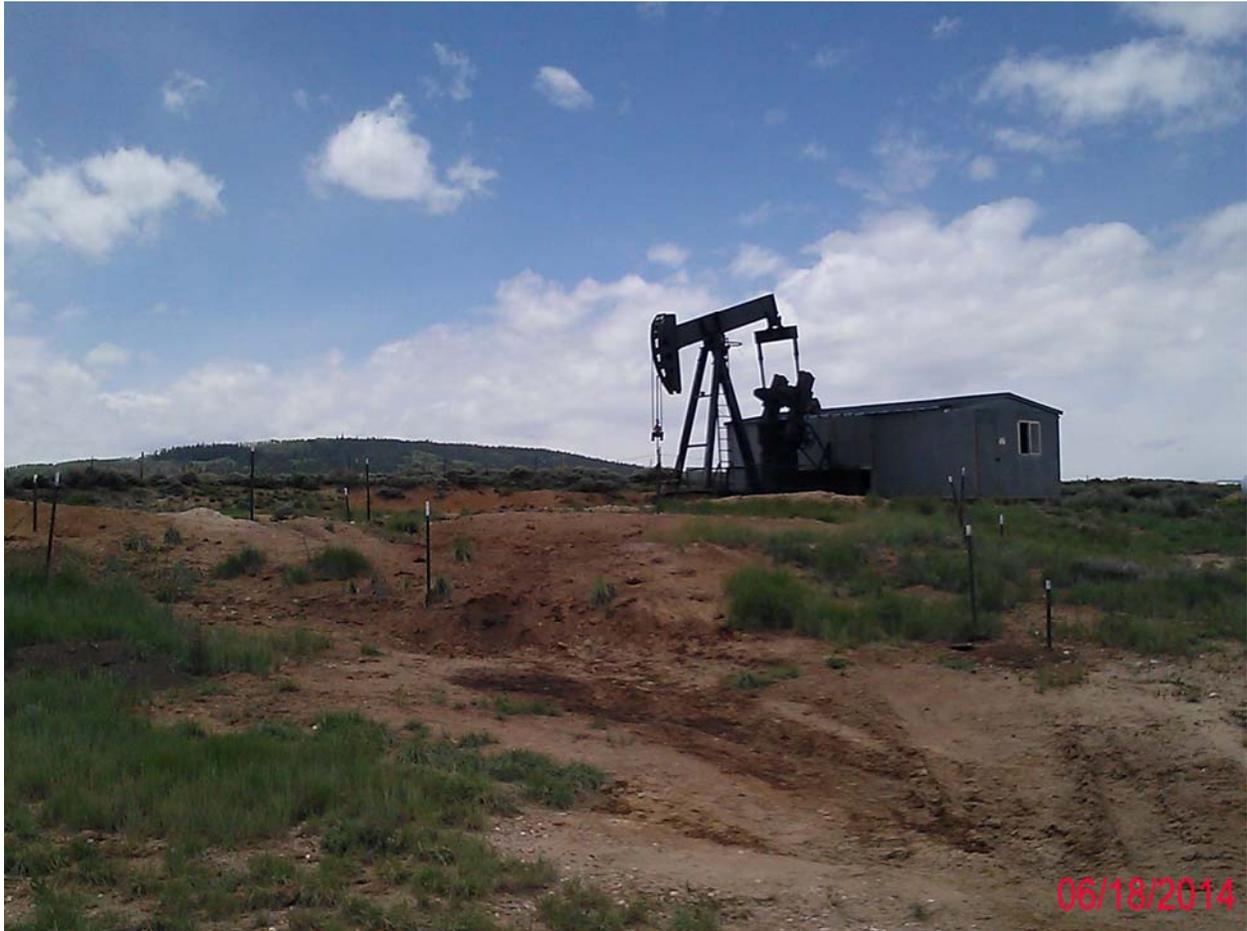
Oil run-off from spill still present.

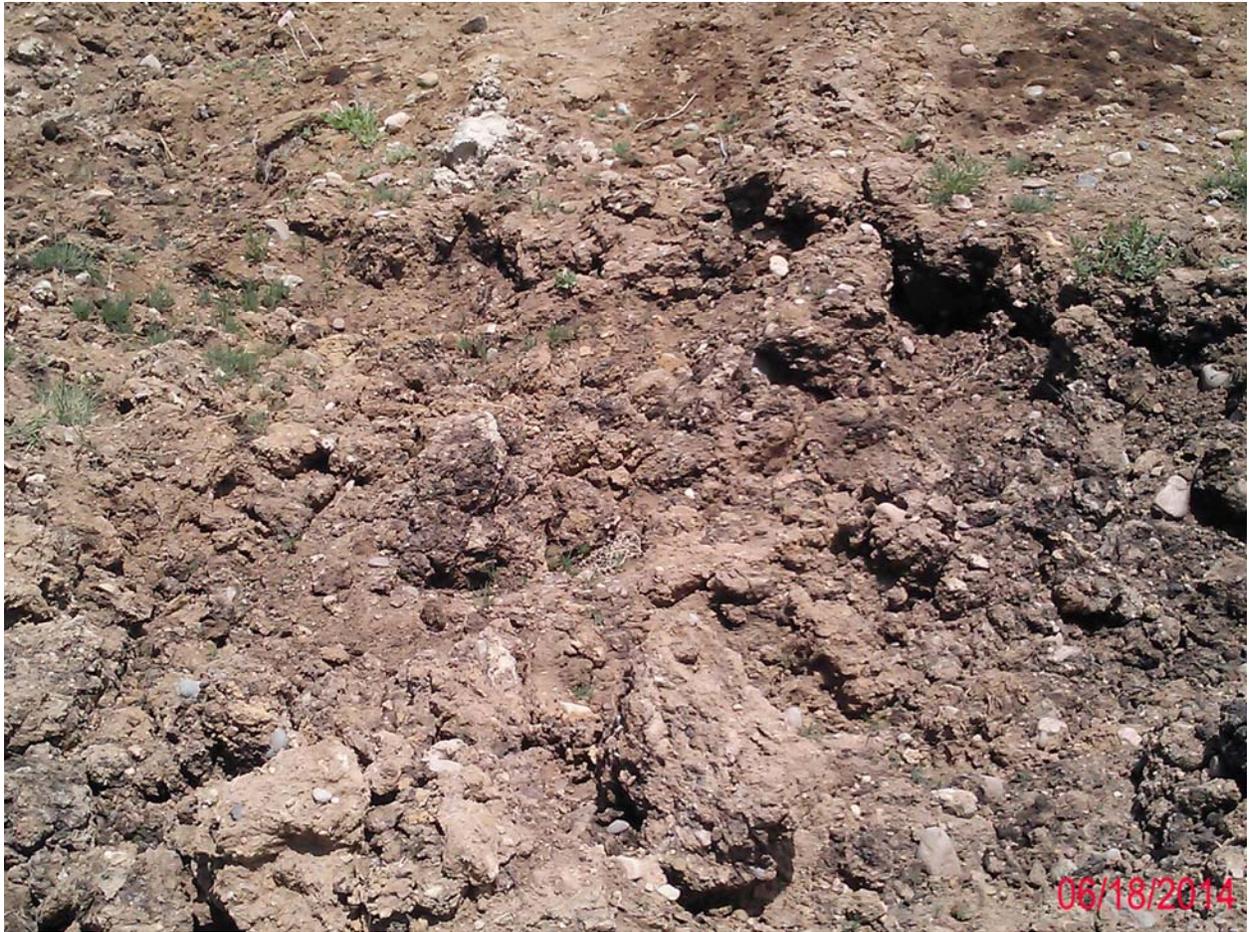
Cuttings/ dewatering mud pile with oily residue found on-site.

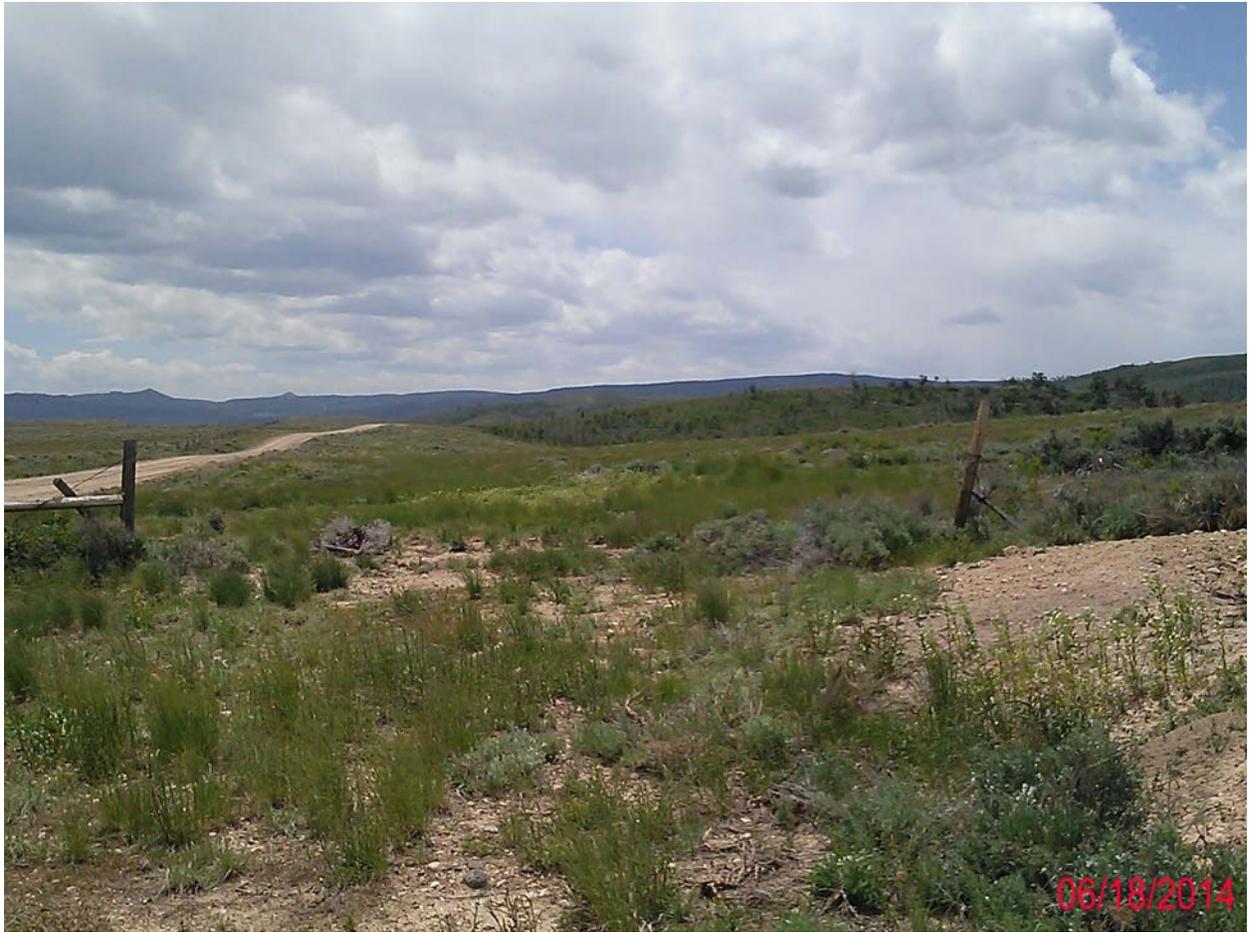
Location fencing removed.

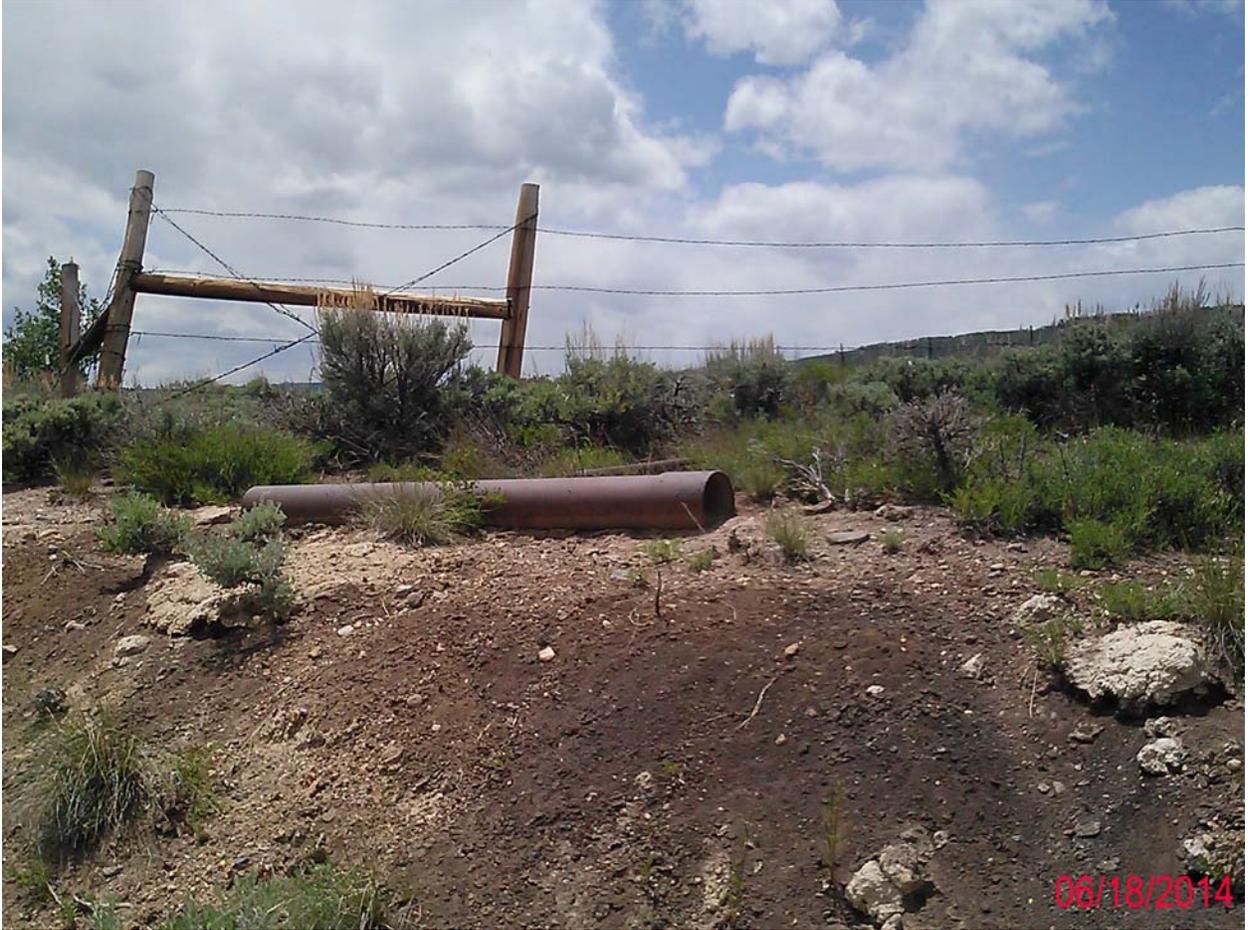
Debris and perimeter erosion.
