Location: 262078

06/11/2014 Interim Site Inspection photos (3 total)

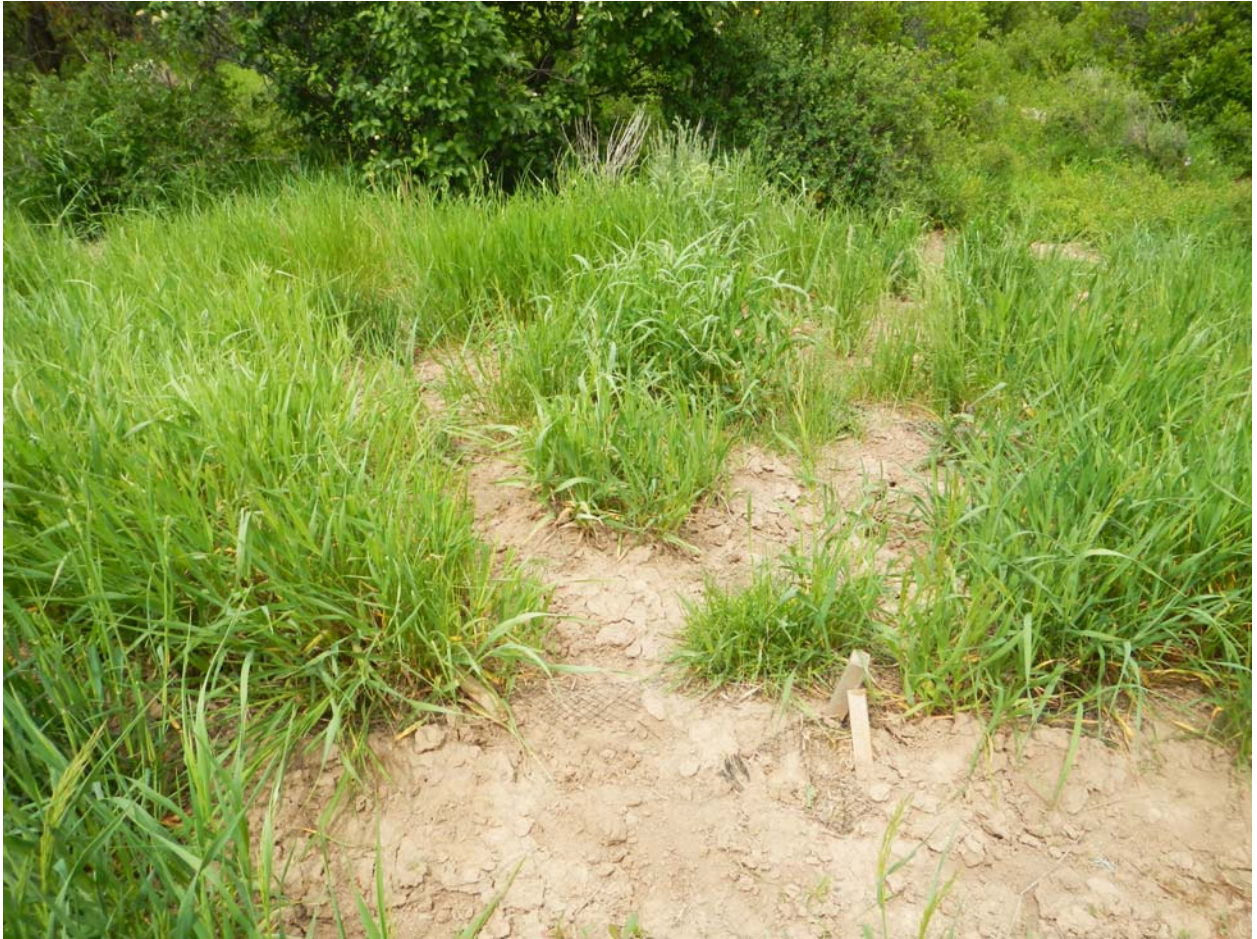
Perimeter wattles failing (1)

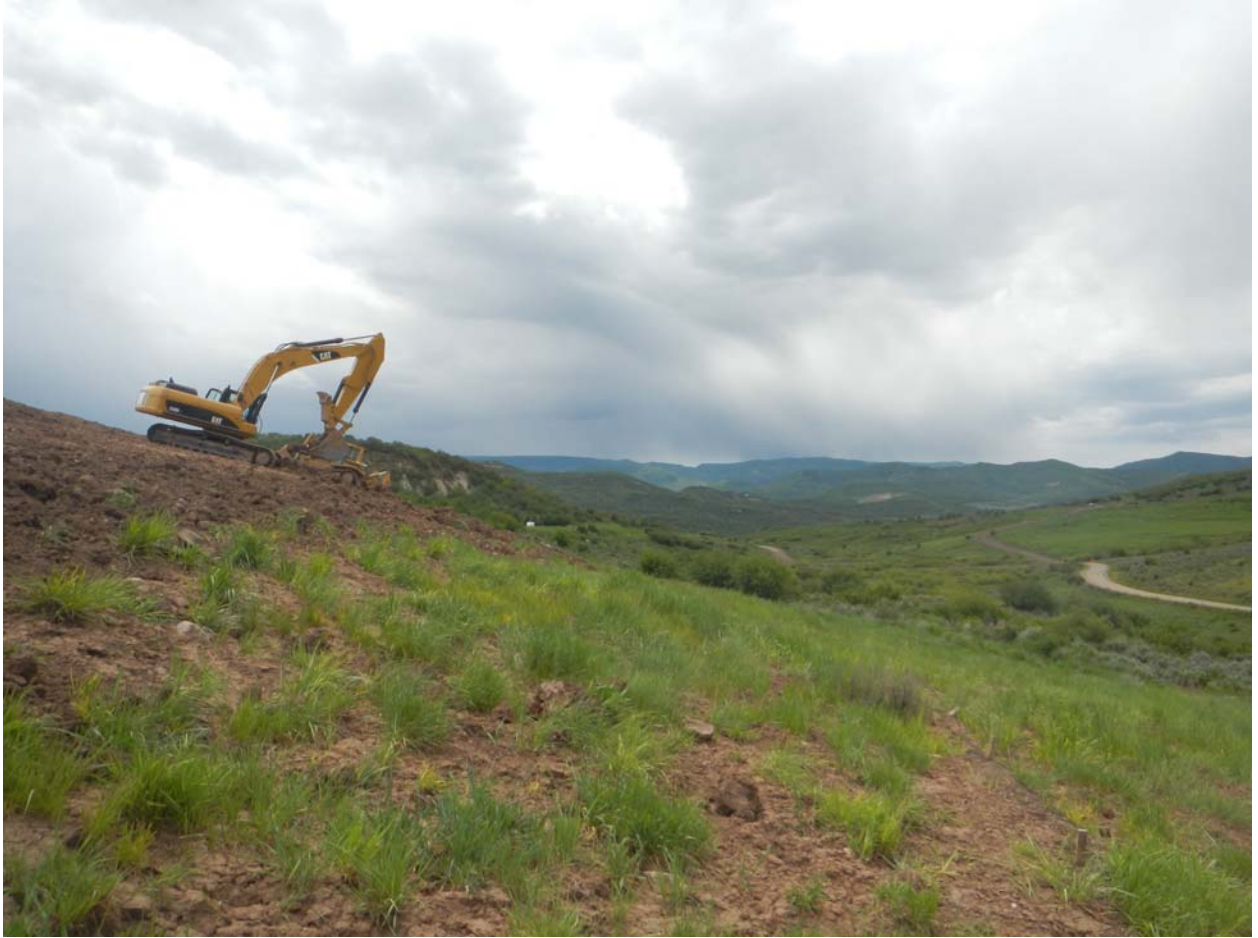
Perimeter wattles failing (2)

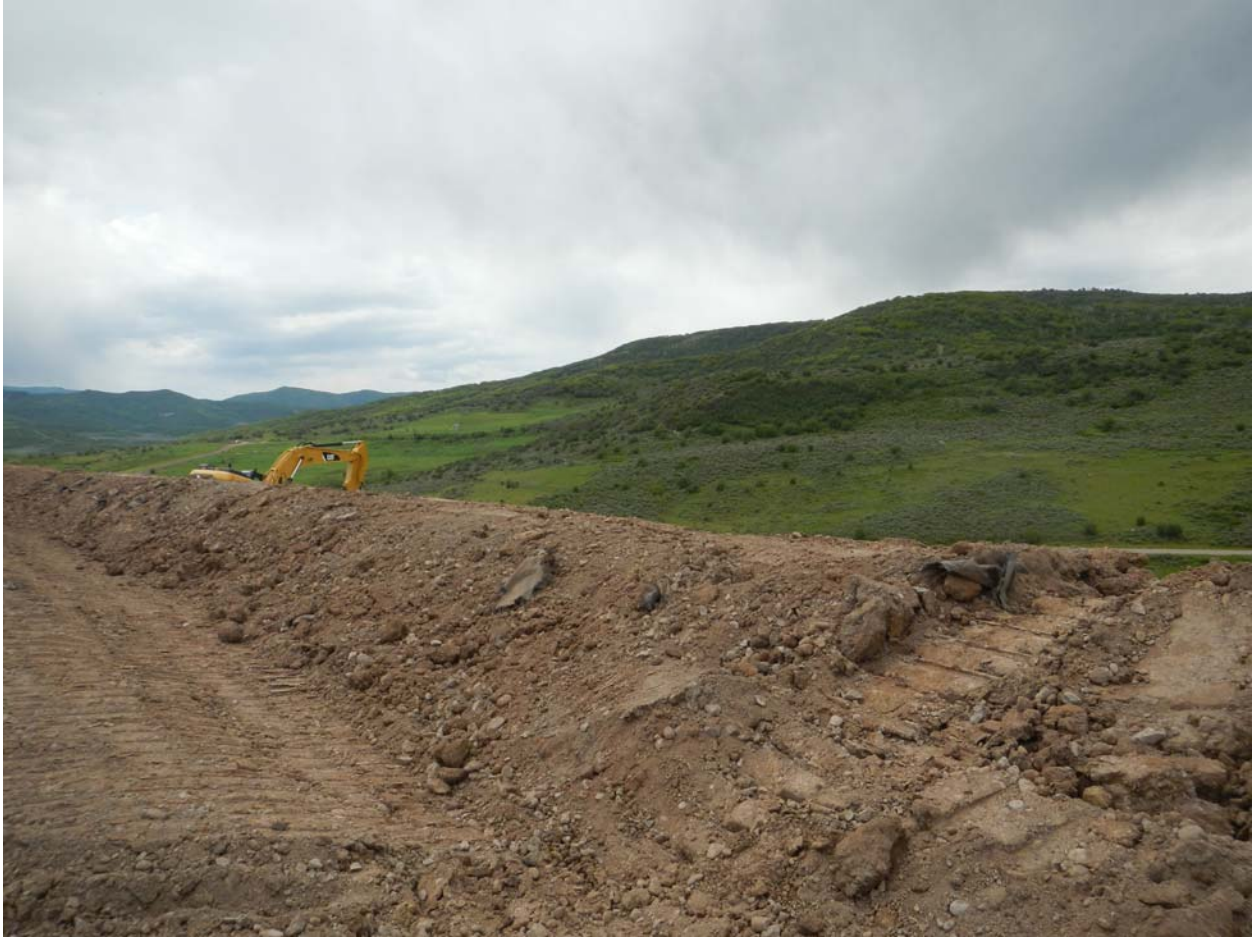
Debris being incorporated into perimeter berms
