HMU – 68S92W 6NWSE

Inspection DOC# 675200167

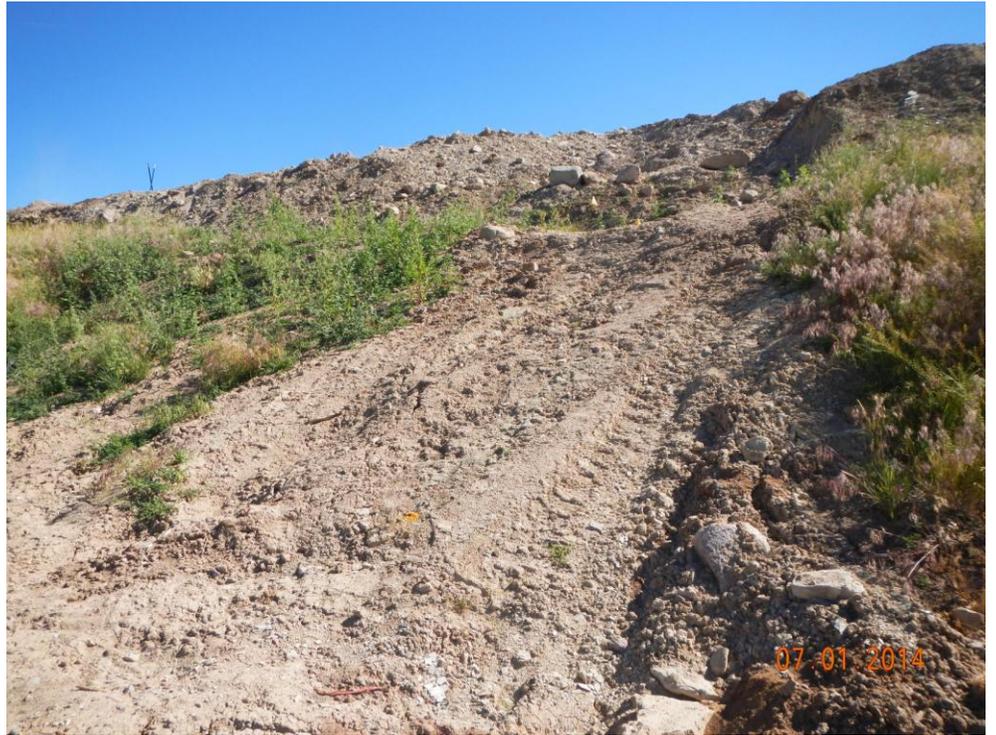
Erosion on cut slope.

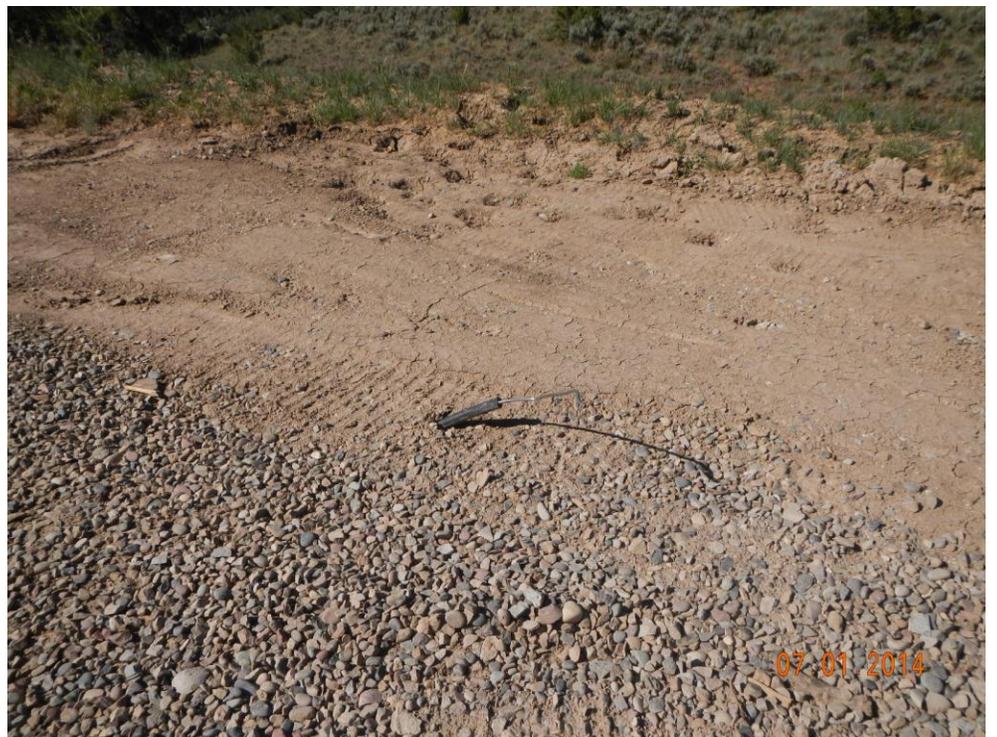
Tubing sticking out of ground.

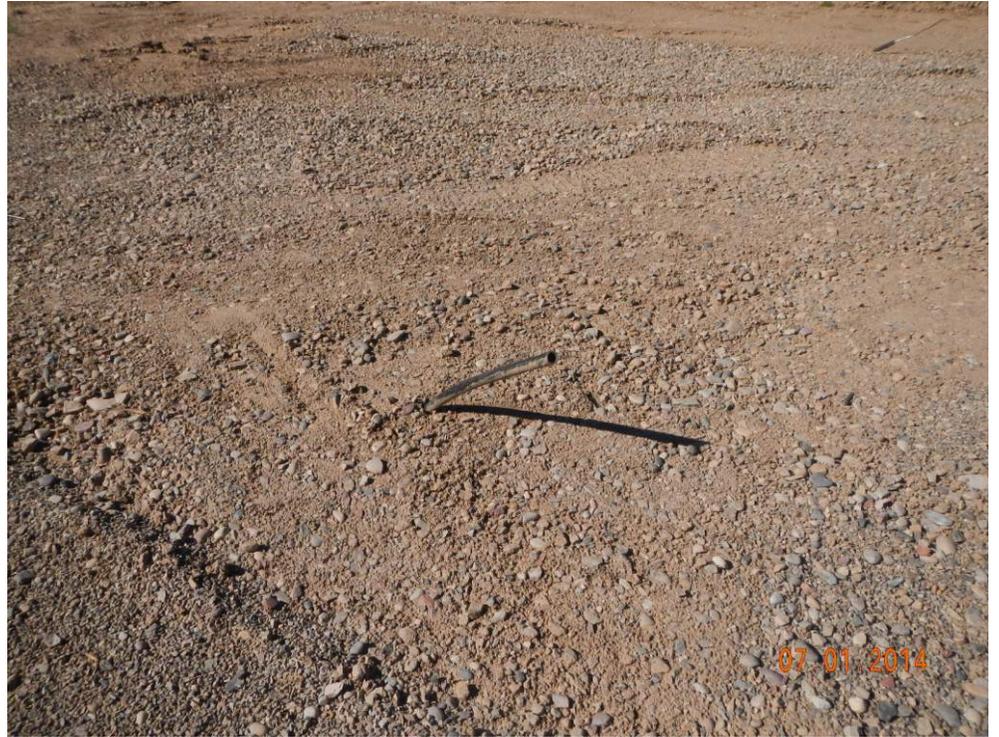
Tubing sticking out of
ground.
