HMU – 68S92W 7L4NE

Inspection DOC# 675200170

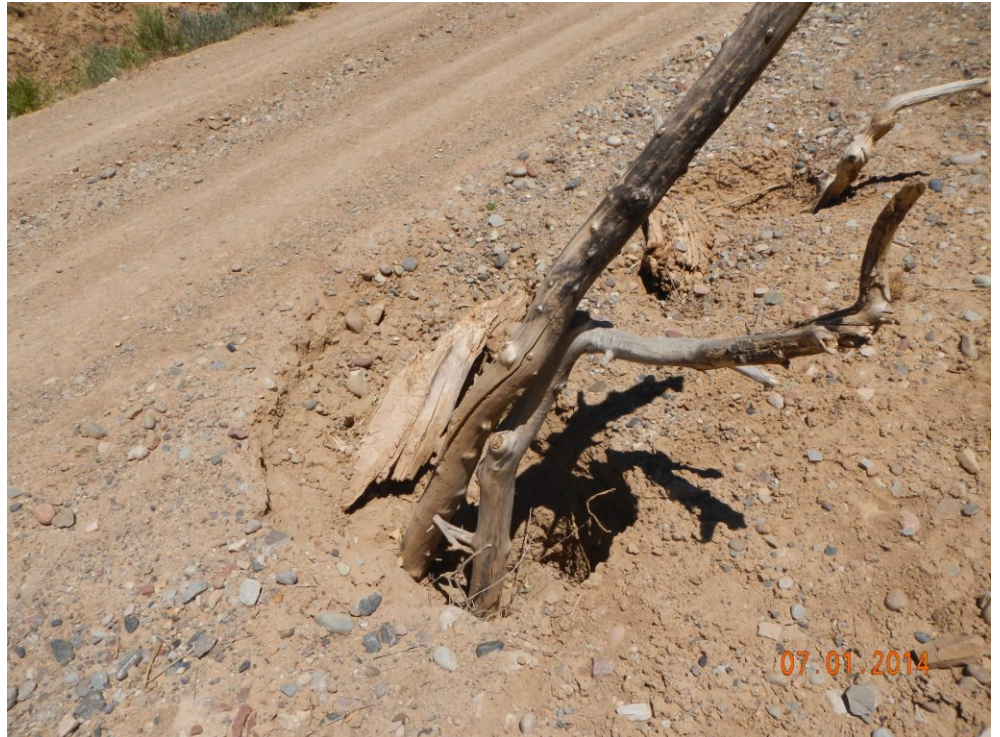
Erosion on main road
filled with debris.

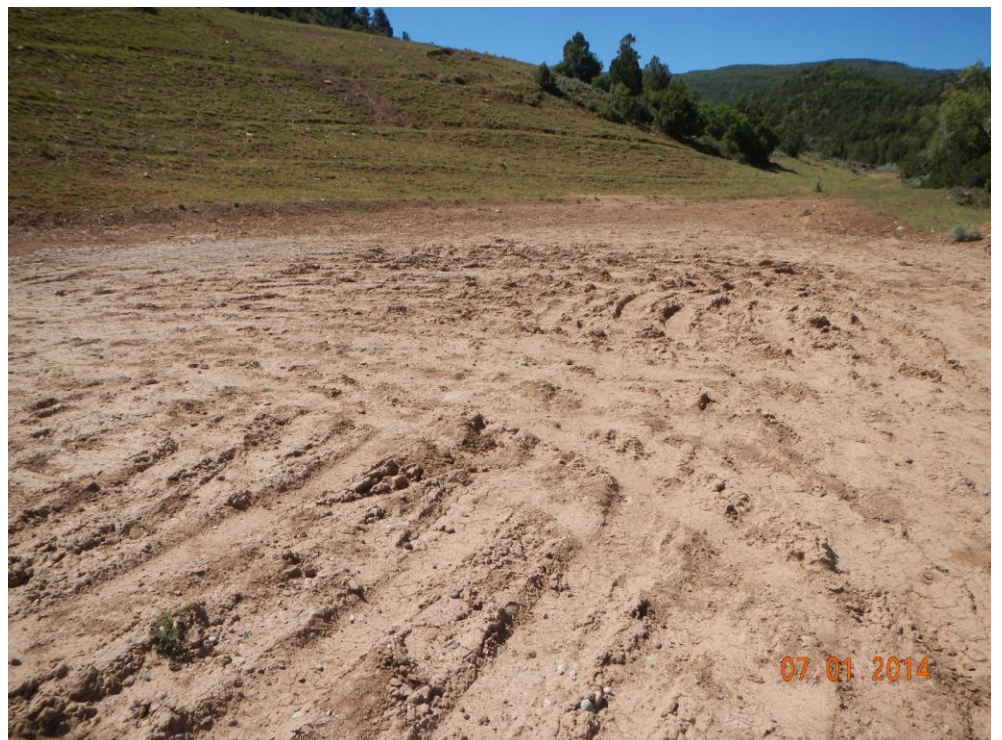
Rutting on location

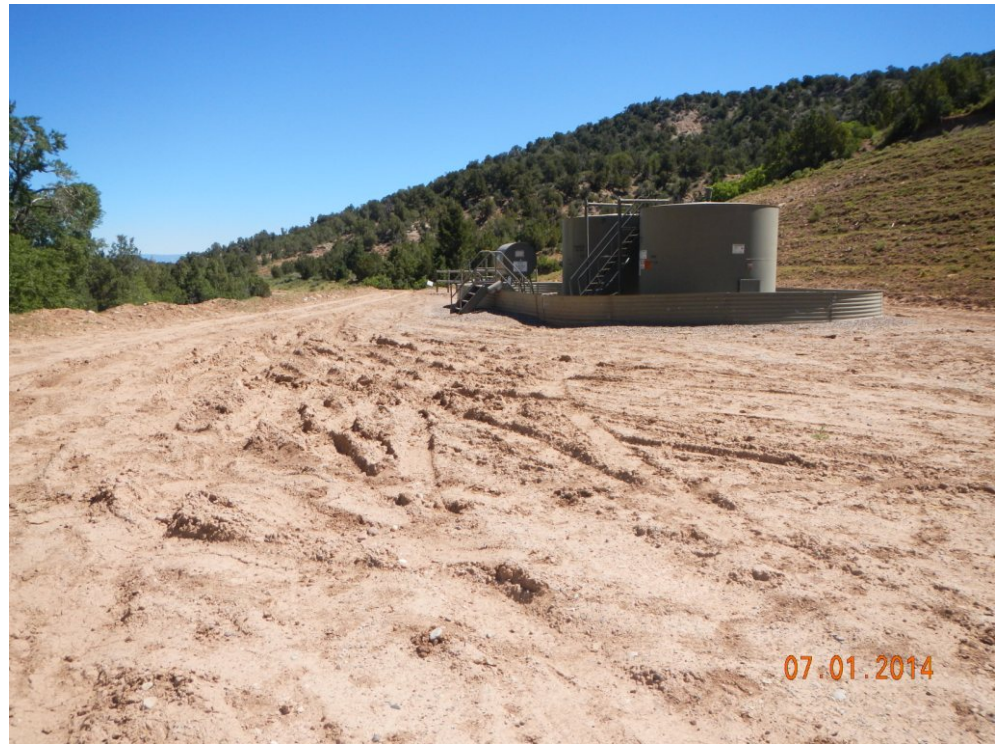
Rutting on location
