# Savage RWF 22-25

Inspection DOC# 675200190

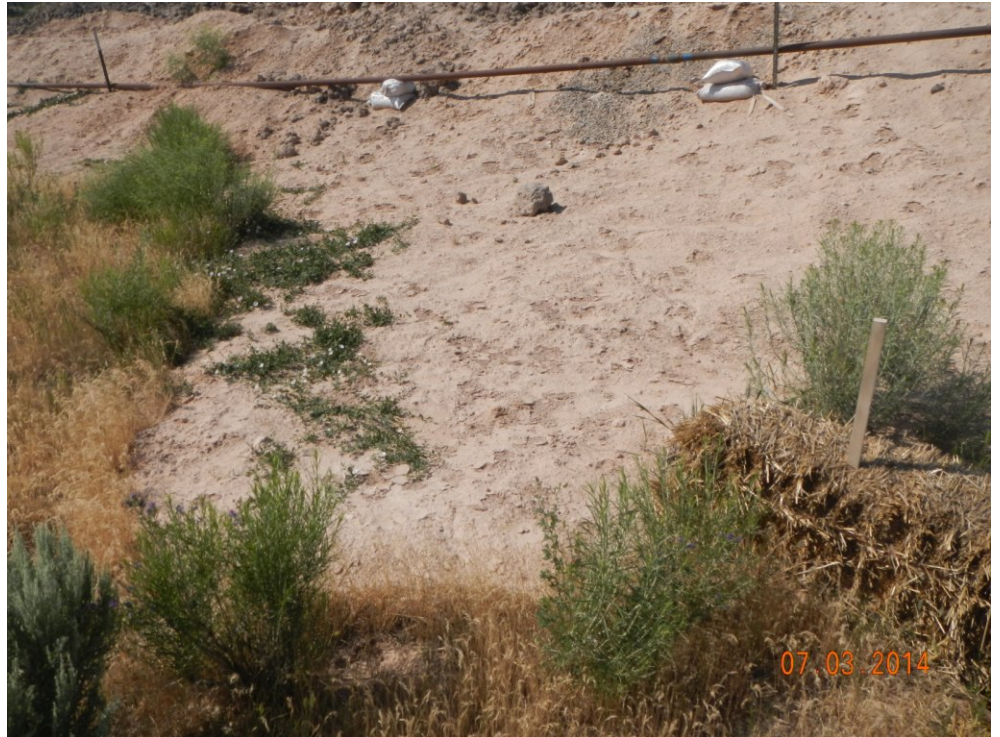
Sediment has gone  
around straw bales on  
East end of location.

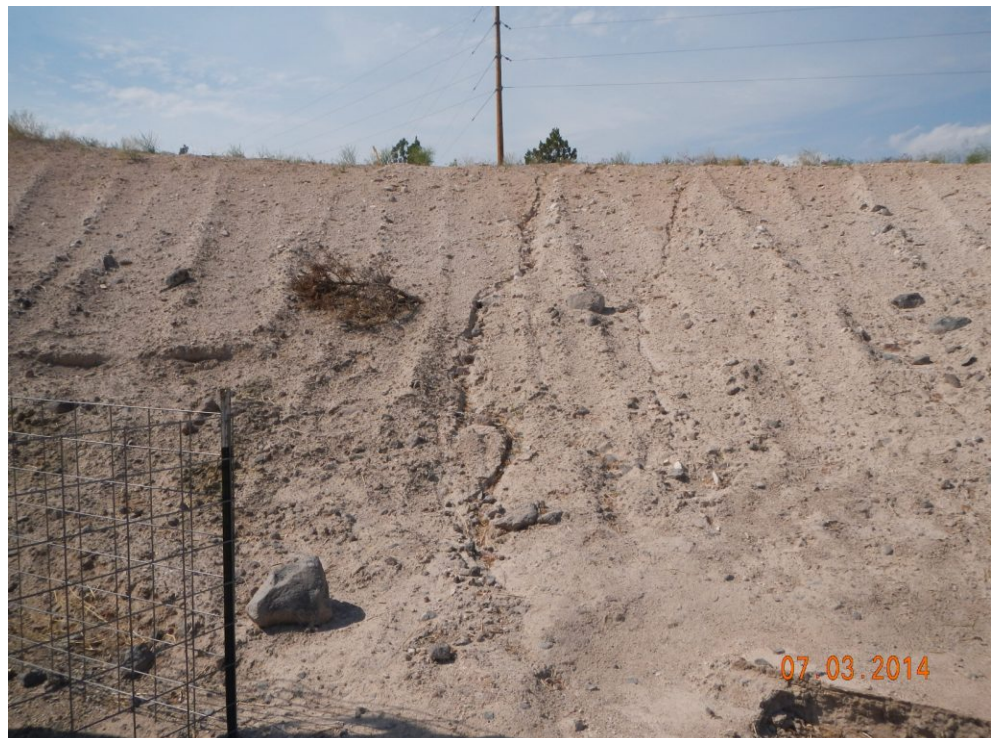
Erosion and rilling on  
cut slope.

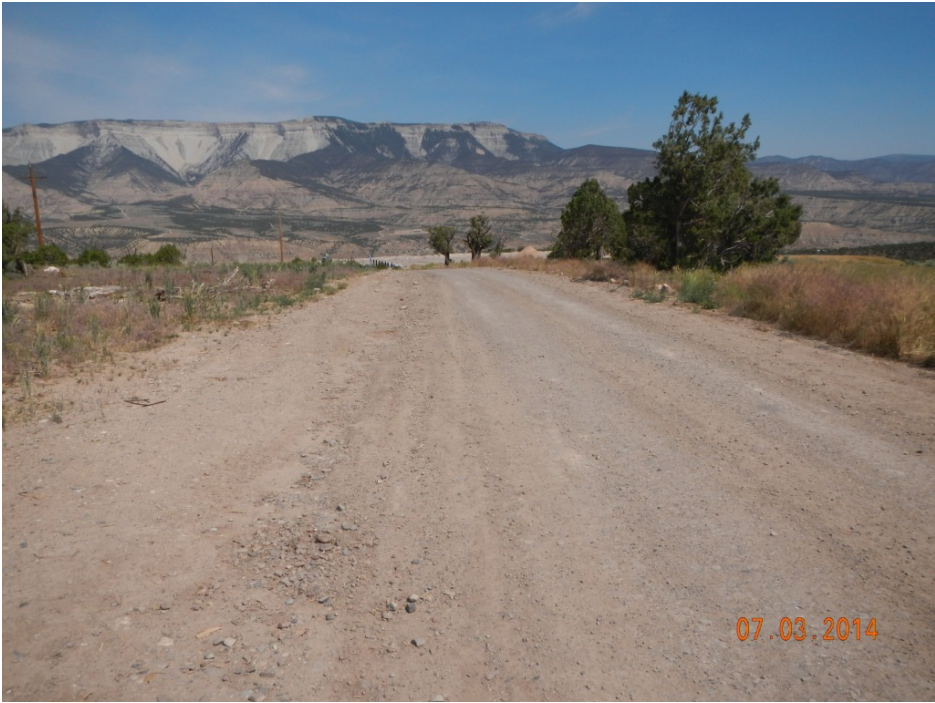
No visible storm water  
BMPs on access road.
