## Savage RWF 23-25

Inspection DOC# 675200191

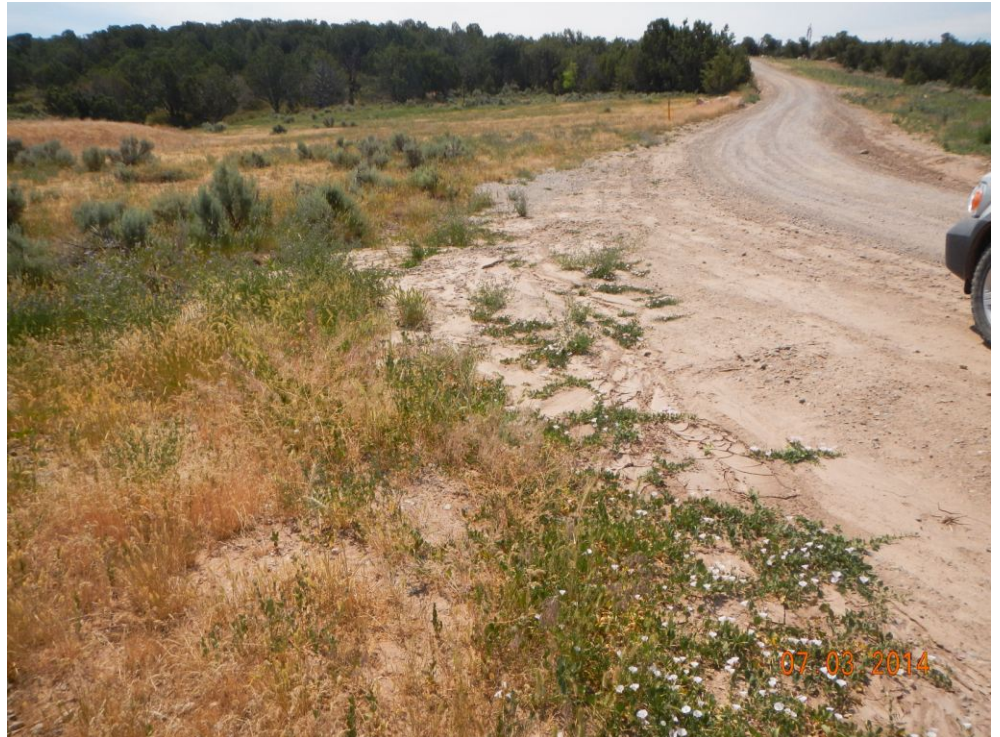
Sediment has gone into  
vegetation off of main  
road.

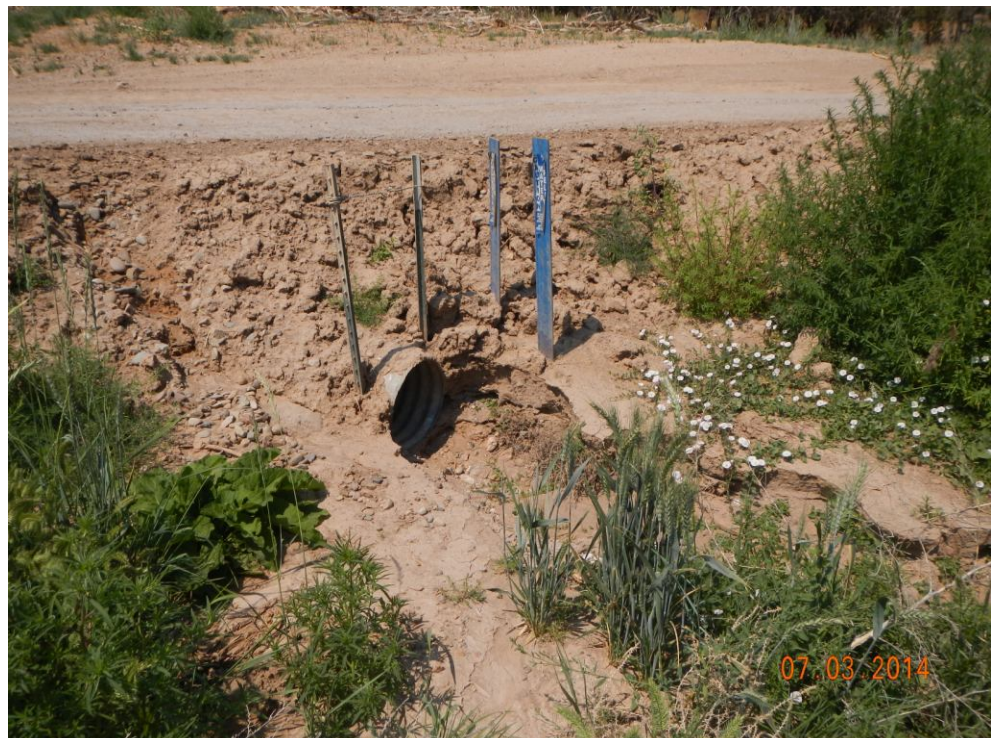
Erosion from road at  
culvert. Culvert outlet  
not armored.

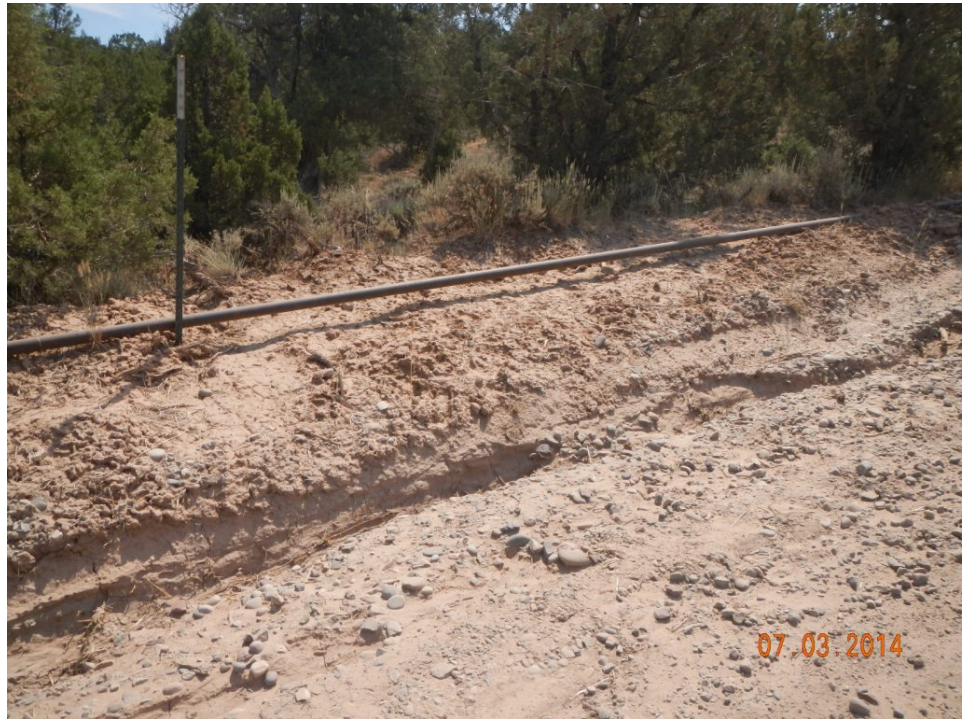
Erosion on road, no ditch  
in place.

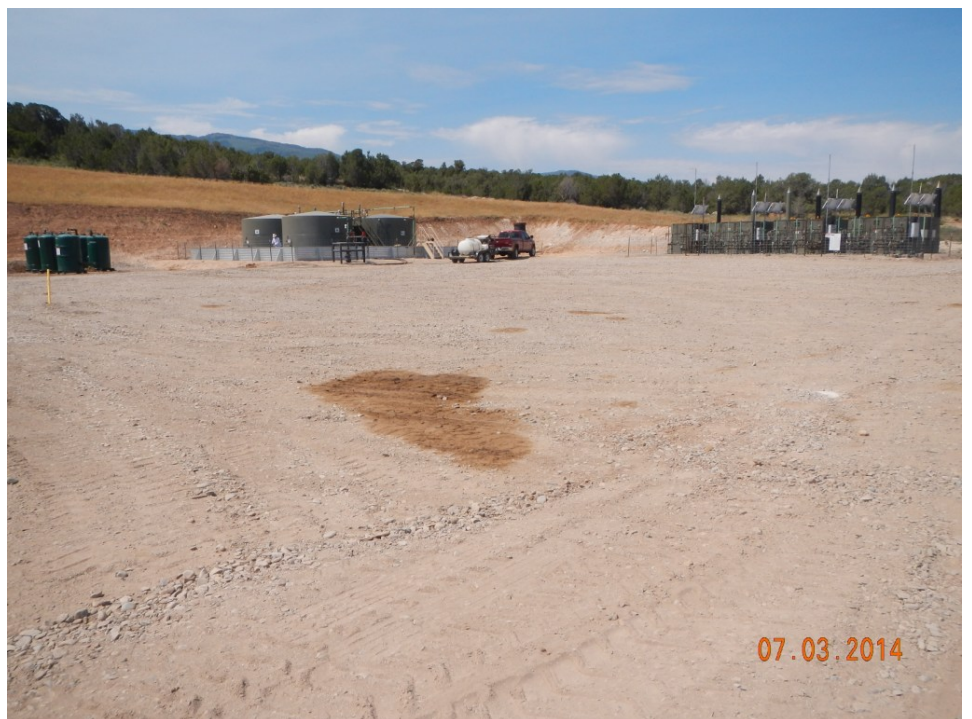
Staining on location

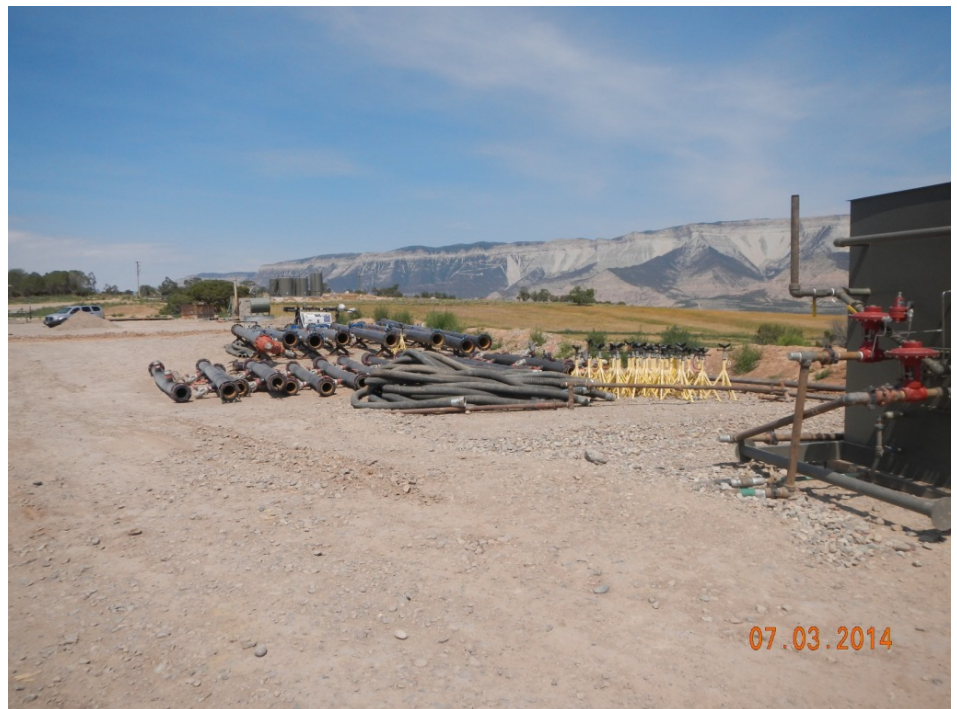
Stored equipment

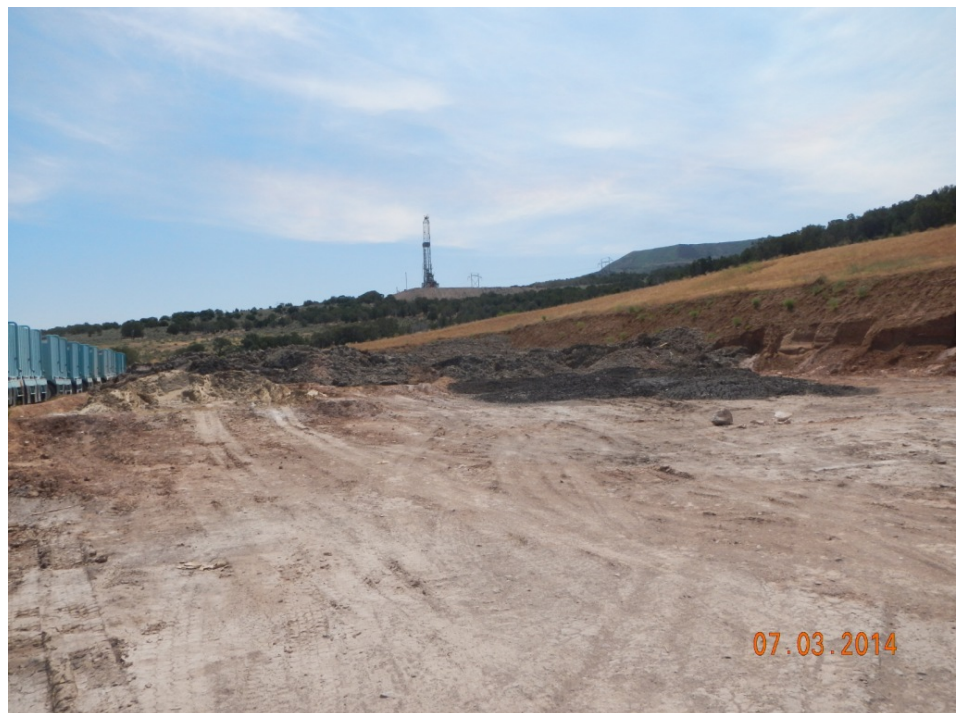
Cuttings stacked on location.
