DOWNING-66S94W - #335511

07/11/2014 Inspection pictures (4 total).

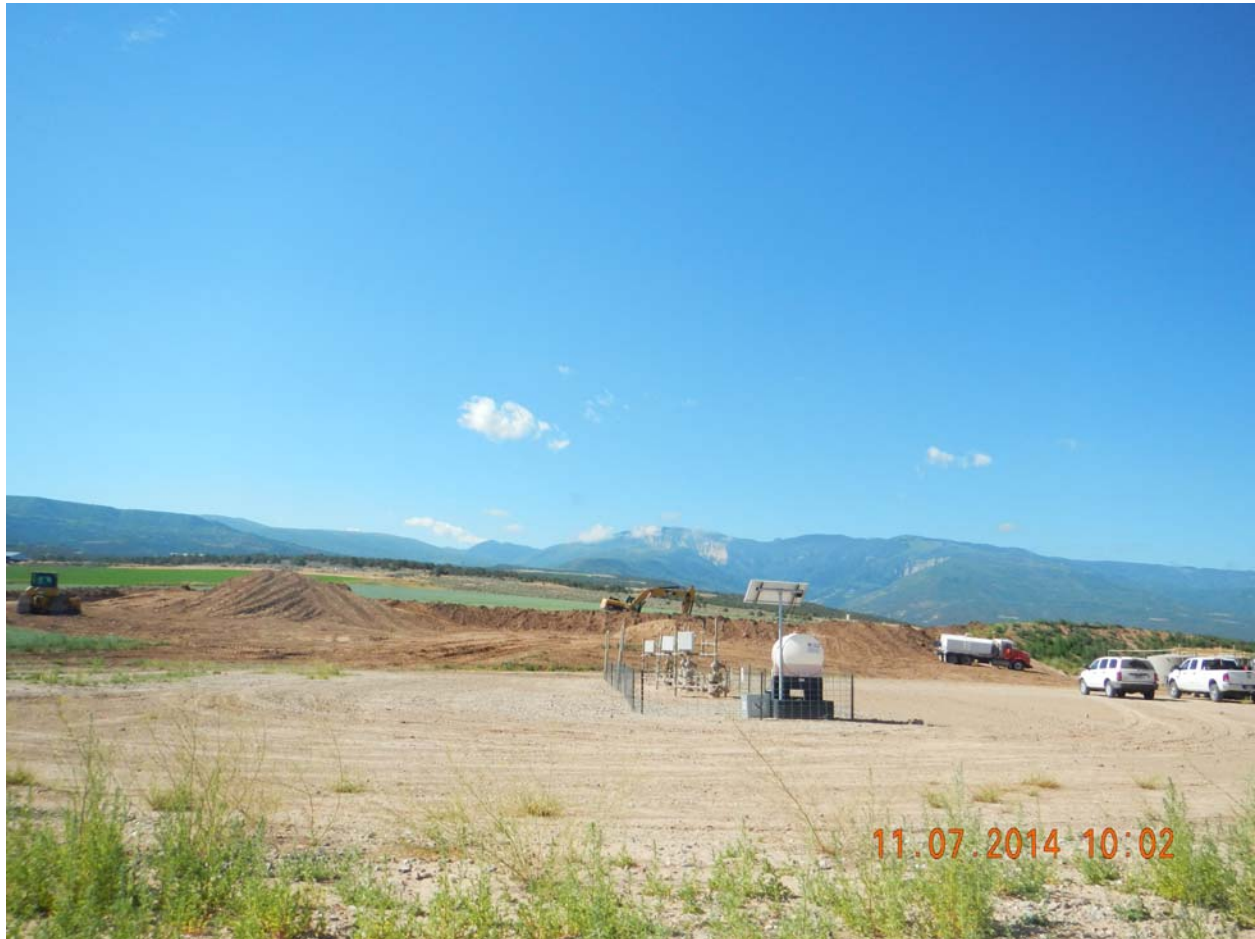
Southern cut of pad being compacted and re-graded to relieve subsidence. Tracking in place and BMP.

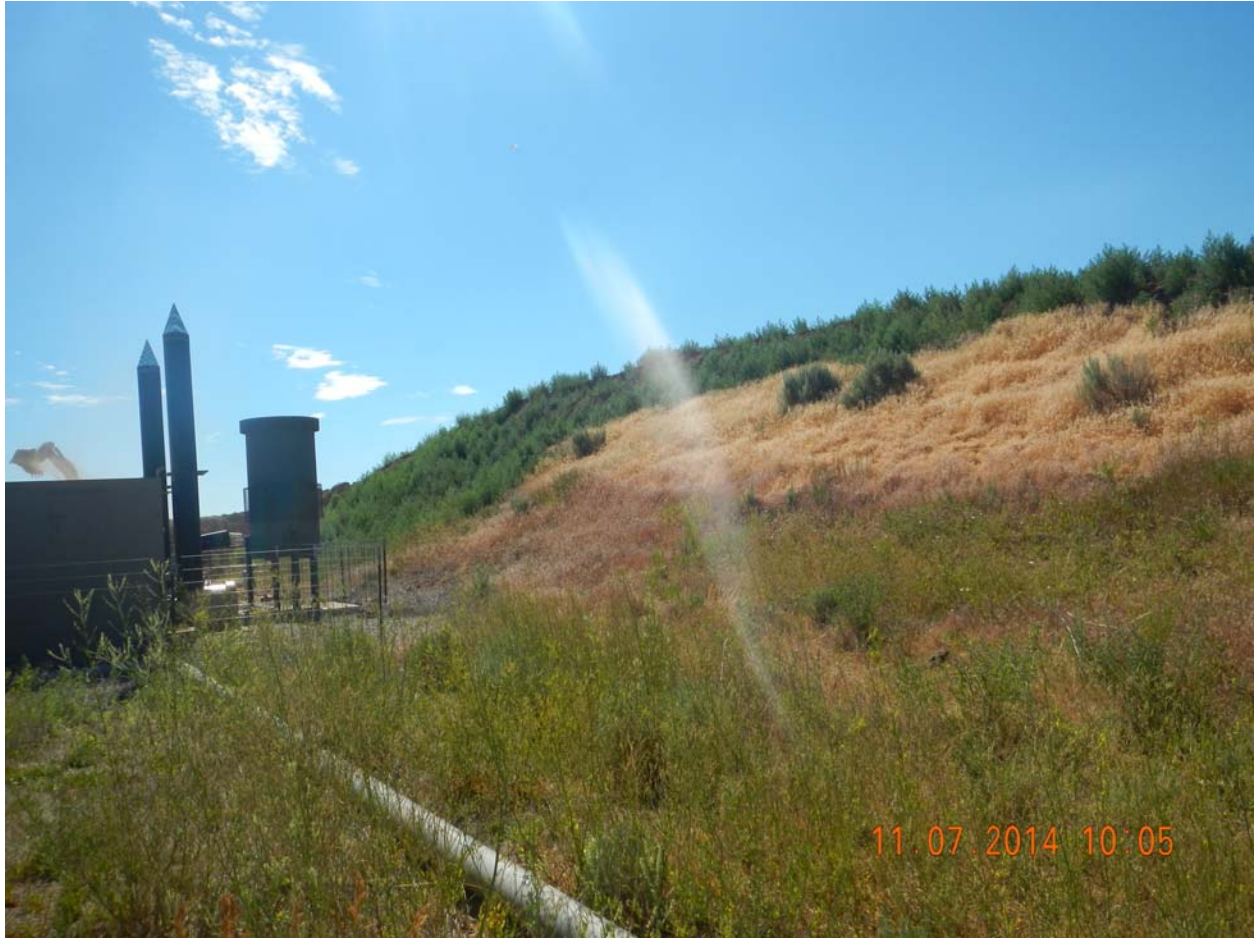
Pad interim overrun with weeds.

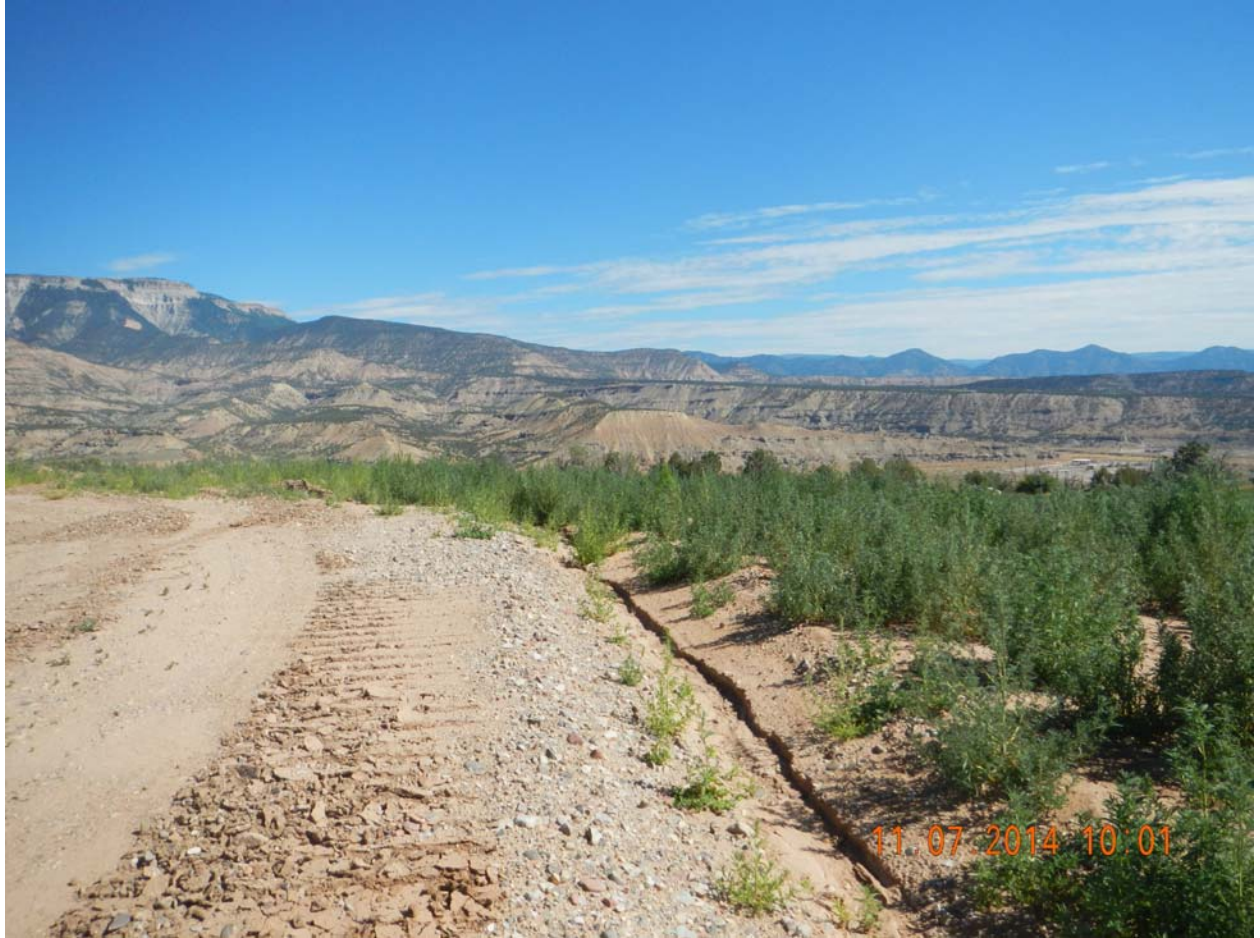
Erosion and rilling on Northern pad perimeter.

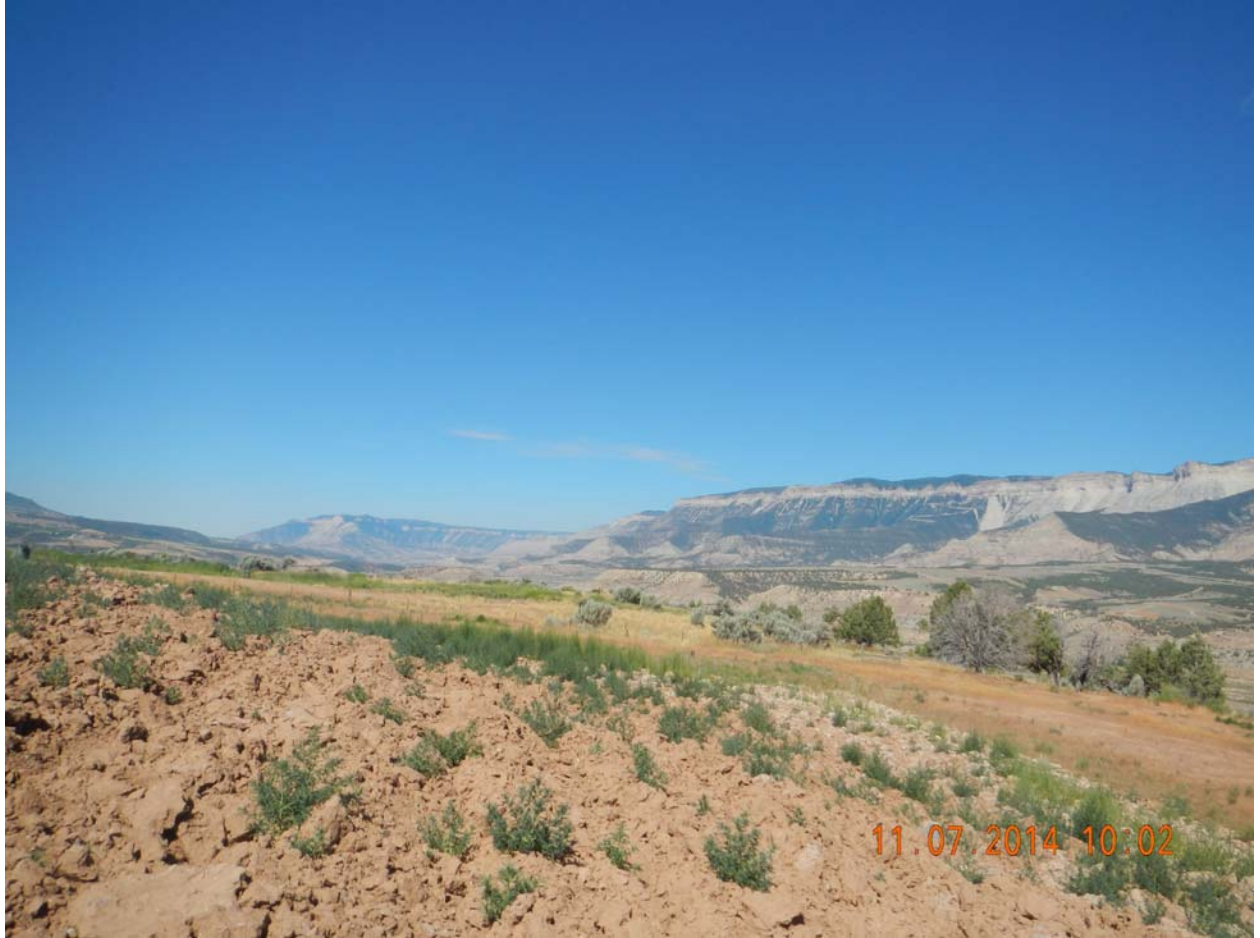
Surface roughening appropriate stormwater BMP. Vegetation sparse.
