Shideler 67S92W 20SWNW

Inspection DOC# 675200225

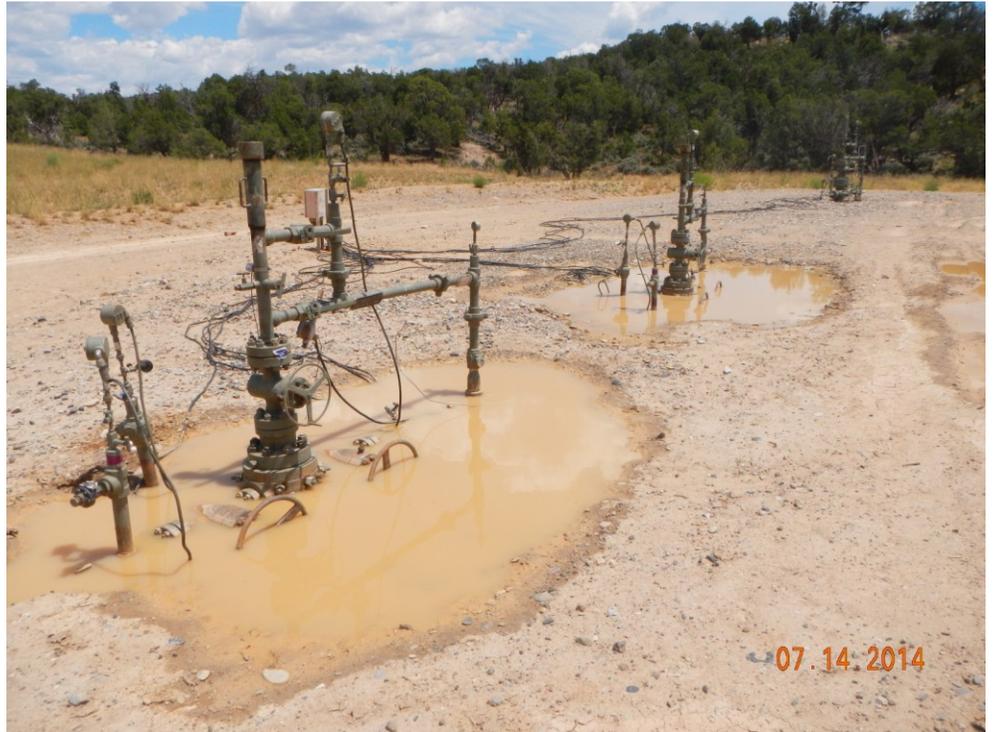
Stormwater around wellheads.

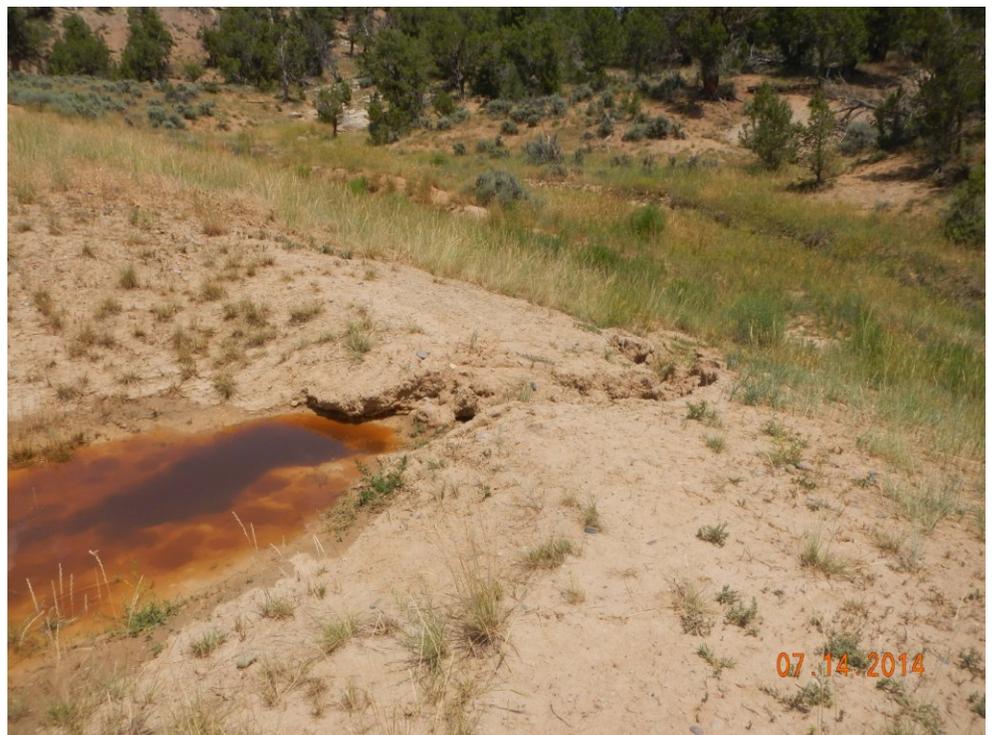
Erosion at retention pond.

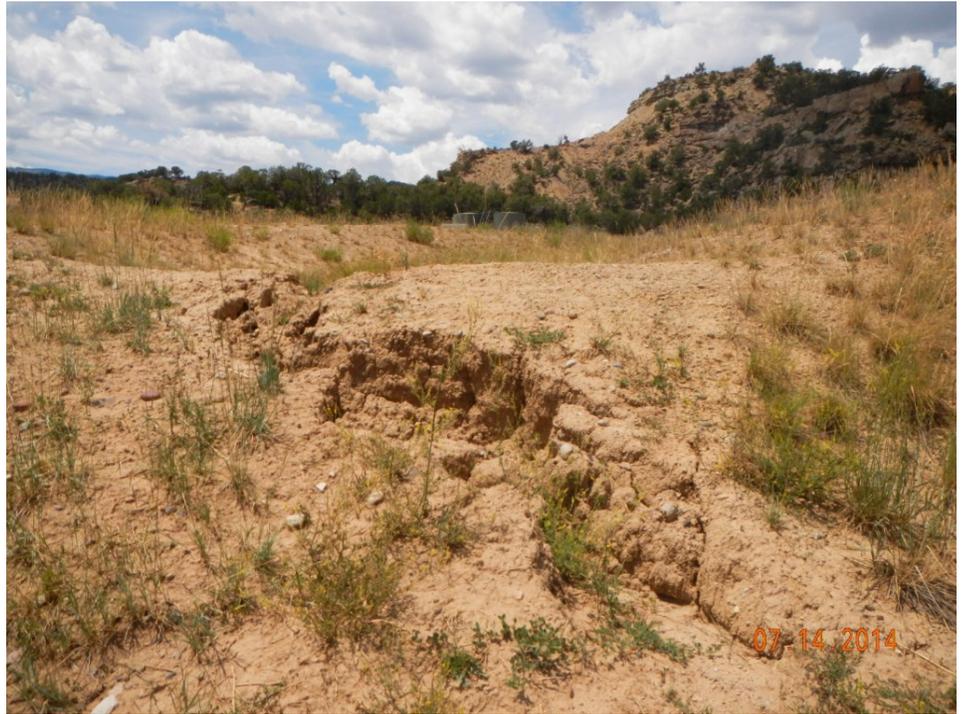
Erosion at retention ponds.
