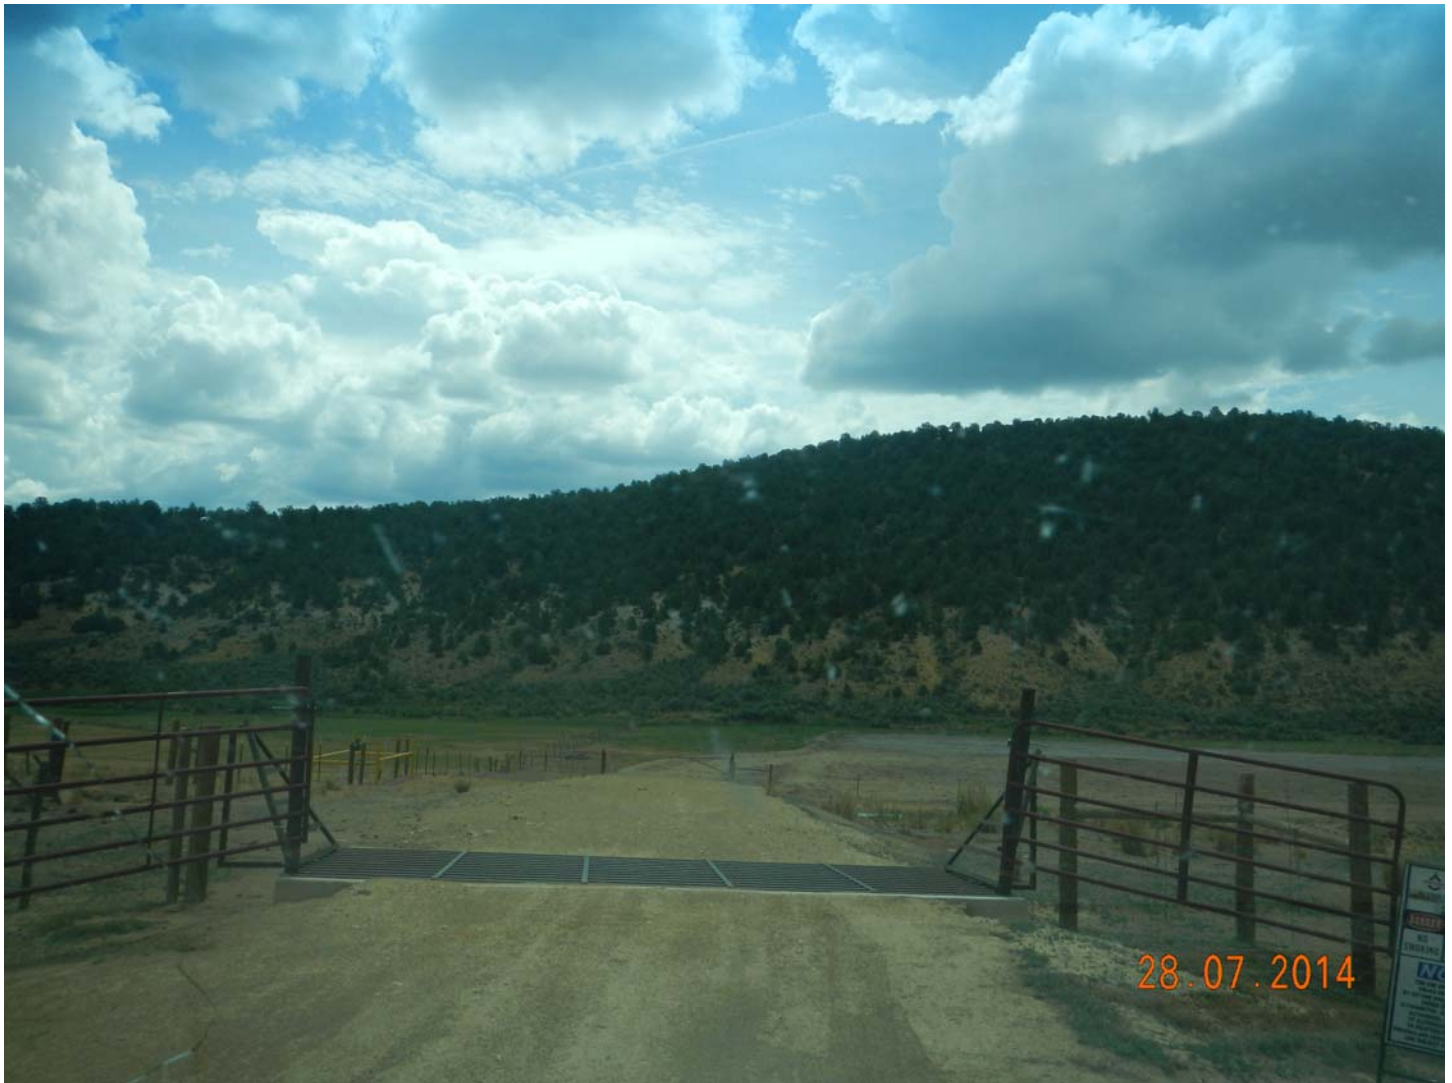
1.) Location entrance. Culvert and cattle guard intact.

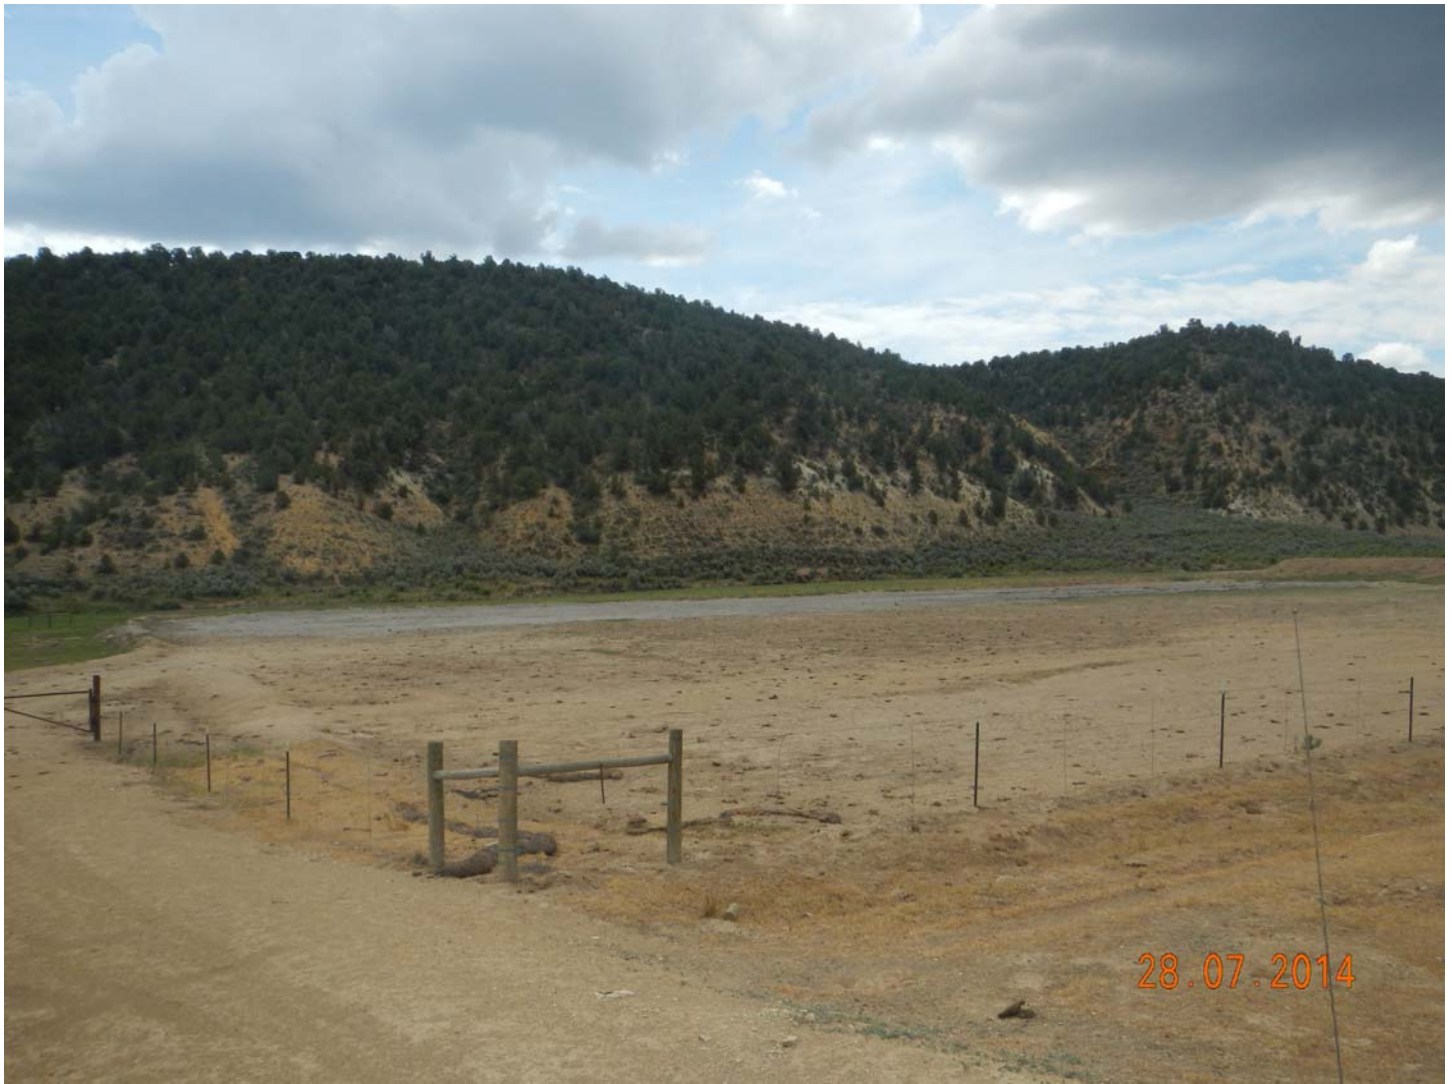
2.) Location BMPS gravel and fencing remain intact.

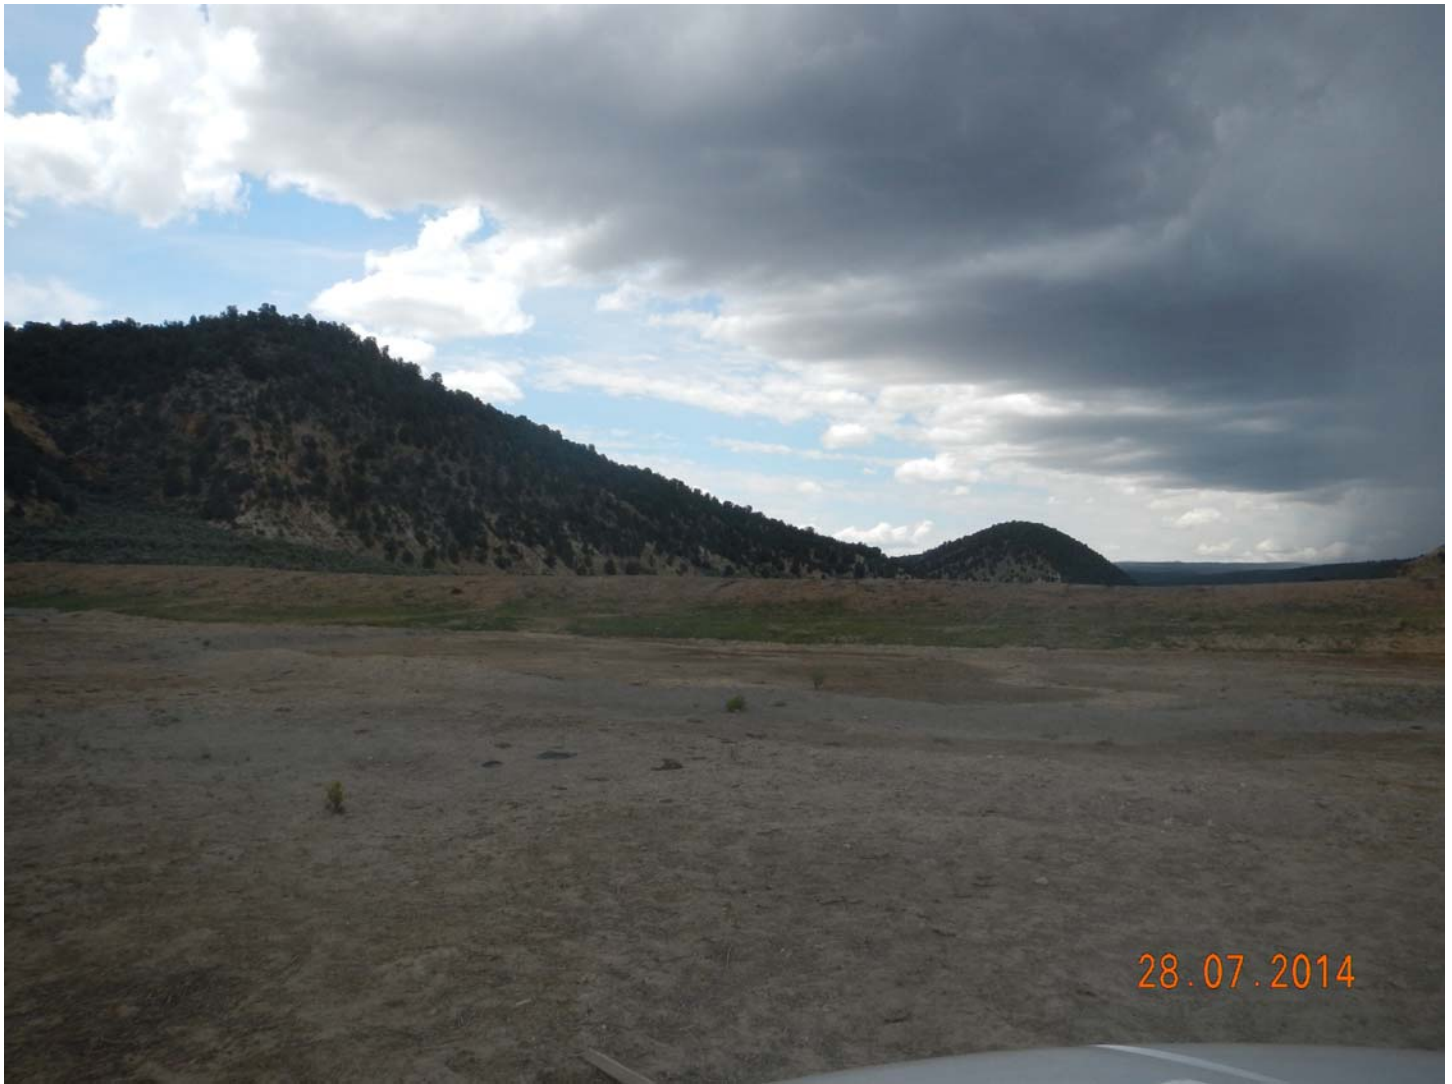
3.) Pit remains.

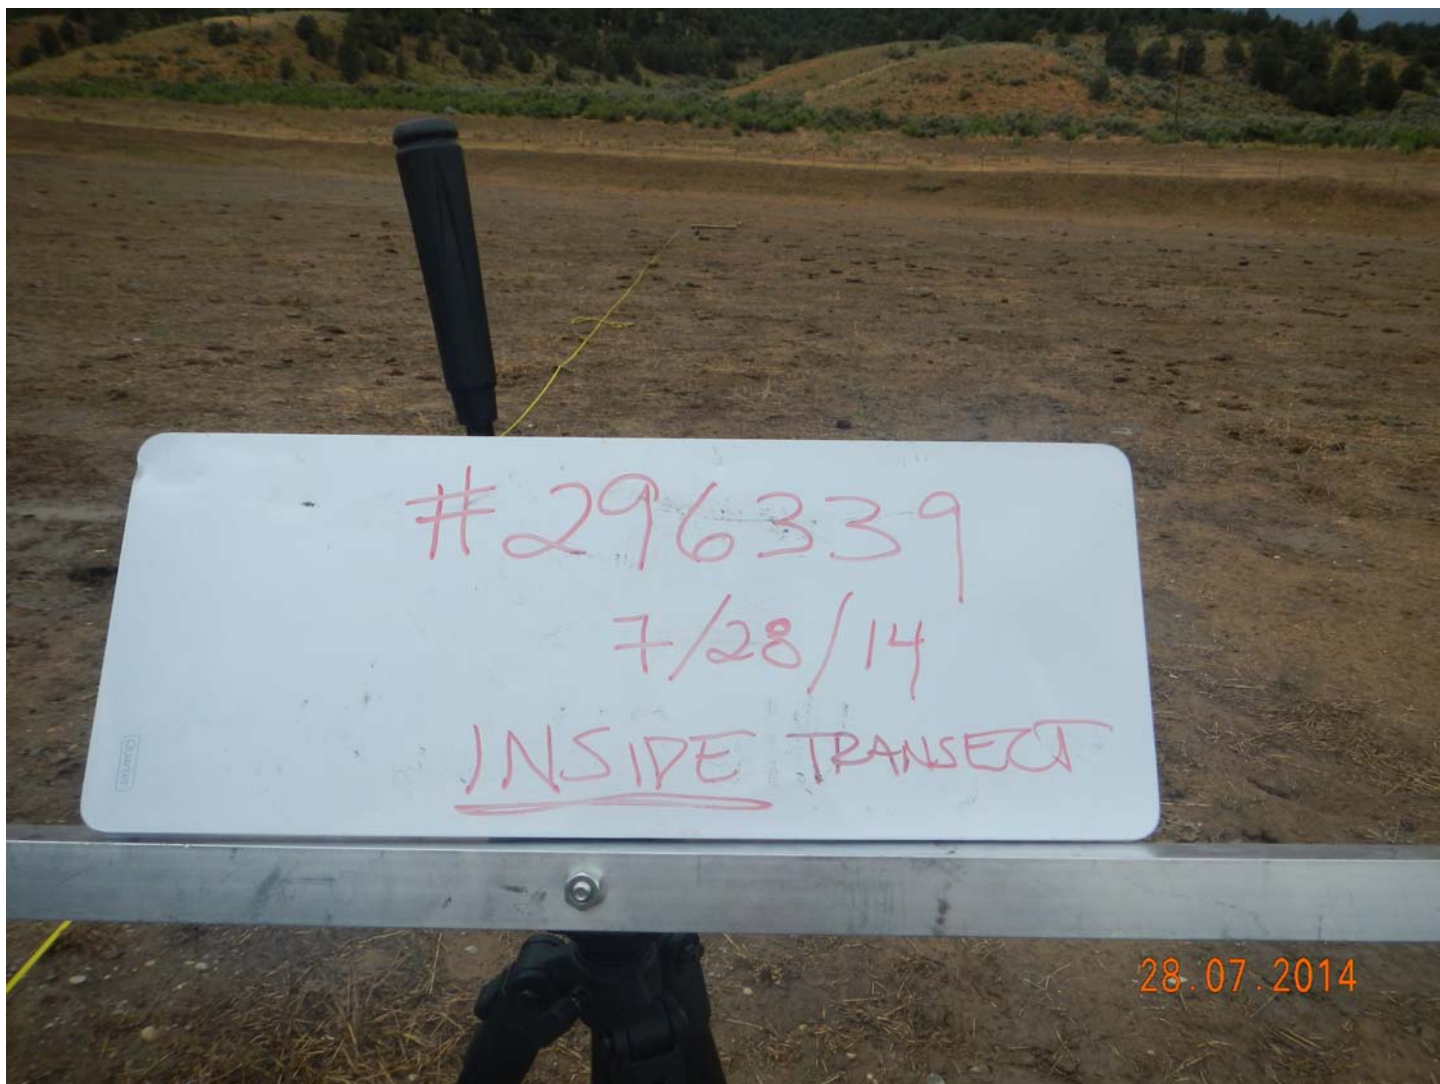
4.) Inside Transect conducted.

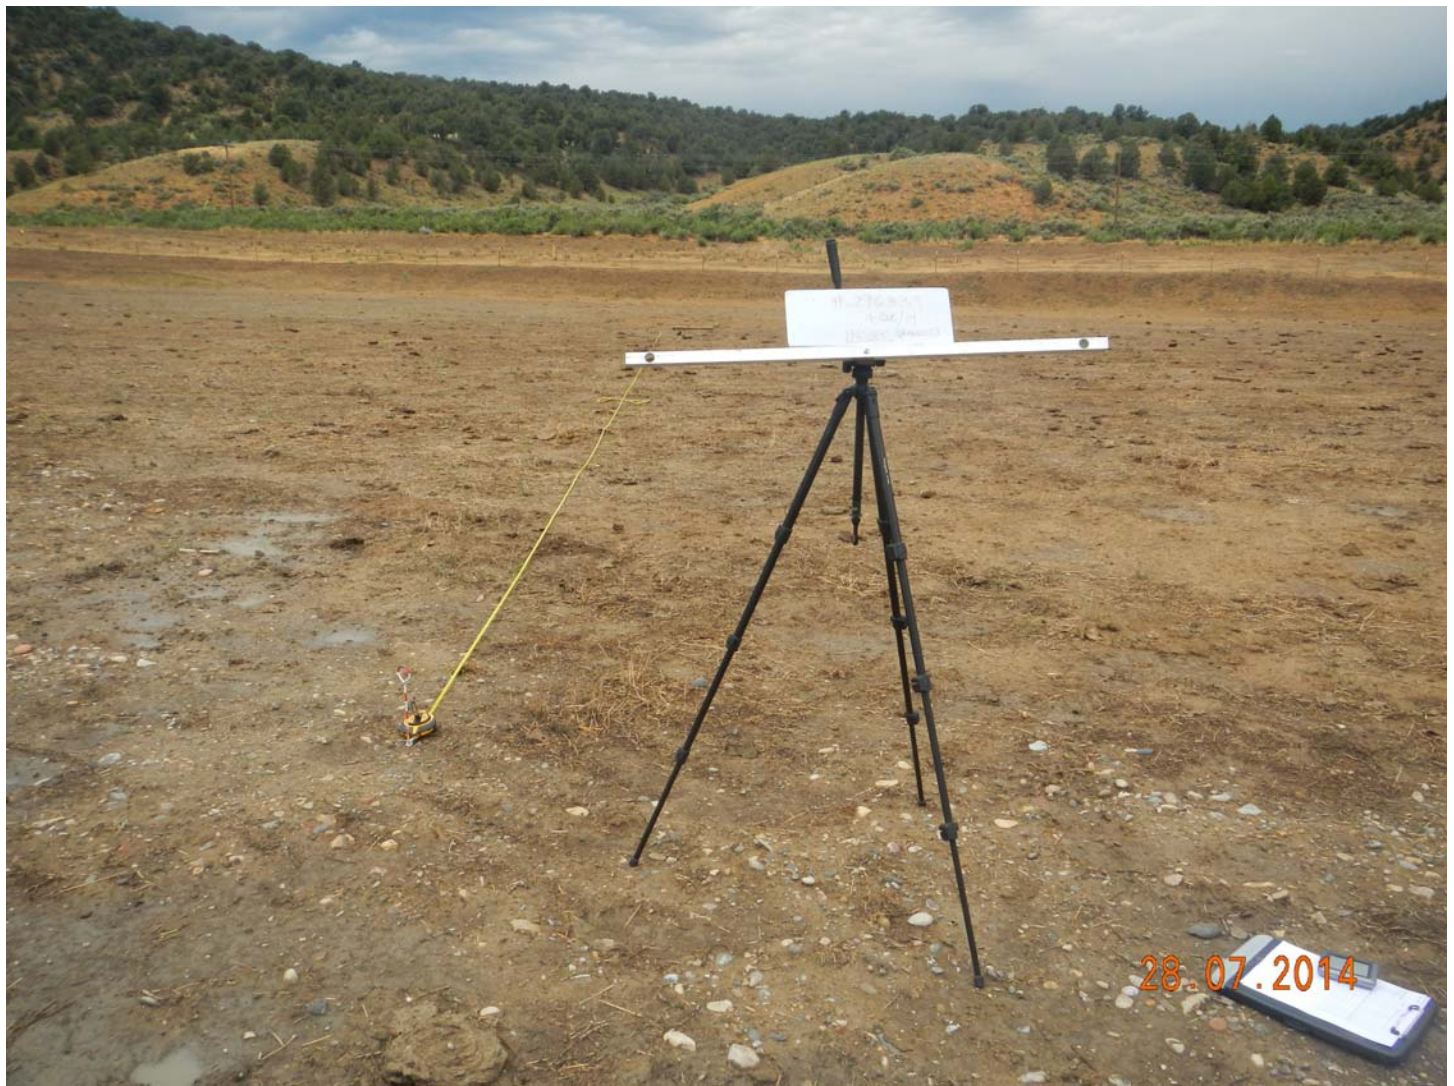
5.) Inside transect beginning.

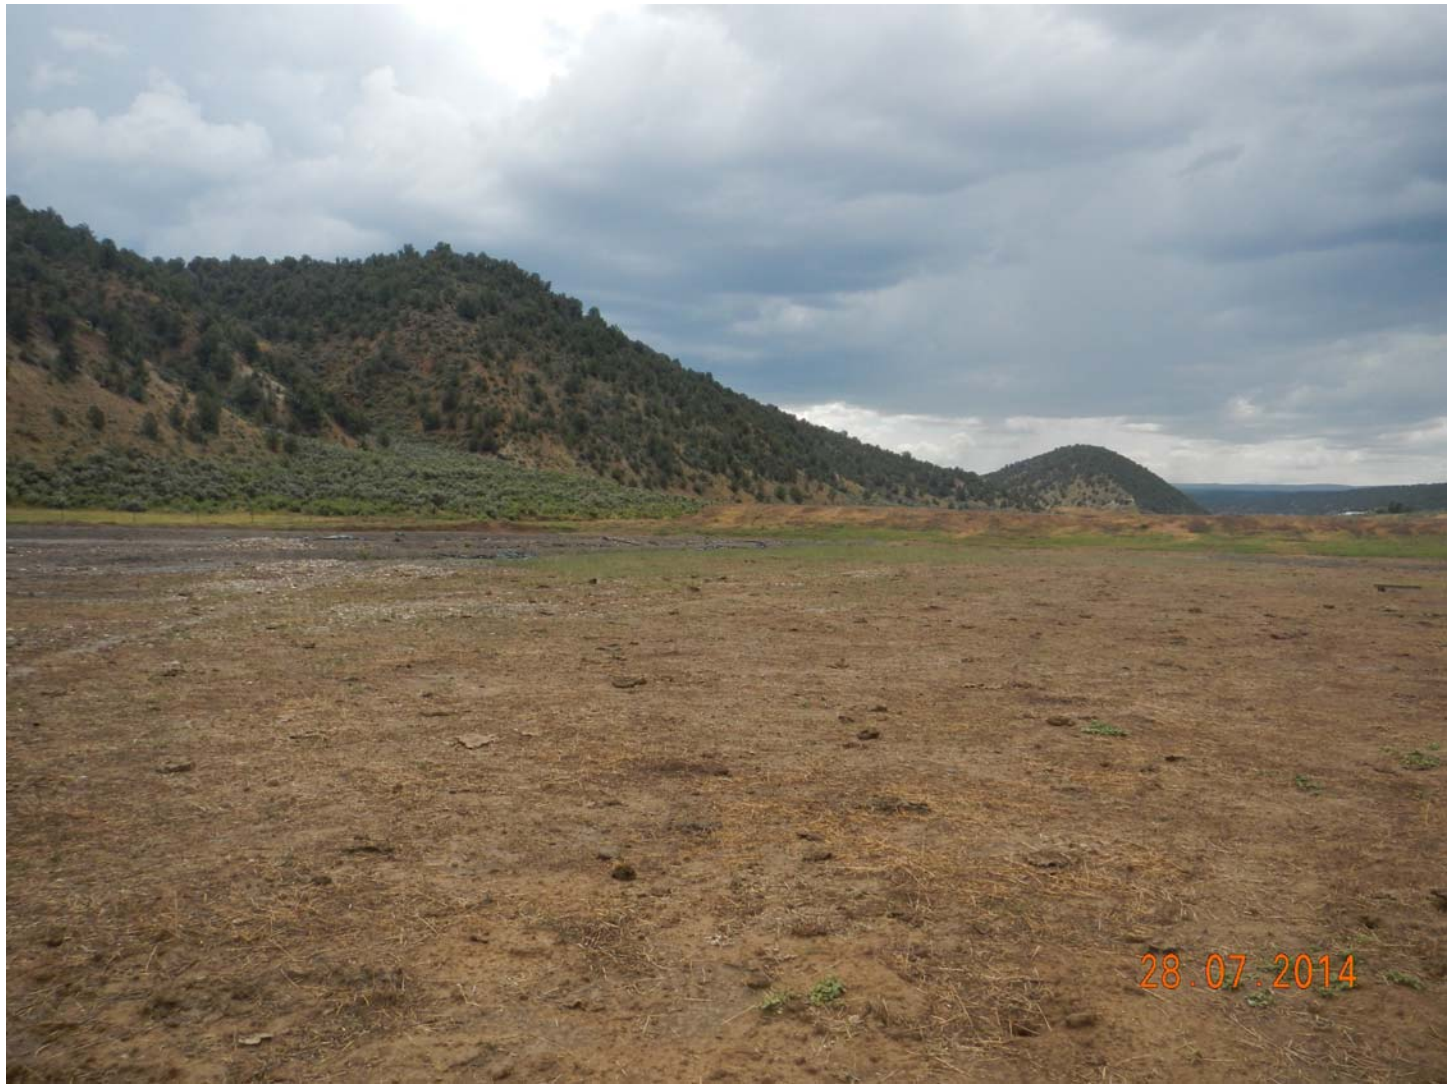
6.) Midpoint perpendicular photo 1.

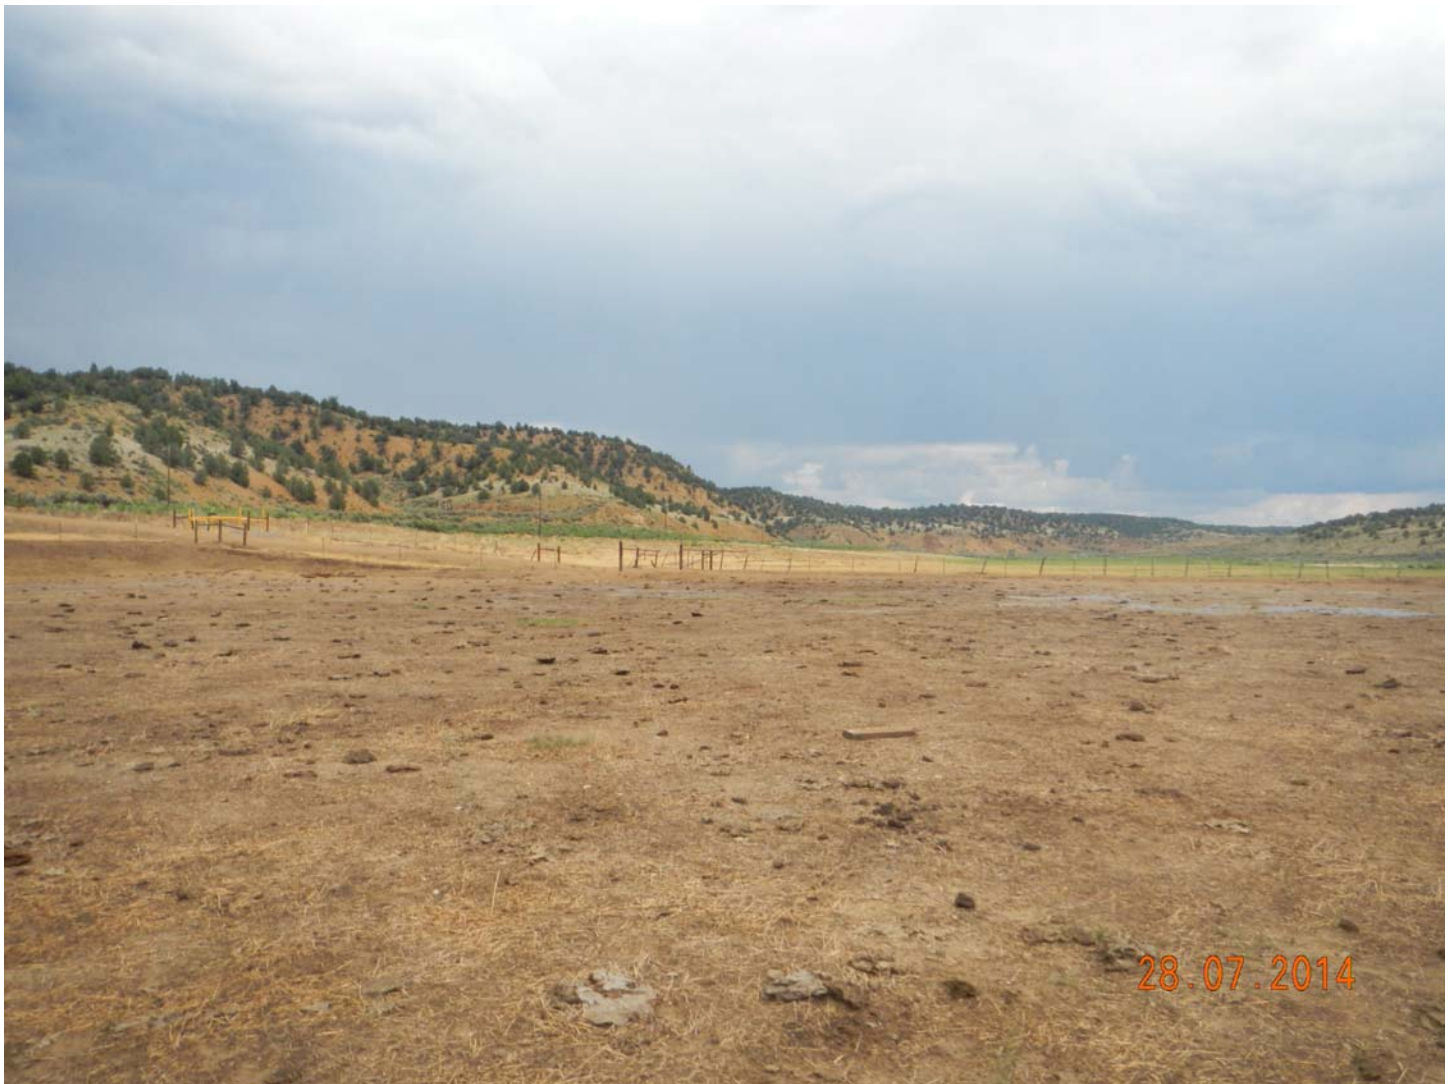
7.) Midpoint perpendicular photo 2
